VEHICLE INSPECTION REPORT

GR55MYC

Volkswagen Golf Plus 1.9 SE TDI PD 5dr

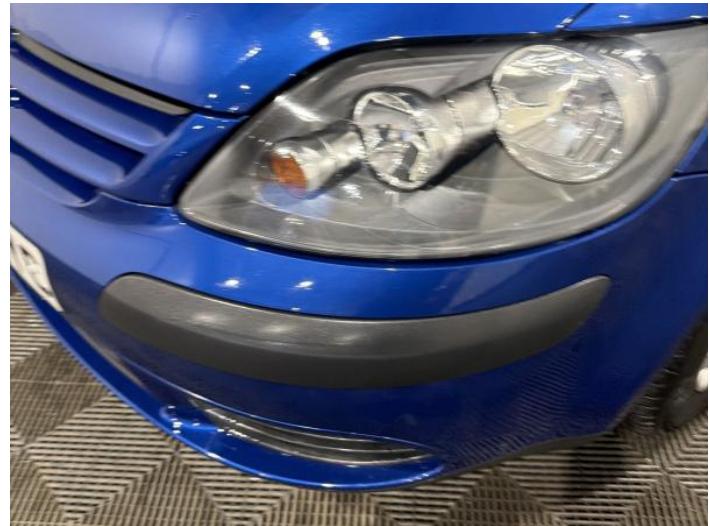
2: Bumper Front

Chipped

Multiple Chips

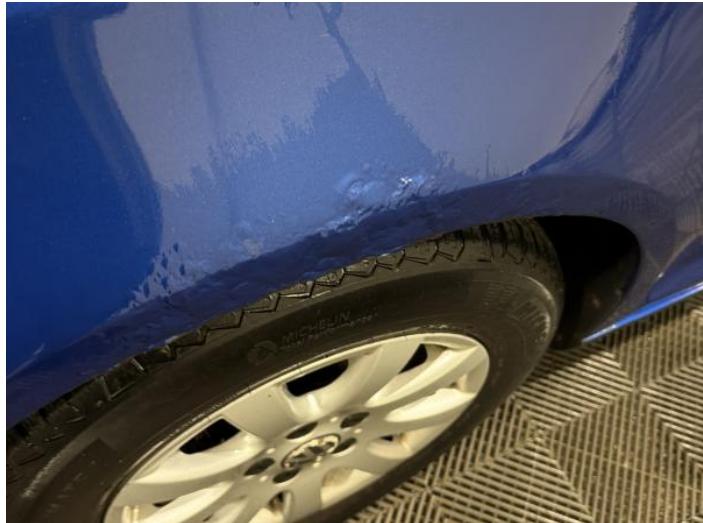
4: Wing nsf
Rusted
Over 5mm

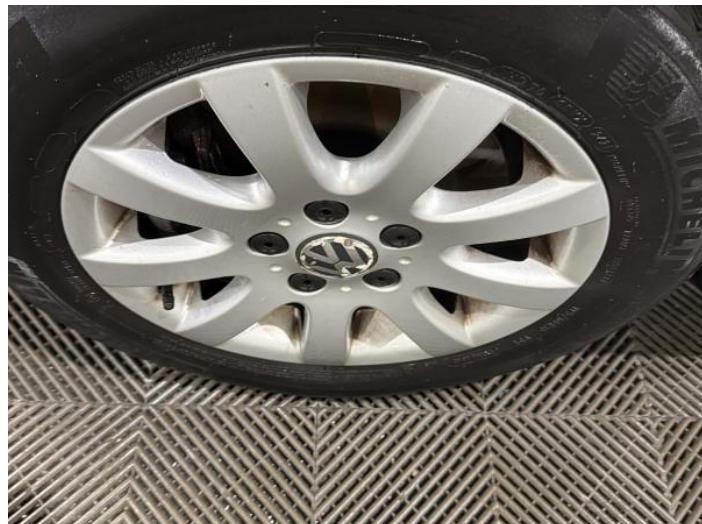
5: Wheel nsf
Scratched
Over 50mm

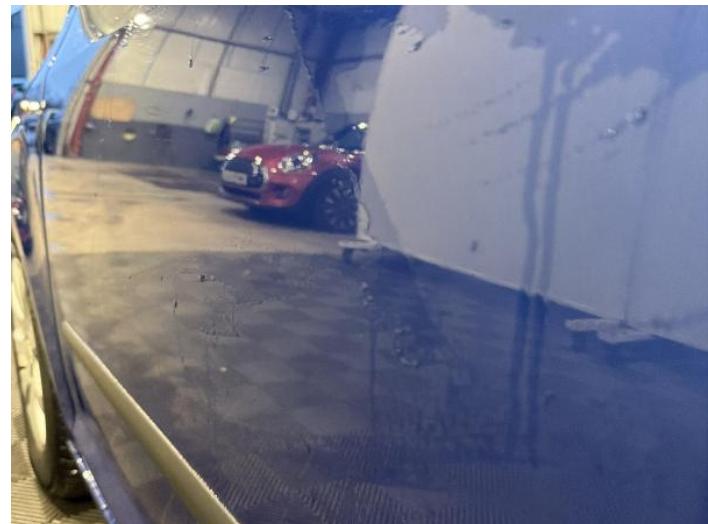
6: Door nsf
Dented
Over 2 UpTo 10mm

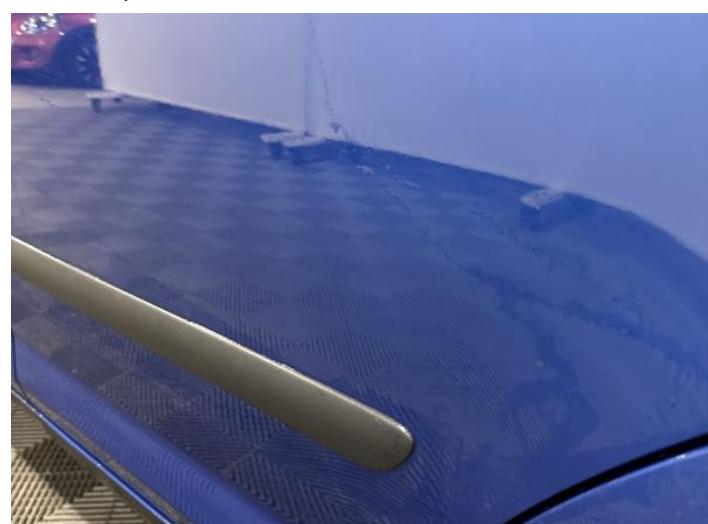
8: Door nsr
Chipped
1 To 5

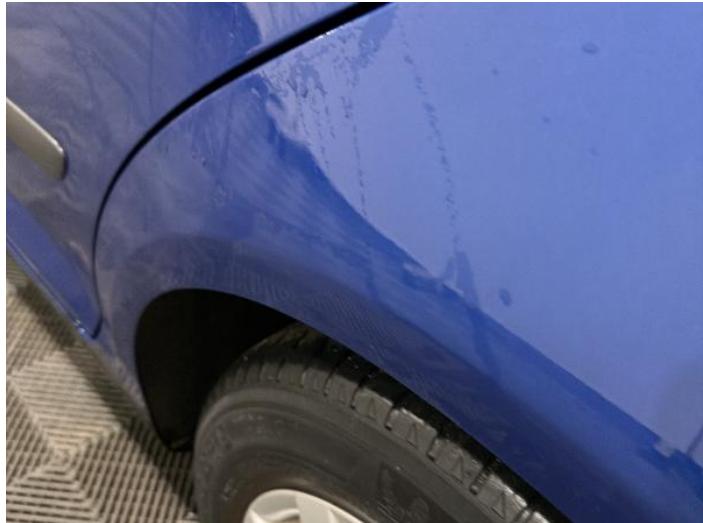
10: Qtr Panel nsr
Dented
Over 2 UpTo 10mm

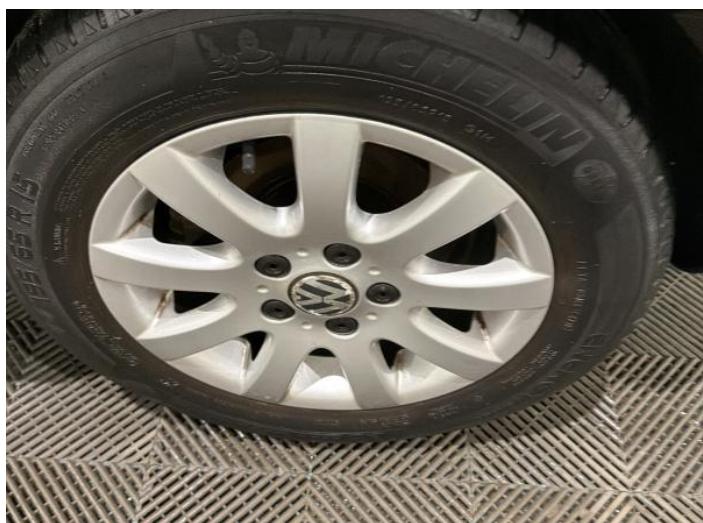
12: Wheel nsr
Scratched
Up To 50mm

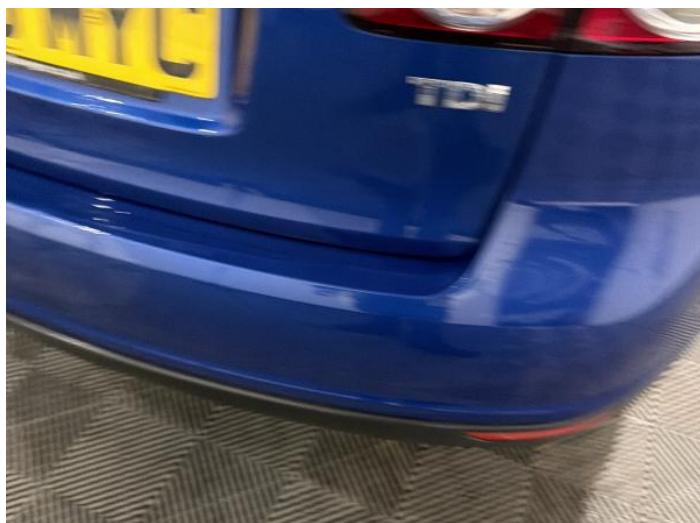
13: Bumper Rear
Scratched
25 to 100mm Thru Paint

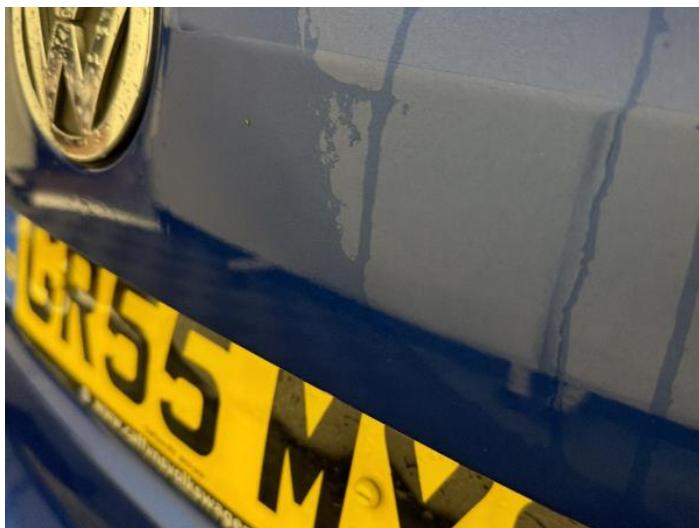
15: Boot Lid
Dented
Over 2 UpTo 10mm

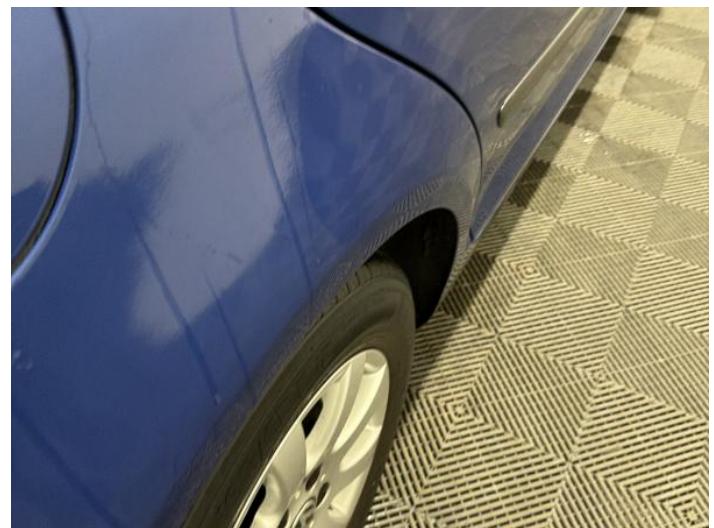
16: Qtr Panel osr
Chipped
1 To 5

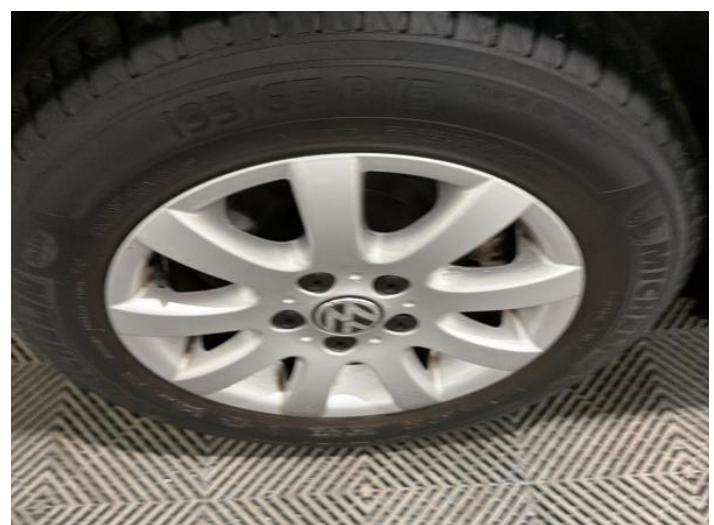
18: Wheel osr
Scratched
Up To 50mm

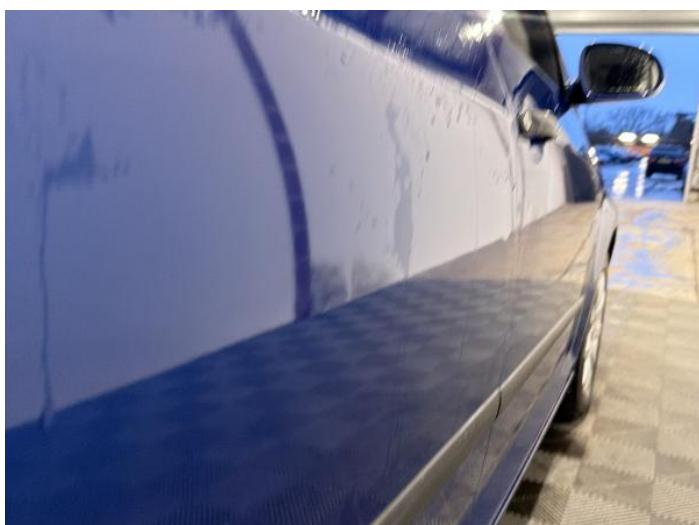
19: Door osr
Poor Previous Repair
Poor Paint

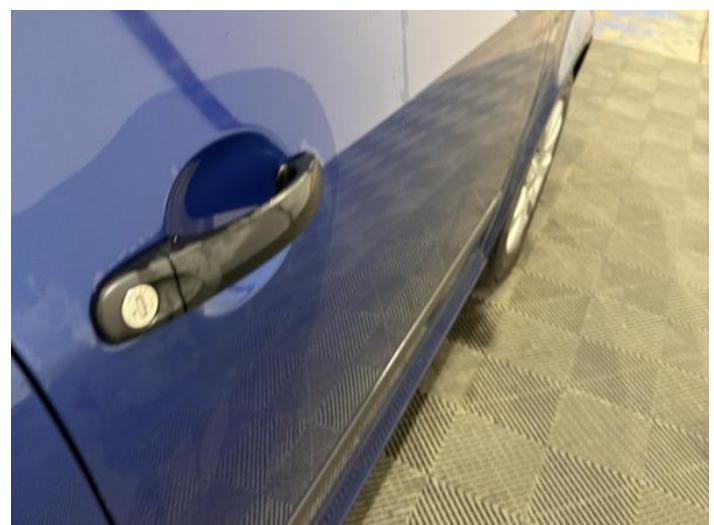
20: Door osf
Poor Previous Repair
Poor Paint

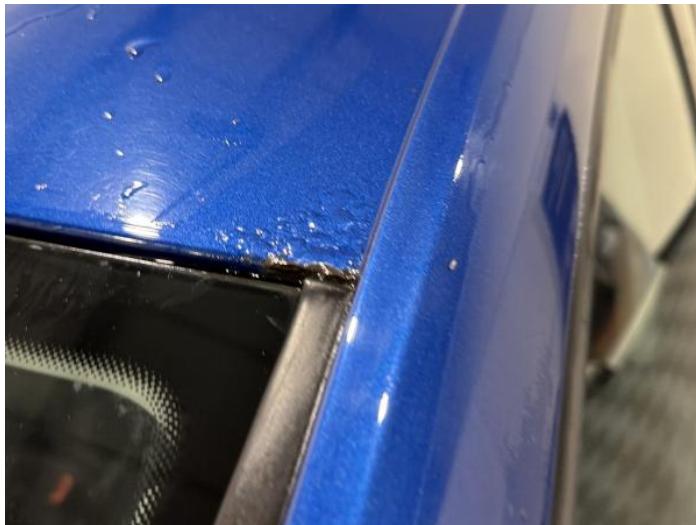
21: Roof
Rusted
Over 5mm

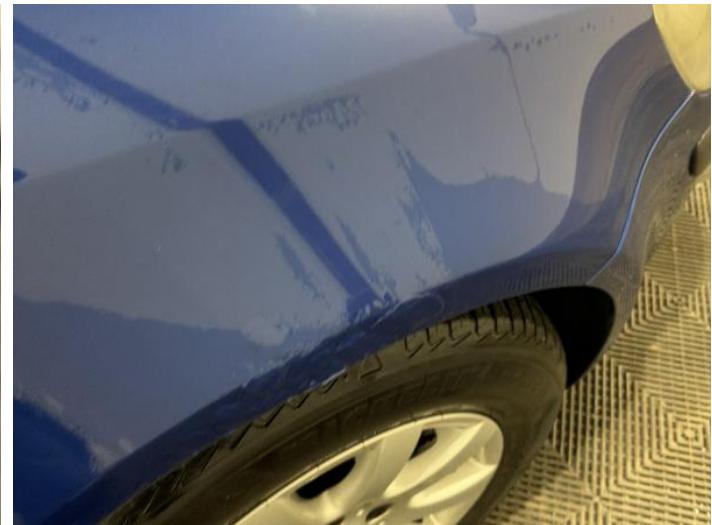
22: Wing osf
Rusted
Over 5mm

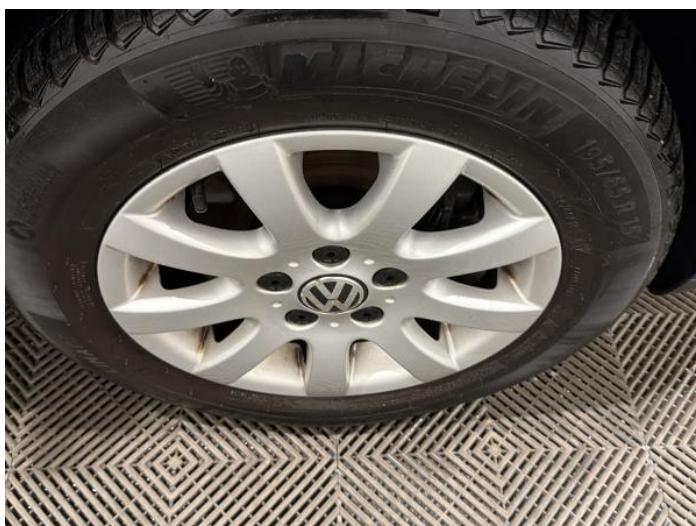
23: Wheel osf
Scratched
Up To 50mm

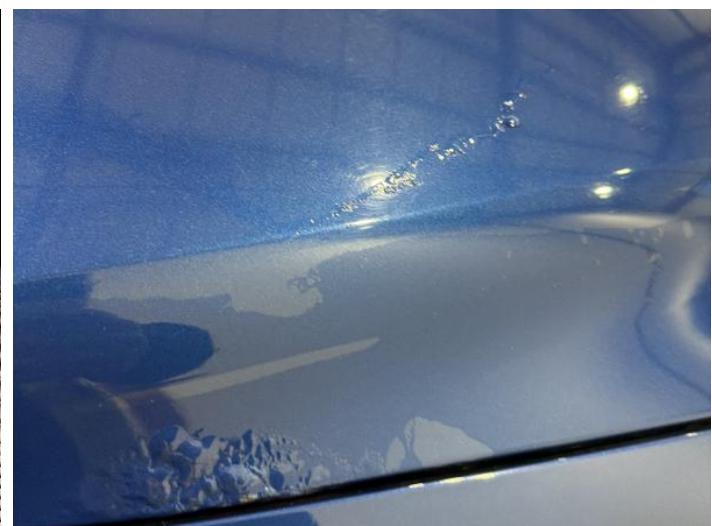
24: Roof
Rusted
Over 5mm

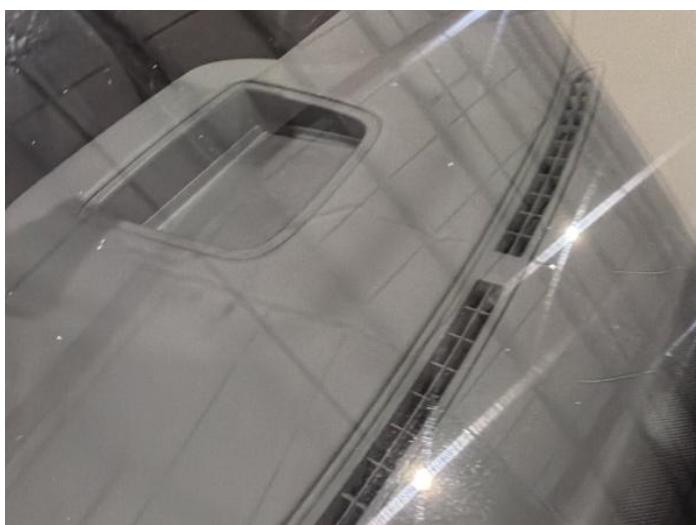
25: Screen Front
Chipped
UpTo 10mm
