VEHICLE INSPECTION REPORT

ND65YJE

Nissan Juke 1.2 DiG-T Tekna 5dr

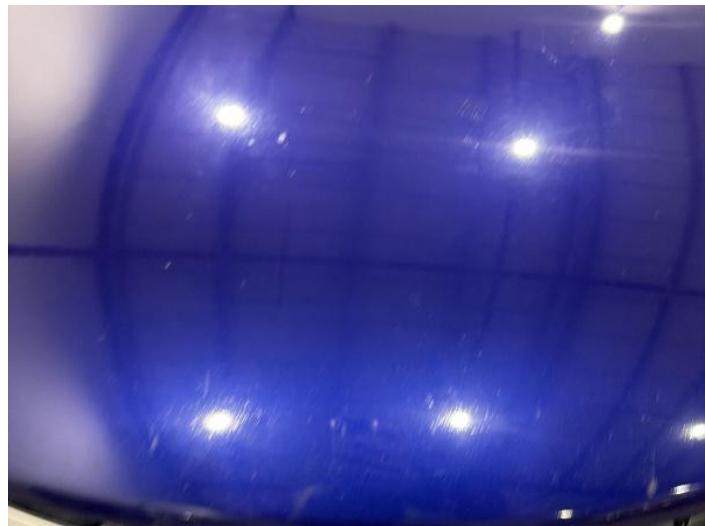
1: Bonnet
Chipped
Multiple Chips

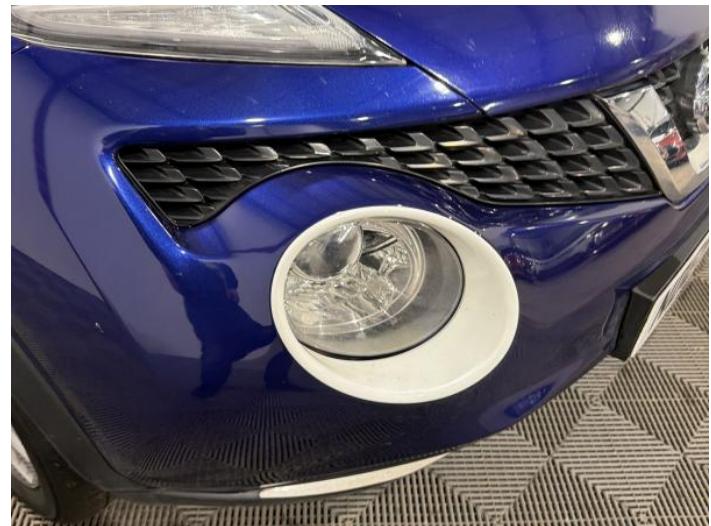
2: Bumper Front
Scratched
Over 100mm Thru Paint

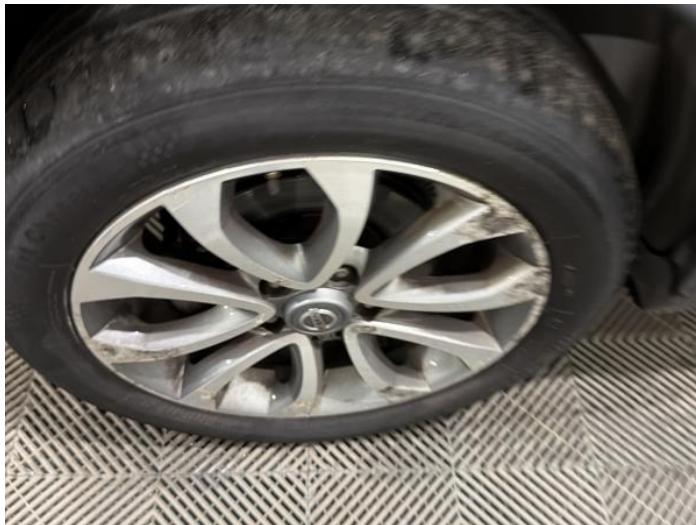
3: Wheel nsf
Scratched
Over 50mm

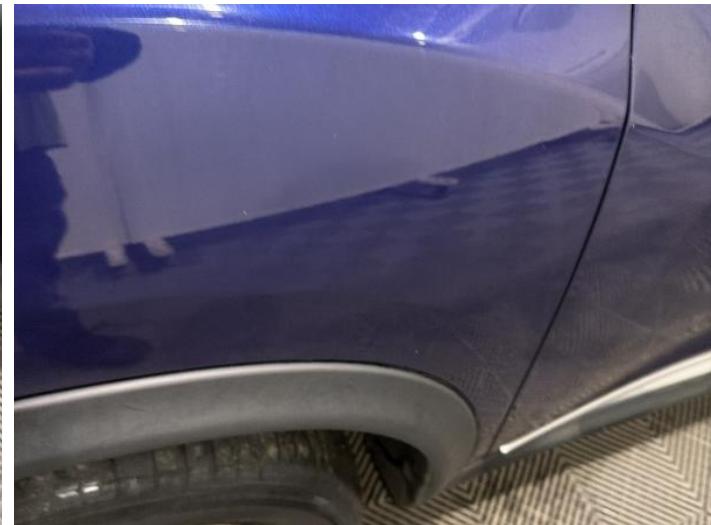
4: Wing nsf
Dented
Over 2 UpTo 10mm

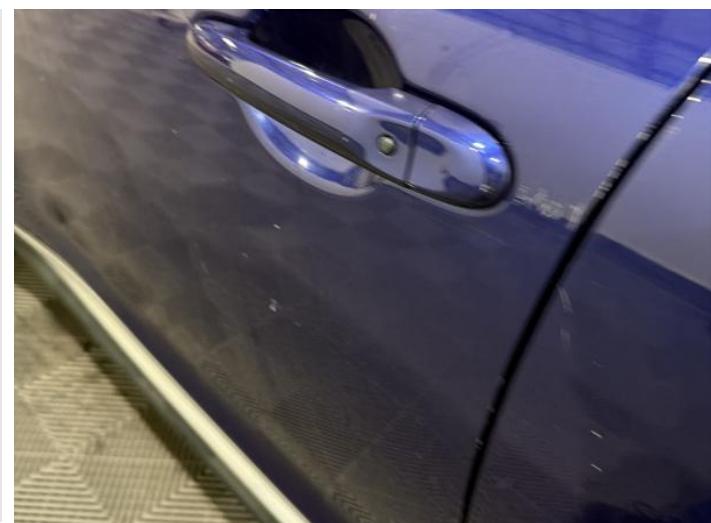
6: Door nsf
Dented
With Paint Damage

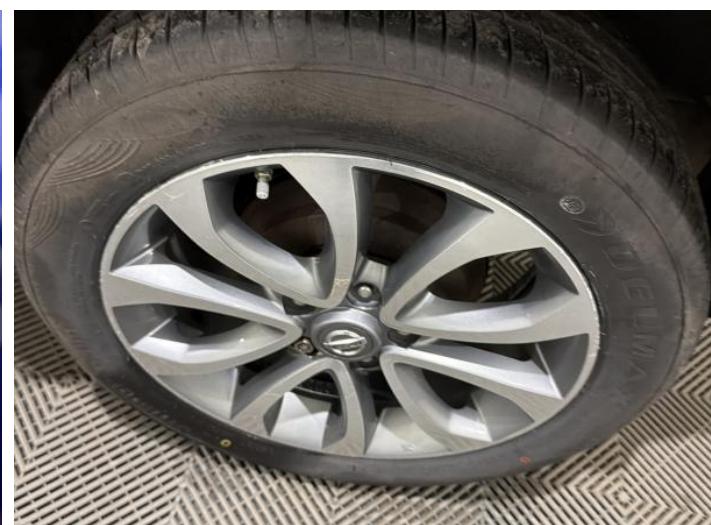
8: Wheel nsr
Scratched
Over 50mm

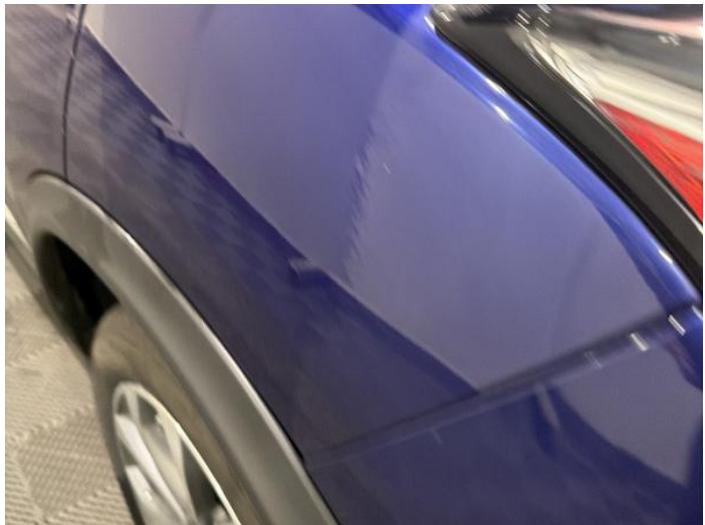
9: Qtr Panel nsr
Dented
Over 2 UpTo 10mm

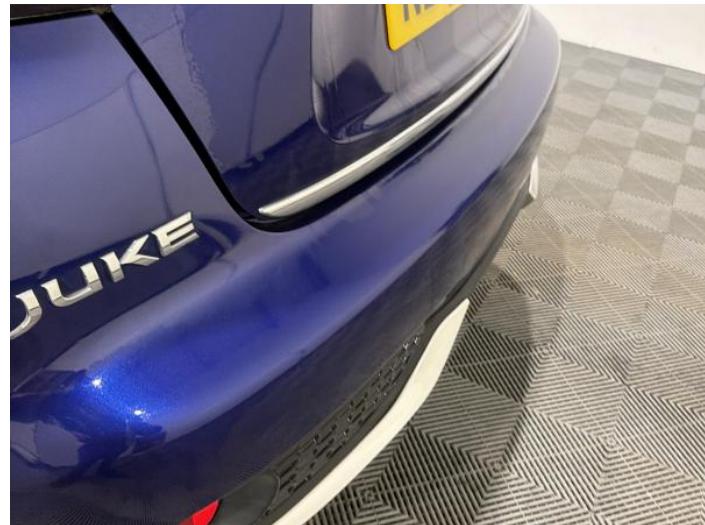
10: Bumper Rear
Poor Previous Repair
Poor Paint

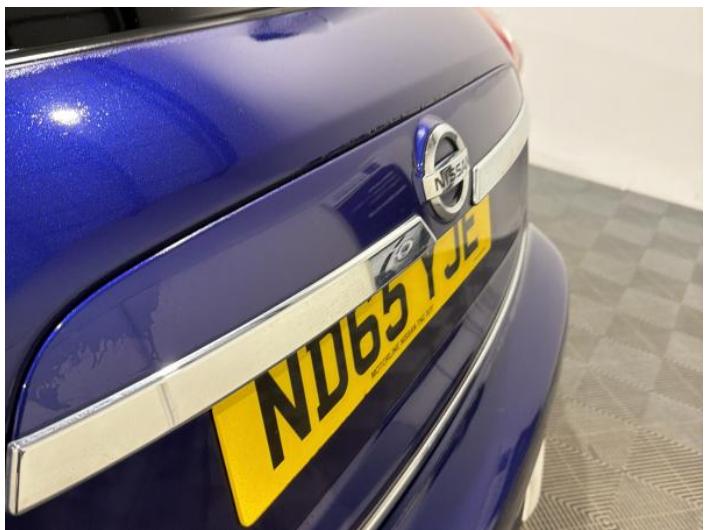
11: Boot Lid
Dented
Over 2 UpTo 10mm

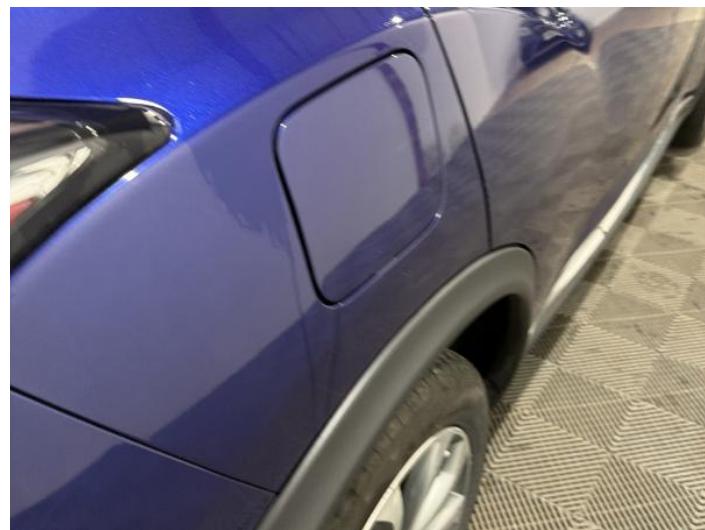
12: Qtr Panel osr
Scratched
Over 25mm Thru Paint

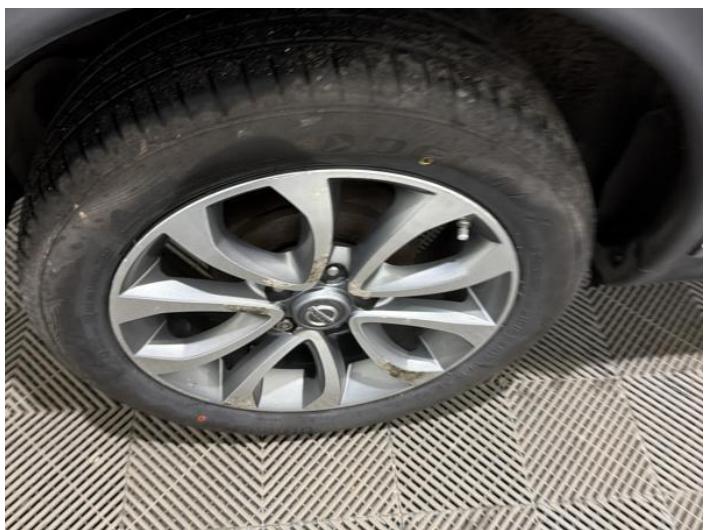
13: Wheel osr
Scratched
Over 50mm

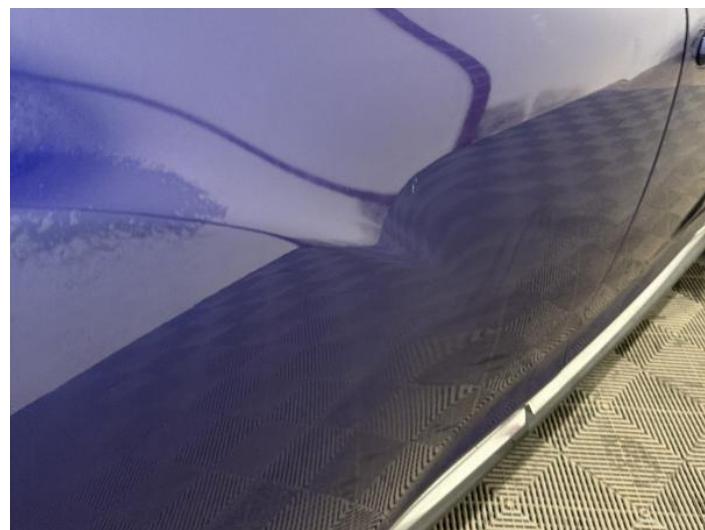
14: Door osr
Dented
With Paint Damage

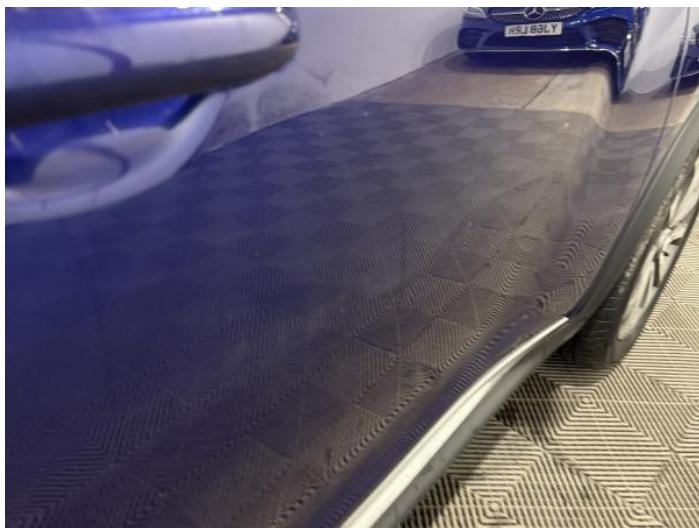
15: Door osf
Dented
With Paint Damage

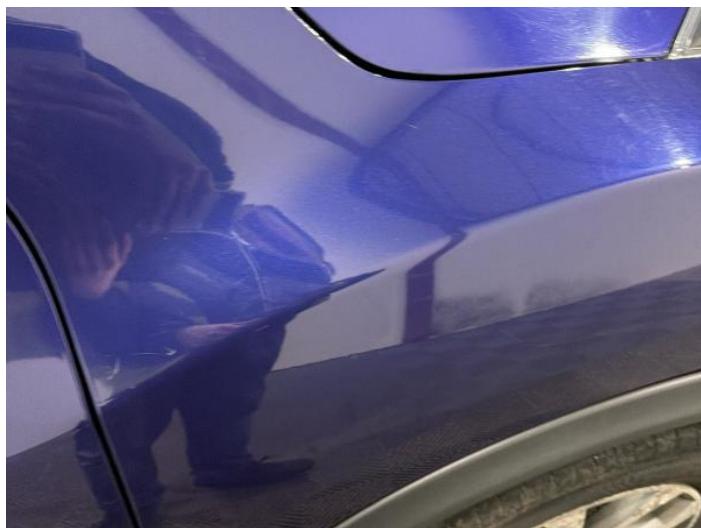
16: Wing osf
Dented
With Paint Damage

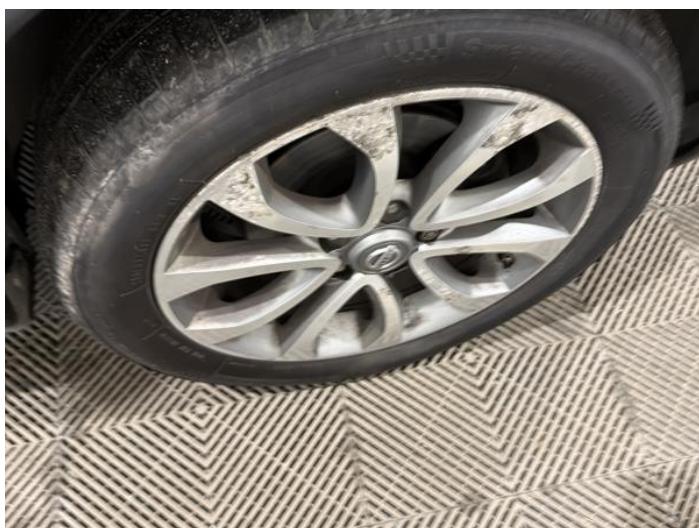
17: Wheel osf
Scratched
Over 50mm
