VEHICLE INSPECTION REPORT

LR10VVL

Volvo XC90 2.4 D5 Active 5dr

Inspection	Vehicle		nama GRADE 4
Serious Damage?	VAT	Margin	
No	V5	Present

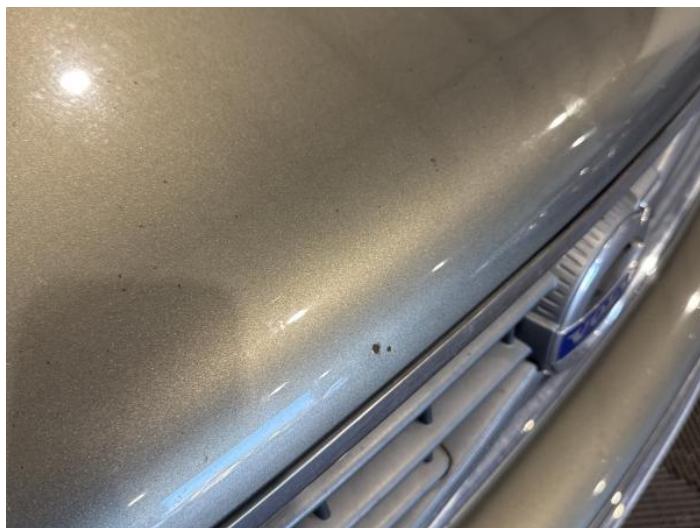
1: Bonnet
Chipped
Multiple Chips

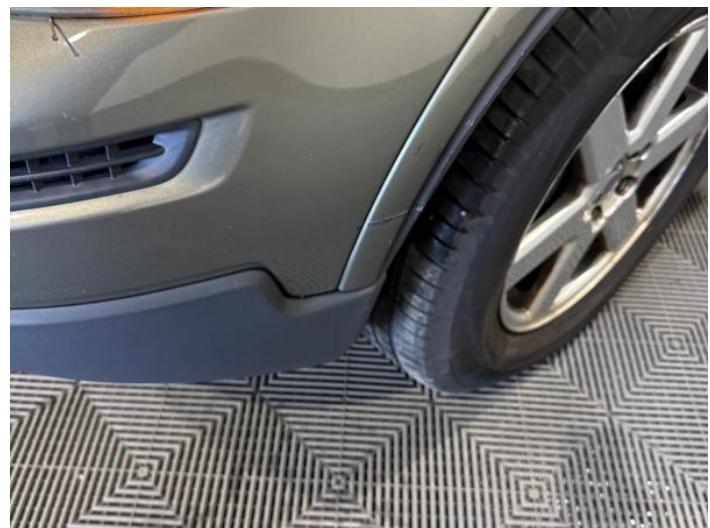
2: Bumper Front
Scratched
Over 100mm Thru Paint

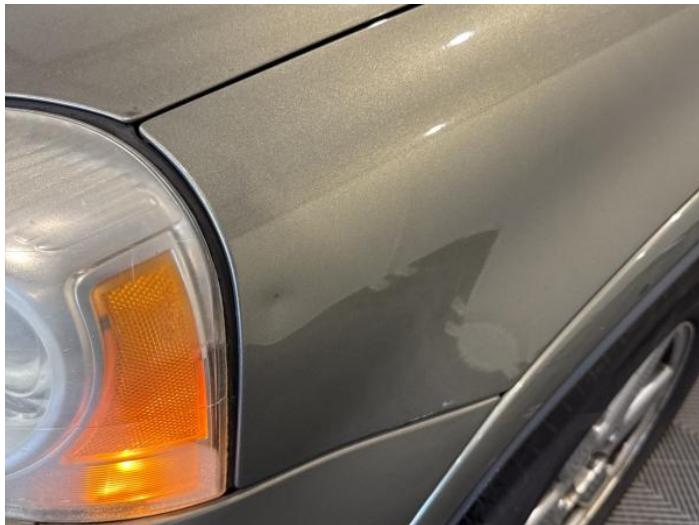
3: Wing nsf
Dented
Between 10mm + 30mm

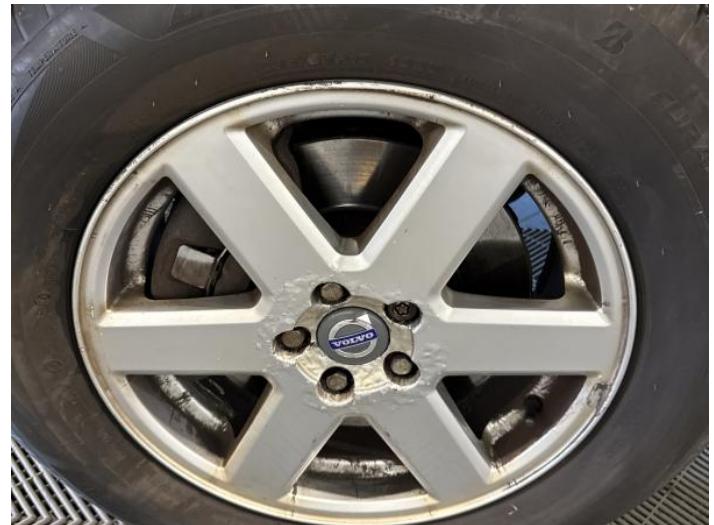
4: Wheel nsf
Scratched
Over 50mm

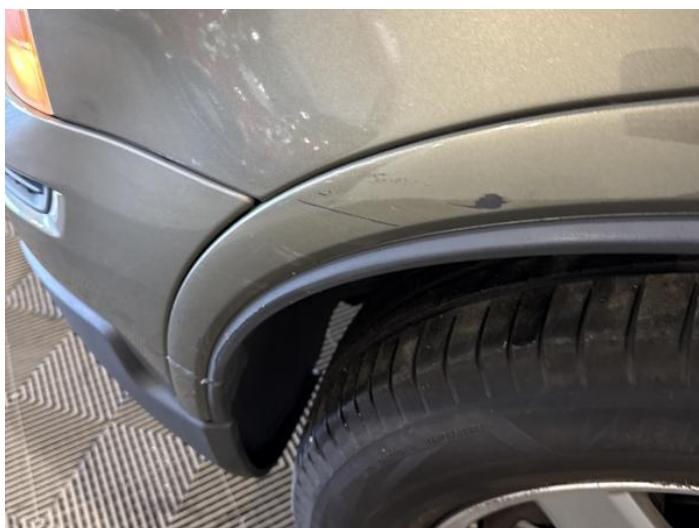
5: Wing Front Arch Extension ns
Scratched (Painted)
Over 25mm Thru Paint

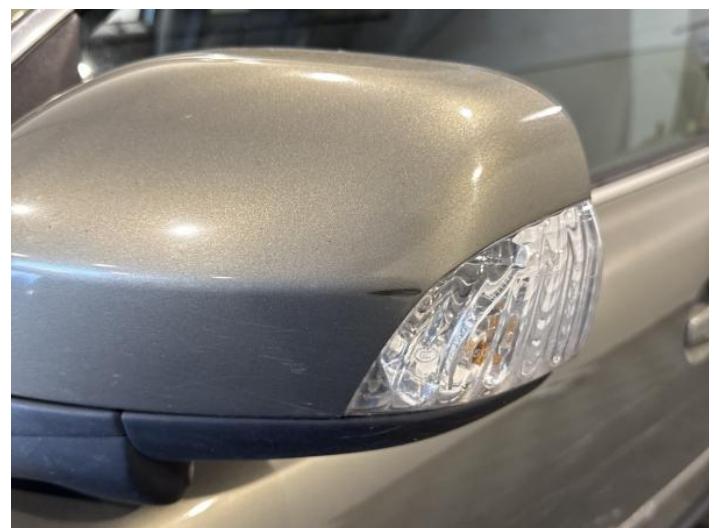
6: Door Mirror Assy nsf
Scratched (Painted)
UpTo 25mm Thru Paint

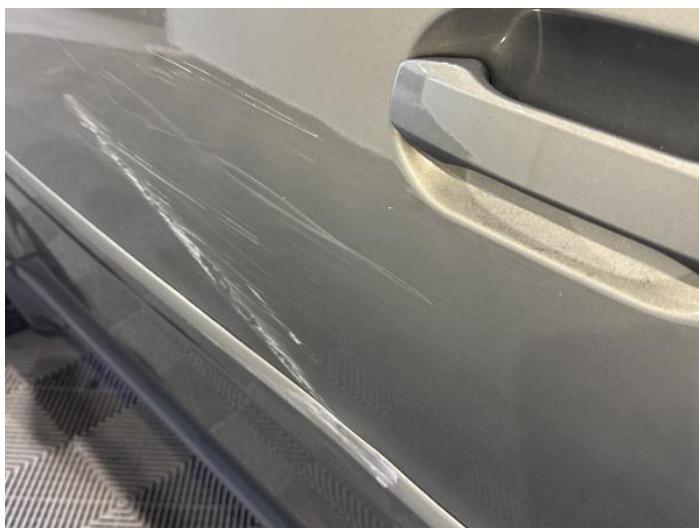
7: Door nsf
Dented
With Paint Damage

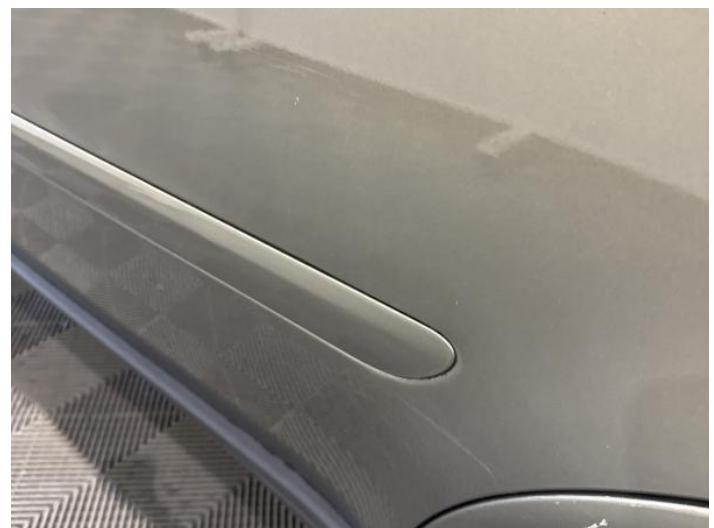
8: Door nsf
Scratched
Over 25mm Thru Paint

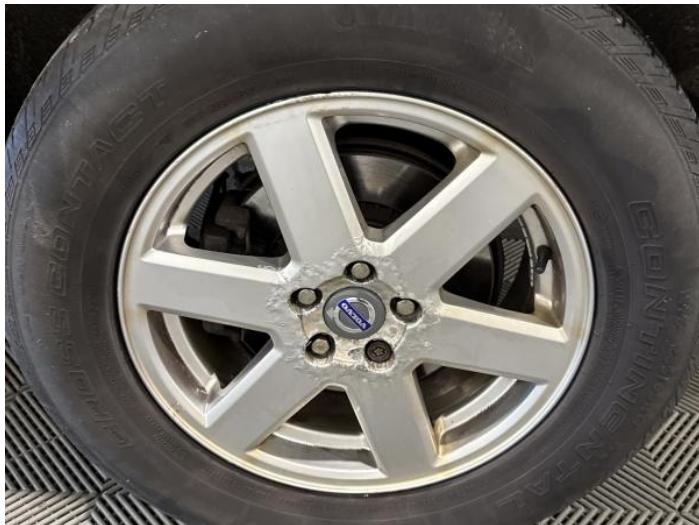
9: Wheel nsr
Corroded
Light

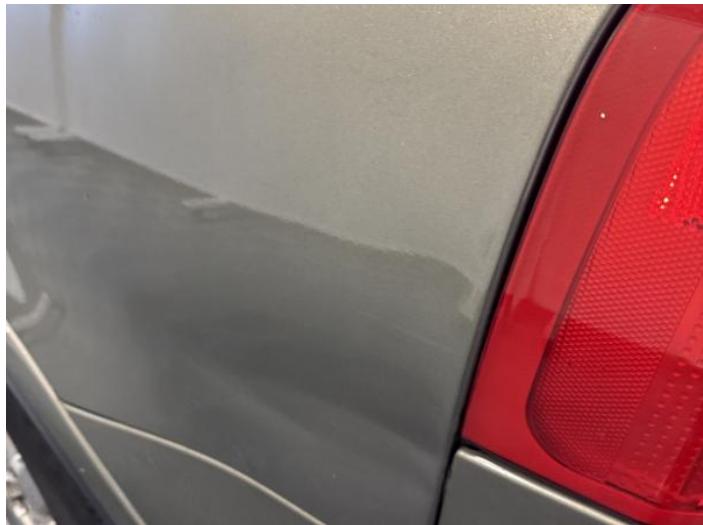
10: Qtr Panel nsr
Dented
Over 30mm

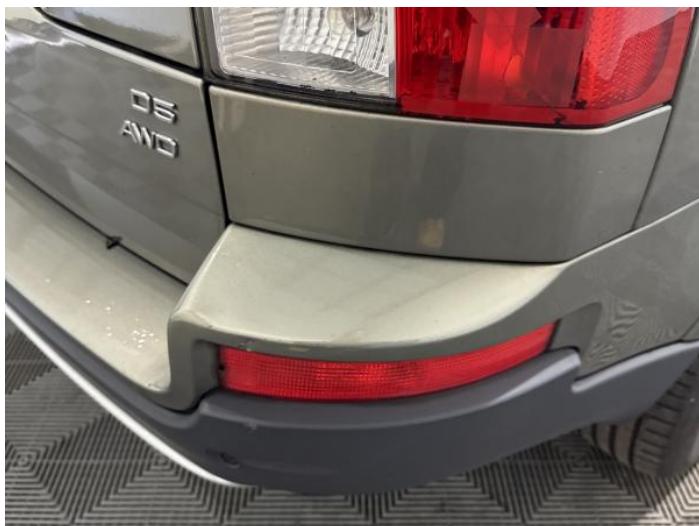
11: Bumper Rear
Scratched
25 to 100mm Thru Paint

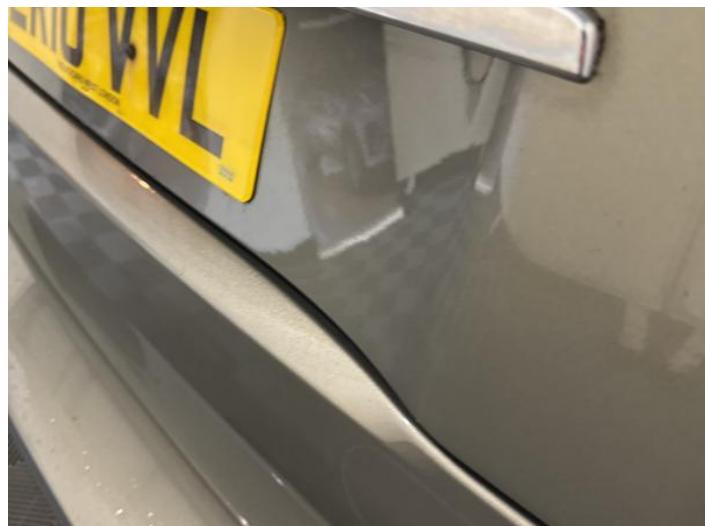
12: Tailgate
Dented
Between 10mm + 30mm

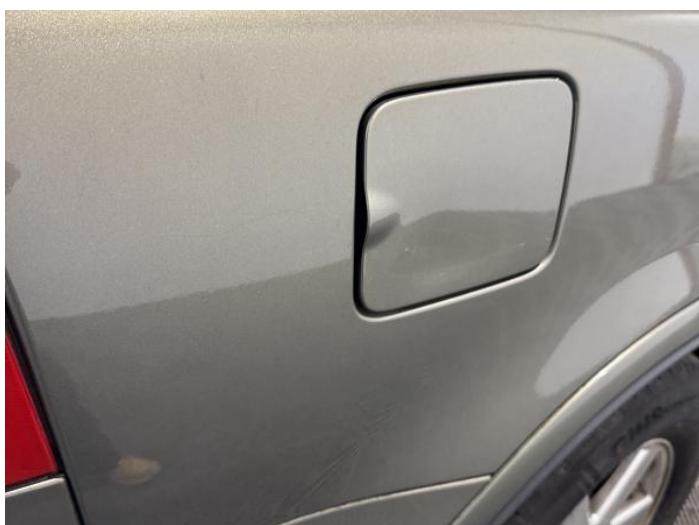
13: Qtr Panel osr
Scratched
Over 25mm Thru Paint

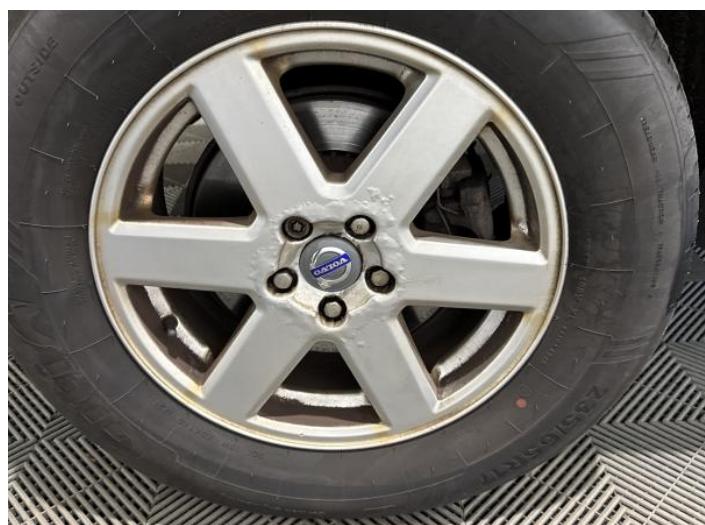
14: Wheel osr
Corroded
Light

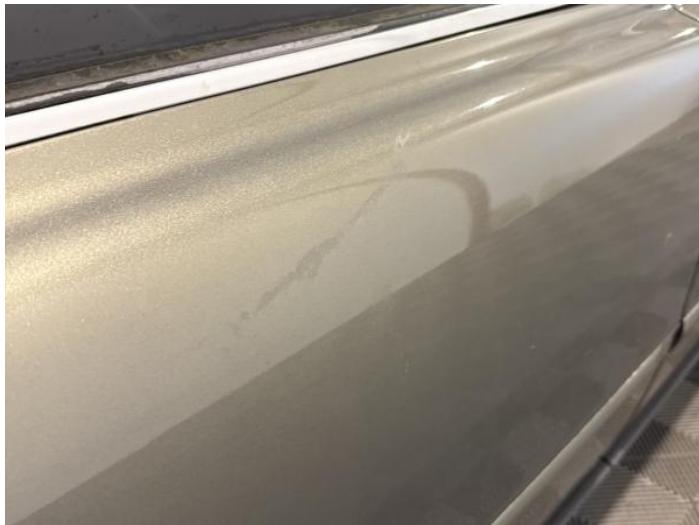
15: Door osr
Scratched
Over 25mm Thru Paint

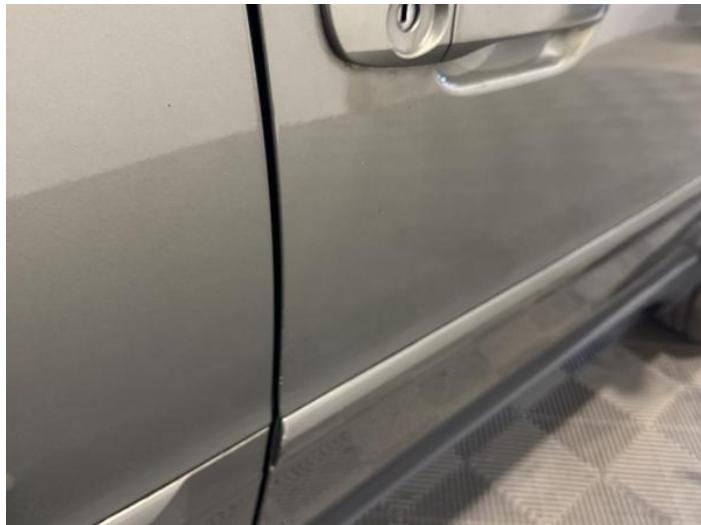
16: Door osf
Chipped
Edge Chip

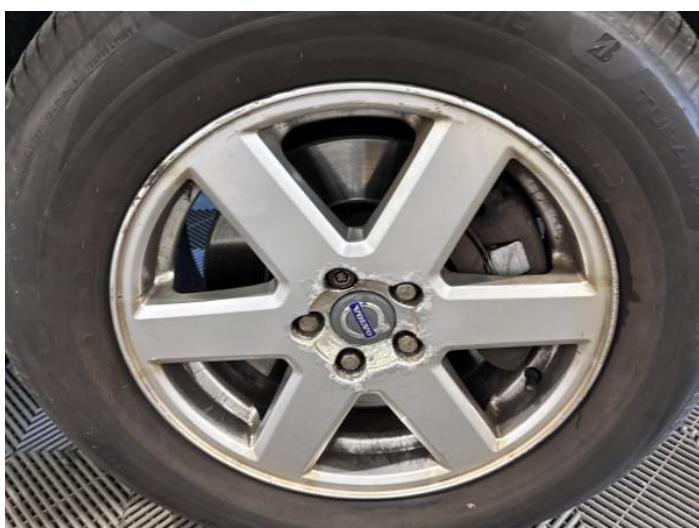
17: Wheel osf
Scratched
Over 50mm

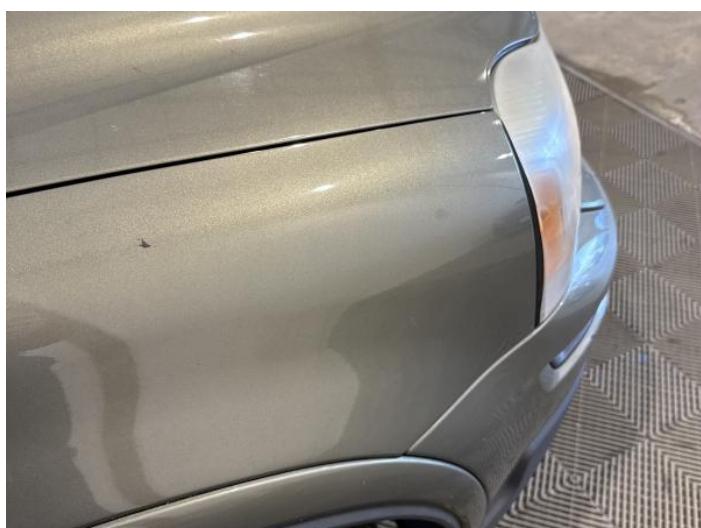
18: Wing osf
Chipped
1 To 5
