VEHICLE INSPECTION REPORT

HK14HHX

Nissan Juke 1.6 Acenta Premium 5dr Xtronic

Inspection	Vehicle	nama GRADE 4
Serious Damage?	VAT	Margin
No	V5	Present

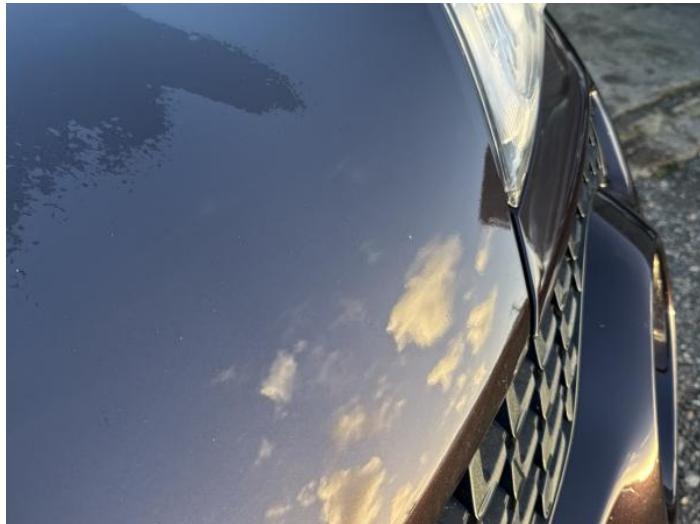
1: Bonnet
Chipped
1 To 5

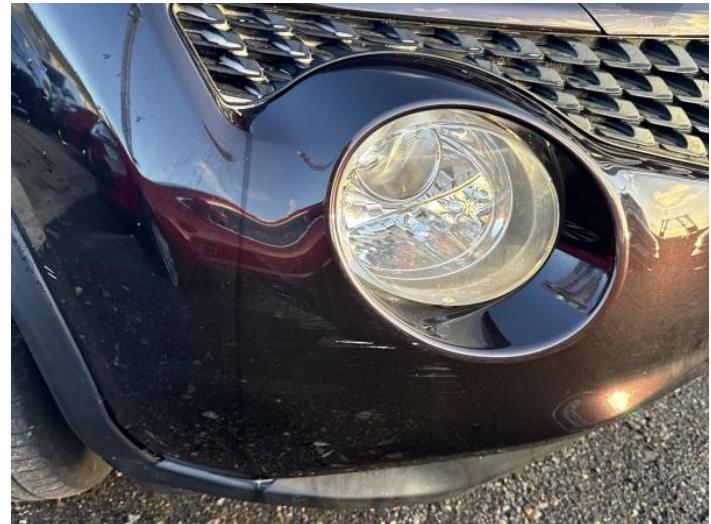
2: Bumper Front
Scratched
25 to 100mm Thru Paint

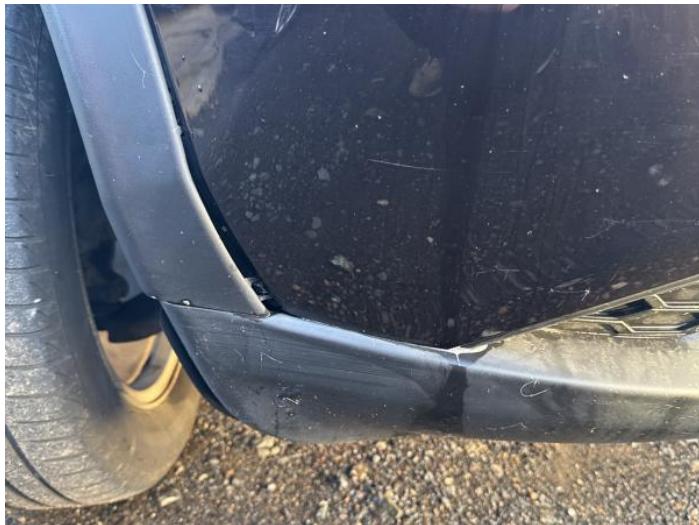
3: Bumper Front Moulding
Scuffed (Unpainted)
Over 100mm

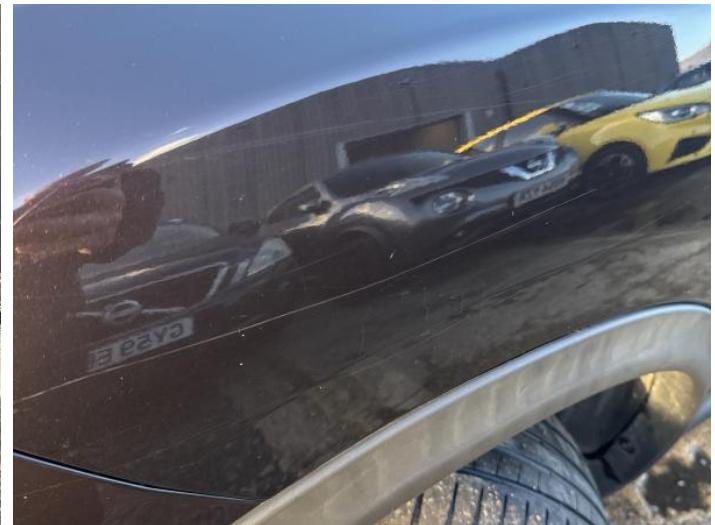
4: Wing osf
Scratched
Over 25mm Thru Paint

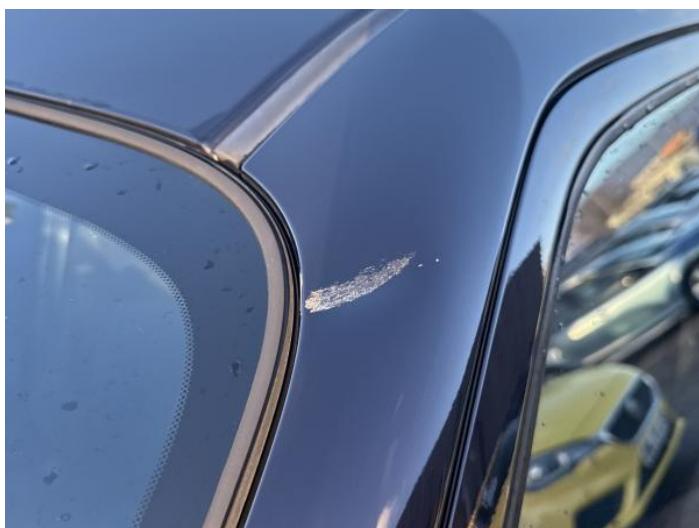
5: A Post ns
Dented
With Paint Damage

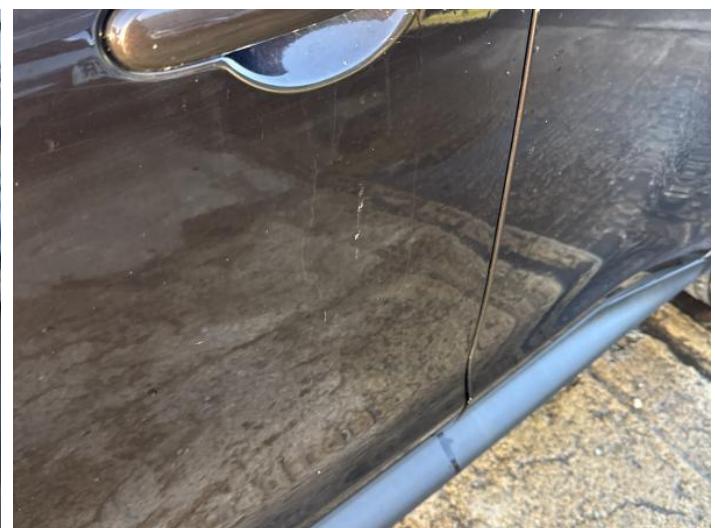
6: Door nsf
Scratched
Over 25mm Thru Paint

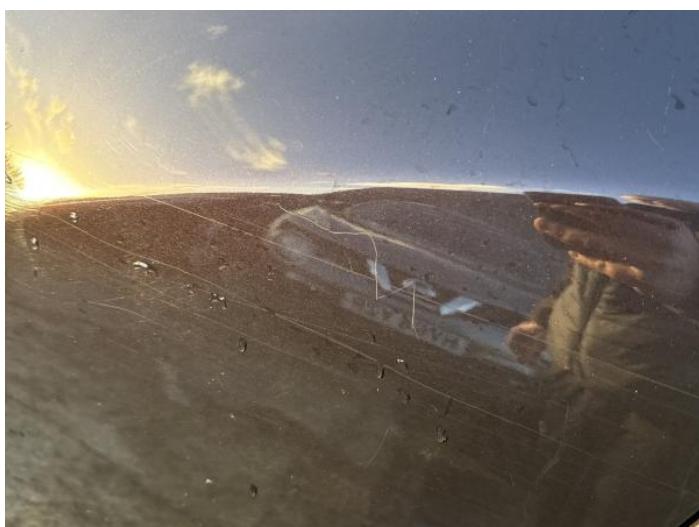
7: Door nsr
Scratched
Over 25mm Thru Paint

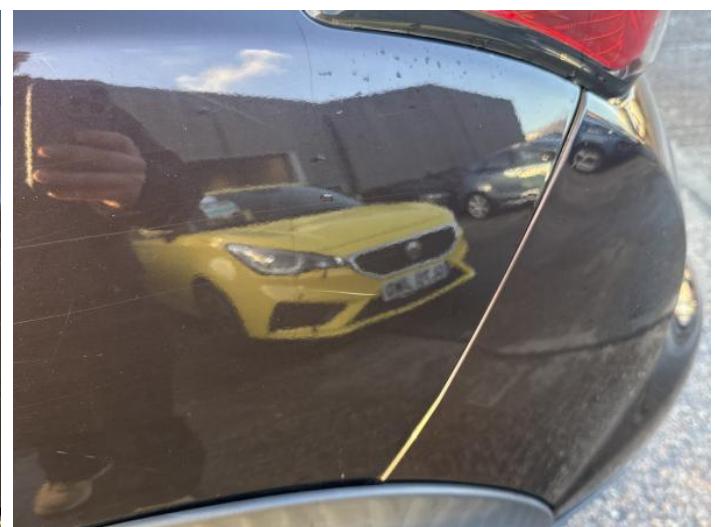
8: Qtr Panel nsr
Scratched
Over 25mm Thru Paint

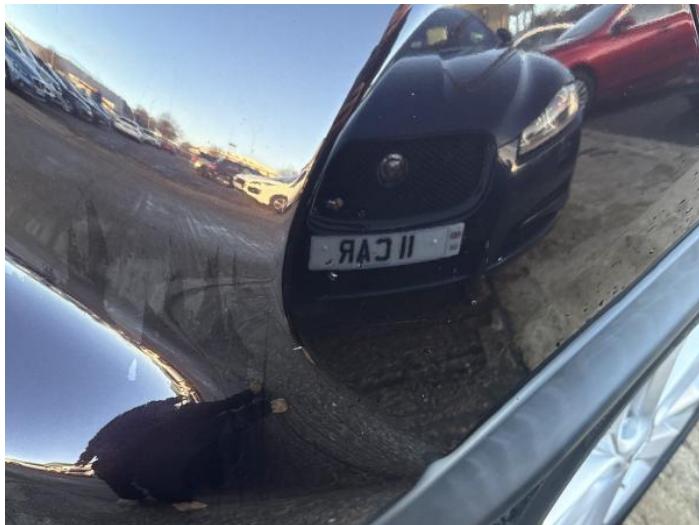
9: Bumper Rear
Chipped
1 To 5

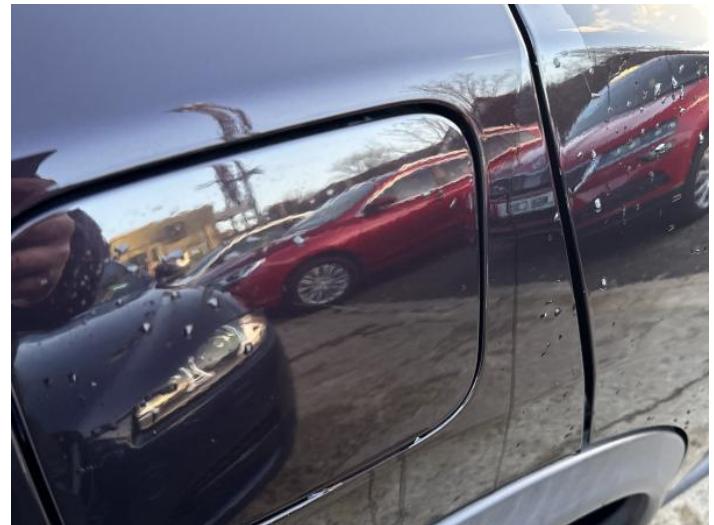
10: Qtr Panel osr
Scratched
UpTo 25mm Thru Paint

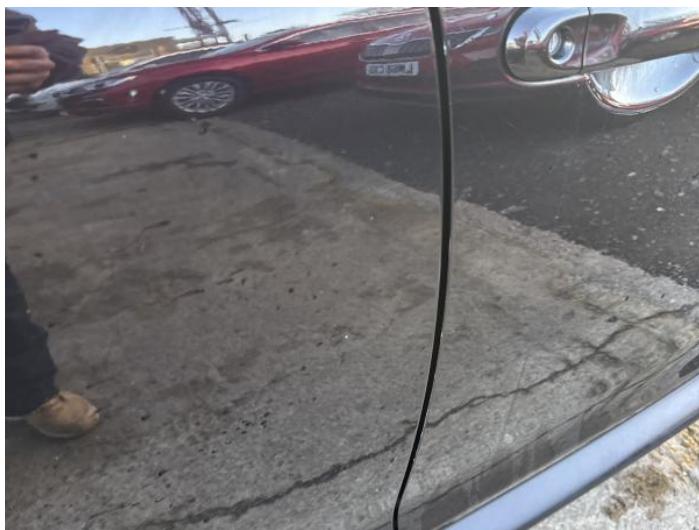
11: Door osr
Chipped
1 To 5

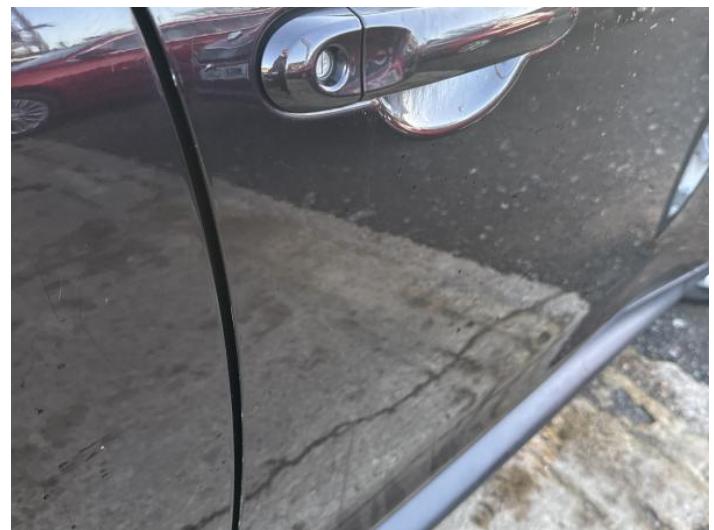
12: Door osf
Chipped
Edge Chip

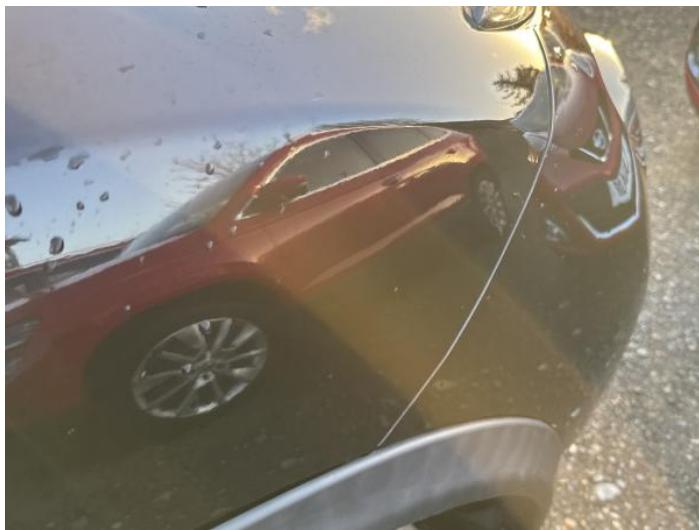
13: Wing osf
Chipped
1 To 5

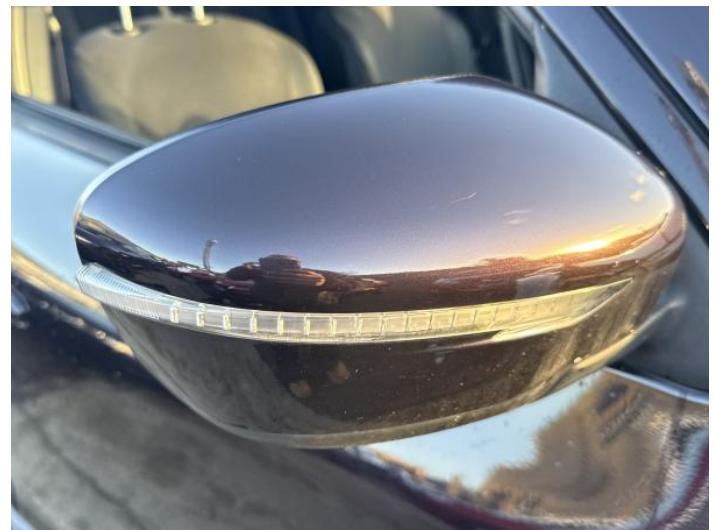
14: Door Mirror Assy osf
Scratched (Painted)
UpTo 25mm Thru Paint

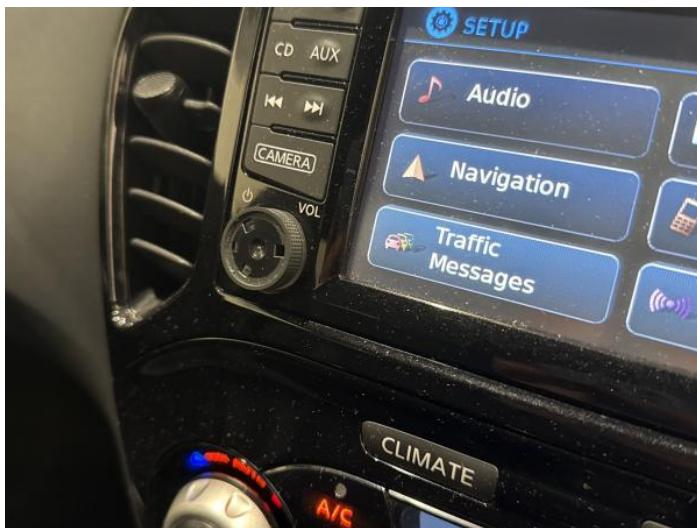
15: Switches And Controls

Broken
Replace
