VEHICLE INSPECTION REPORT

LB09JYS

Peugeot 107 1.0 Urban 5dr 2-Tronic

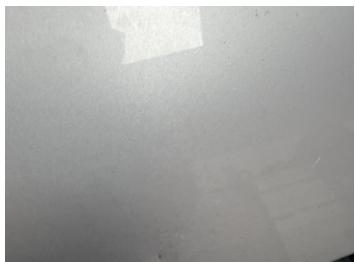
1: Bonnet Dented With Paint Damage

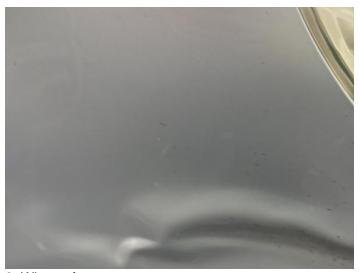
3: Wing osf Dented Over 30% Of Panel

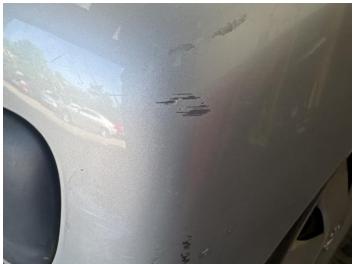
6: Bumper Rear Scratched Over 100mm Thru Paint

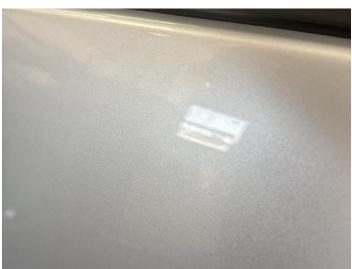
8: Door nsf Chipped 1 To 5

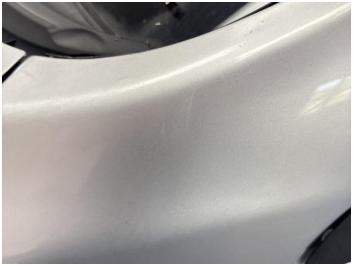
9: Wing nsf Poor Previous Repair Poor Paint

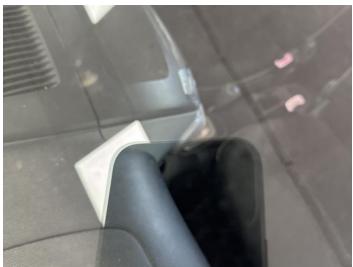
10: Screen Front Chipped UpTo 10mm

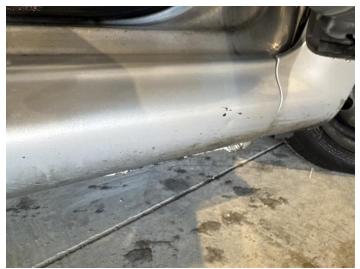
11: Sill os Dented With Paint Damage
