VEHICLE INSPECTION REPORT

GL64OSB

Hyundai i20 1.2 Active 5dr

Inspection	Vehicle		GRADE 3
Serious Damage?	VAT	Margin	
No	V5	Present

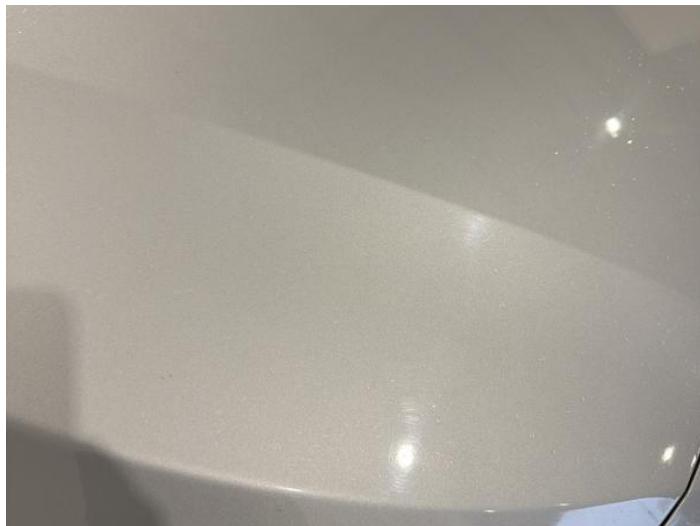
1: Bonnet
Chipped
1 To 5

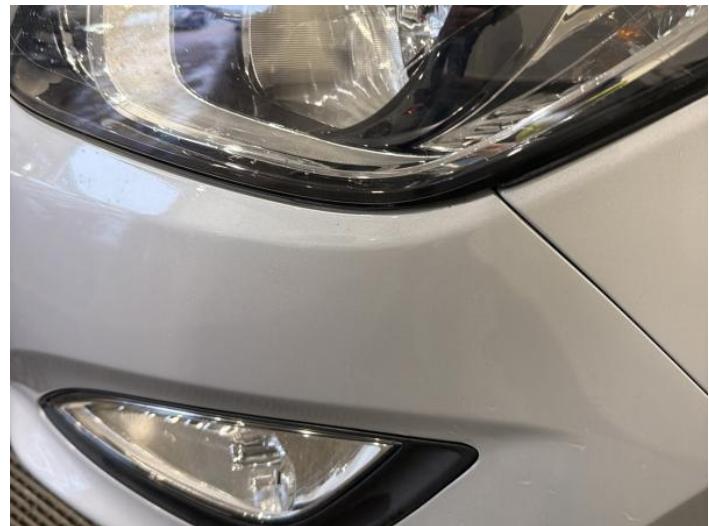
2: Bumper Front
Chipped
Multiple Chips

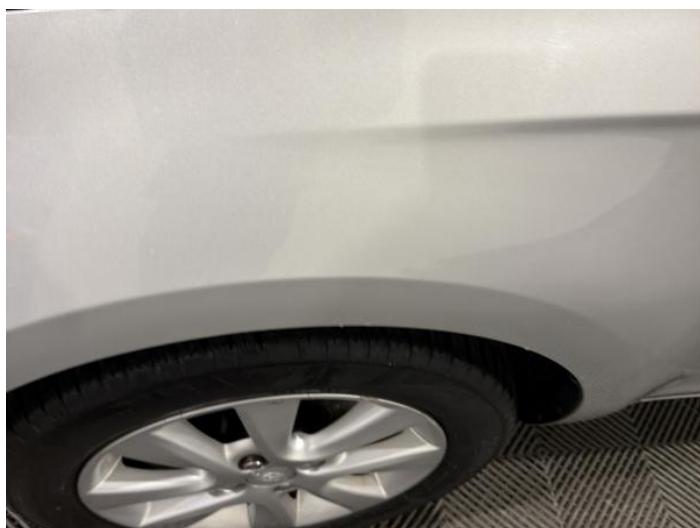
5: Wing nsf
Chipped
1 To 5

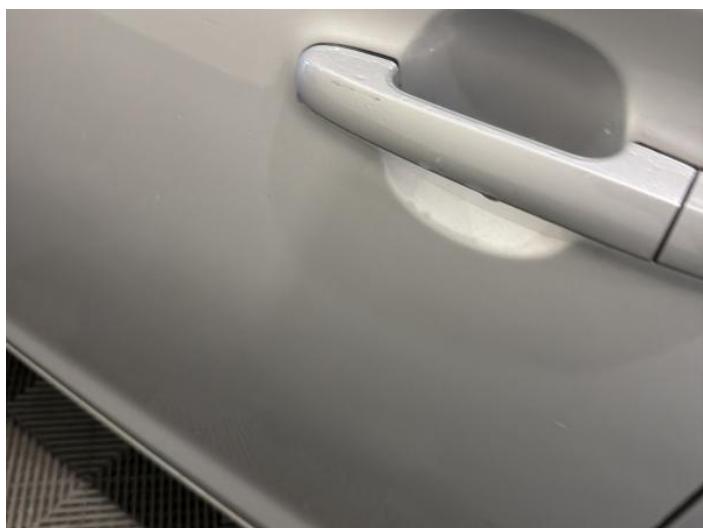
6: Door nsr
Chipped
Multiple Chips

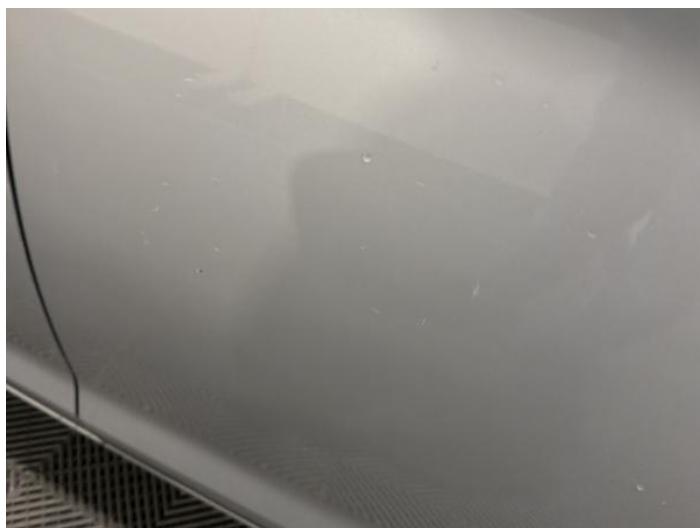
7: Door nsr
Chipped
Multiple Chips

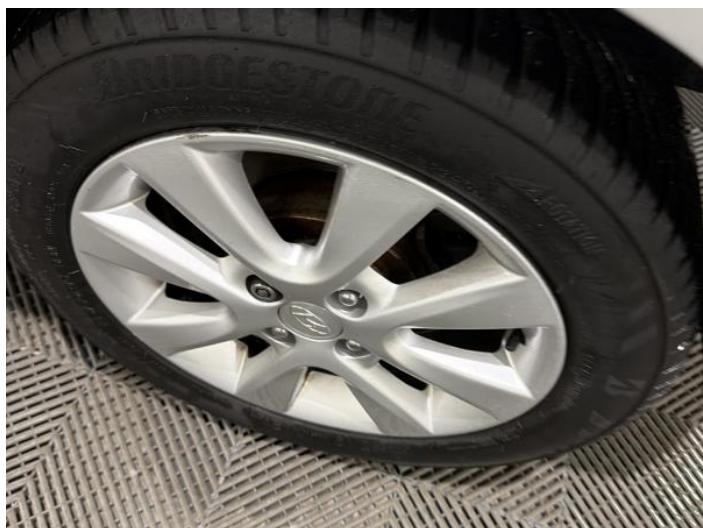
8: Wheel nsf
Scratched
Over 50mm

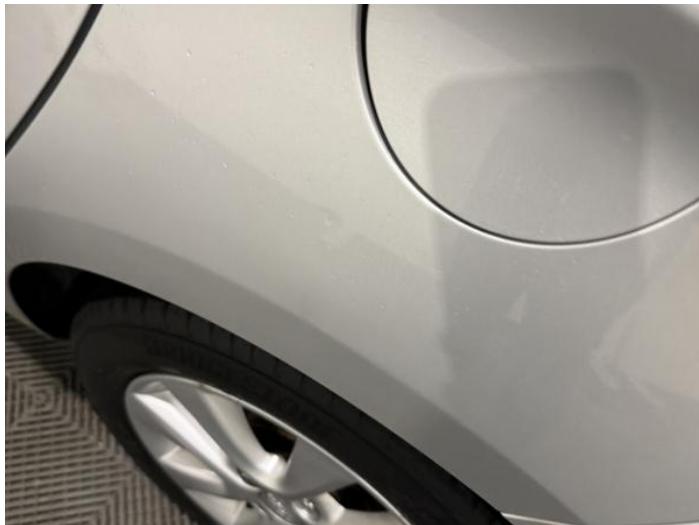
9: Qtr Panel nsr
Dented
Over 2 UpTo 10mm

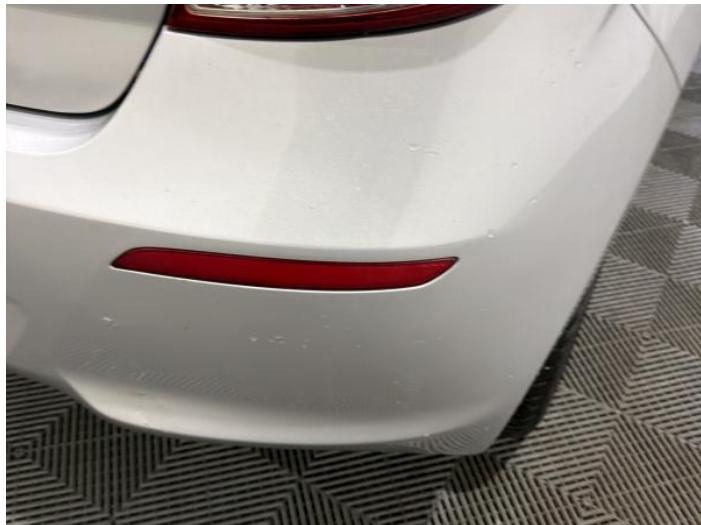
10: Bumper Rear
Scratched
25 to 100mm Thru Paint

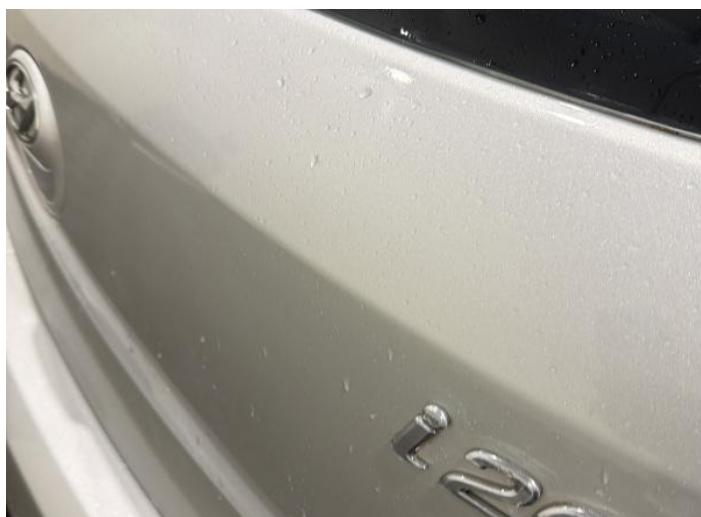
12: Boot Lid
Dented
Over 2 UpTo 10mm

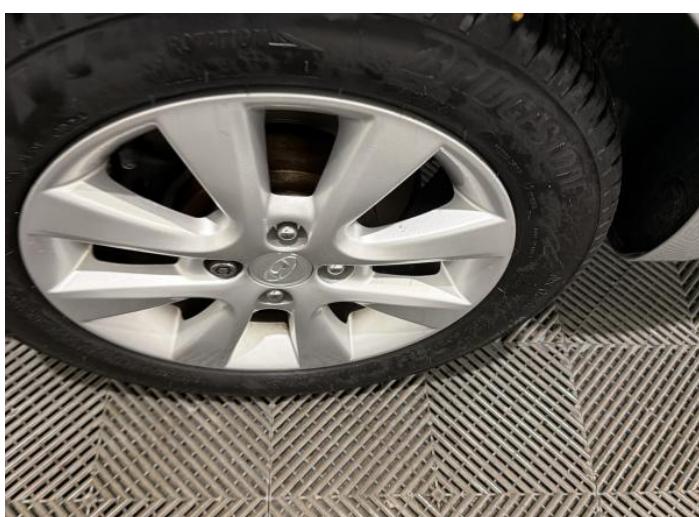
13: Wheel osr
Scratched
Up To 50mm

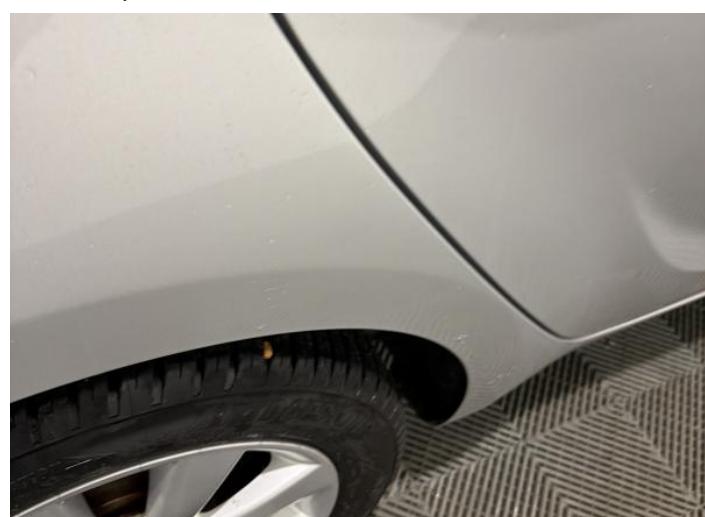
14: Qtr Panel osr
Dented
Between 10mm + 30mm

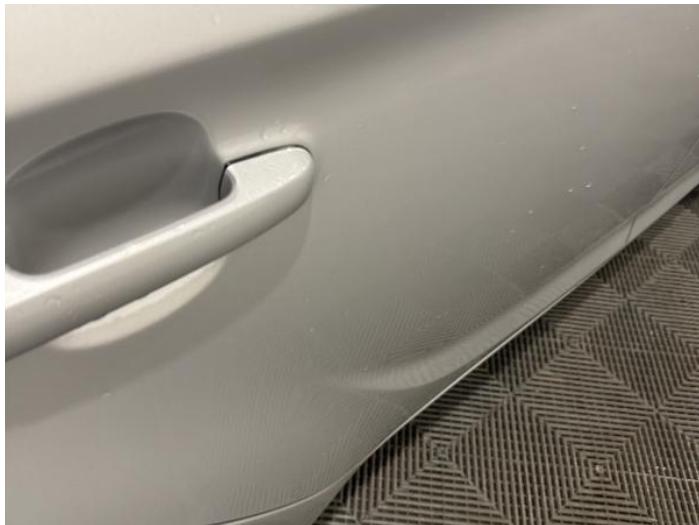
15: Door osr
Chipped
1 To 5

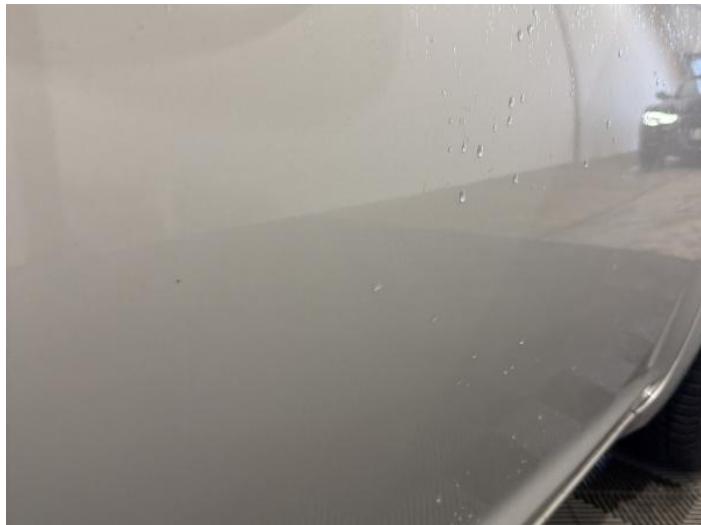
16: Door osf
Dented
Over 2 UpTo 10mm

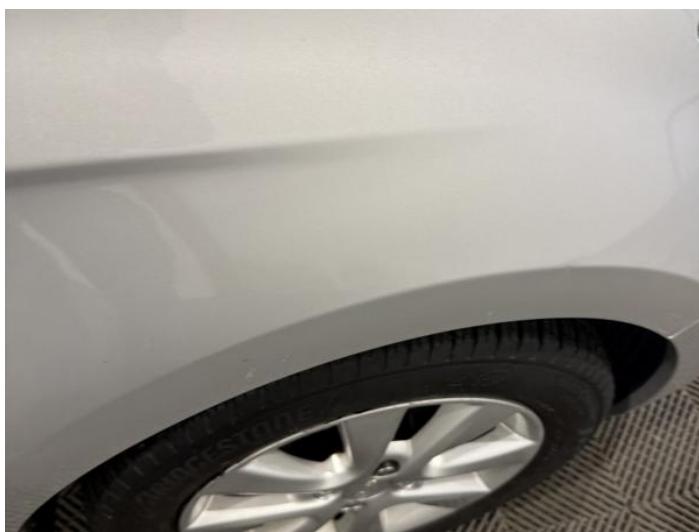
17: Wing osf
Dented
Over 2 UpTo 10mm

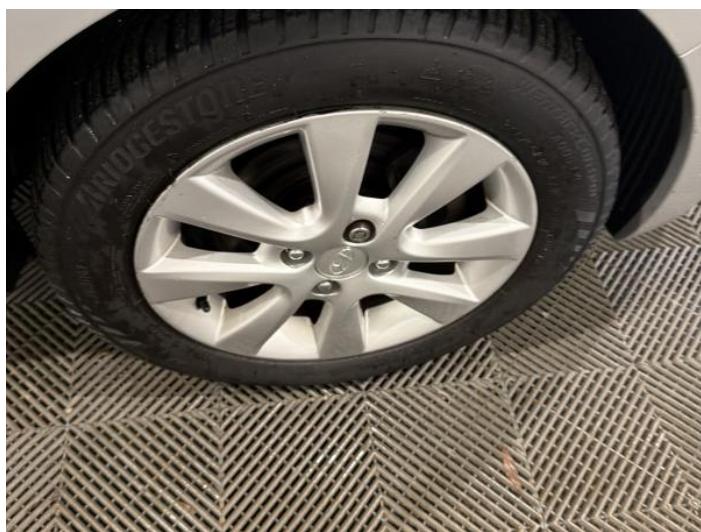
18: Wheel osf
Scratched
Over 50mm

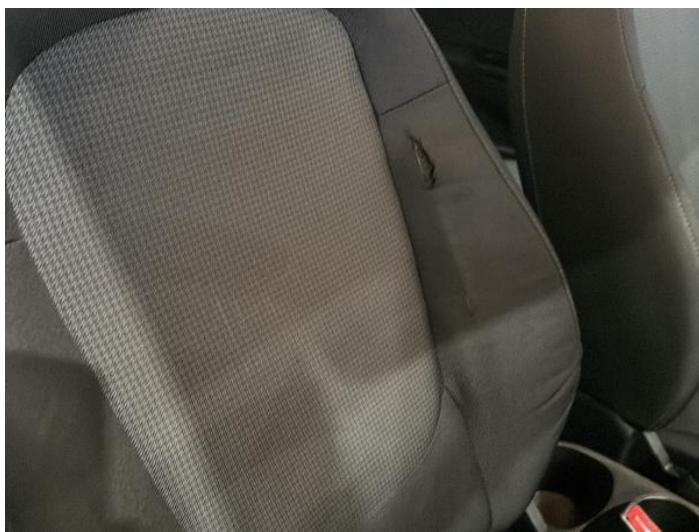
19: Seat Back Cover osf
Torn
Over 3mm
