## VEHICLE INSPECTION REPORT

SA60XPY

### Nissan Qashqai 1.5 dCi Acenta 5dr

Inspection	Vehicle		GRADE 4
Serious Damage?	VAT	Margin	
No	V5	Present

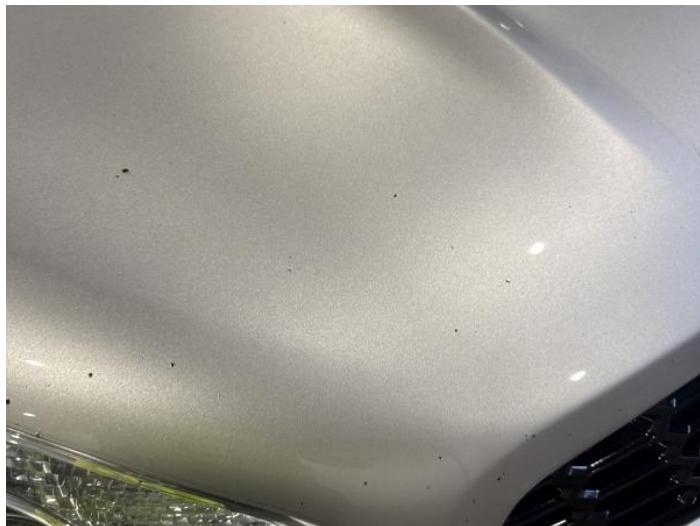
1: Bonnet  
Chipped  
Multiple Chips

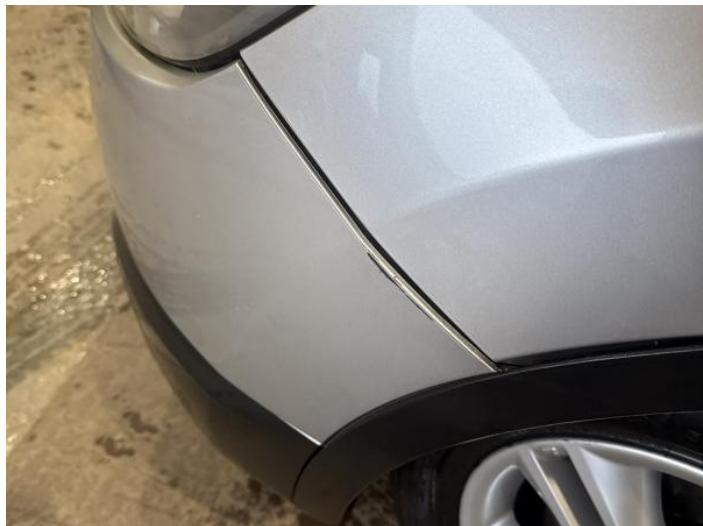
2: Bumper Front  
Insecure  
Action Required

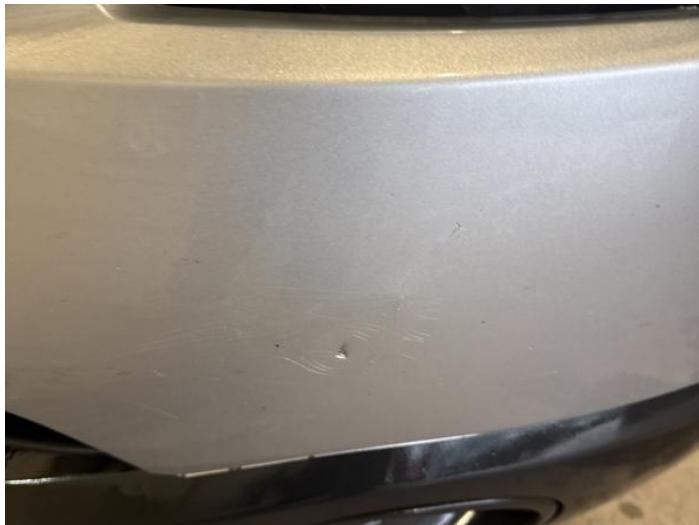
3: Bumper Front  
Dented  
With Paint Damage

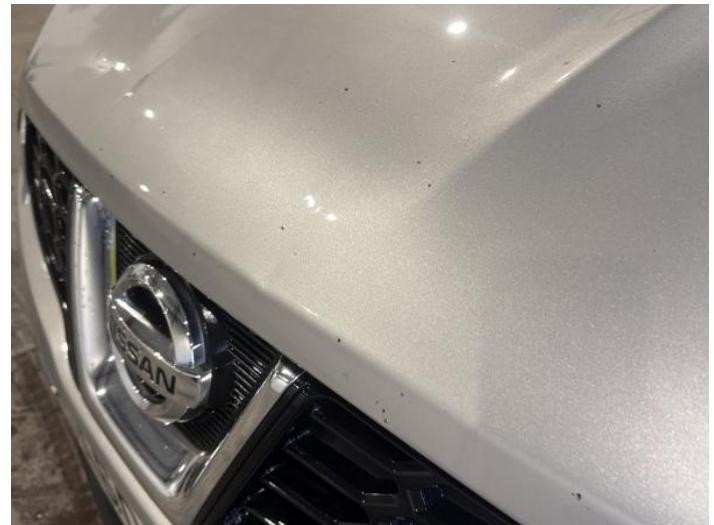
4: Bonnet  
Dented  
Over 30mm

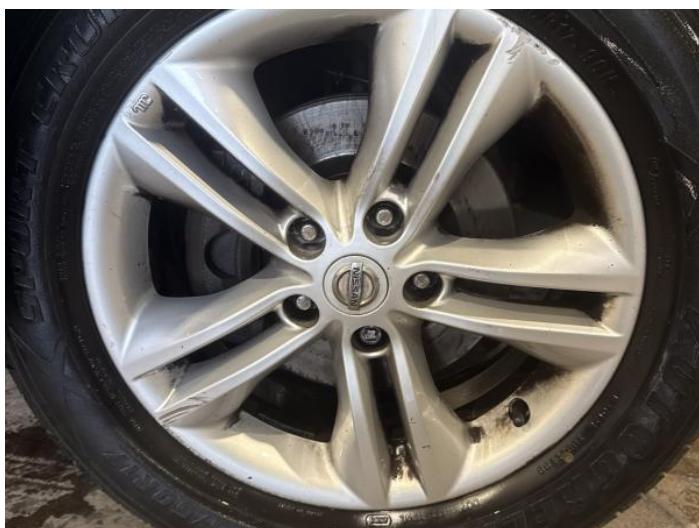
5: Wheel nsf  
Scratched  
Over 50mm

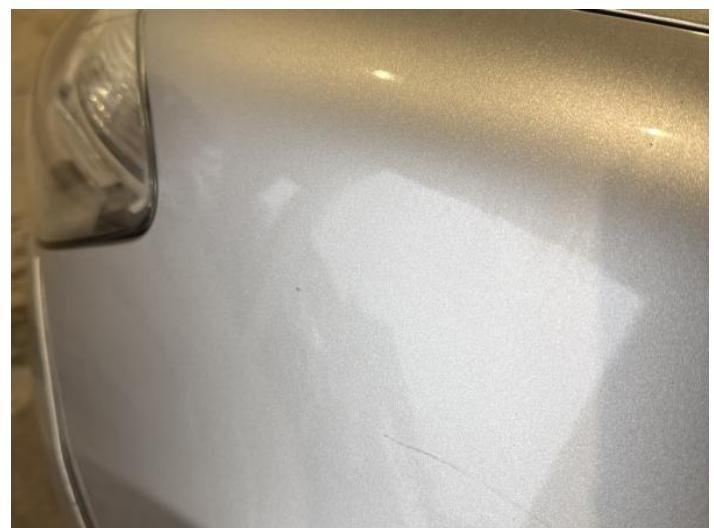
6: Wing nsf  
Scratched  
Over 25mm Thru Paint

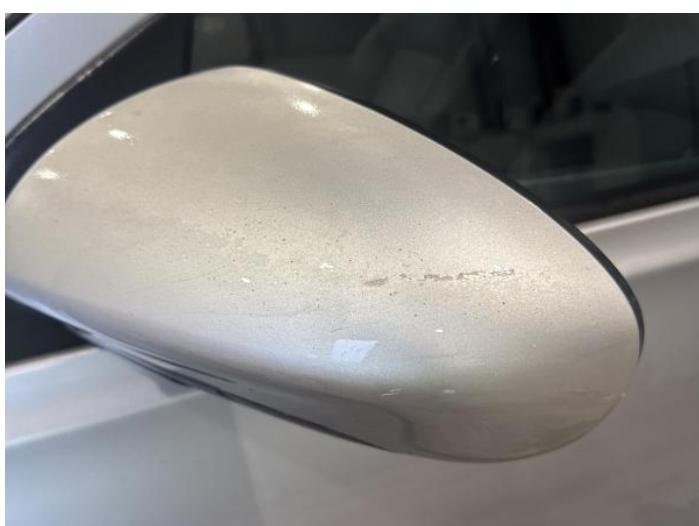
7: Door Mirror Assy nsf  
Scratched (Painted)  
Over 25mm Thru Paint

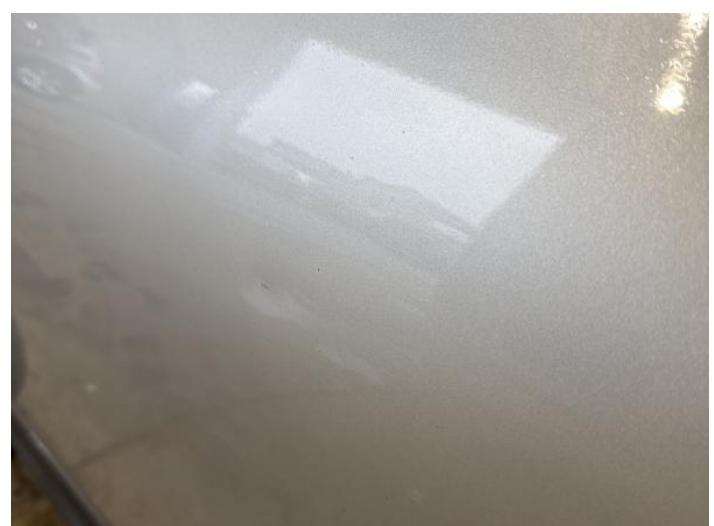
8: Door nsf  
Dented  
Between 10mm + 30mm

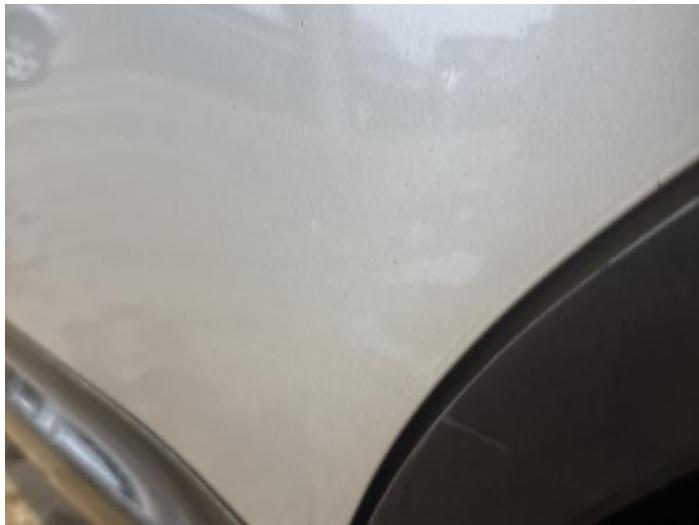
9: Door nsr  
Scratched  
UpTo 25mm Thru Paint

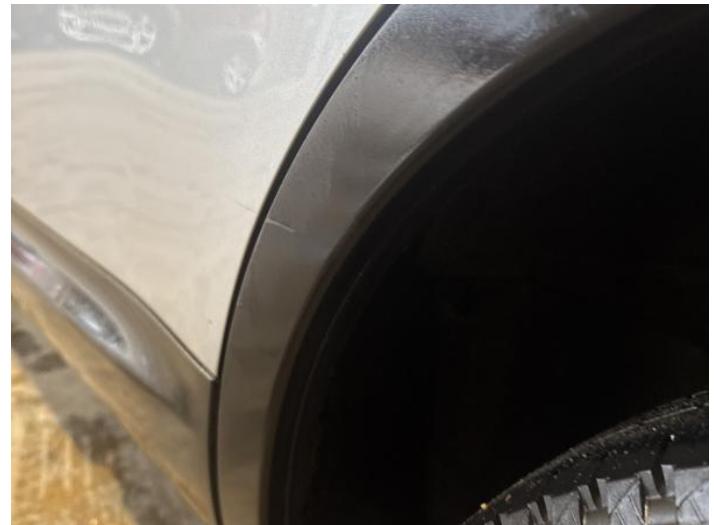
10: Qtr Panel Moulding ns  
Scuffed (Unpainted)  
UpTo 100mm

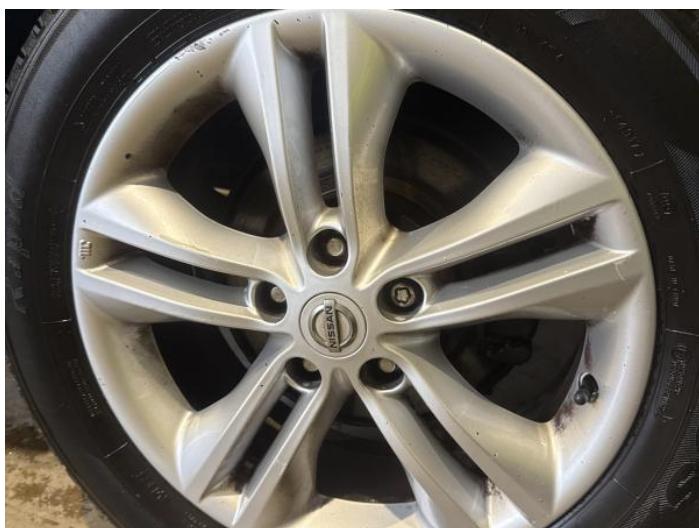
11: Wheel nsr  
Scratched  
Over 50mm

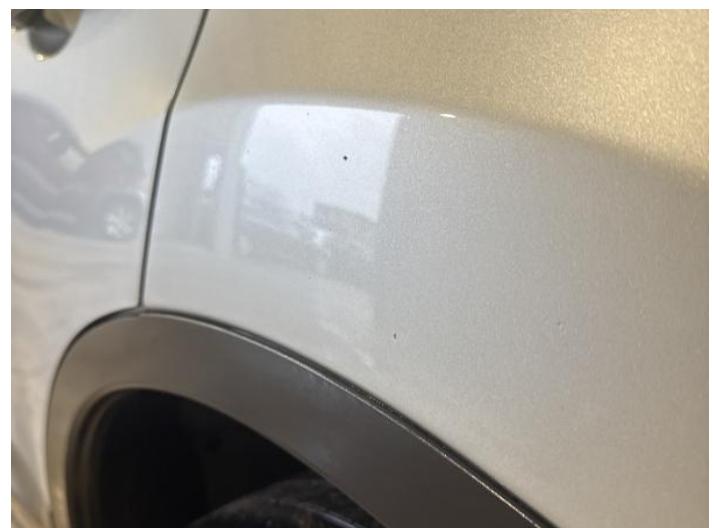
12: Qtr Panel nsr  
Dented  
Between 10mm + 30mm

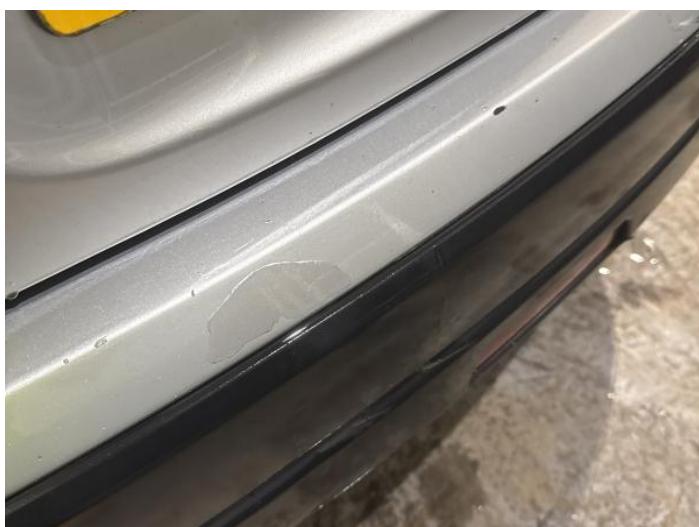
13: Bumper Rear  
Poor Previous Repair  
Paint Flake

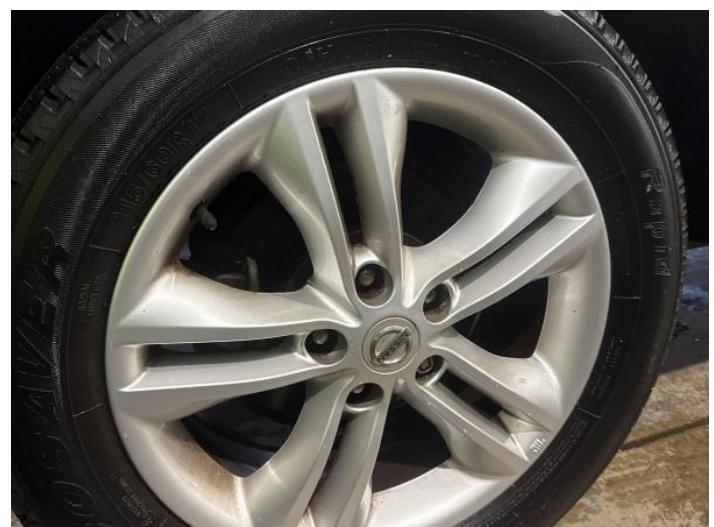
14: Wheel osr  
Scratched  
Up To 50mm

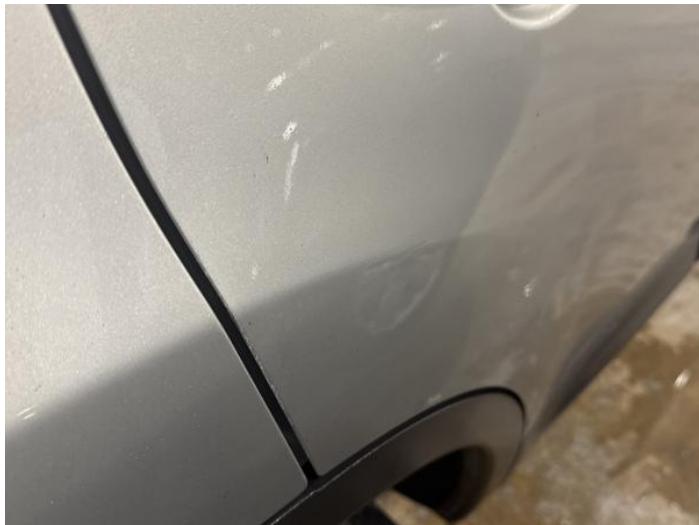
15: Door osr  
Scratched  
Over 25mm Thru Paint

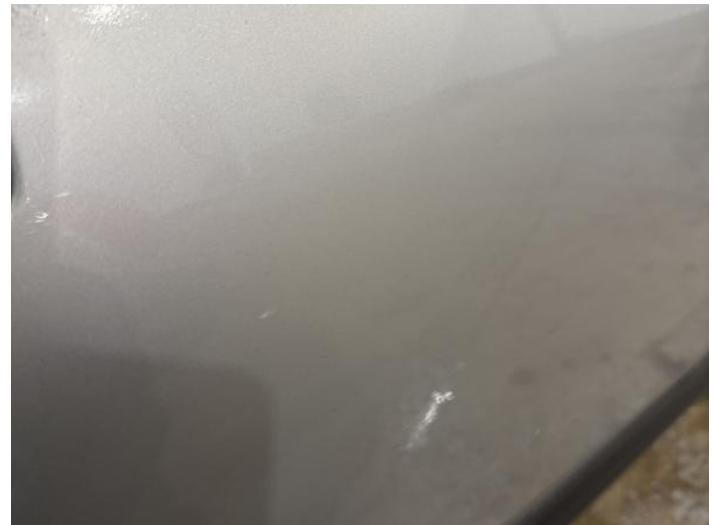
16: Door osf  
Scratched  
UpTo 25mm Thru Paint

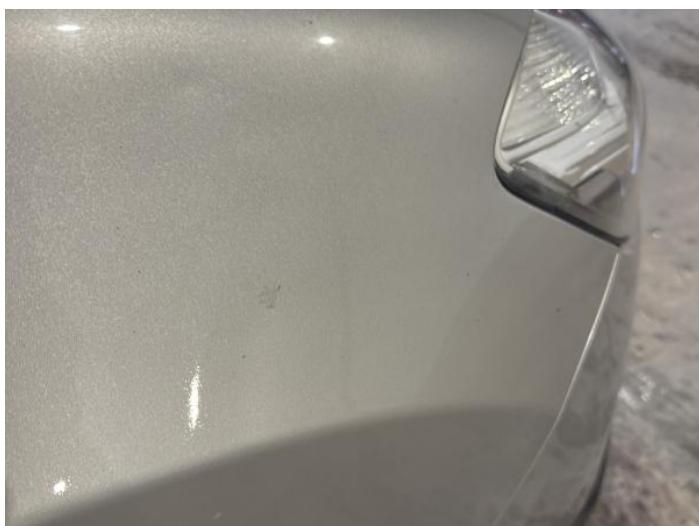
17: Wing osf  
Scratched  
UpTo 25mm Thru Paint

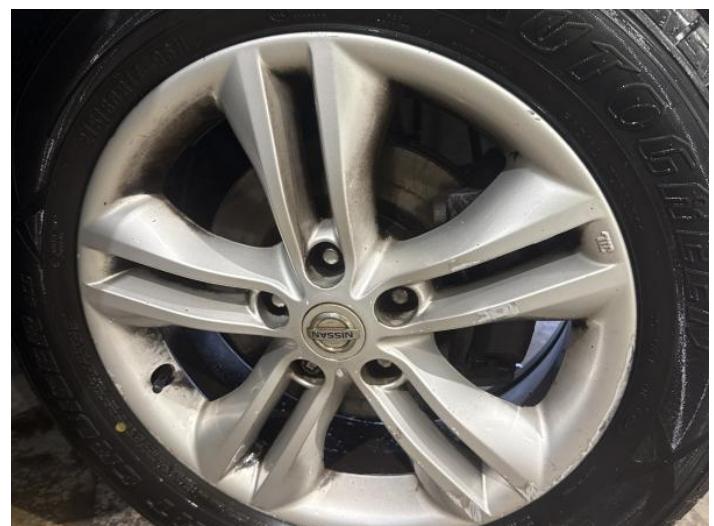
18: Wheel osf  
Scratched  
Over 50mm

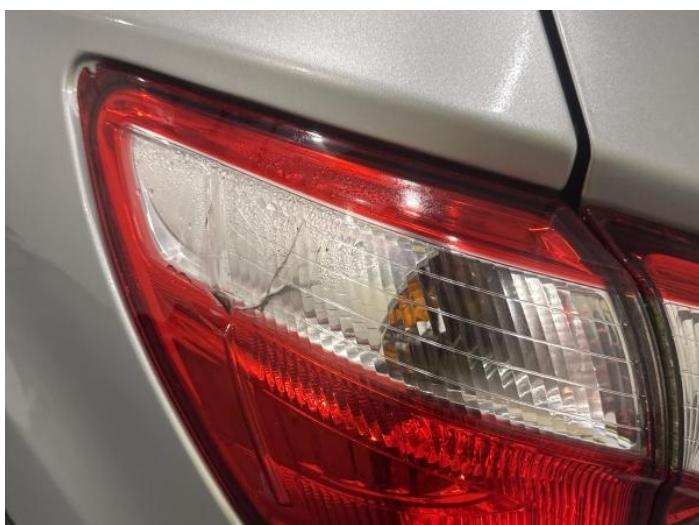
19: Lamp nsr  
Broken  
Replace
