## VEHICLE INSPECTION REPORT

FD64FYC

### Ford Focus 1.6 TDCi 115 Zetec S 5dr

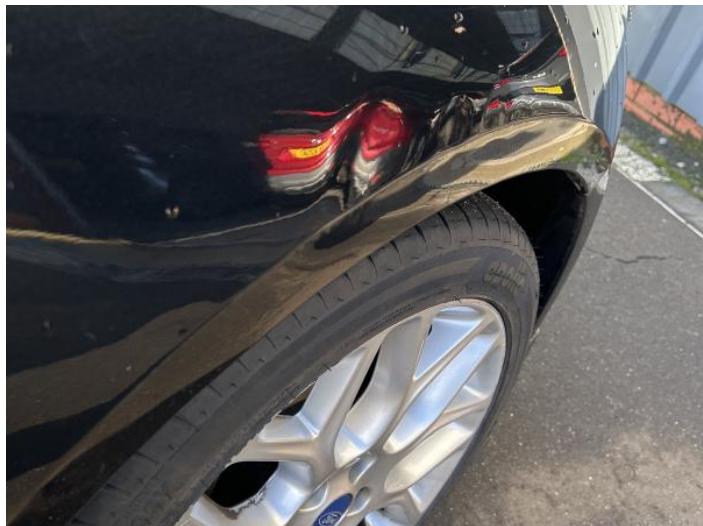
1: Wing osf  
Dented  
Over 30mm

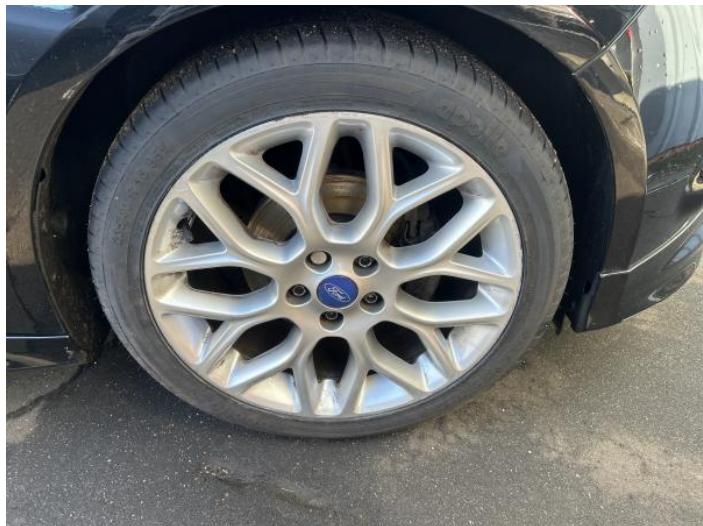
2: Wheel osf  
Scratched  
Over 50mm

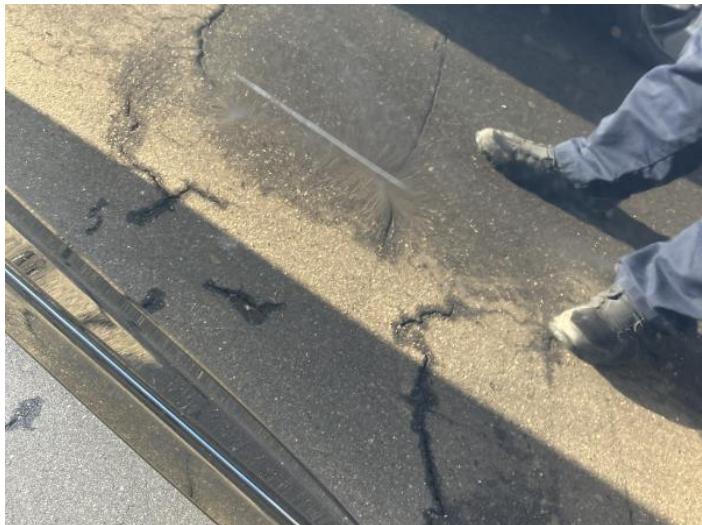
3: Door osr  
Scratched  
Over 25mm Thru Paint

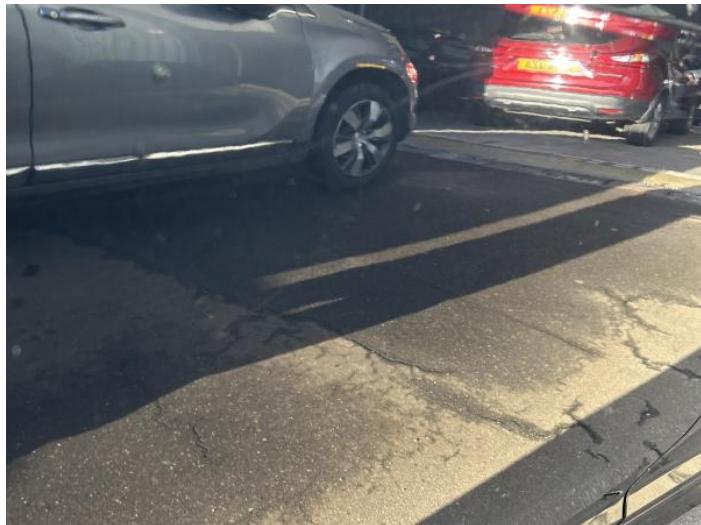
4: Door osr  
Scratched  
Over 25mm Not Thru Paint

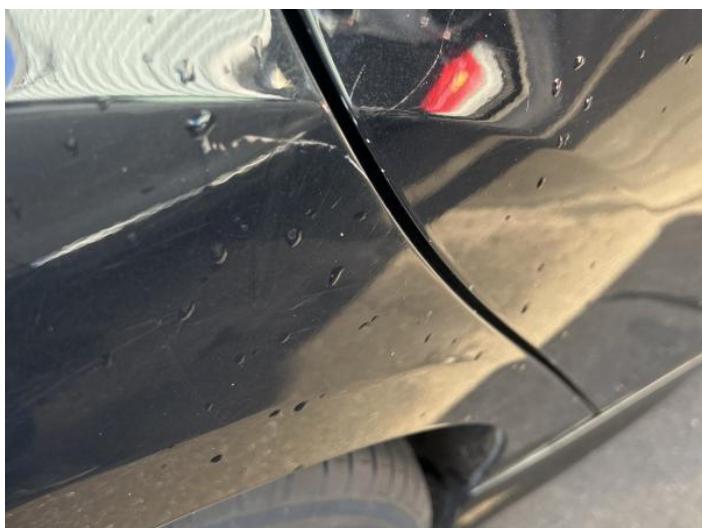
5: Qtr Panel osr  
Scratched  
Over 25mm Not Thru Paint

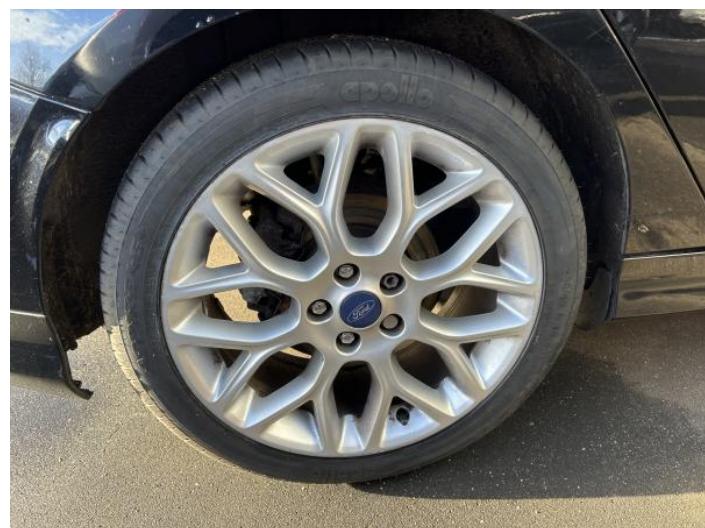
6: Wheel osr  
Scratched  
Up To 50mm

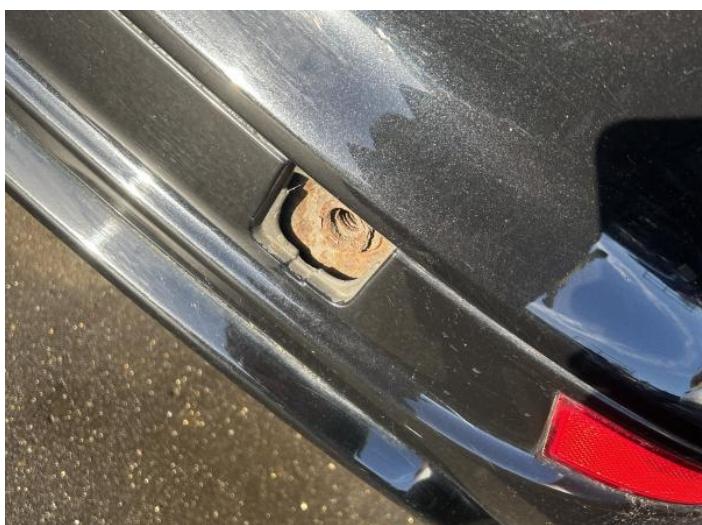
7: Rear TowEye Cvr  
Missing  
Replace

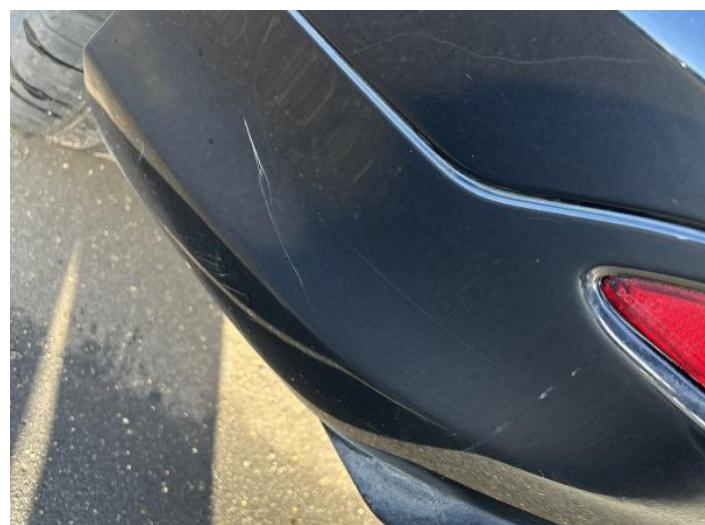
8: Bumper Rear  
Scratched  
Over 25mm Not Thru Paint

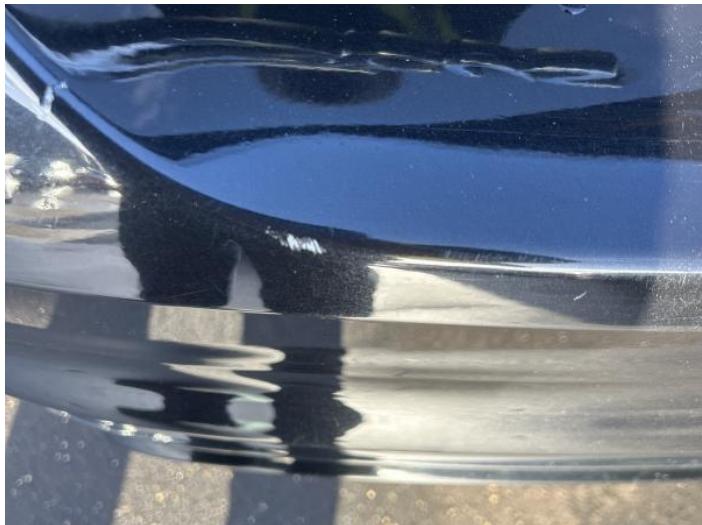
9: Bumper Rear  
Chipped  
1 To 5

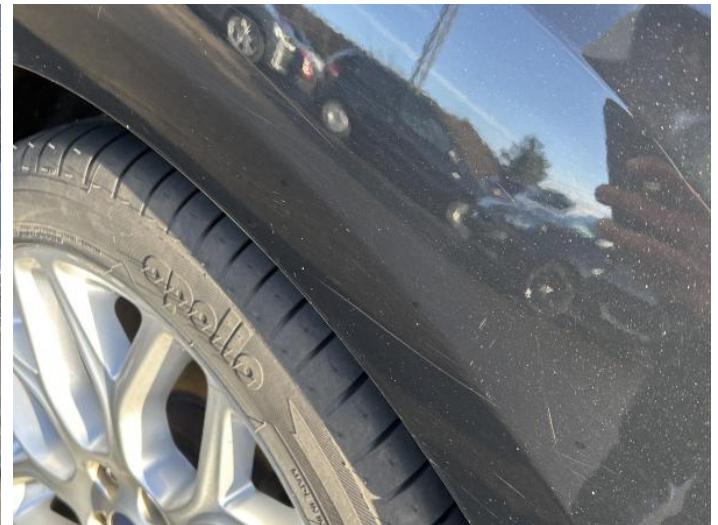
10: Qtr Panel nsr  
Scratched  
Over 25mm Not Thru Paint

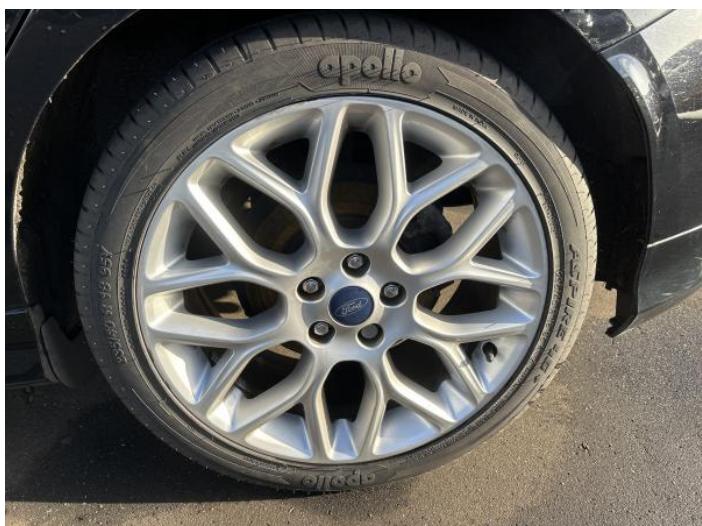
11: Wheel nsr  
Scratched  
Up To 50mm

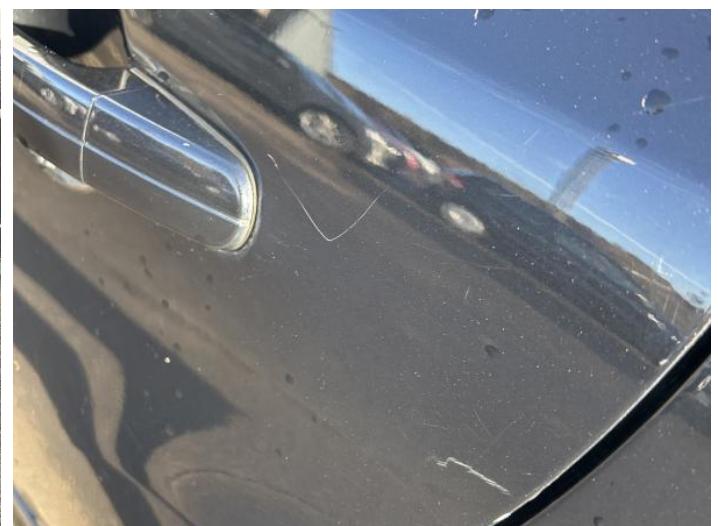
12: Door nsr  
Scratched  
Over 25mm Not Thru Paint

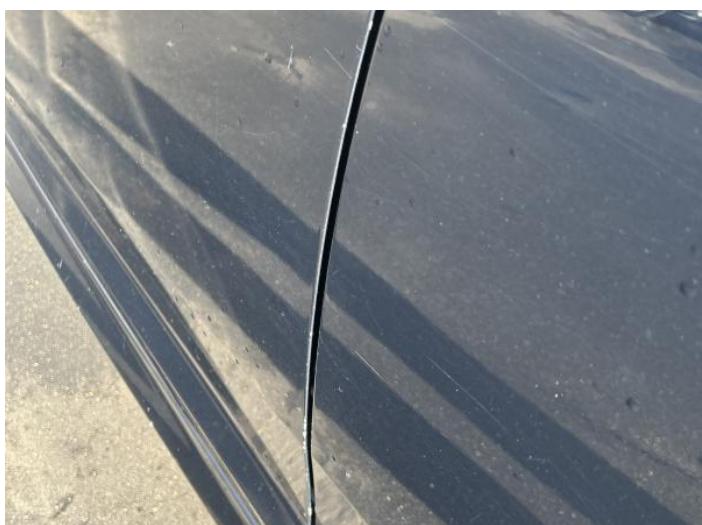
13: Door nsf  
Chipped  
Edge Chip

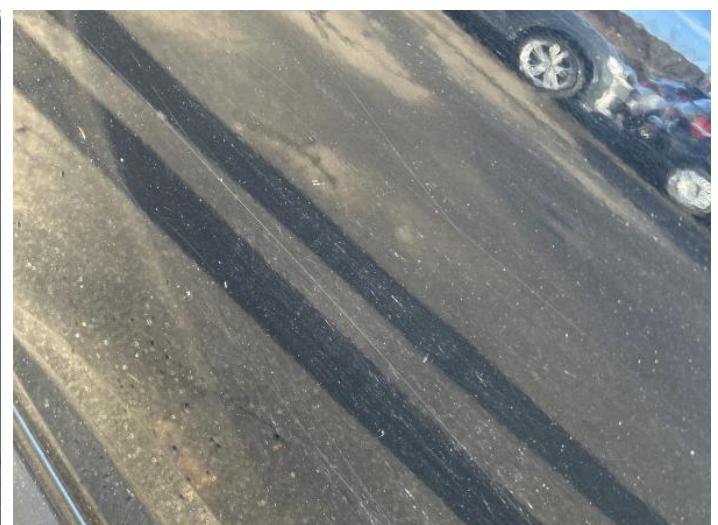
14: Door nsf  
Scratched  
Over 25mm Not Thru Paint

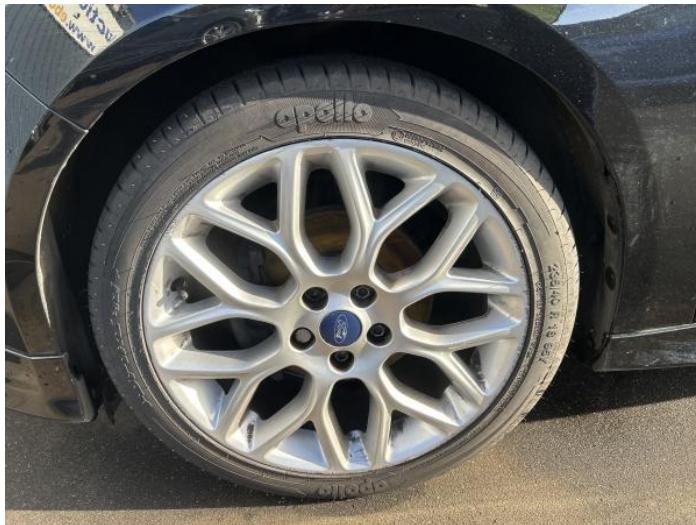
15: Wheel nsf  
Scratched  
Over 50mm

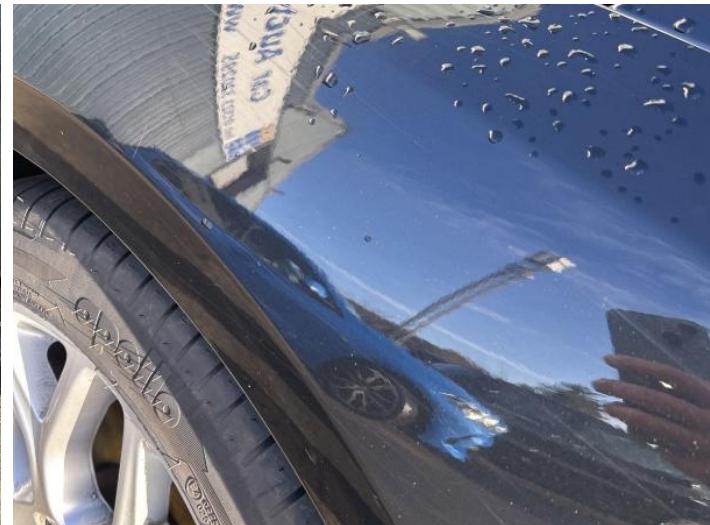
16: Wing nsf  
Scratched  
Over 25mm Not Thru Paint

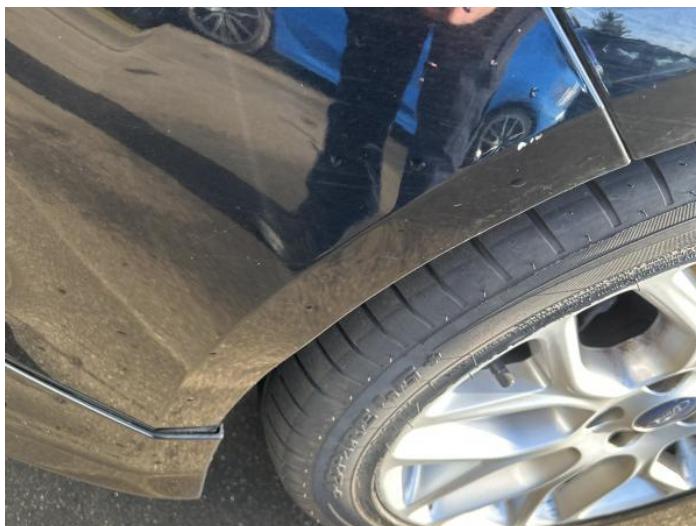
17: Bumper Front  
Chipped  
1 To 5

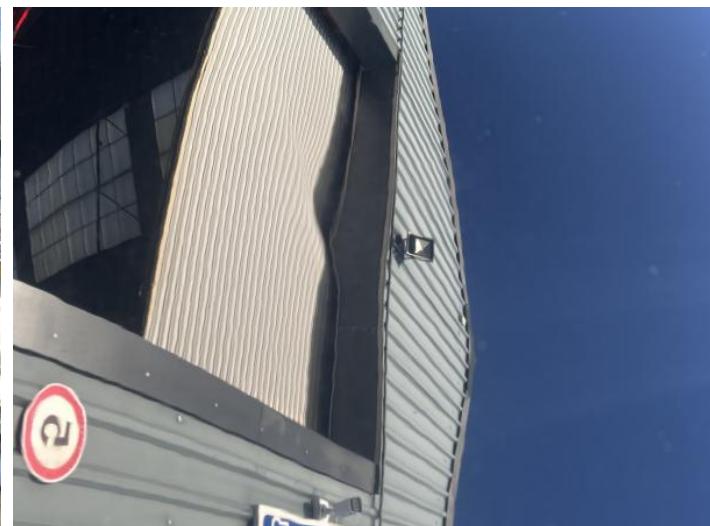
18: Bonnet  
Dented  
Over 30mm

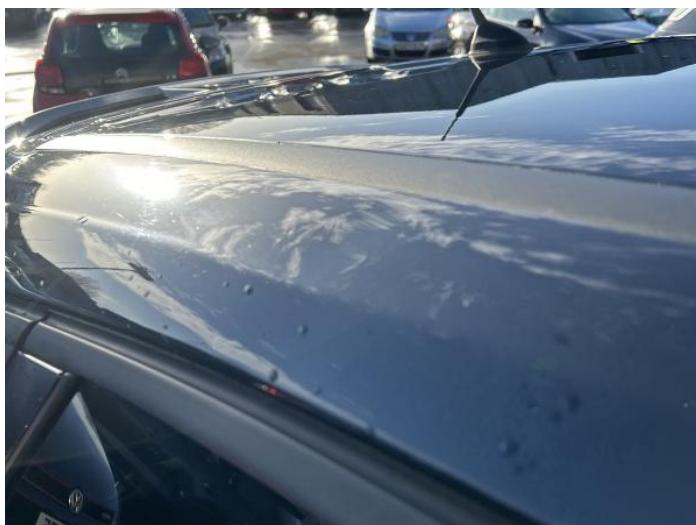
19: C Post os  
Dented  
Over 30mm
