VEHICLE INSPECTION REPORT

GH17GVP

Nissan Qashqai 1.2 DiG-T N-Vision 5dr

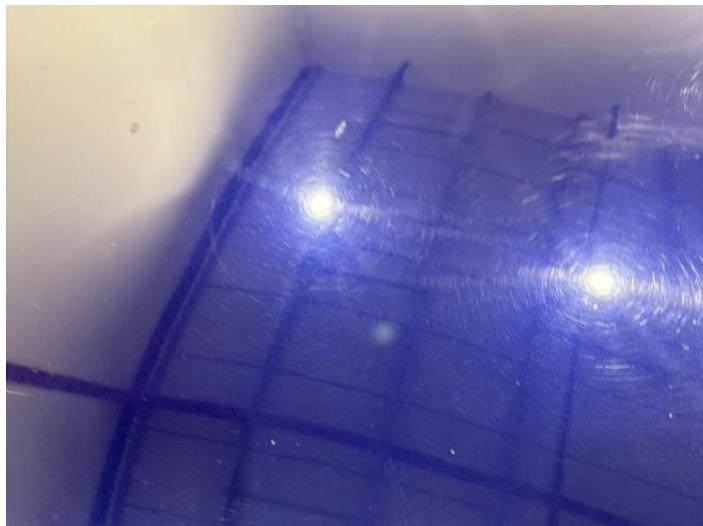
1: Bonnet
Chipped
Multiple Chips

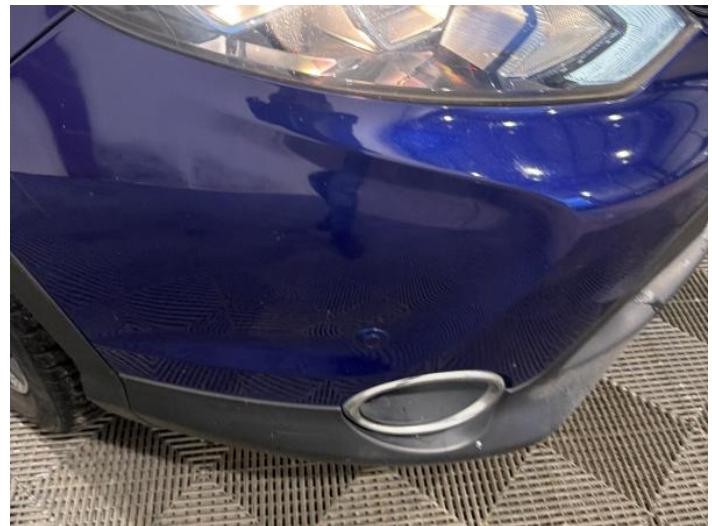
2: Bumper Front
Poor Previous Repair
Poor Paint

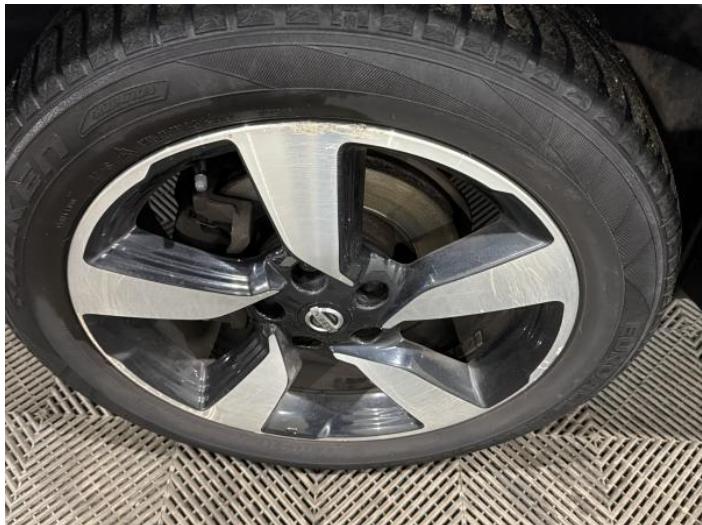
3: Wheel nsf
Scratched
Over 50mm

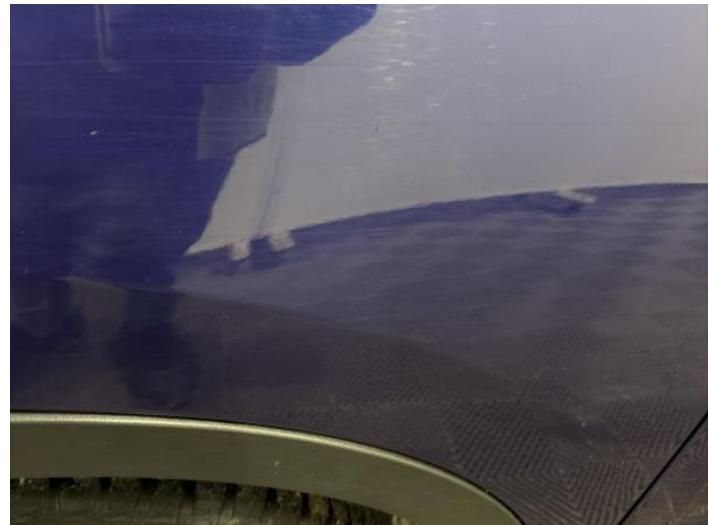
4: Wing nsf
Chipped
1 To 5

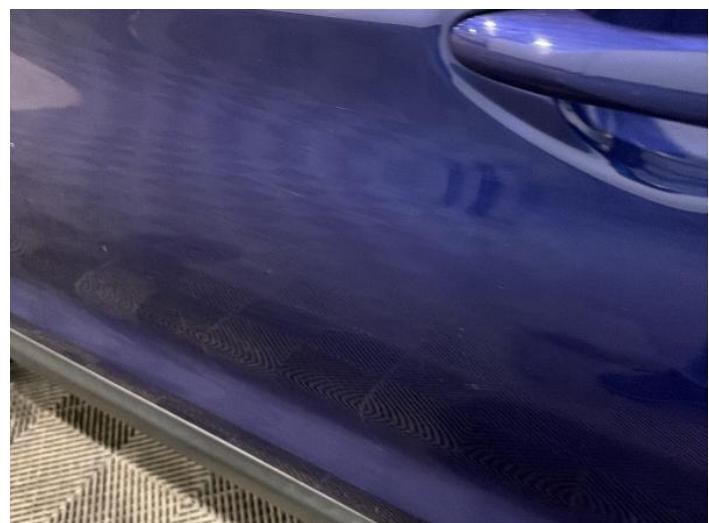
6: Door nsf
Dented
With Paint Damage

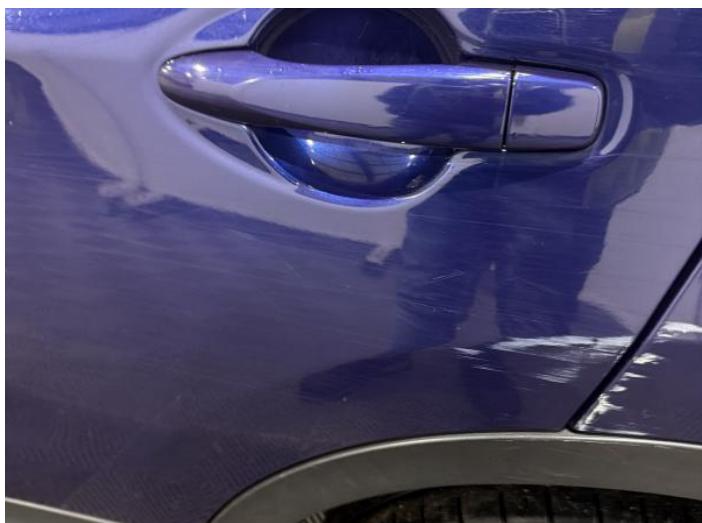
7: Door nsr
Dented
With Paint Damage

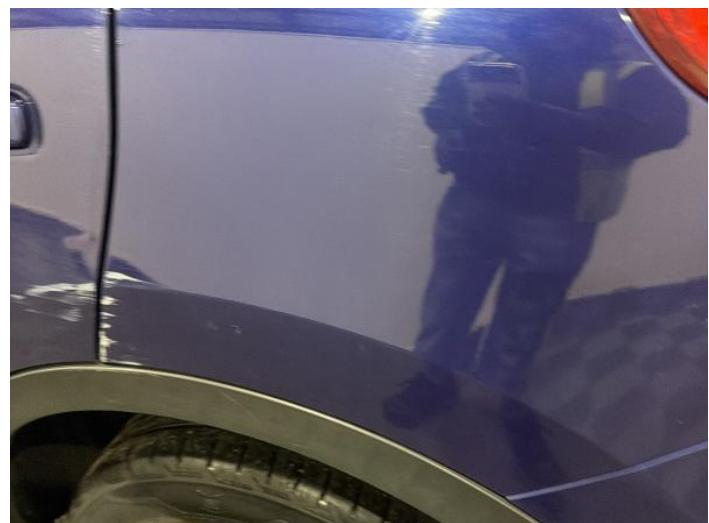
8: Qtr Panel nsr
Dented
With Paint Damage

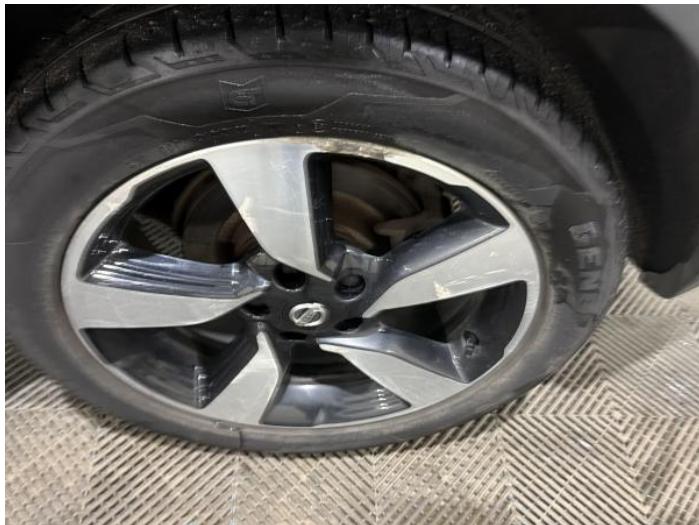
9: Wheel nsr
Scratched
Over 50mm

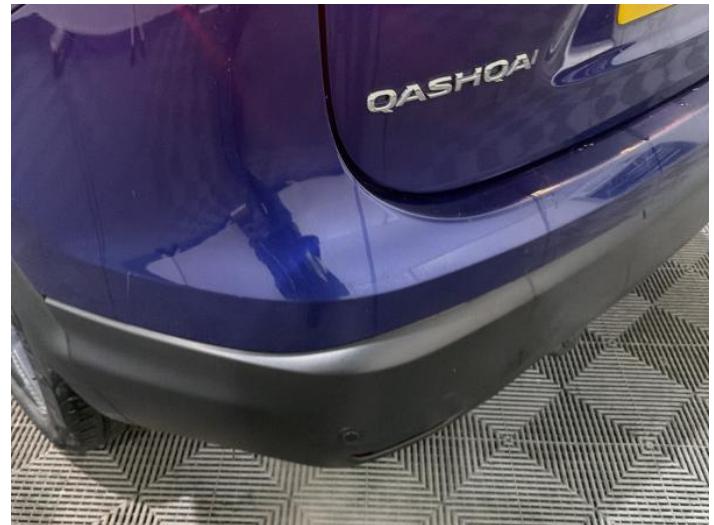
10: Bumper Rear
Scratched
Over 100mm Thru Paint

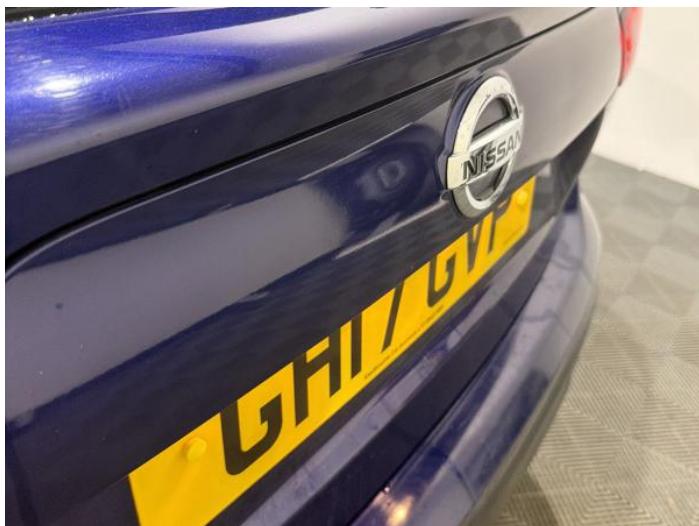
11: Boot Lid
Dented
Over 2 UpTo 10mm

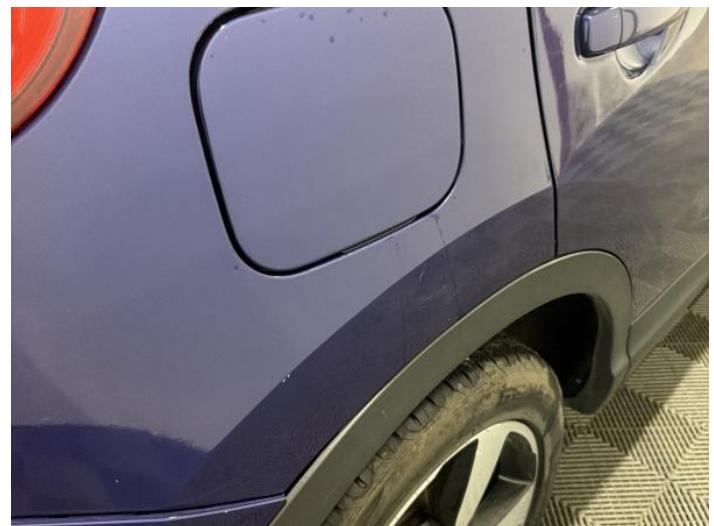
12: Qtr Panel osr
Chipped
1 To 5

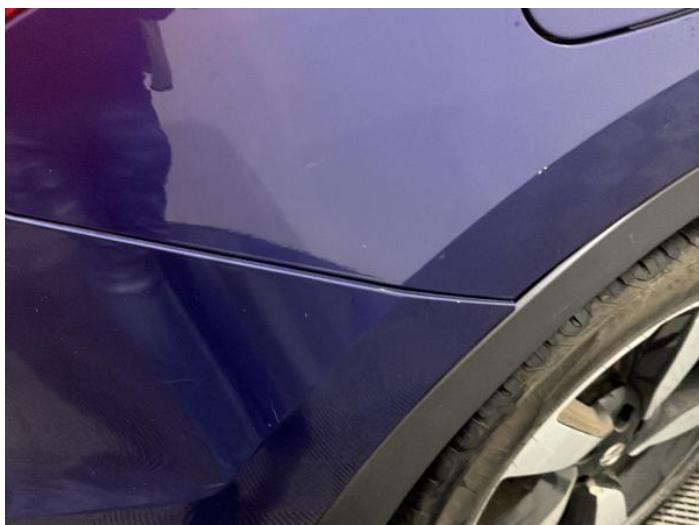
13: Bumper Rear
Insecure
Action Required

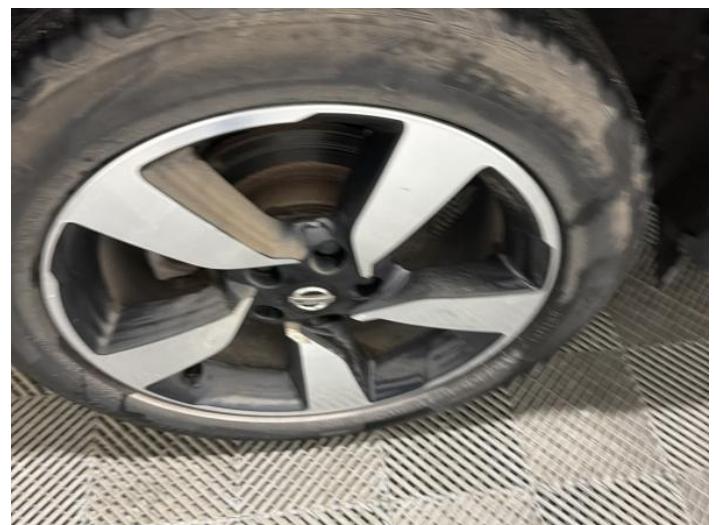
14: Wheel osr
Scratched
Over 50mm

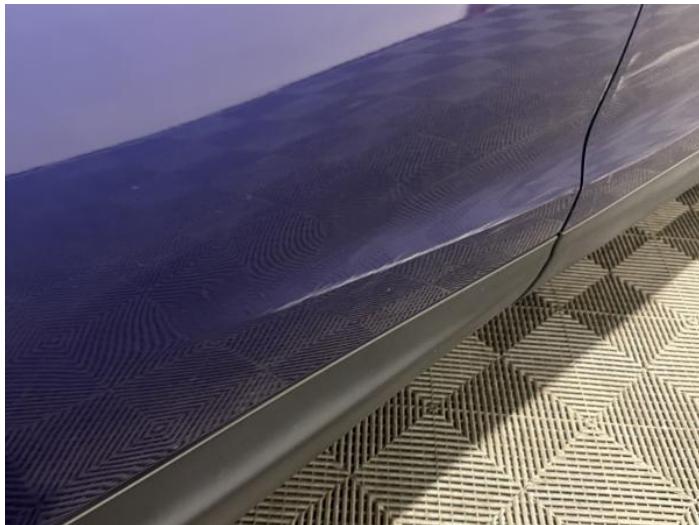
15: Door osr
Dented
With Paint Damage

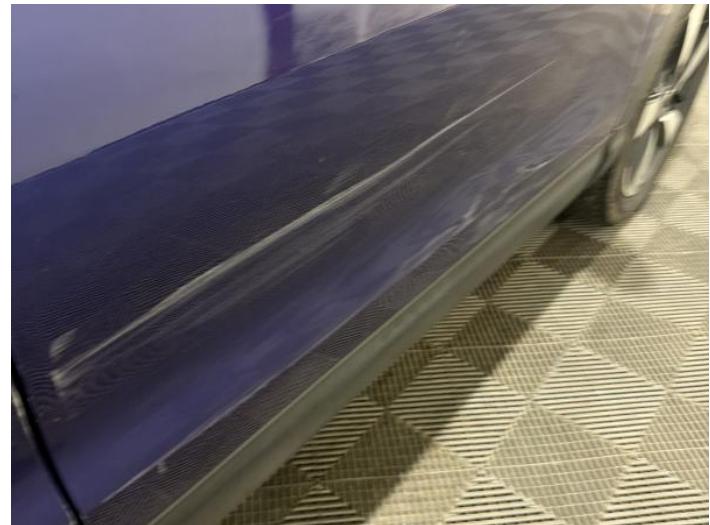
16: Door osf
Dented
With Paint Damage

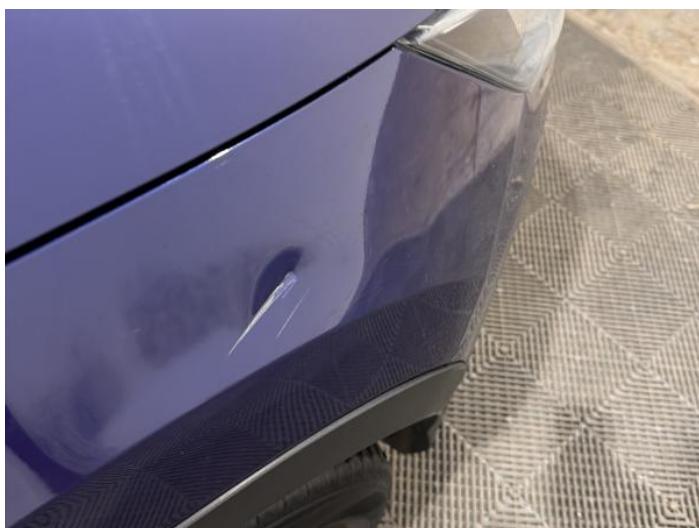
17: Wing osf
Dented
With Paint Damage

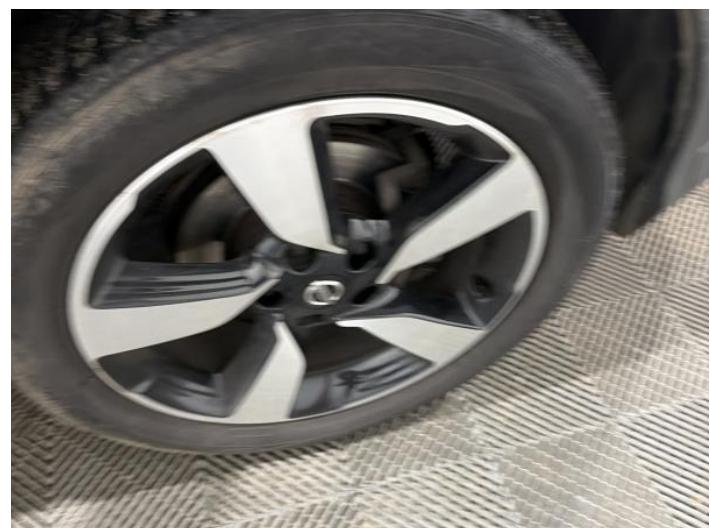
18: Wheel osf
Scratched
Up To 50mm
