VEHICLE INSPECTION REPORT

SW68CXZ

Volkswagen T-Roc 1.5 TSI EVO SEL 5dr

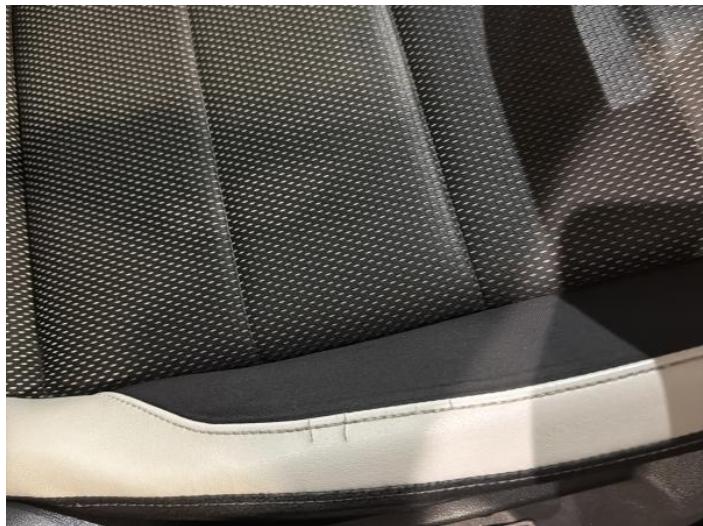
1: Seat Base Cover osf
Torn
UpTo 3mm

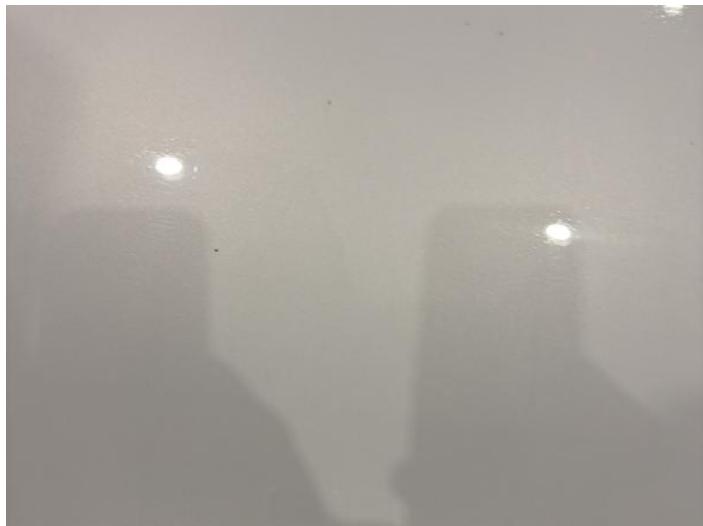
2: Bonnet
Chipped
1 To 5

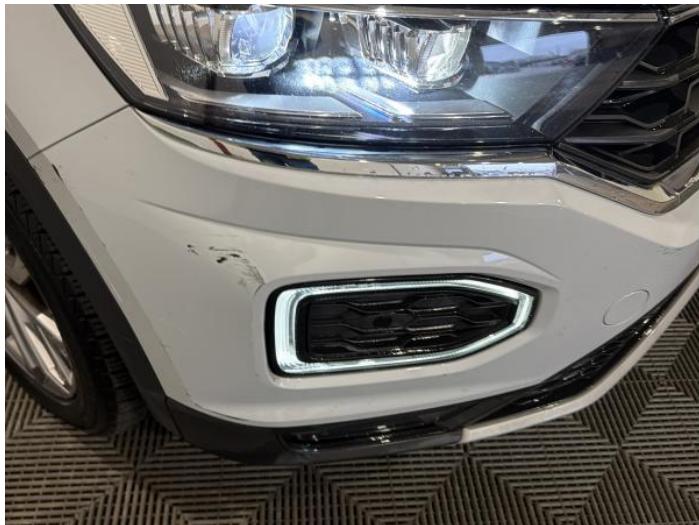
3: Bumper Front
Scratched
Over 100mm Thru Paint

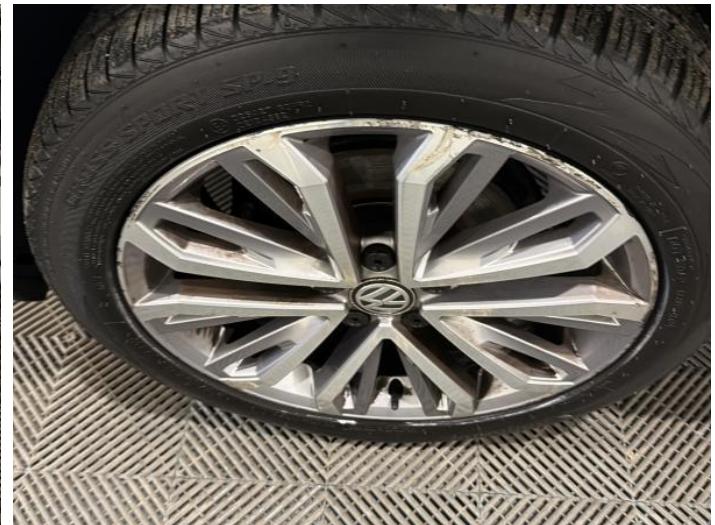
4: Wheel nsf
Scratched
Over 50mm

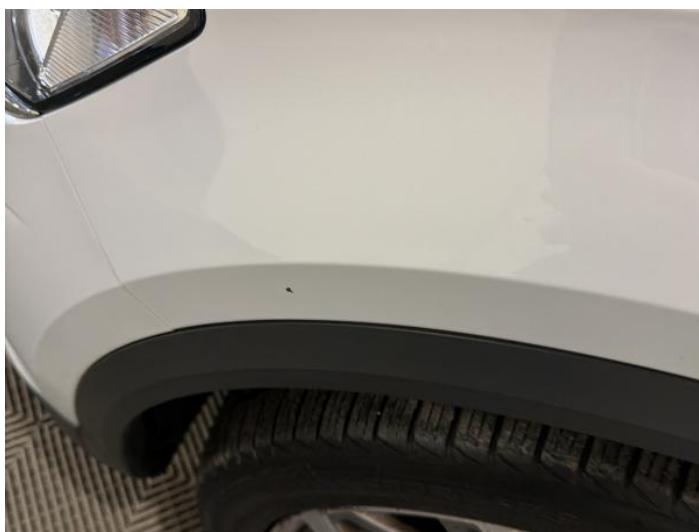
5: Wing nsf
Chipped
1 To 5

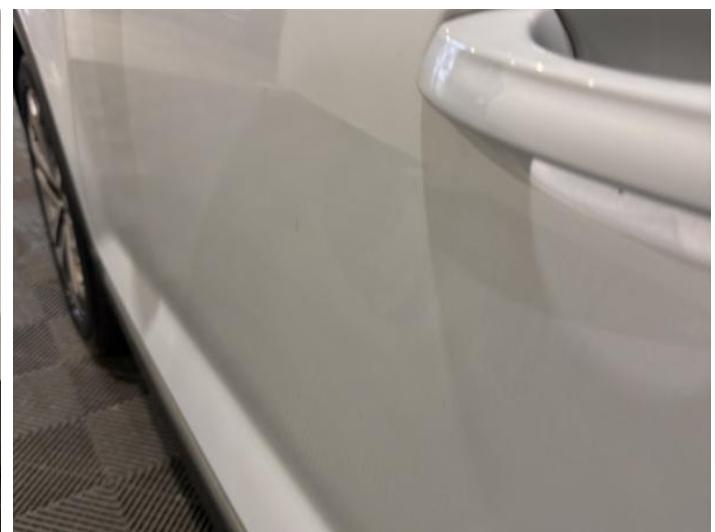
6: Door nsf
Chipped
1 To 5

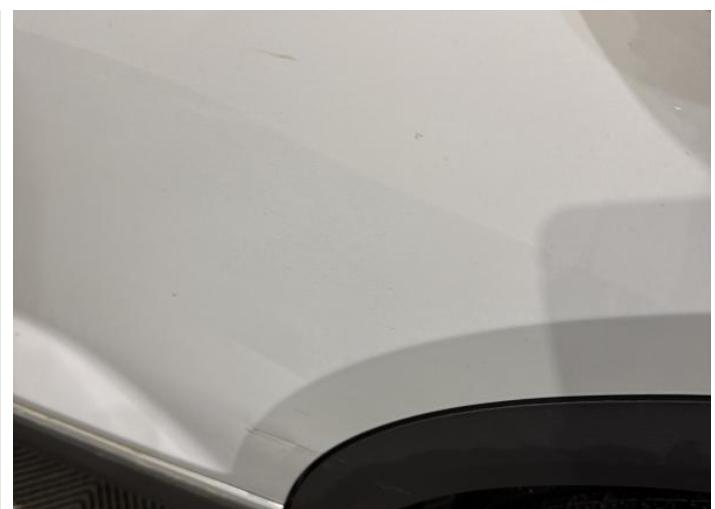
8: Door nsr
Dented
With Paint Damage

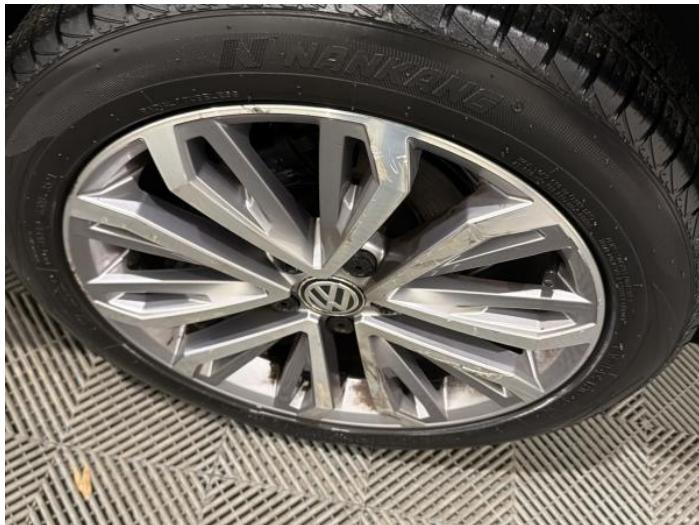
9: Wheel nsr
Scratched
Over 50mm

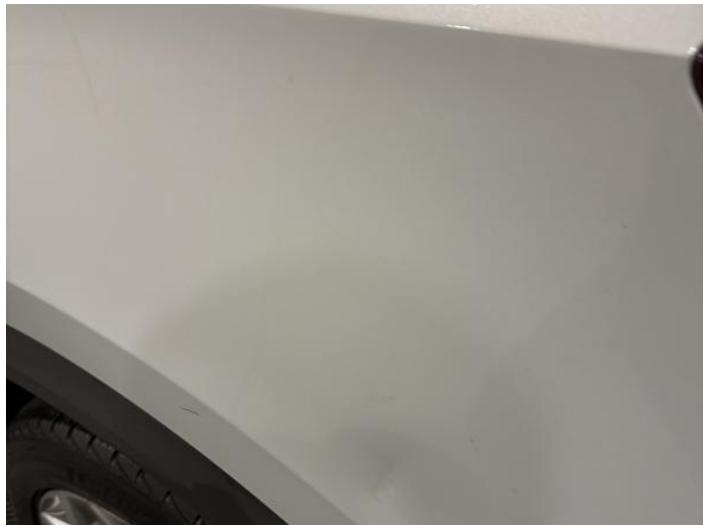
10: Qtr Panel nsr
Dented
With Paint Damage

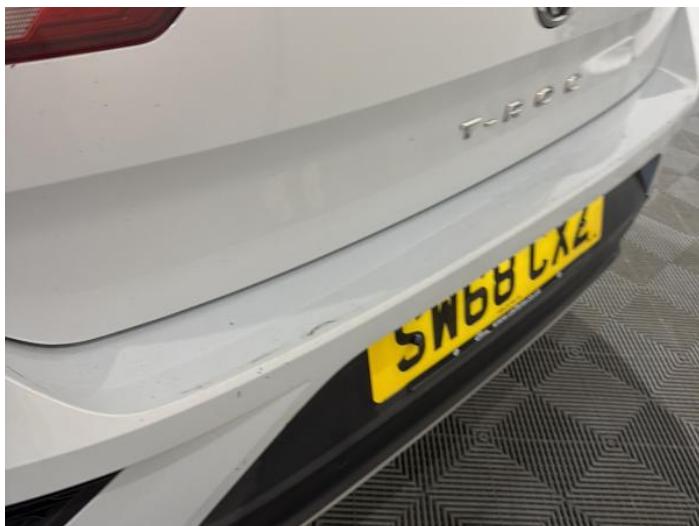
11: Bumper Rear
Scratched
25 to 100mm Thru Paint

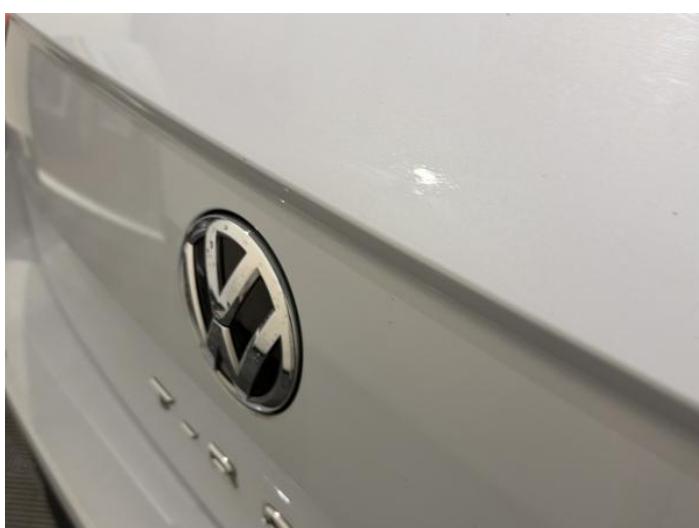
13: Boot Lid
Chipped
1 To 5

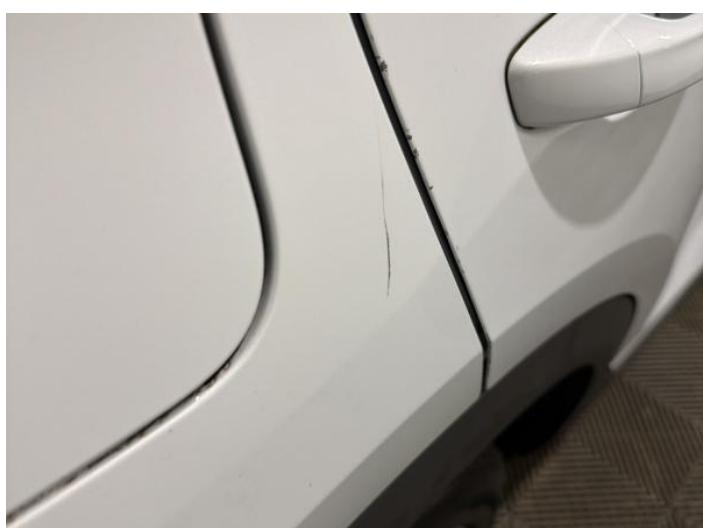
14: Qtr Panel osr
Scratched
UpTo 25mm Thru Paint

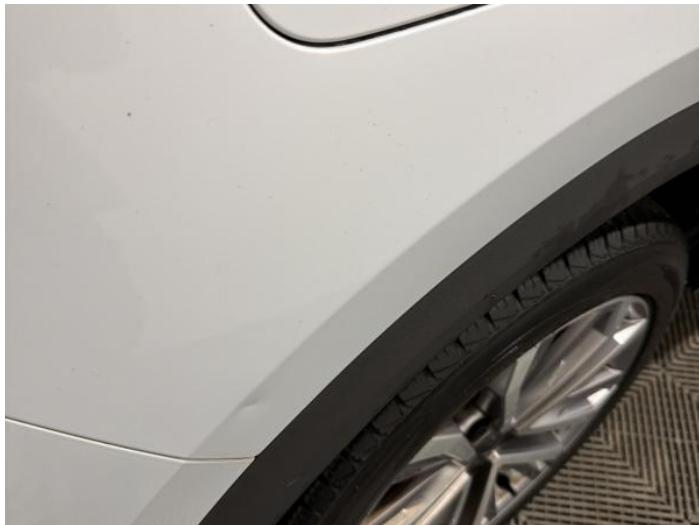
15: Qtr Panel osr
Dented
2 Or Less UpTo 10mm

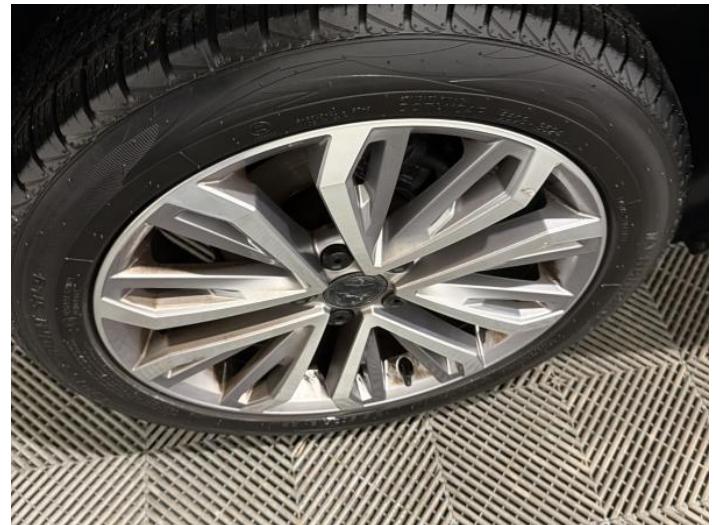
16: Wheel osr
Scratched
Over 50mm

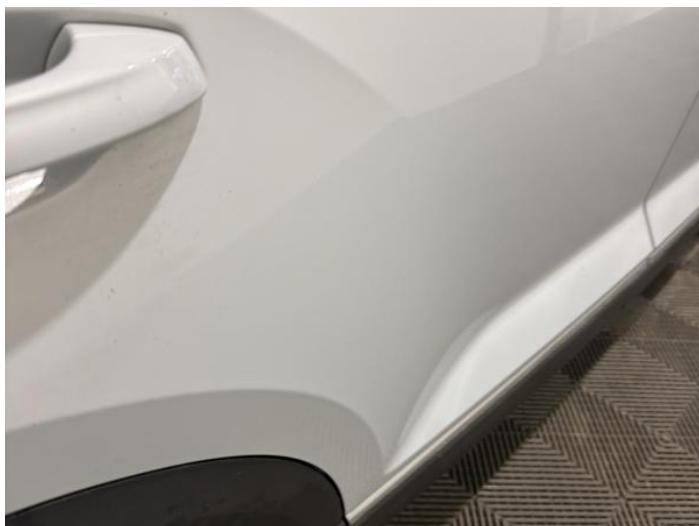
17: Door osr
Dented
Over 2 UpTo 10mm

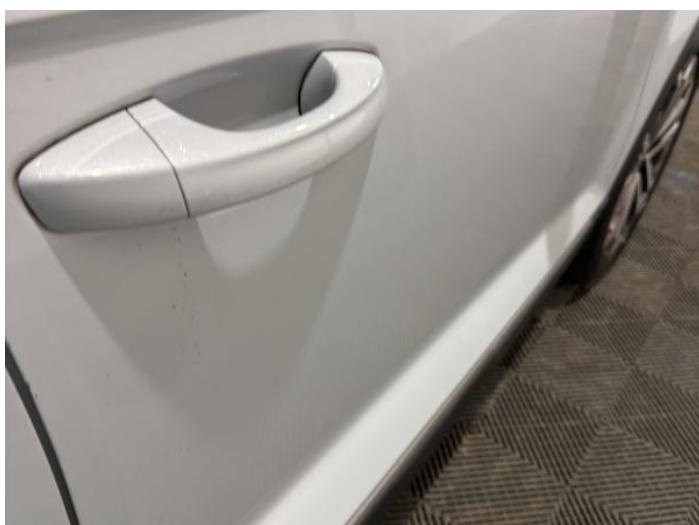
19: Door osf
Chipped
1 To 5

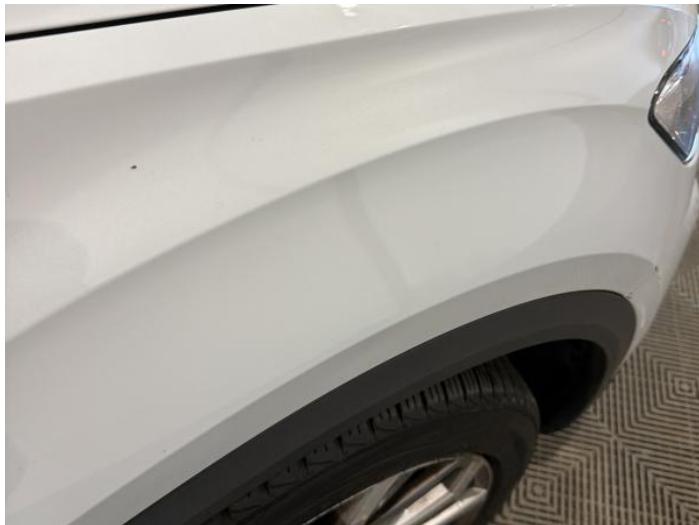
21: Wing osf
Chipped
1 To 5

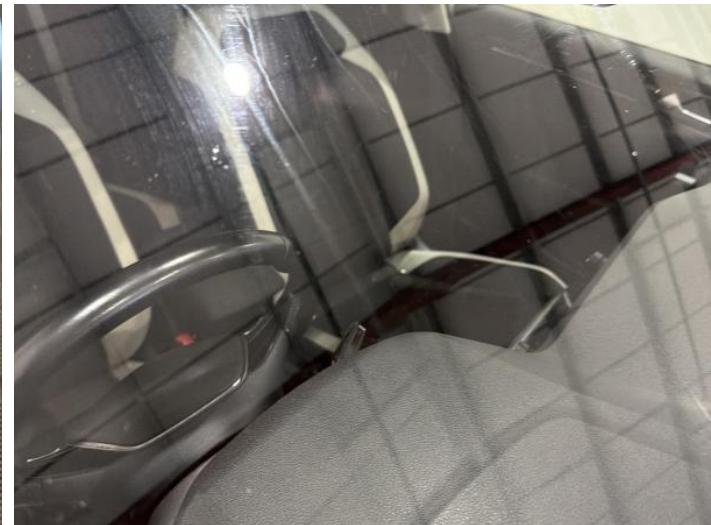
22: Screen Front
Chipped
UpTo 10mm

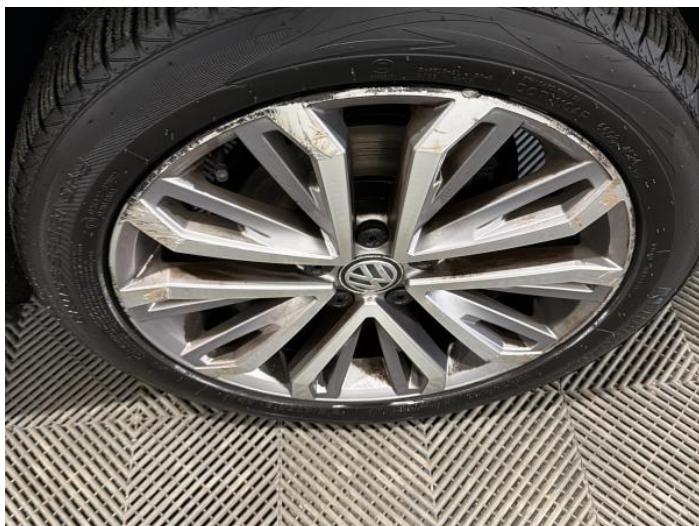
23: Wheel osf
Scratched
Over 50mm
