VEHICLE INSPECTION REPORT

SE64LXJ

Nissan Qashqai 1.2 DiG-T N-Tec+ 5dr

Inspection	Vehicle		nama GRADE 4
Serious Damage?	VAT	Margin	
No	V5	Present

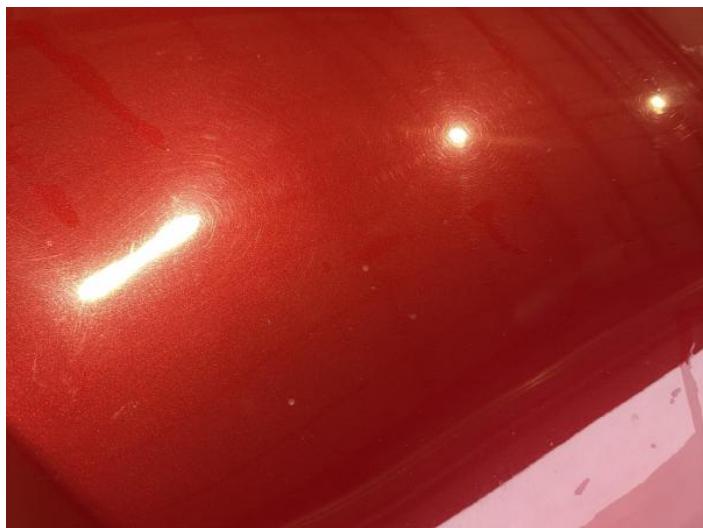
1: Bonnet
Chipped
Multiple Chips

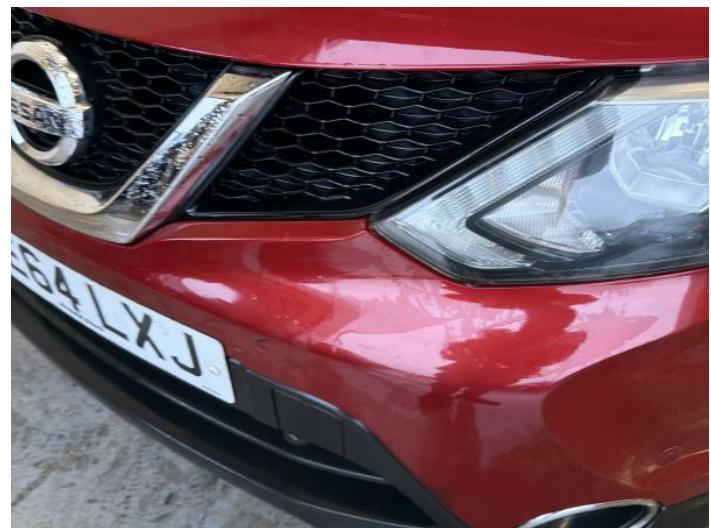
2: Bumper Front
Scratched
Over 100mm Thru Paint

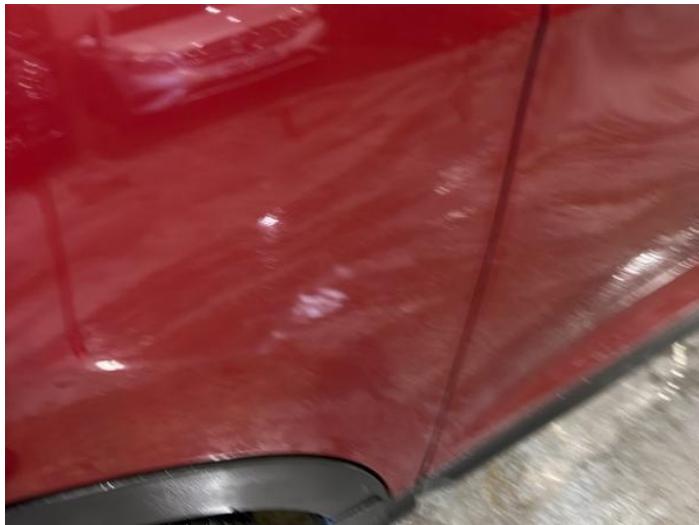
3: Wing nsf
Scratched
Over 25mm Thru Paint

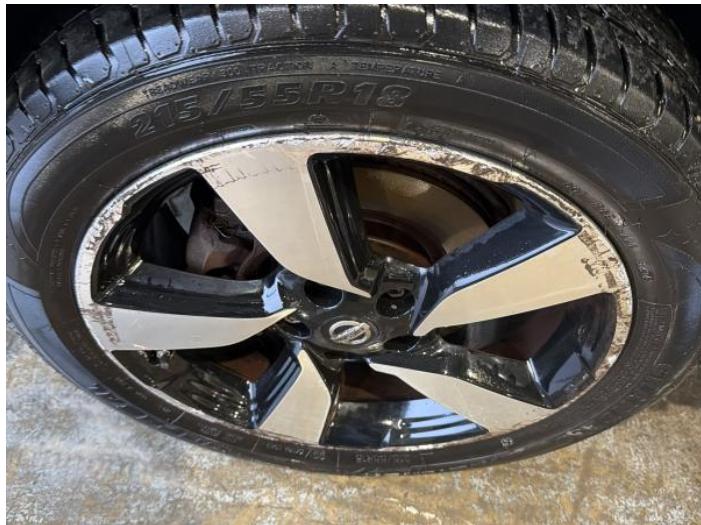
4: Wheel nsf
Scratched
Over 50mm

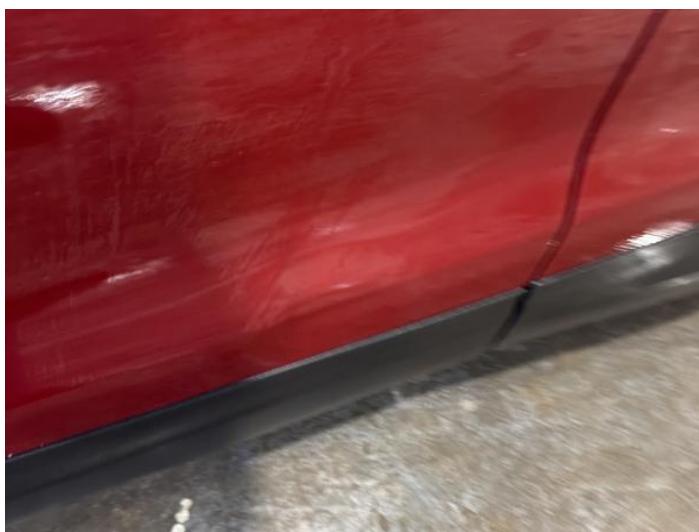
5: Door nsf
Dented
Over 30mm

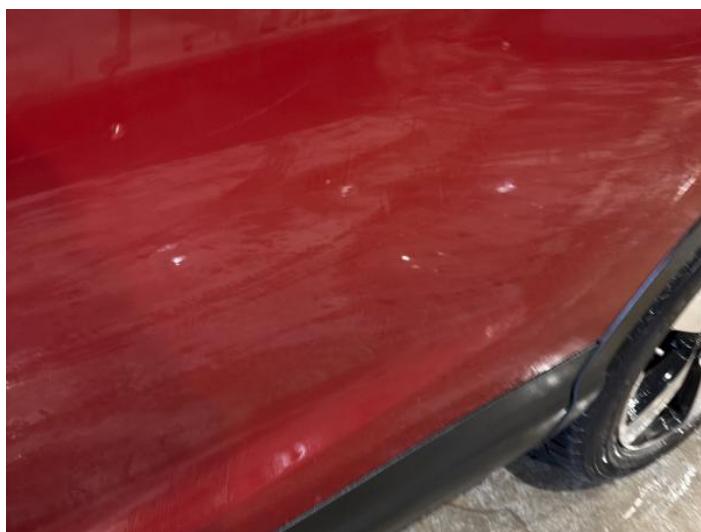
6: Door nsr
Scratched
Over 25mm Thru Paint

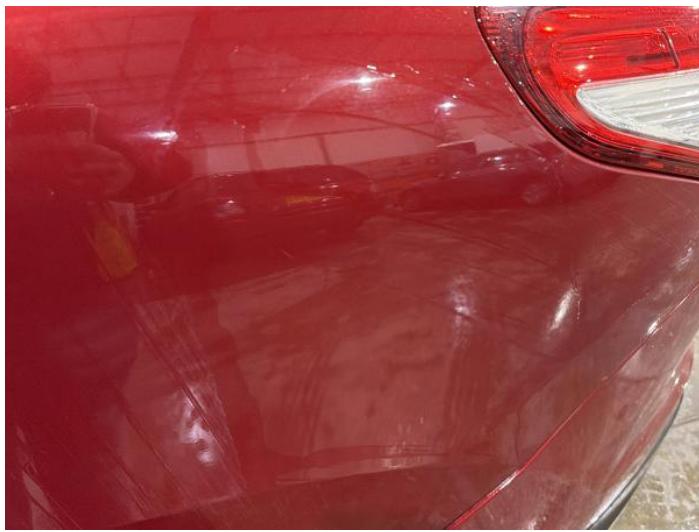
7: Qtr Panel nsr
Dented
Over 2 UpTo 10mm

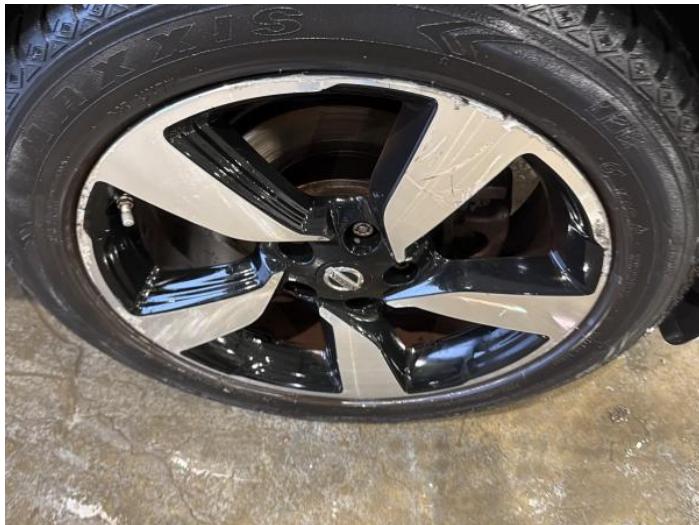
9: Wheel nsr
Scratched
Over 50mm

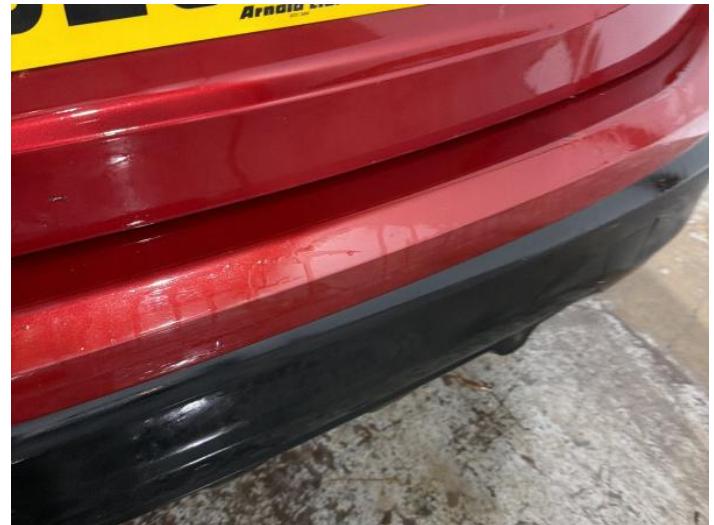
10: Bumper Rear
Scratched
25 to 100mm Thru Paint

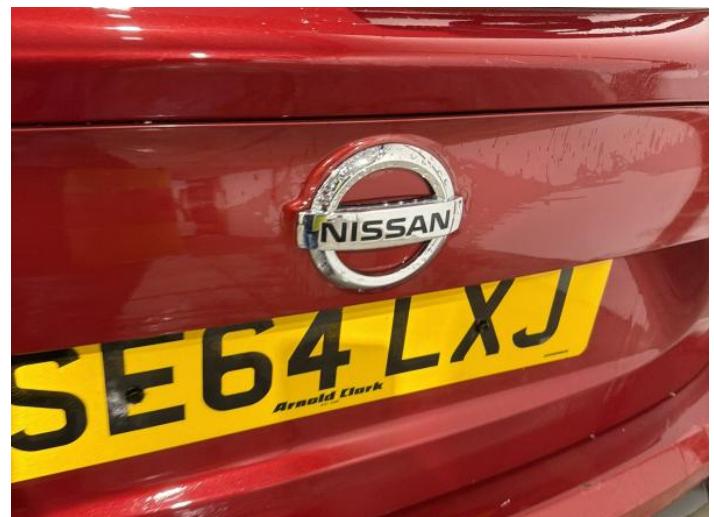
12: Boot Lid
Dented
Over 2 UpTo 10mm

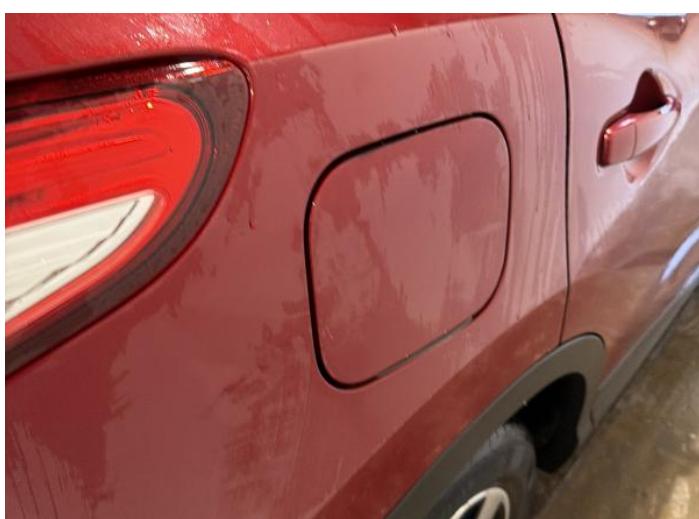
13: Qtr Panel osr
Scratched
Over 25mm Thru Paint

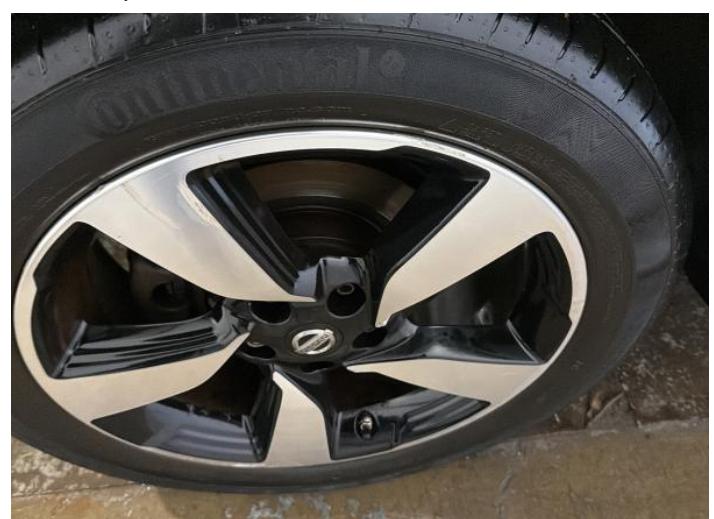
14: Wheel osr
Scratched
Over 50mm

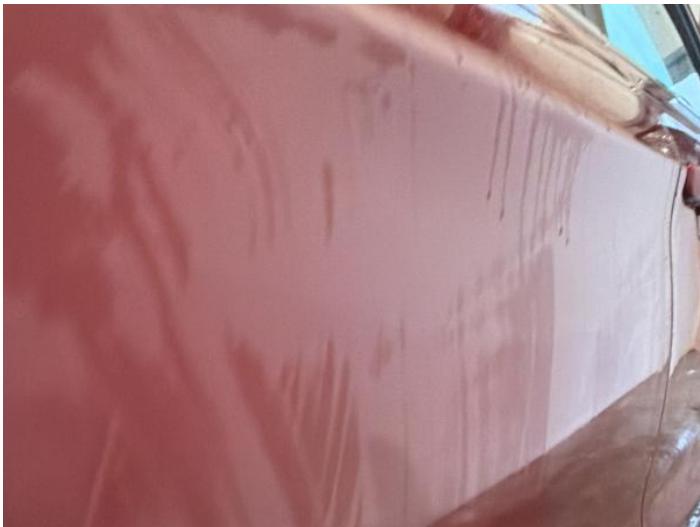
15: Door osr
Dented
Over 2 UpTo 10mm

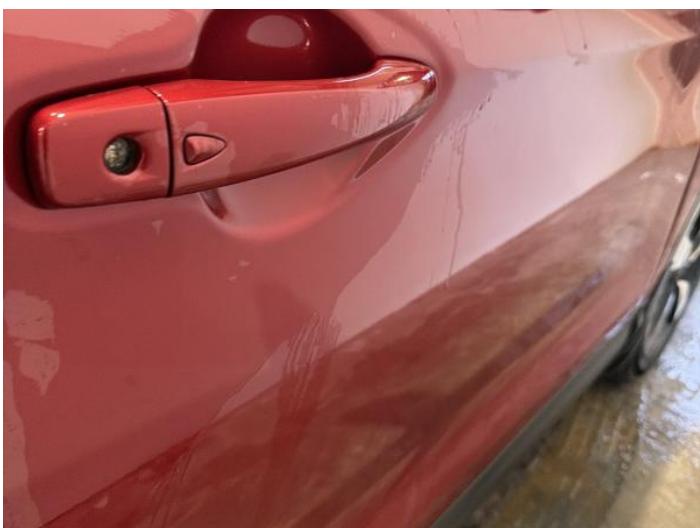
17: Door osf
Chipped
1 To 5

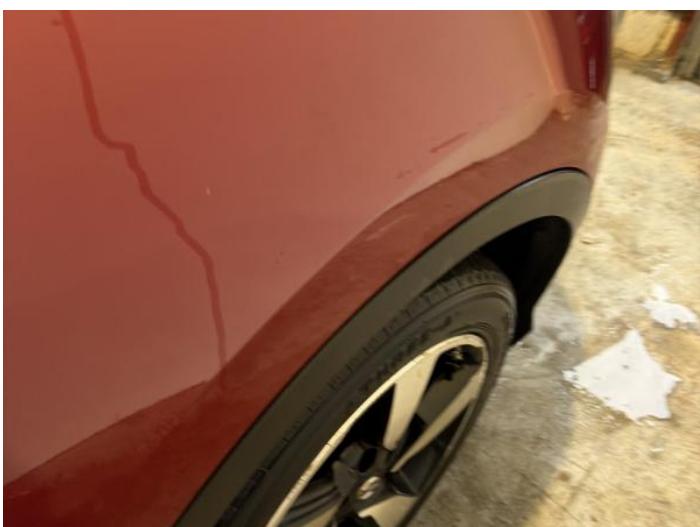
19: Wing osf
Scratched
Over 25mm Thru Paint

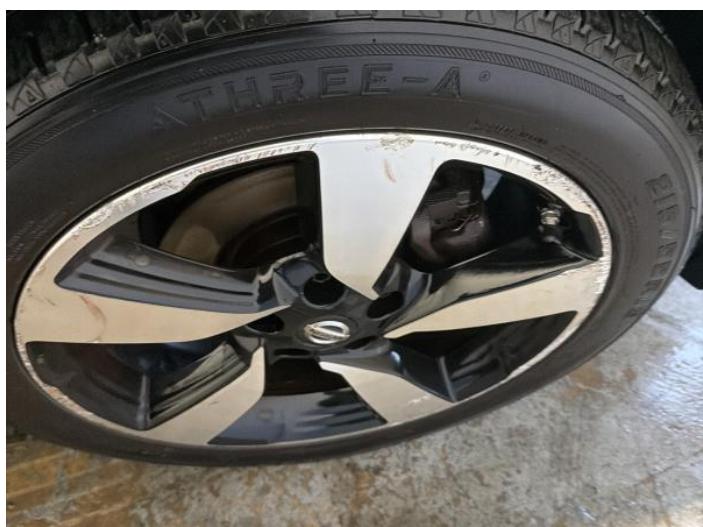
20: Wheel osf
Scratched
Over 50mm
