VEHICLE INSPECTION REPORT

LF19UDL

Citroen C4 Cactus 1.5 BlueHDI 120 Flair EAT6 5dr

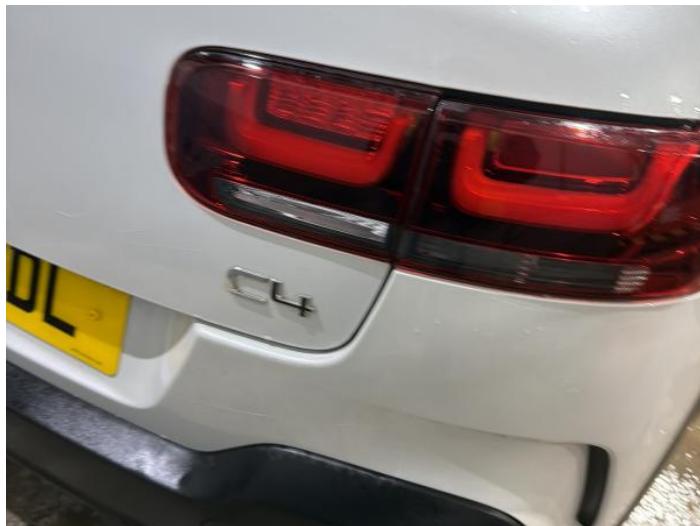
1: Bumper Rear
Chipped
Multiple Chips

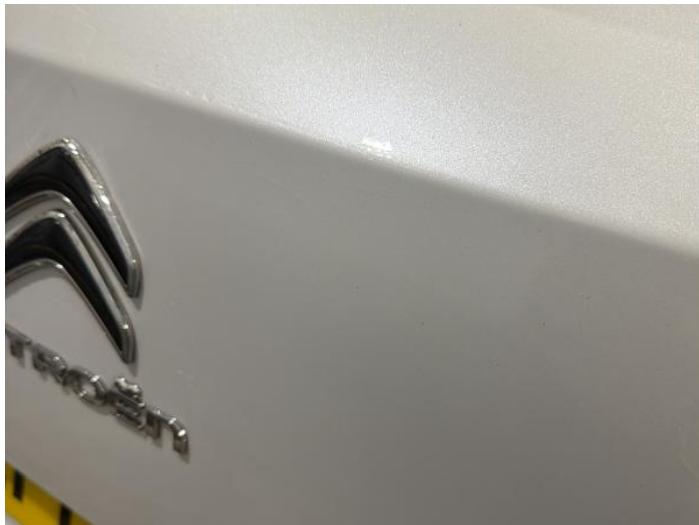
3: Boot Lid
Chipped
1 To 5

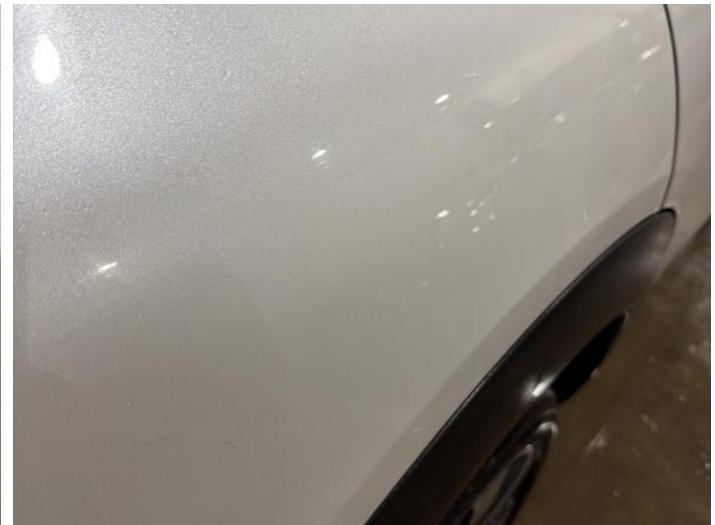
4: Qtr Panel osr
Chipped
1 To 5

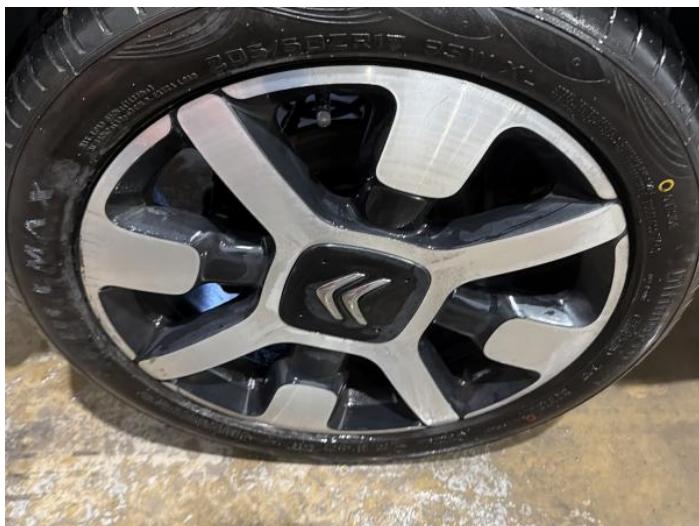
5: Wheel osr
Scratched
Over 50mm

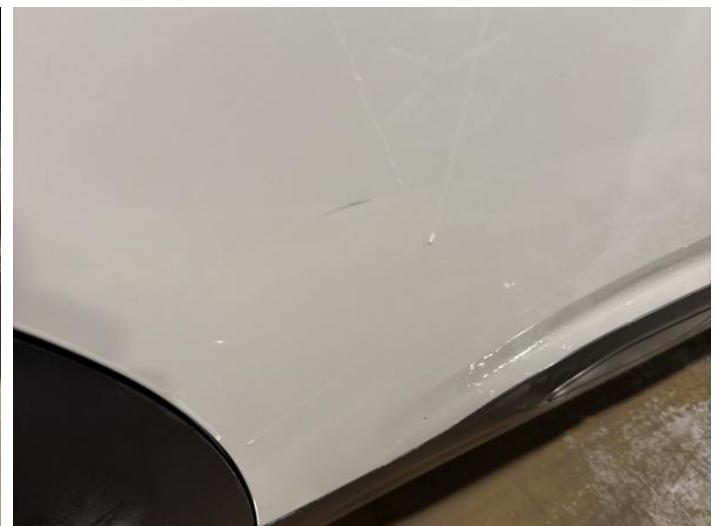
6: Door osr
Dented
Between 10mm + 30mm

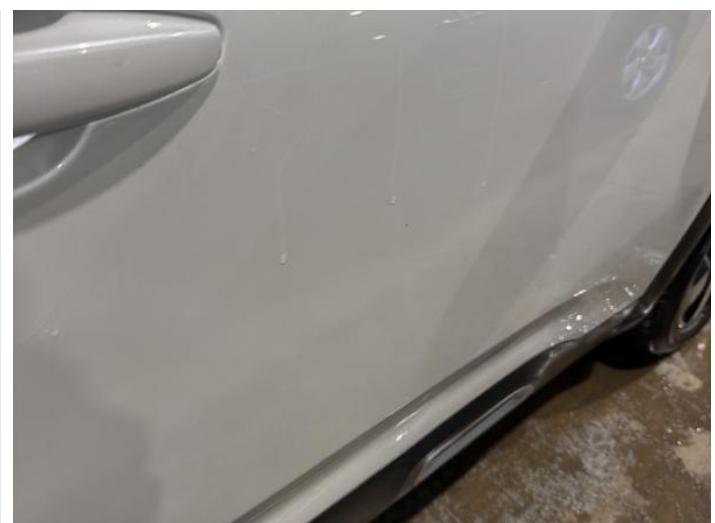
8: Door osf
Chipped
1 To 5

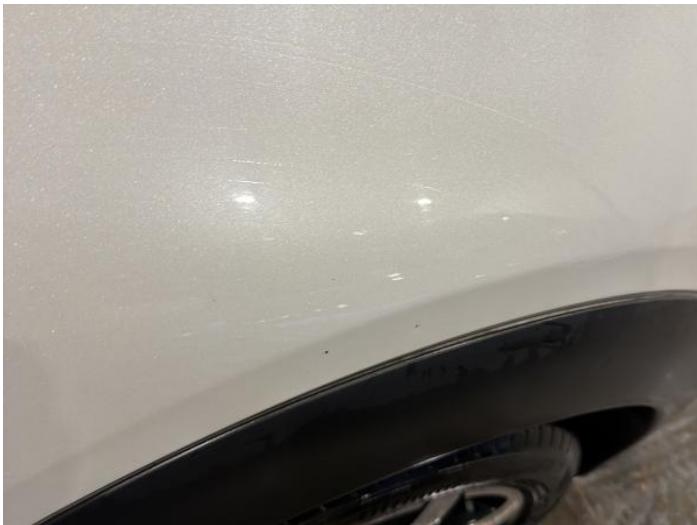
9: Wing osf
Chipped
1 To 5

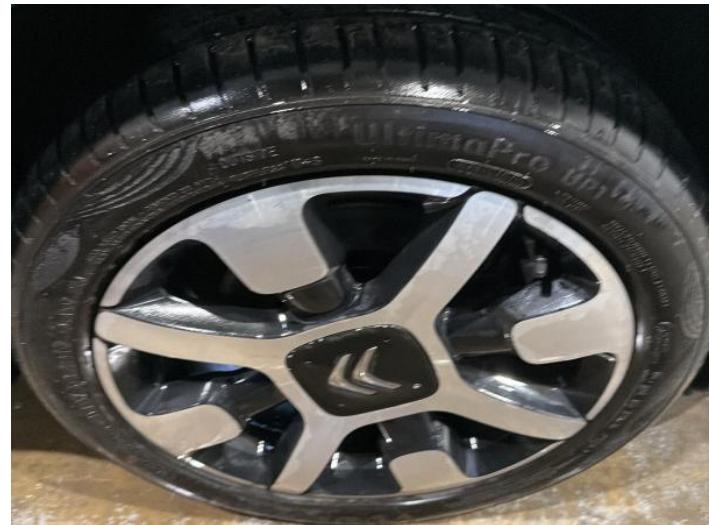
10: Wheel osf
Scratched
Up To 50mm

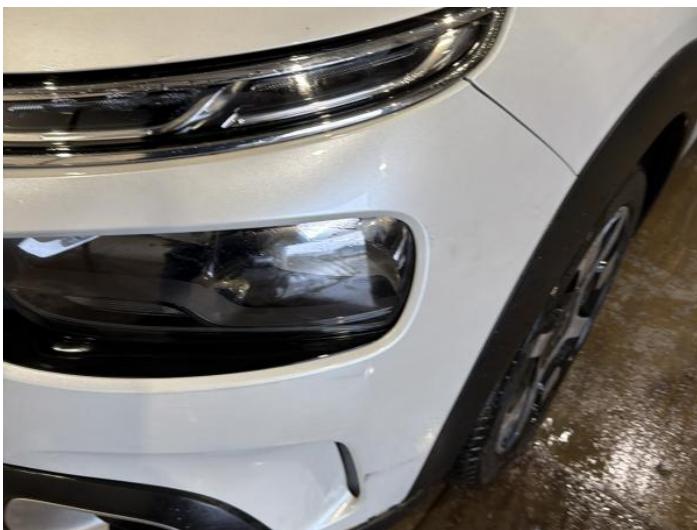
11: Bumper Front
Scratched
25 to 100mm Thru Paint

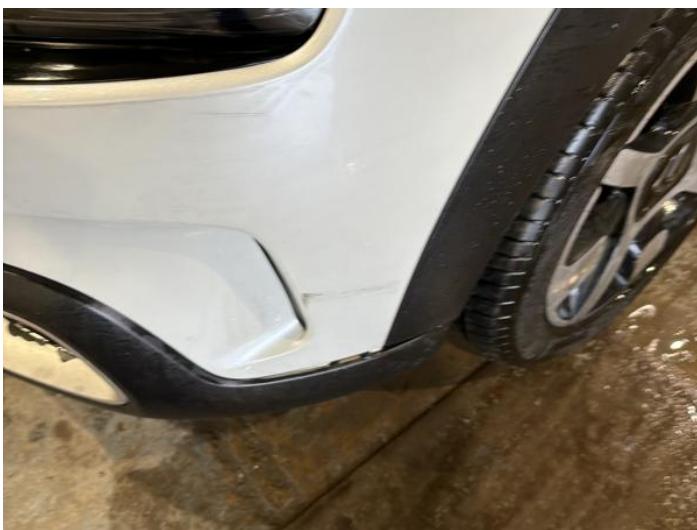
13: Bumper Front Moulding
Broken
Replace

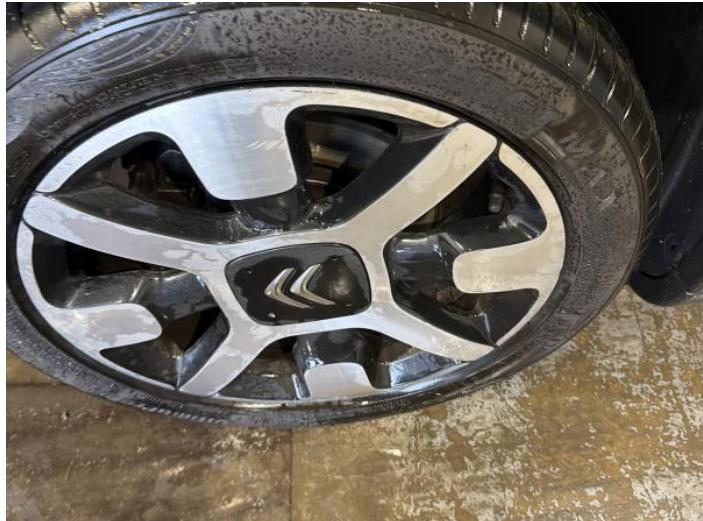
16: Wheel nsf
Scratched
Over 50mm

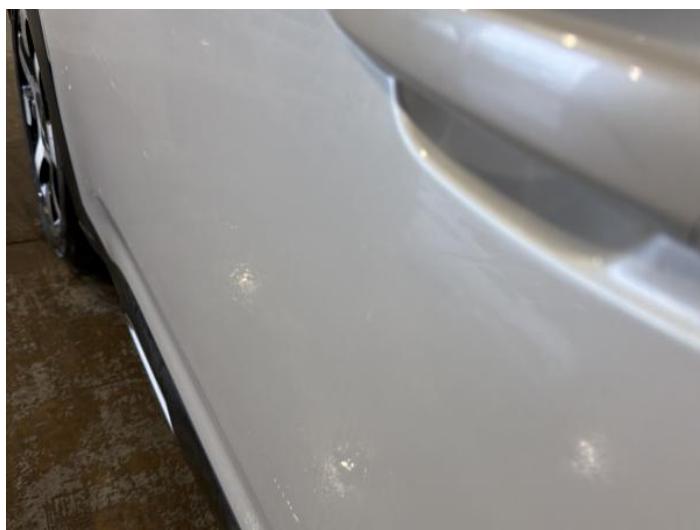
17: Door nsf
Dented
Over 2 UpTo 10mm

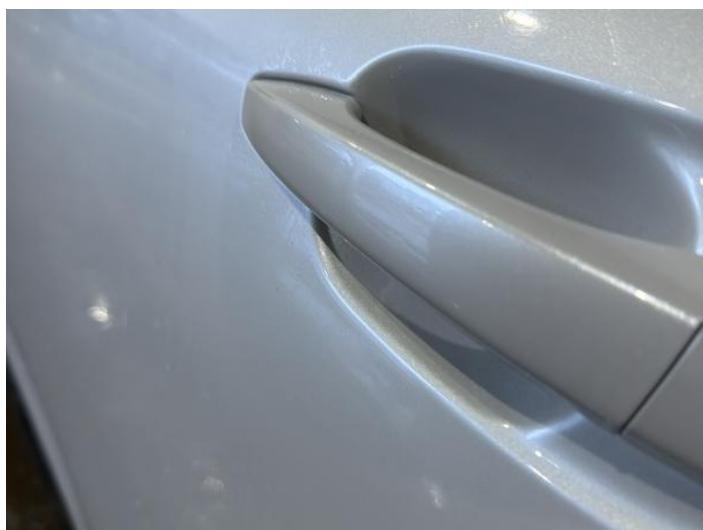
18: Door nsr
Chipped
1 To 5

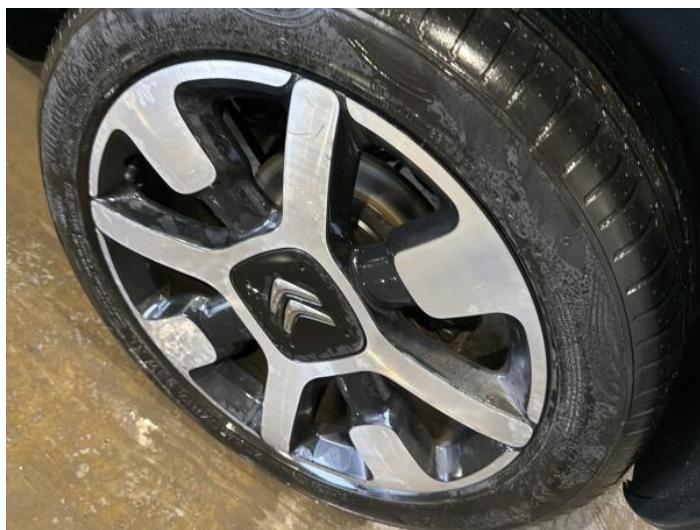
19: Wheel nsr
Scratched
Up To 50mm

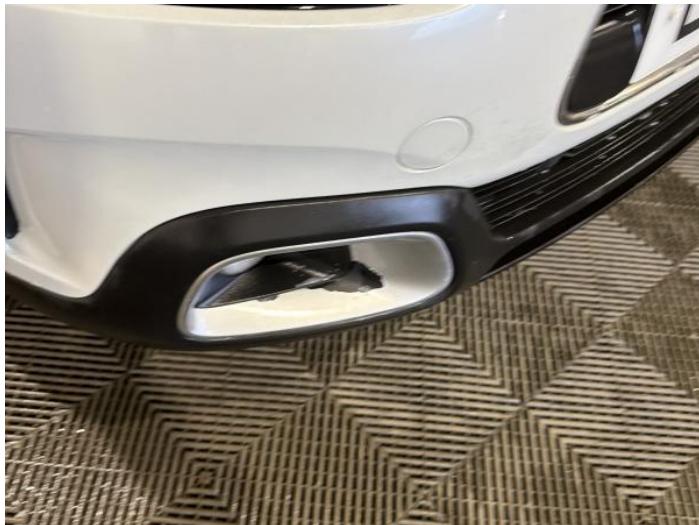
21: Bumper Front Moulding
Scratched (Painted)
Over 25mm Thru Paint
