VEHICLE INSPECTION REPORT

GX64UEC

Seat Leon 1.4 TSI 125 SE 5dr [Technology Pack]

Inspection	Vehicle		GRADE 4
Serious Damage?	VAT	Margin	
No	V5	Present

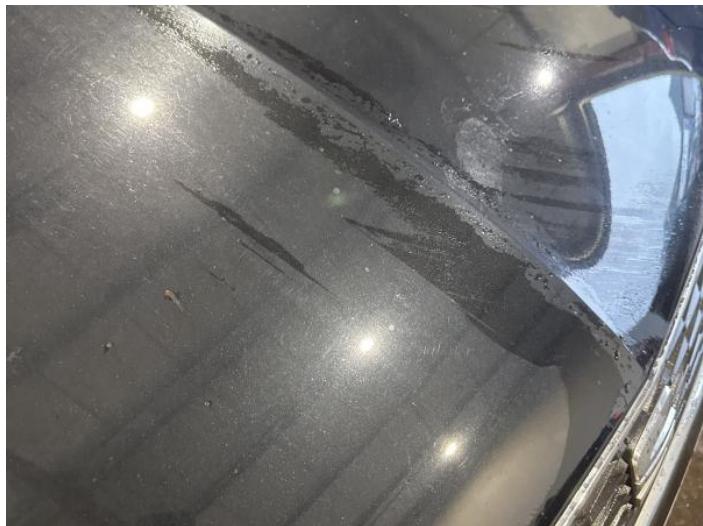
1: Bonnet
Chipped
Multiple Chips

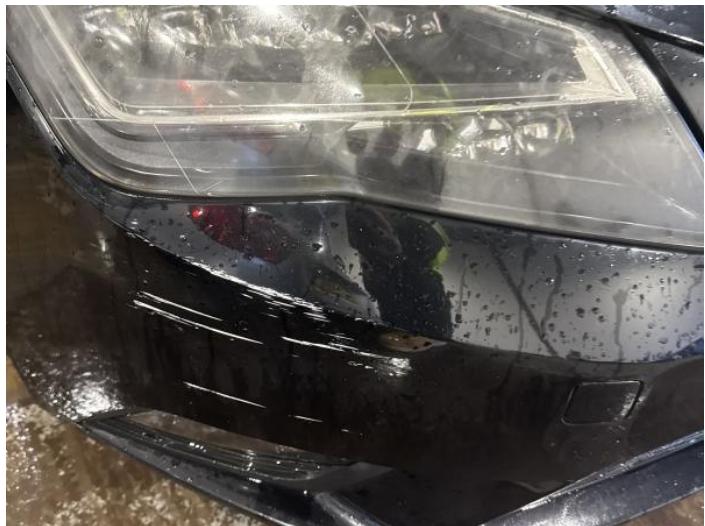
2: Bumper Front
Scratched
Over 100mm Thru Paint

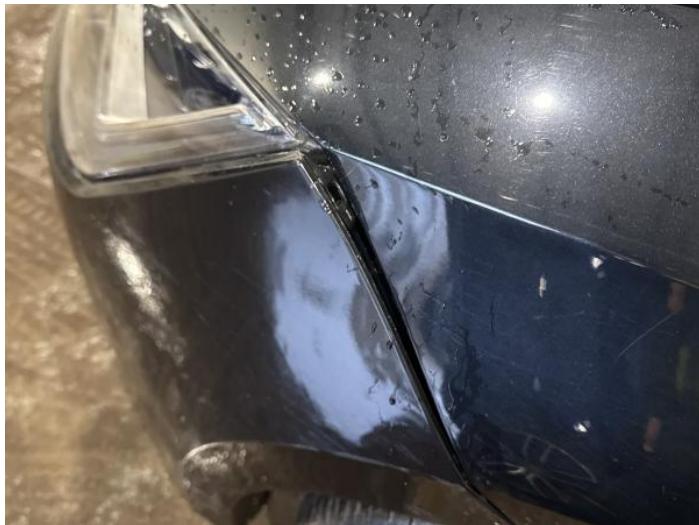
3: Bumper Front
Insecure
Action Required

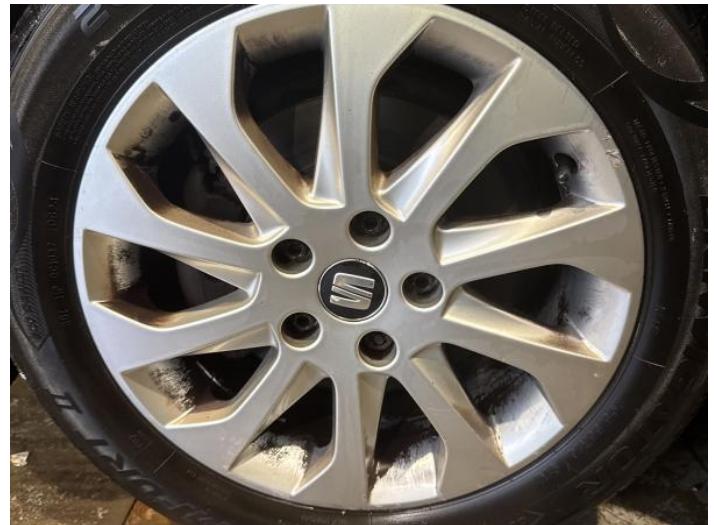
4: Wheel nsf
Scratched
Over 50mm

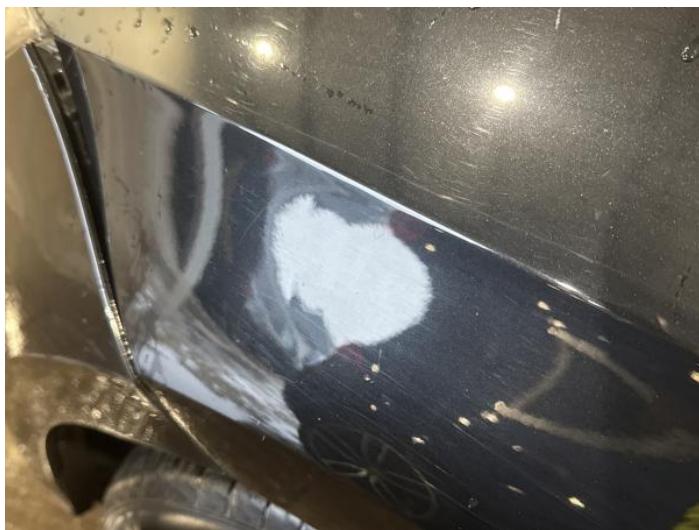
5: Wing nsf
Scratched
UpTo 25mm Thru Paint

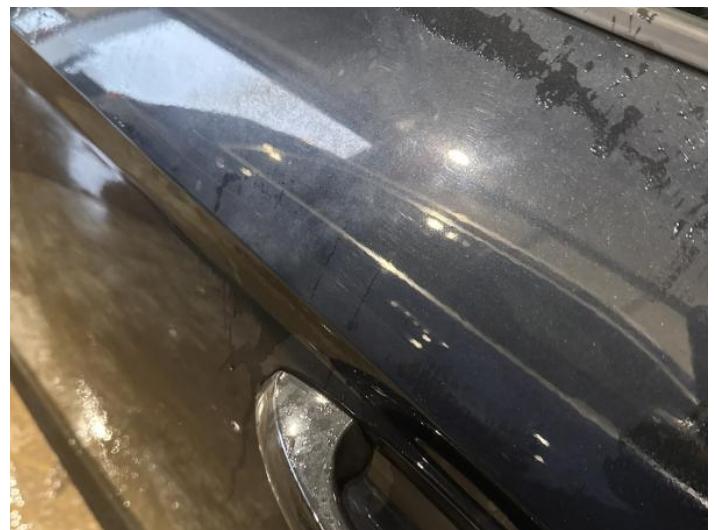
6: Door nsf
Scratched
Over 25mm Thru Paint

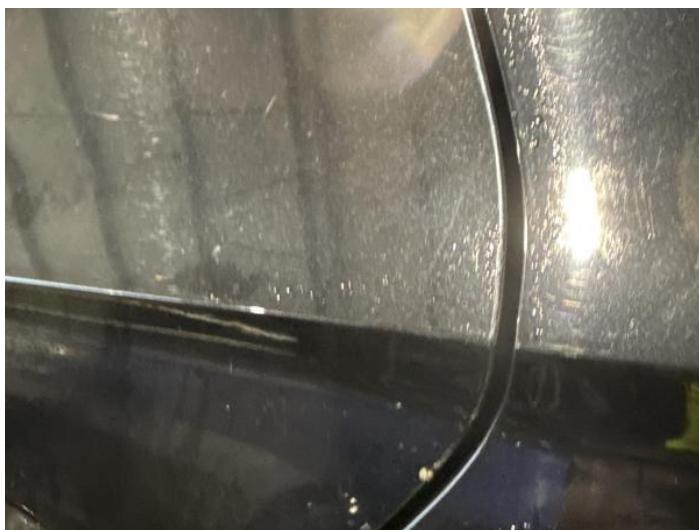
7: Door osr
Chipped
1 To 5

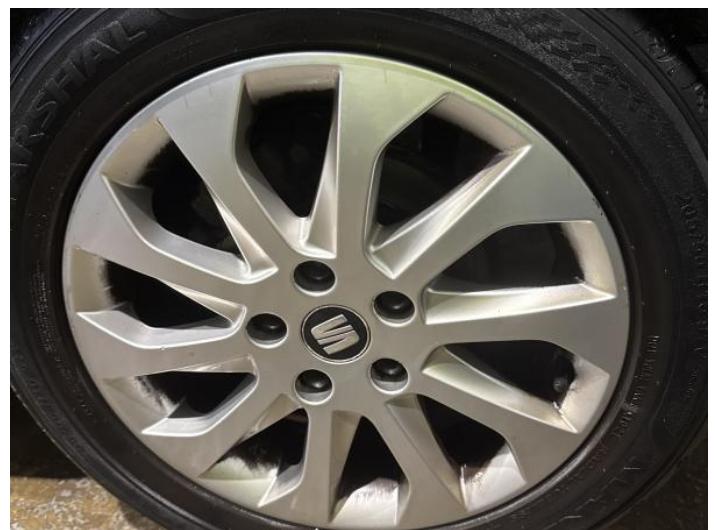
8: Wheel osr
Scratched
Over 50mm

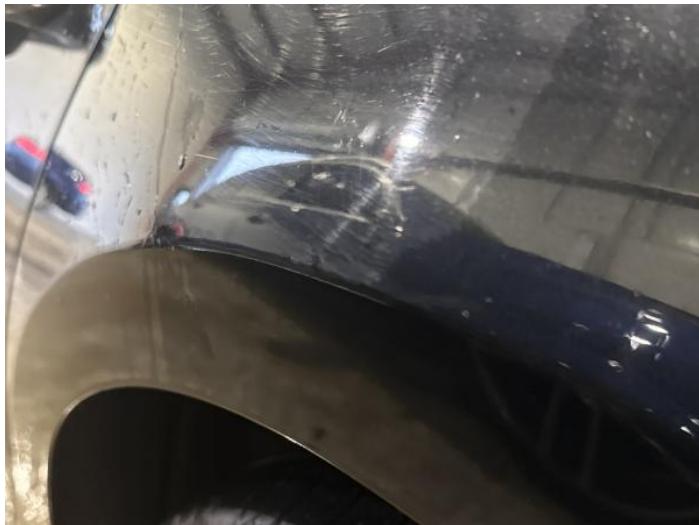
9: Qtr Panel nsr
Dented
Between 10mm + 30mm

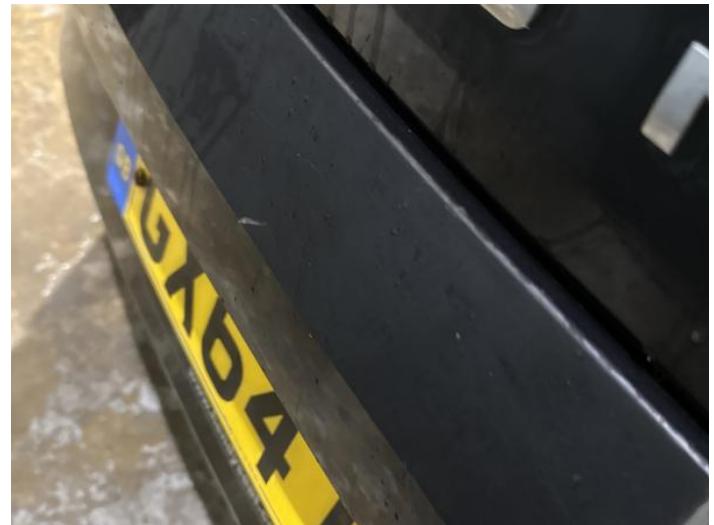
10: Bumper Rear
Scratched
25 to 100mm Thru Paint

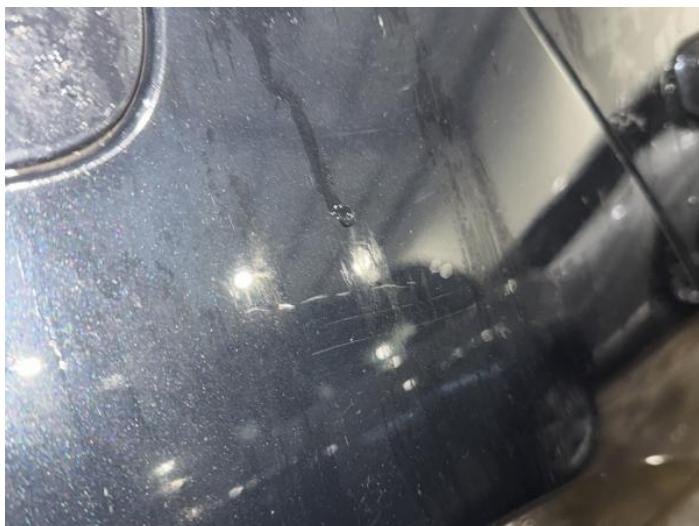
11: Qtr Panel osr
Scratched
Over 25mm Thru Paint

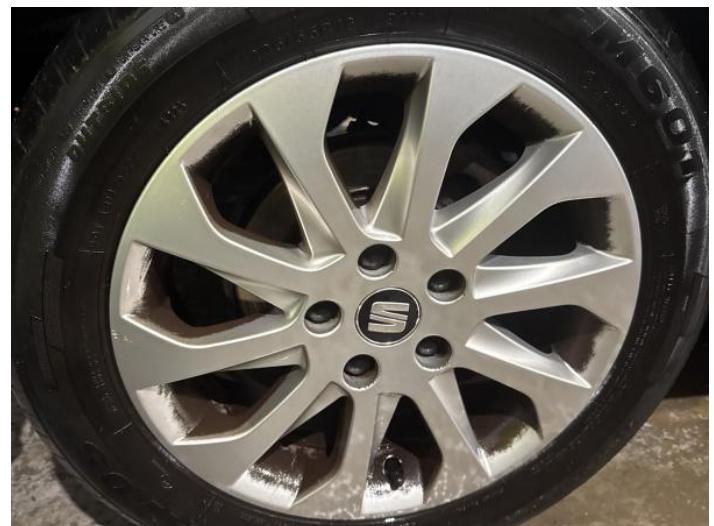
12: Wheel osr
Scratched
Up To 50mm

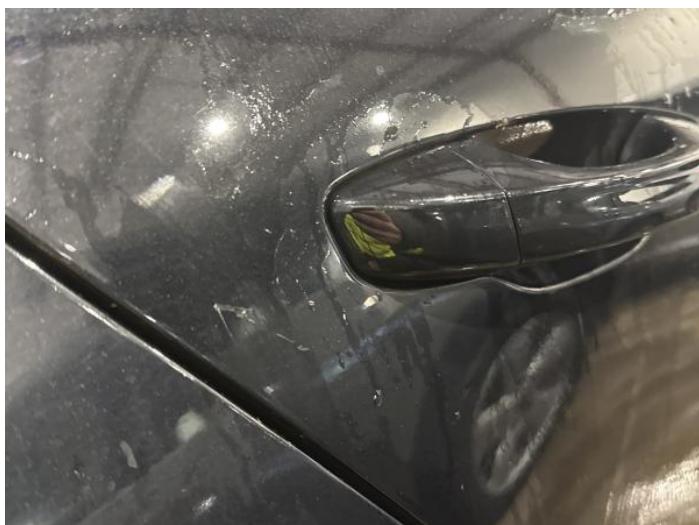
13: Door osr
Scratched
Over 25mm Thru Paint

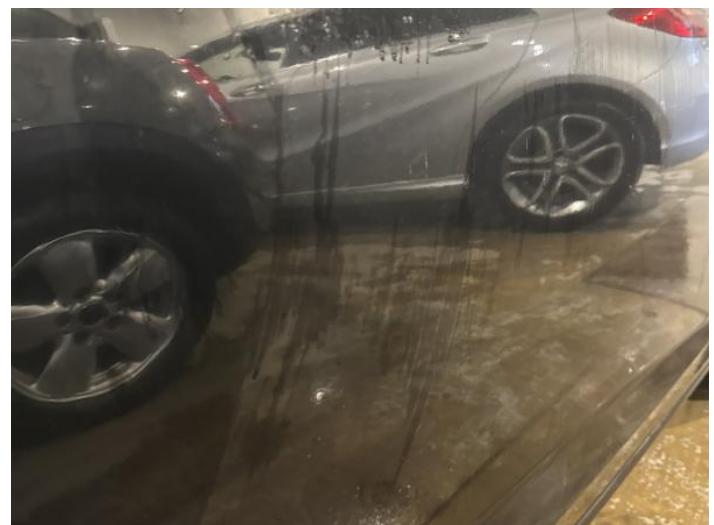
14: Door osf
Scratched
Over 25mm Thru Paint

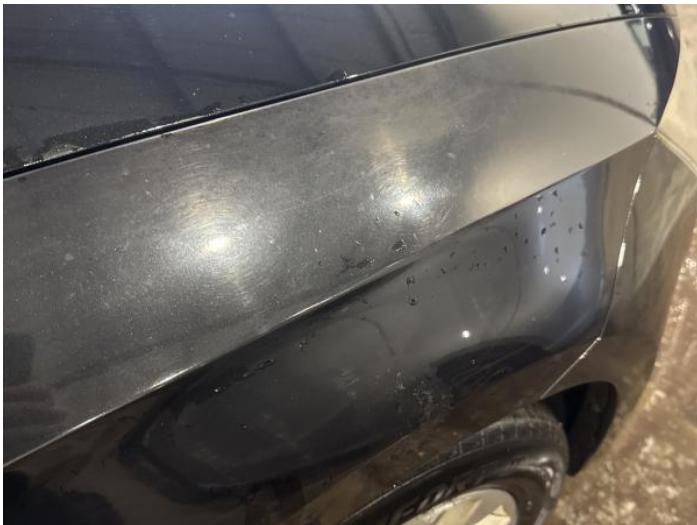
15: Wing osf
Scratched
Over 25mm Thru Paint

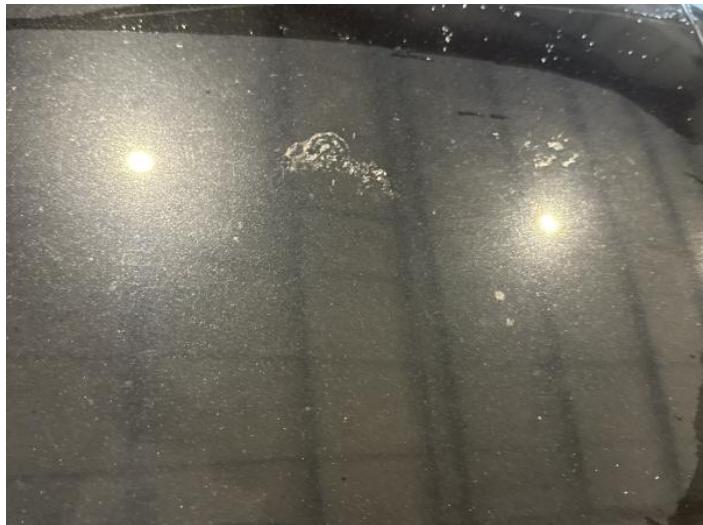
16: Roof
Scratched
Over 25mm Thru Paint

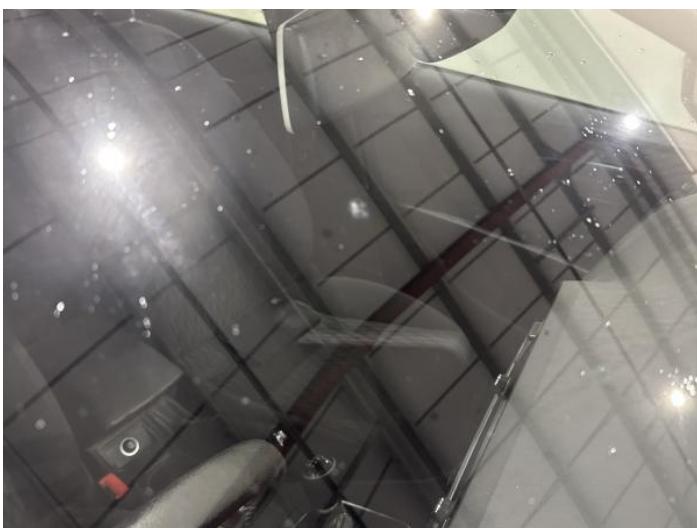
17: Screen Front
Chipped
UpTo 10mm
