## VEHICLE INSPECTION REPORT

LP68ACJ

### Mercedes-Benz A Class A180d Sport Executive 5dr Auto

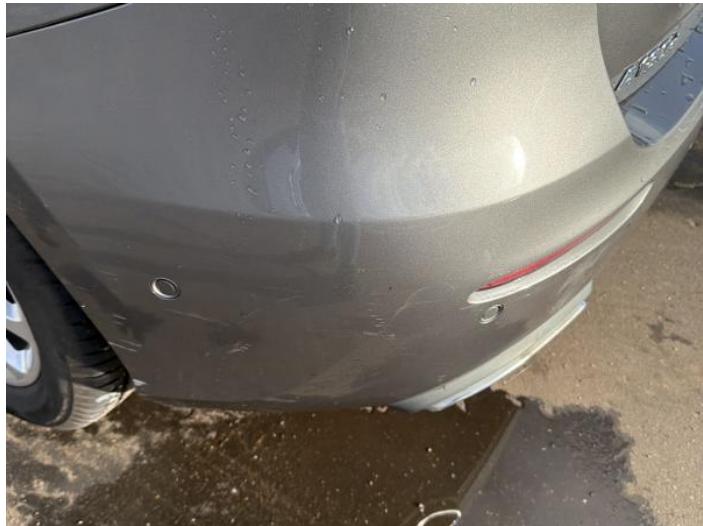
1: Bumper Rear  
Scratched  
Over 100mm Thru Paint

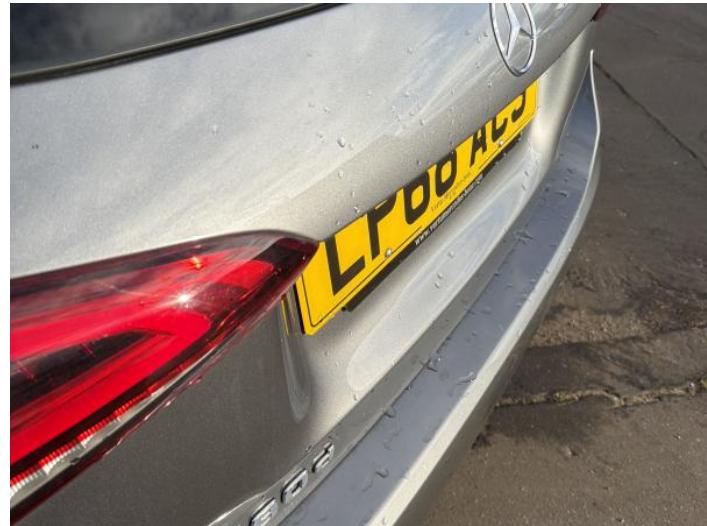
2: Boot Lid  
Dented  
Over 2 UpTo 10mm

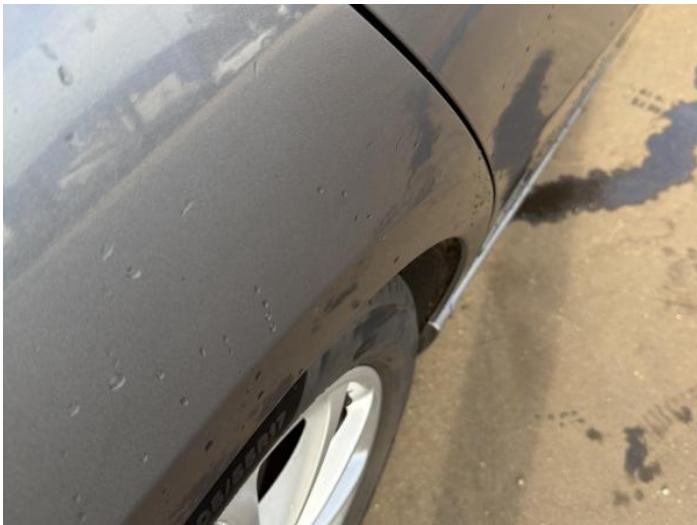
3: Qtr Panel osr  
Dented  
2 Or Less UpTo 10mm

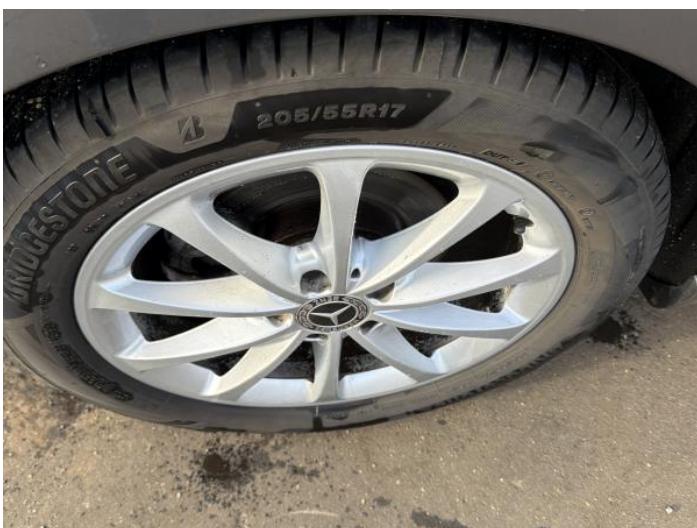
5: Wheel osr  
Scratched  
Up To 50mm

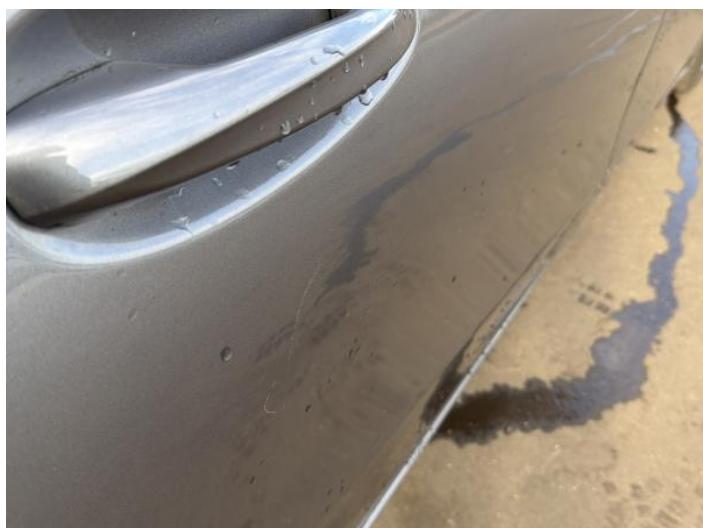
6: Door osr  
Scratched  
Over 25mm Thru Paint

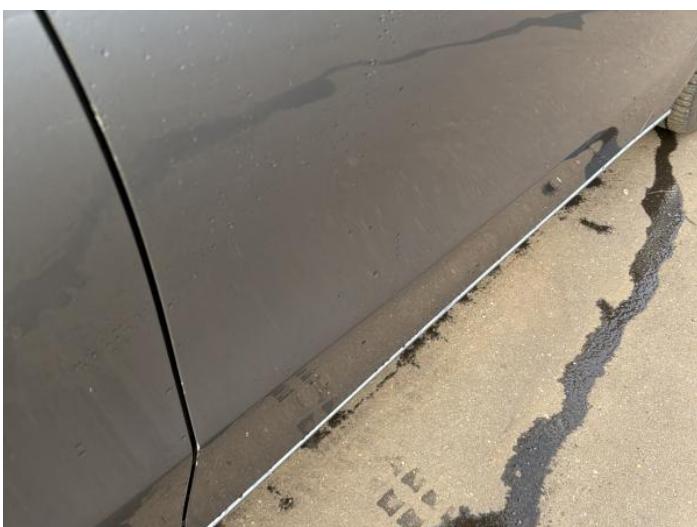
7: Door osf  
Chipped  
Edge Chip

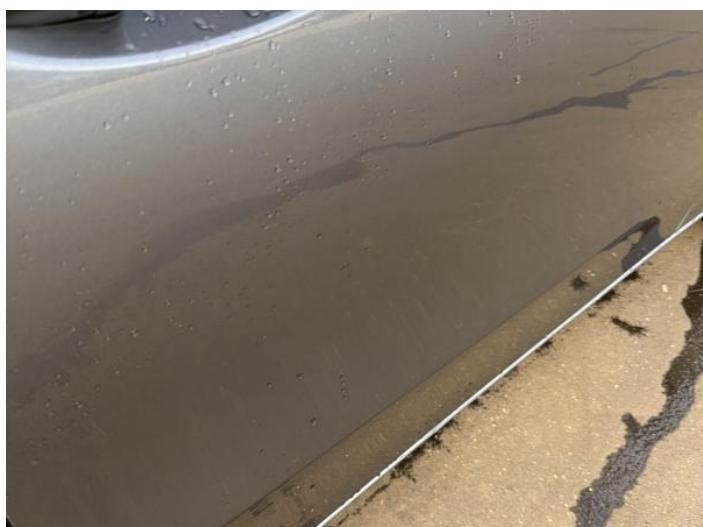
8: Door osf  
Dented  
Over 2 UpTo 10mm

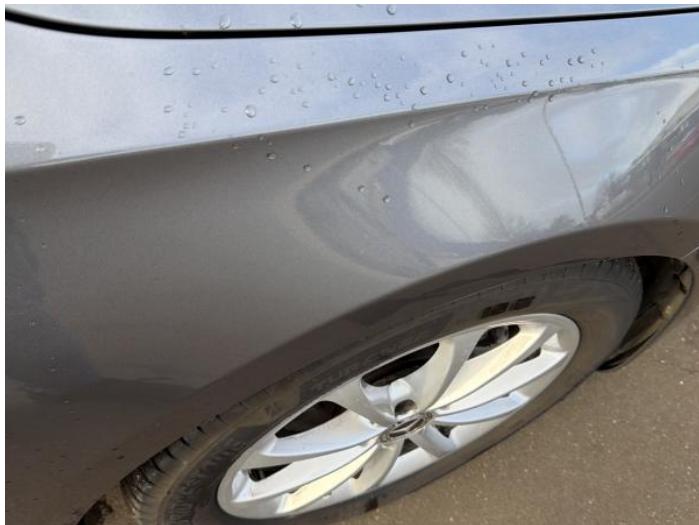
9: Wing osf  
Chipped  
1 To 5

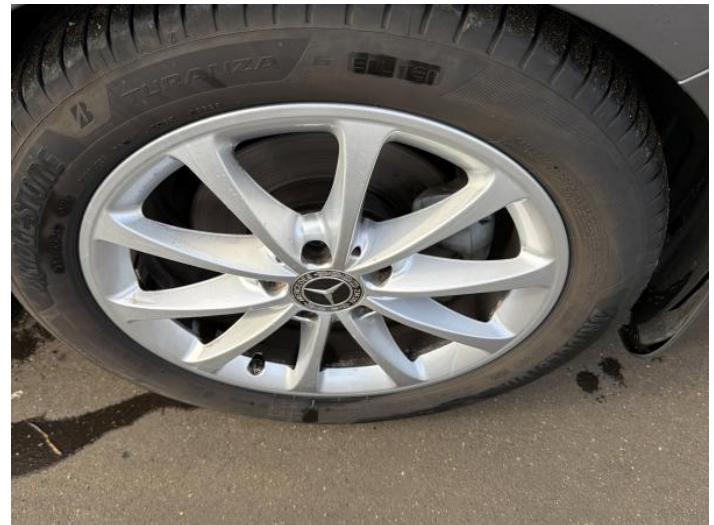
10: Wheel osf  
Scratched  
Up To 50mm

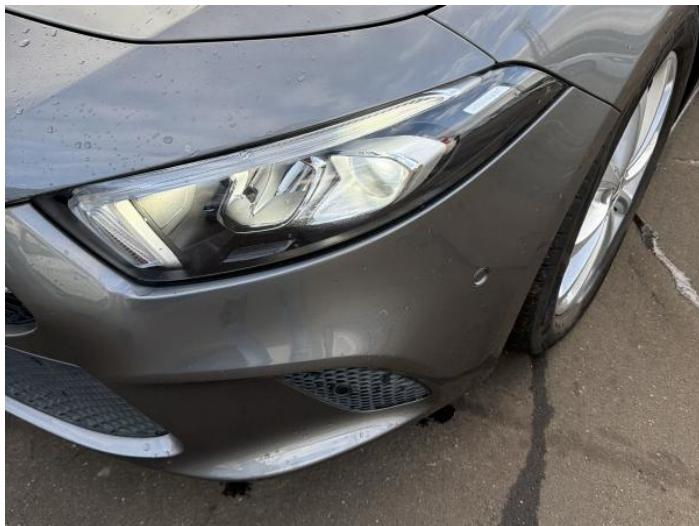
11: Bumper Front  
Scratched  
25 to 100mm Thru Paint

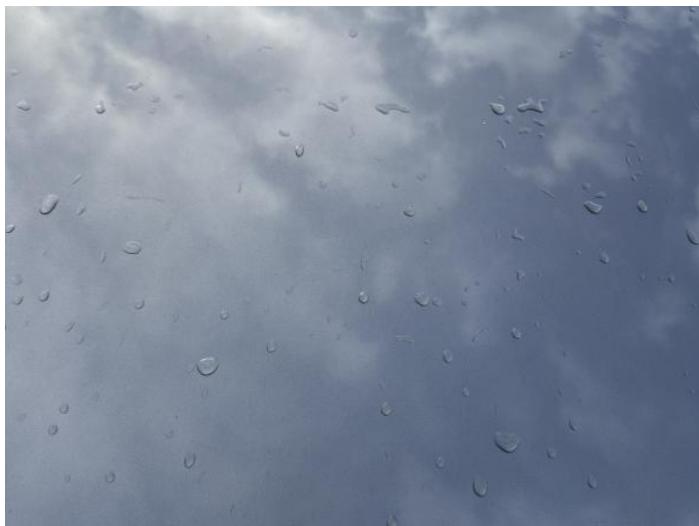
13: Bonnet  
Chipped  
1 To 5

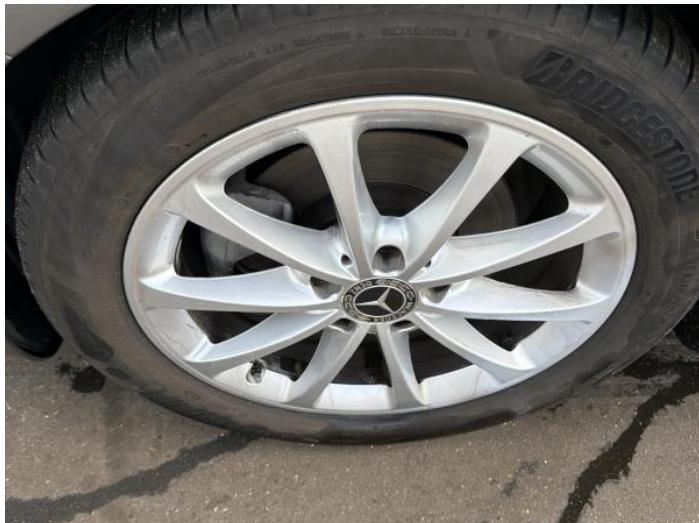
15: Wheel nsf  
Scratched  
Up To 50mm

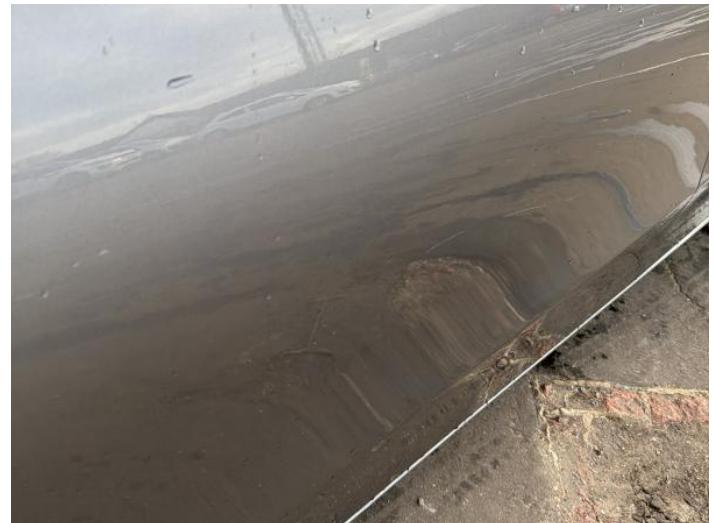
16: Door nsf  
Scratched  
Over 25mm Thru Paint

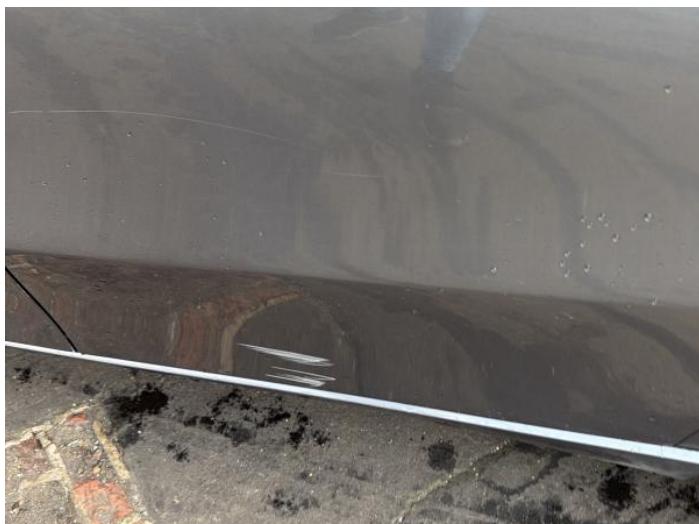
17: Door nsr  
Dented  
With Paint Damage

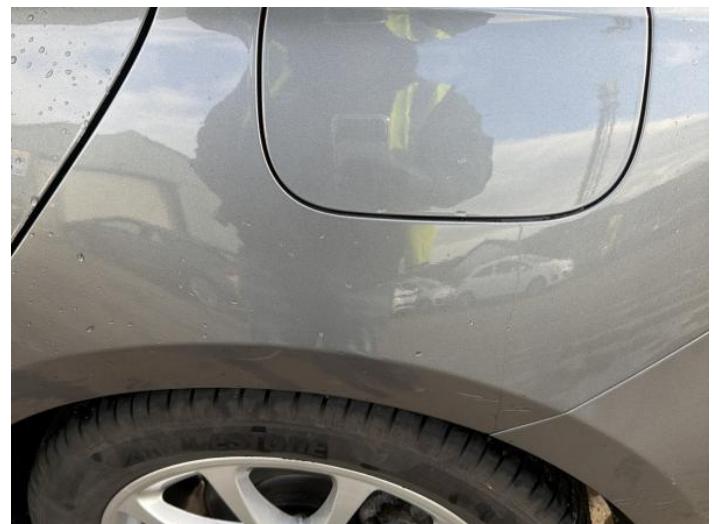
18: Qtr Panel nsr  
Poor Previous Repair  
Poor Paint

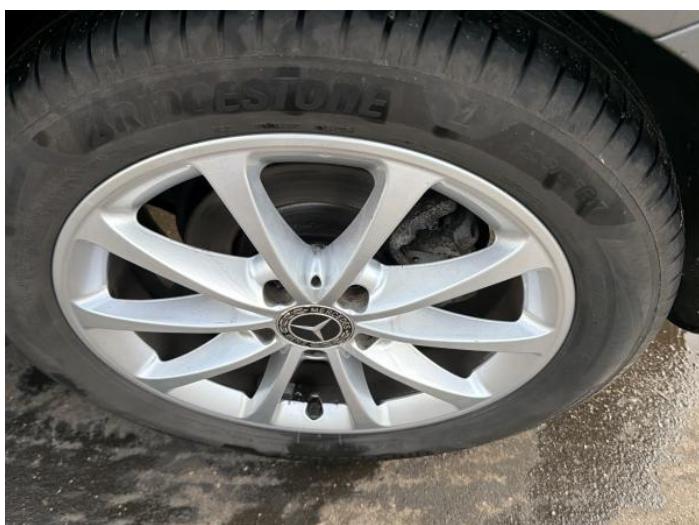
19: Wheel nsr  
Scratched  
Up To 50mm
