VEHICLE INSPECTION REPORT

GU62HSV

Citroen C4 Picasso 1.6 HDi Platinum 5dr

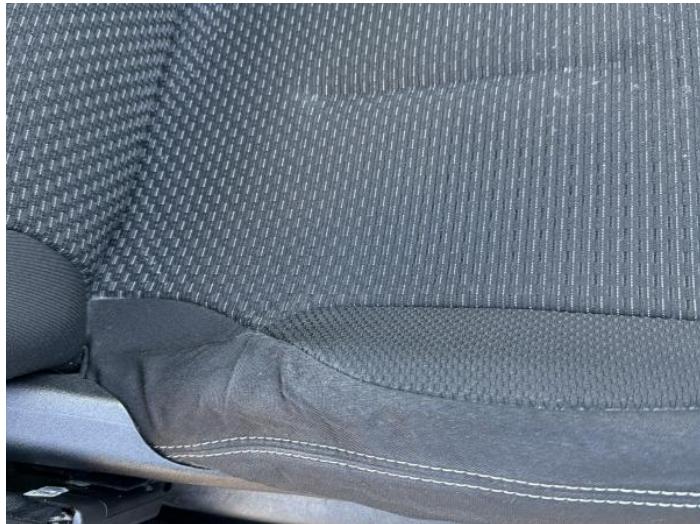
1: Seat Base Cover osf
Scuffed
UpTo 25mm

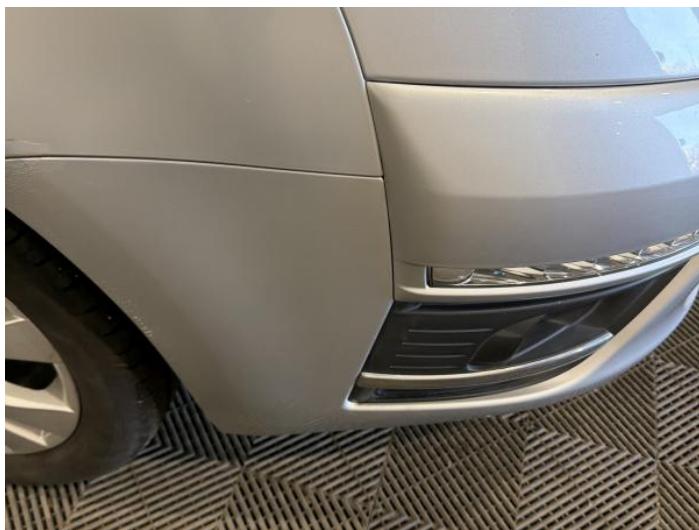
5: Bumper Front
Poor Previous Repair
Poor Paint

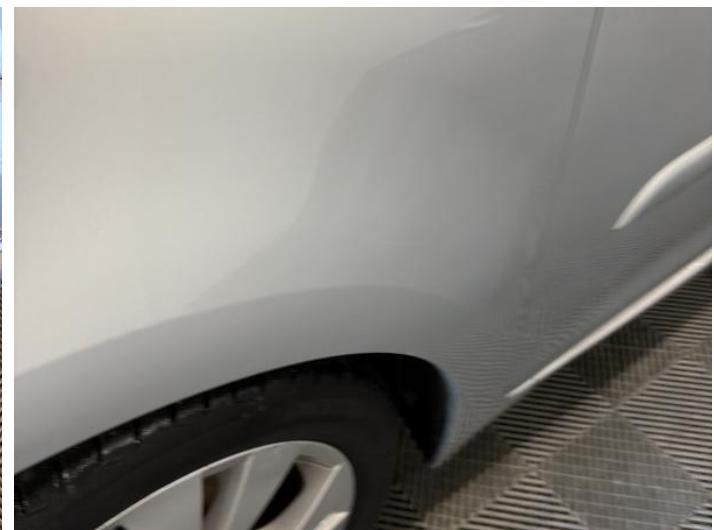
6: Wing nsf
Chipped
1 To 5

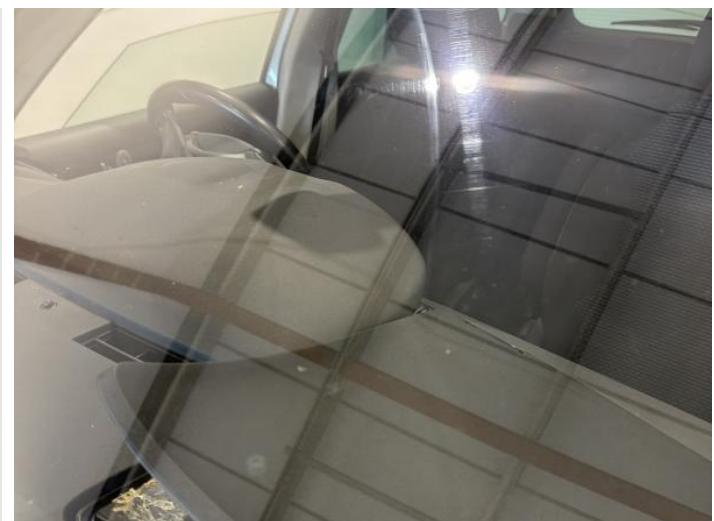
8: Screen Front
Chipped
UpTo 10mm

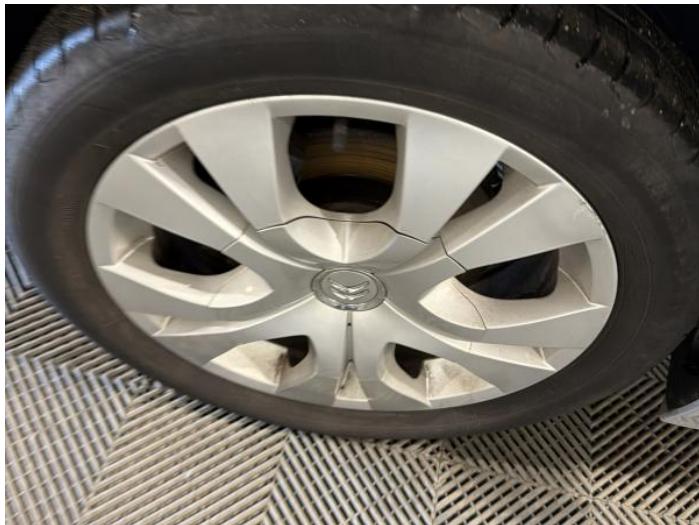
9: Wheel nsf
Scratched
Over 50mm

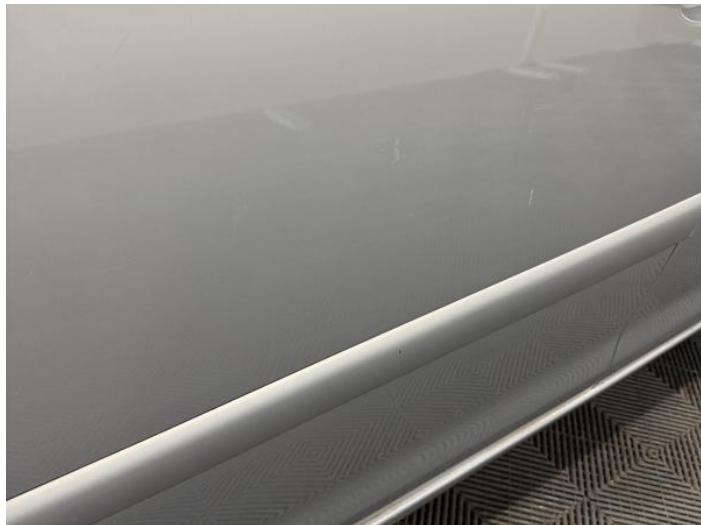
10: Door nsf
Chipped
Multiple Chips

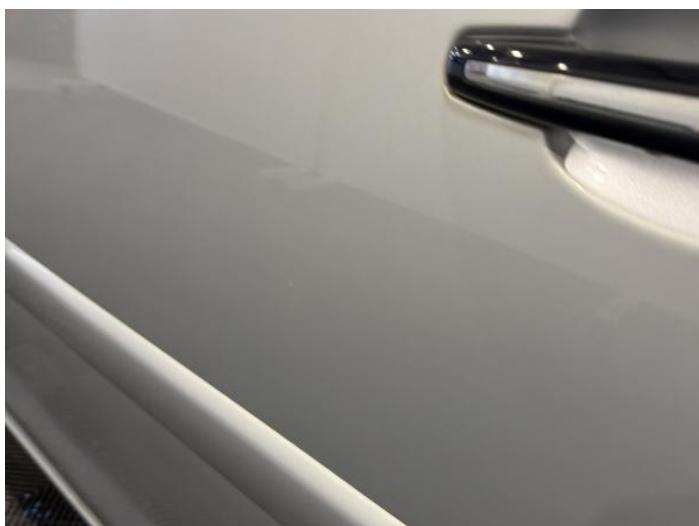
11: Door nsr
Chipped
1 To 5

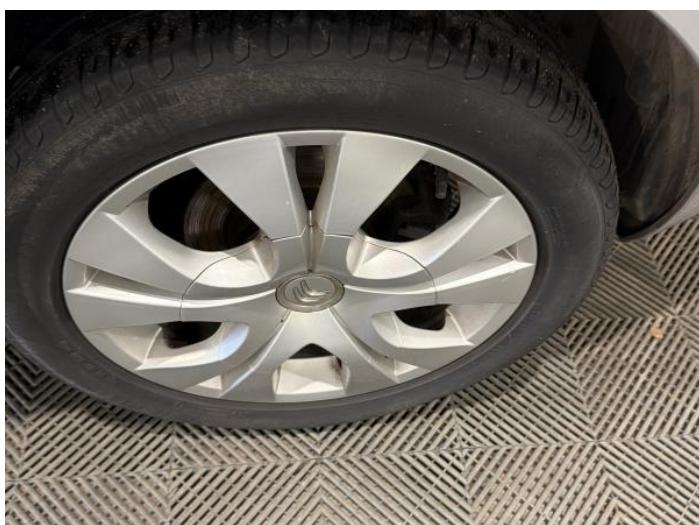
13: Wheel nsr
Scratched
Over 50mm

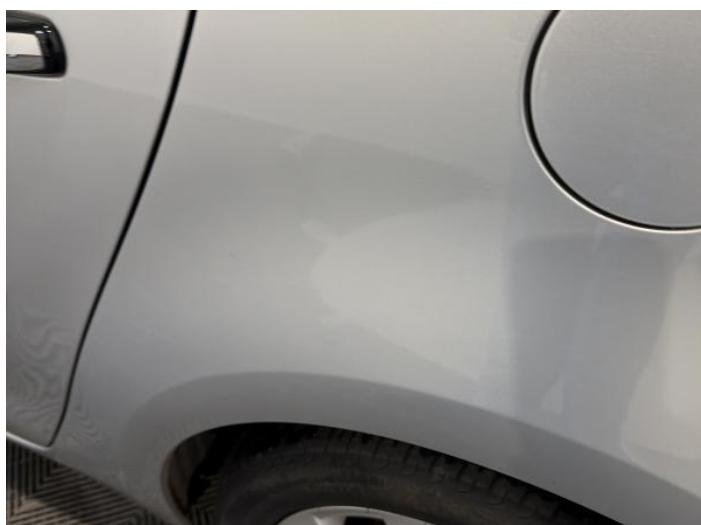
14: Qtr Panel nsr
Scratched
Over 25mm Thru Paint

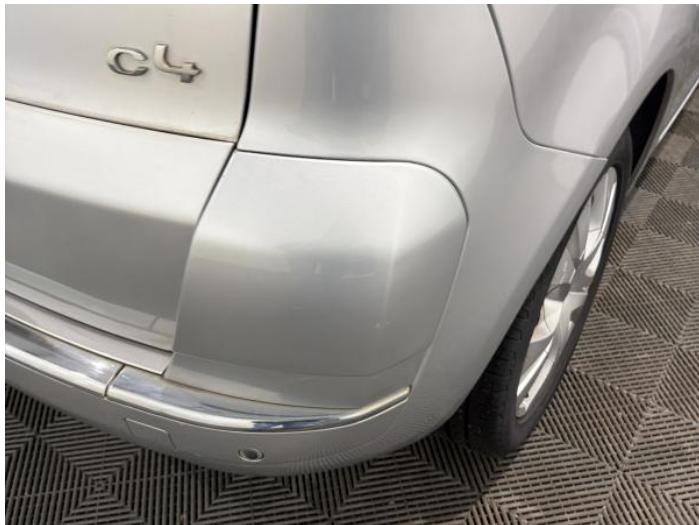
15: Bumper Rear
Scratched
Over 100mm Thru Paint

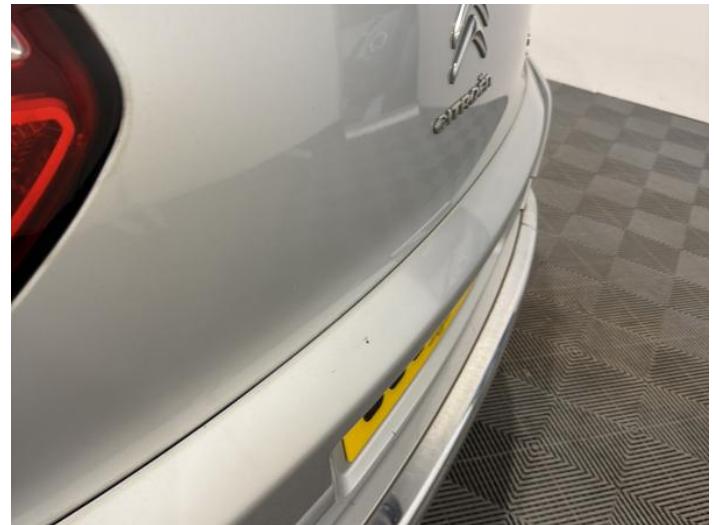
16: Boot Lid
Chipped
1 To 5

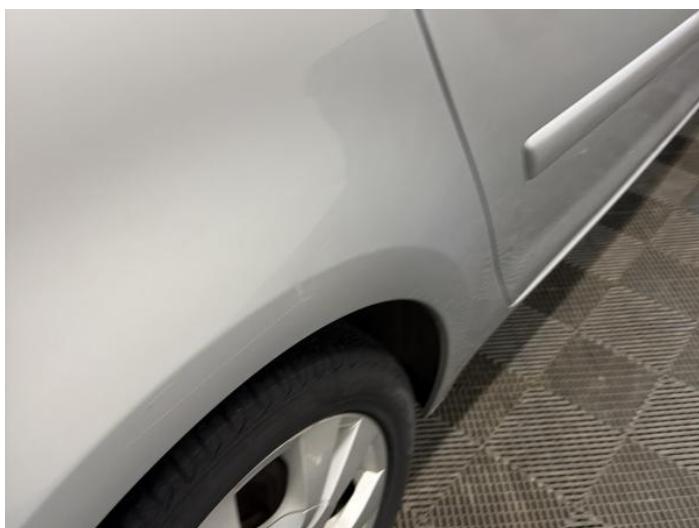
17: Qtr Panel osr
Scratched
Over 25mm Thru Paint

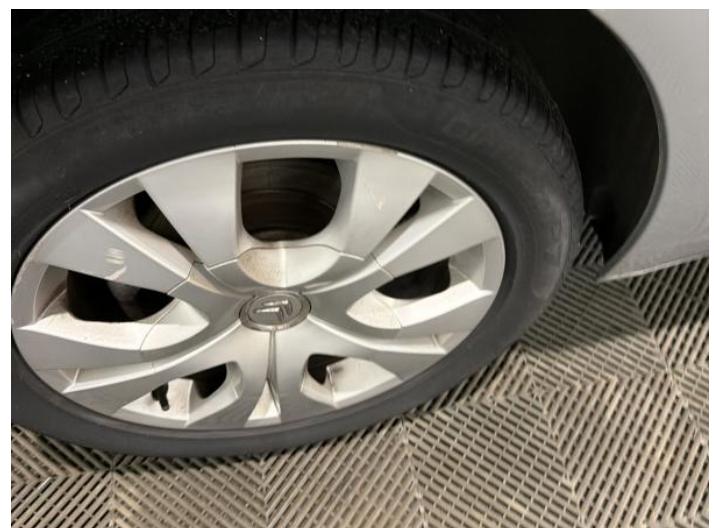
18: Wheel osr
Scratched
Over 50mm

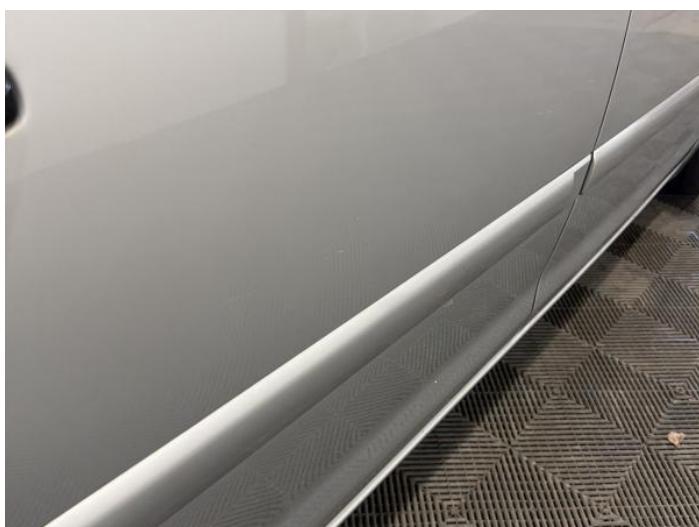
19: Door osr
Chipped
Multiple Chips

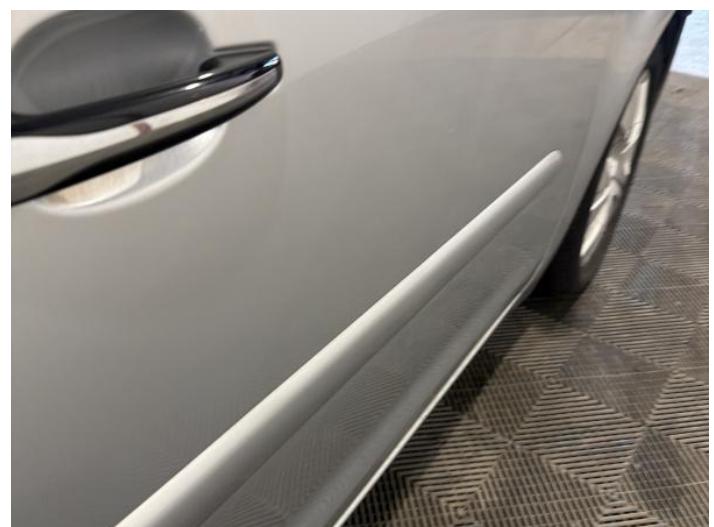
20: Door osf
Chipped
Multiple Chips

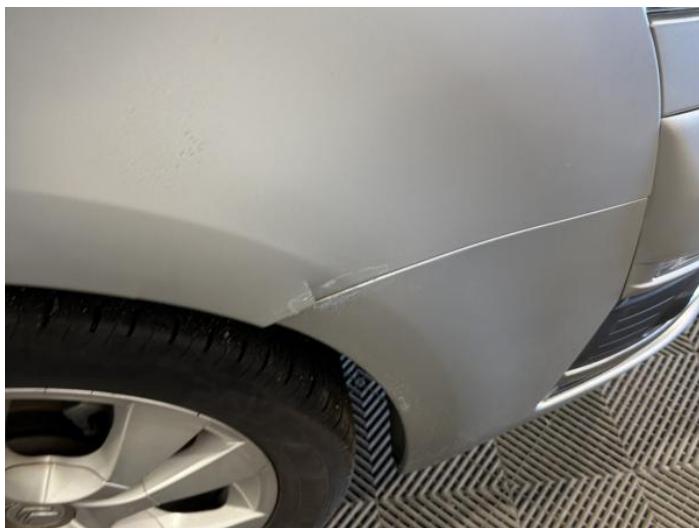
21: Wing osf
Cracked
Replace

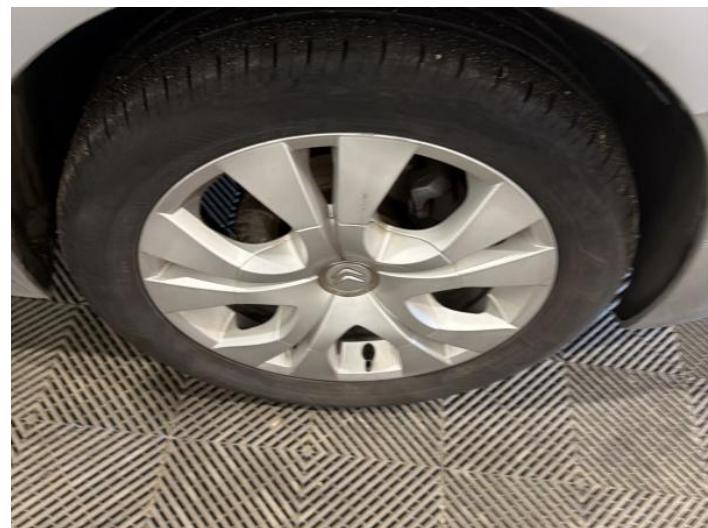
22: Wheel osf
Scratched
Over 50mm

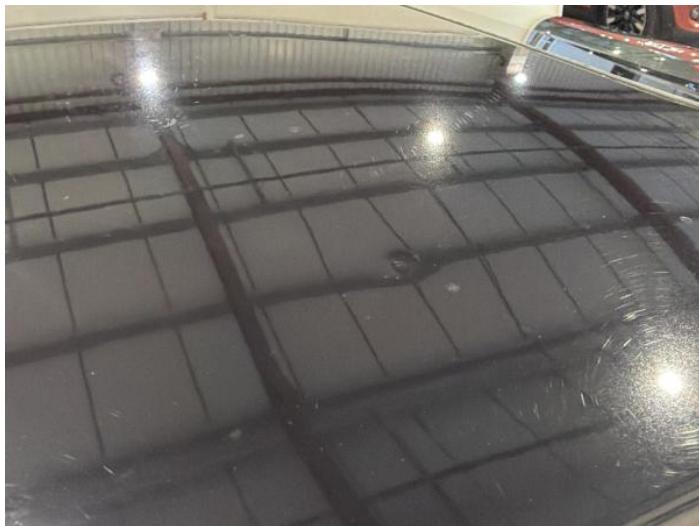
23: Roof
Dented
Between 10mm + 30mm
