# VEHICLE INSPECTION REPORT

GL22JXB

## MG Mg 5 EXCLUSIVE

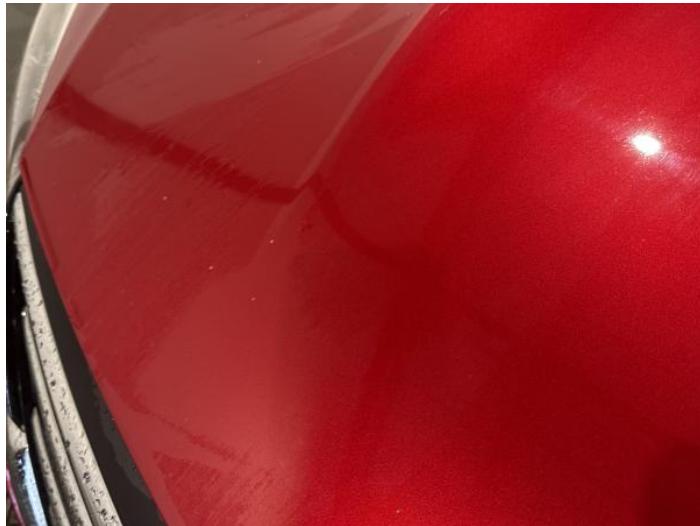
1: Bonnet  
Chipped  
Multiple Chips

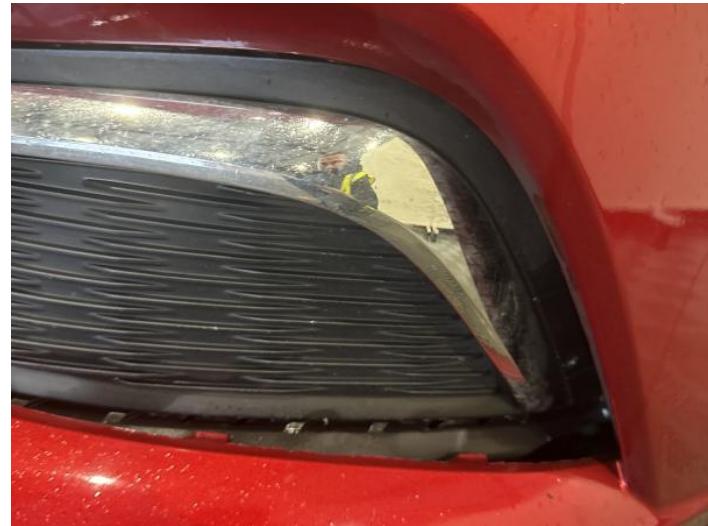
2: Bumper Front Grill  
Broken  
Replace

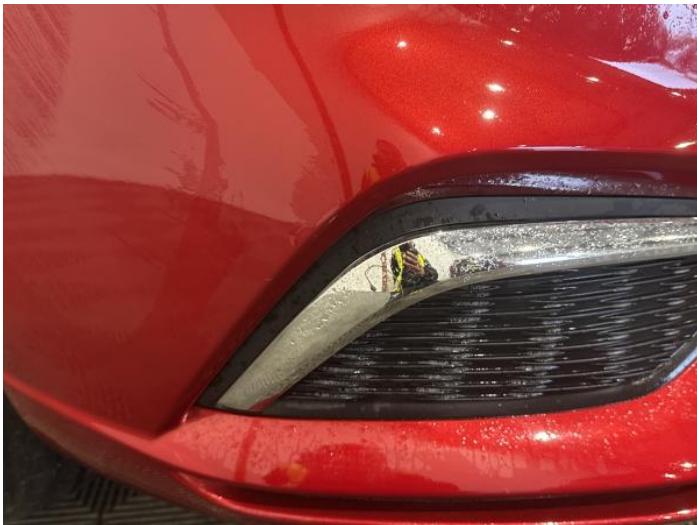
3: Bumper Front  
Chipped  
Multiple Chips

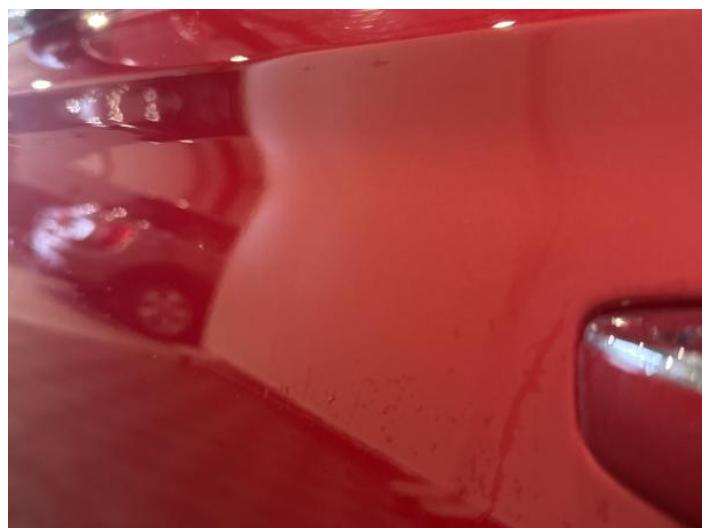
5: Door nsf  
Chipped  
1 To 5

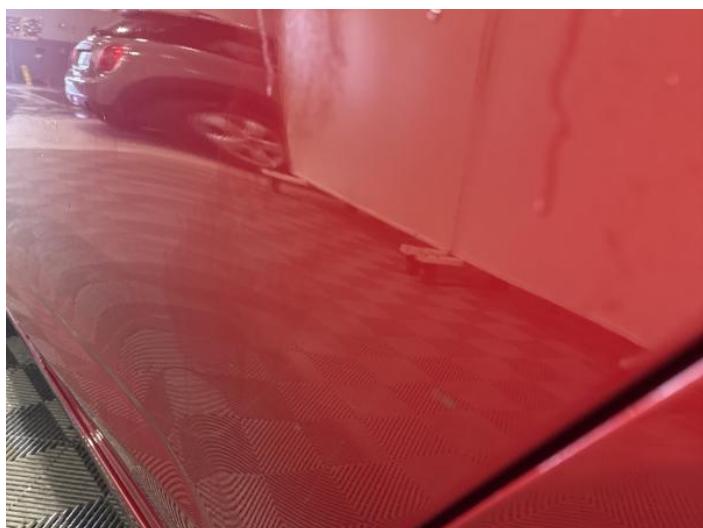
6: Door nsr  
Scratched  
UpTo 25mm Thru Paint

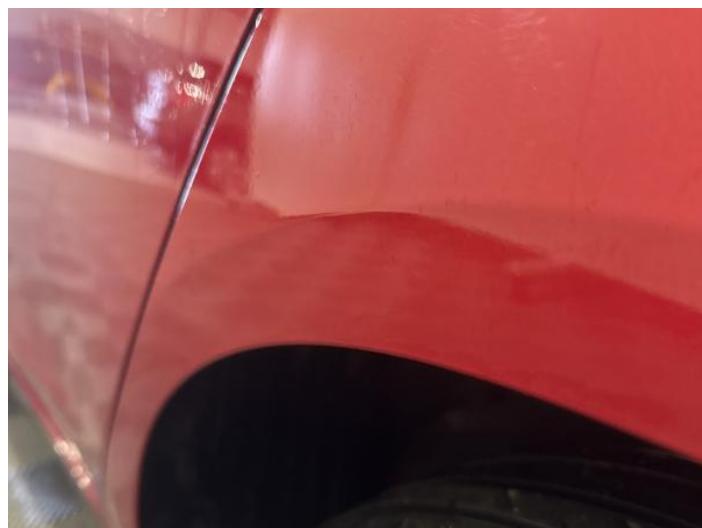
7: Qtr Panel nsr  
Dented  
Between 10mm + 30mm

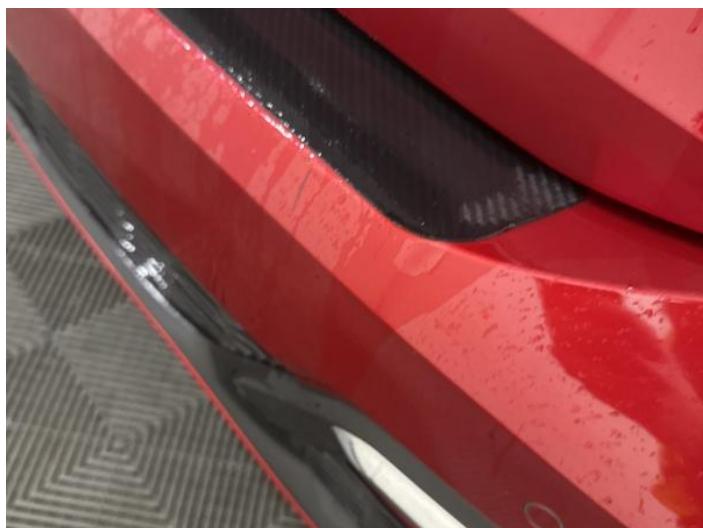
8: Bumper Rear  
Scratched  
Up To 25mm Thru Paint

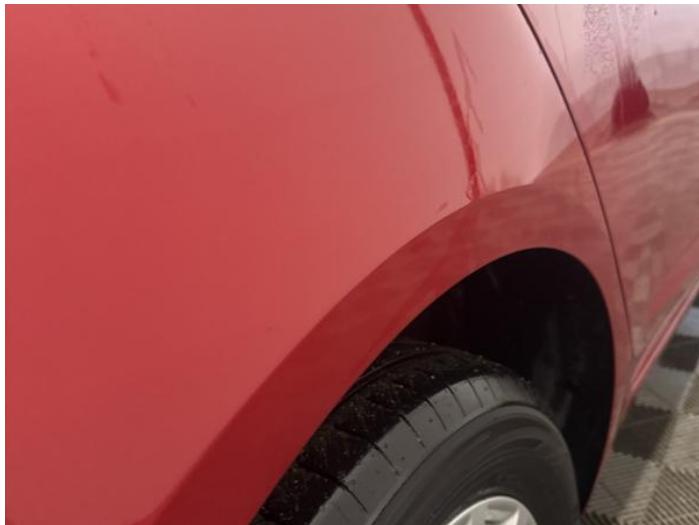
9: Qtr Panel osr  
Dented  
2 Or Less UpTo 10mm

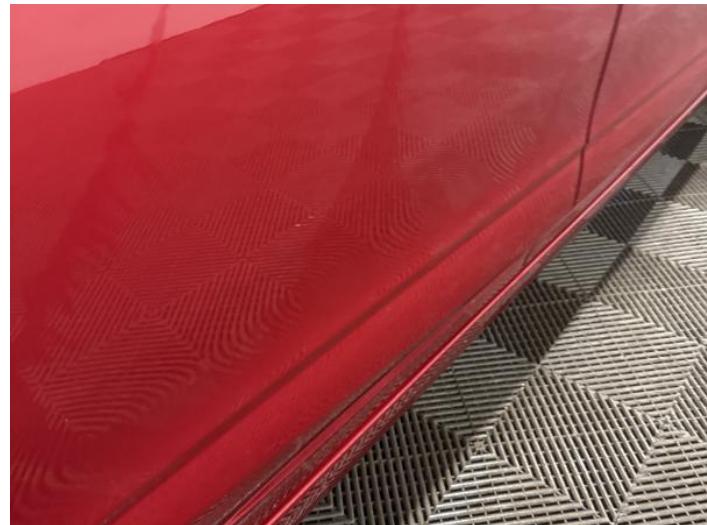
10: Door osr  
Dented  
Between 10mm + 30mm

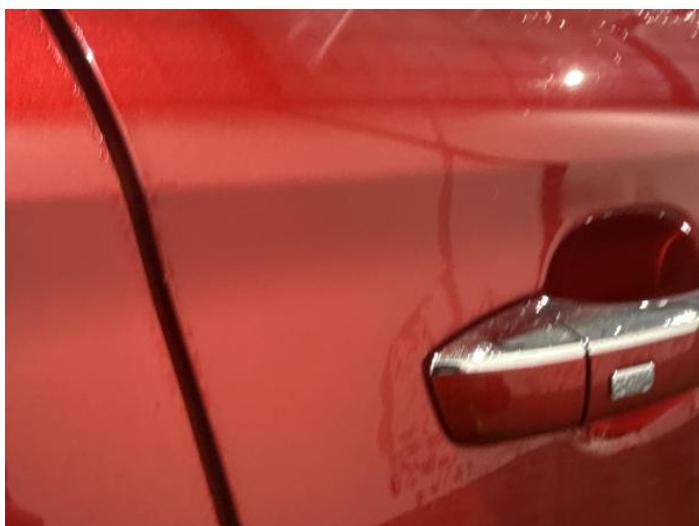
11: Door osf  
Scratched  
UpTo 25mm Thru Paint

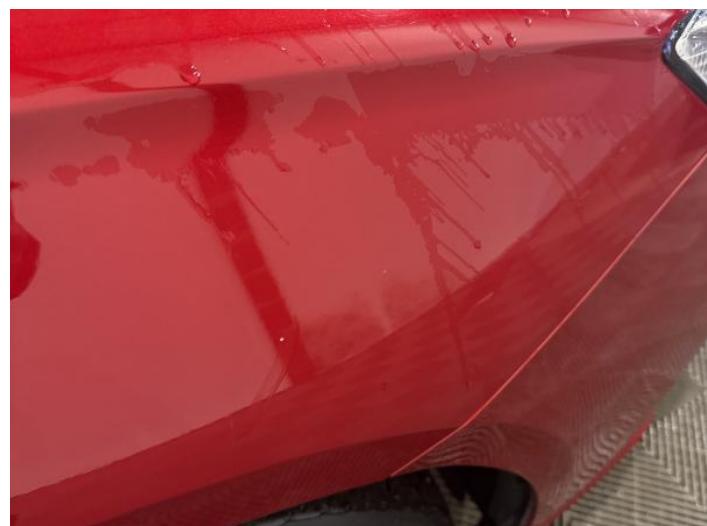
12: Wing nsf  
Chipped  
1 To 5
