## VEHICLE INSPECTION REPORT

KR55LZO

### Ford Focus 1.6 LX 5dr [115]

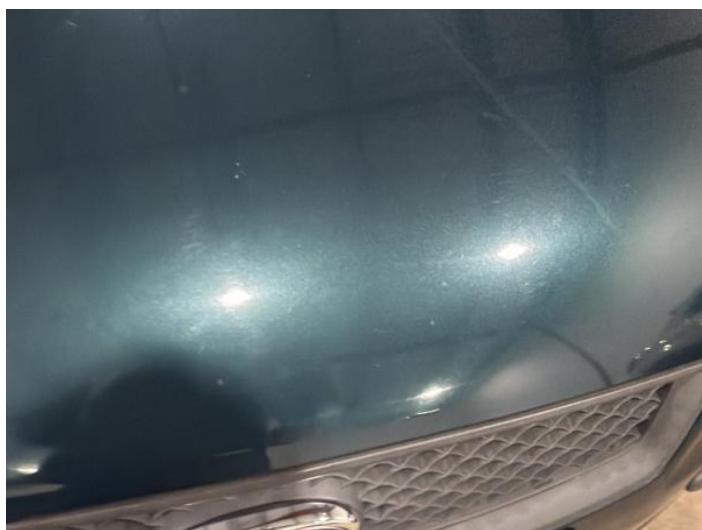
1: Bonnet  
Dented  
With Paint Damage

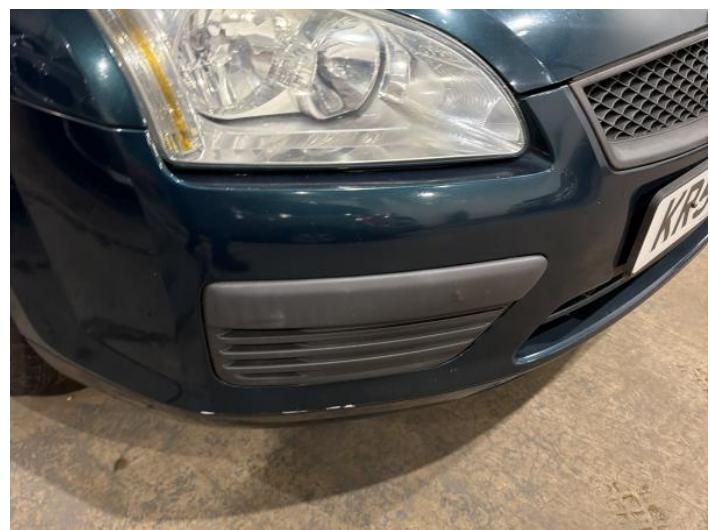
2: Bumper Front  
Scratched  
Over 100mm Thru Paint

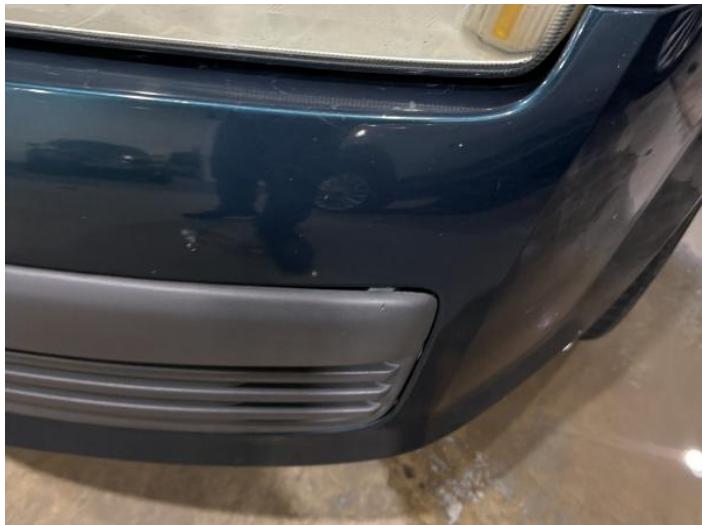
3: Bumper Front Moulding  
Broken  
Replace

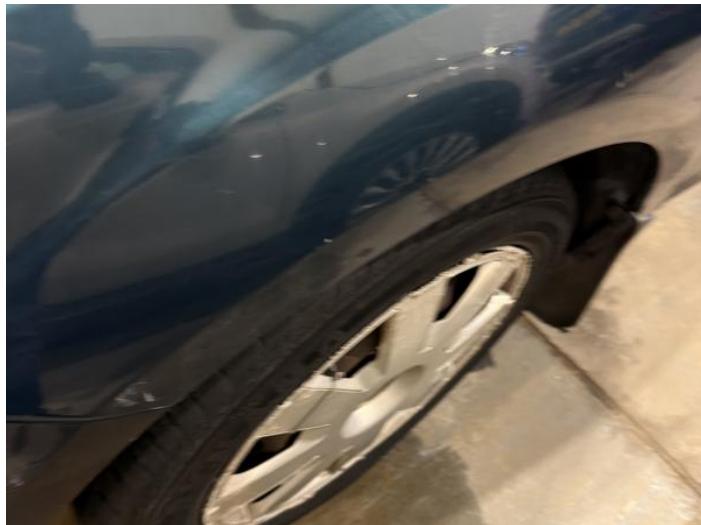
4: Wing nsf  
Dented  
With Paint Damage

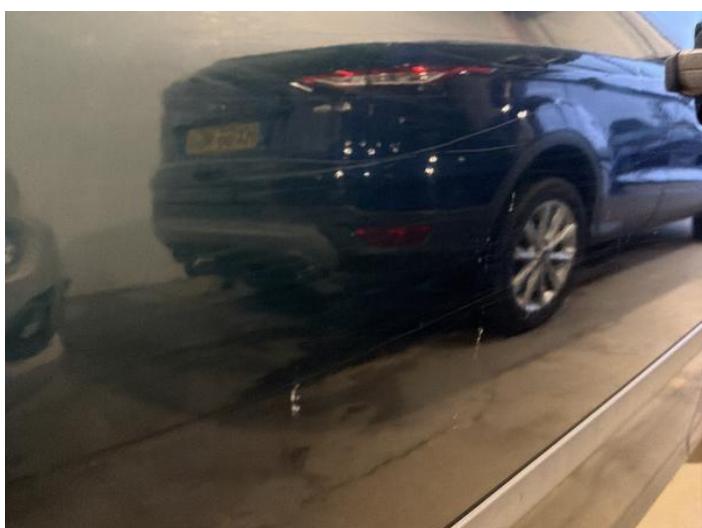
5: Door nsf  
Chipped  
Multiple Chips

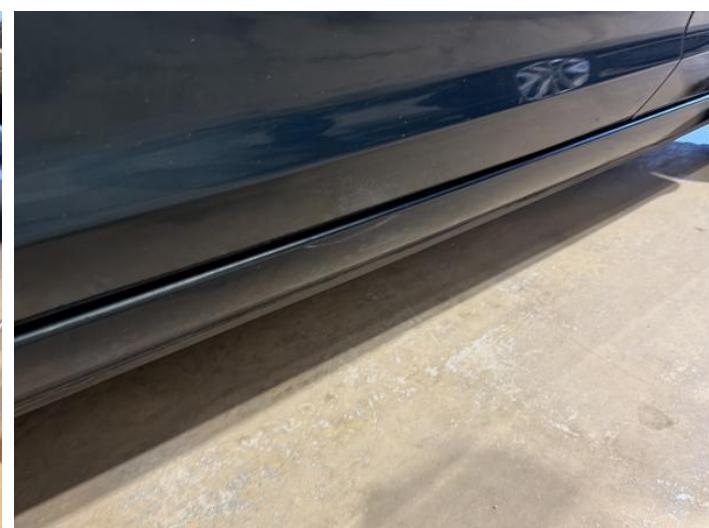
6: Sill ns  
Scratched  
Over 25mm Thru Paint

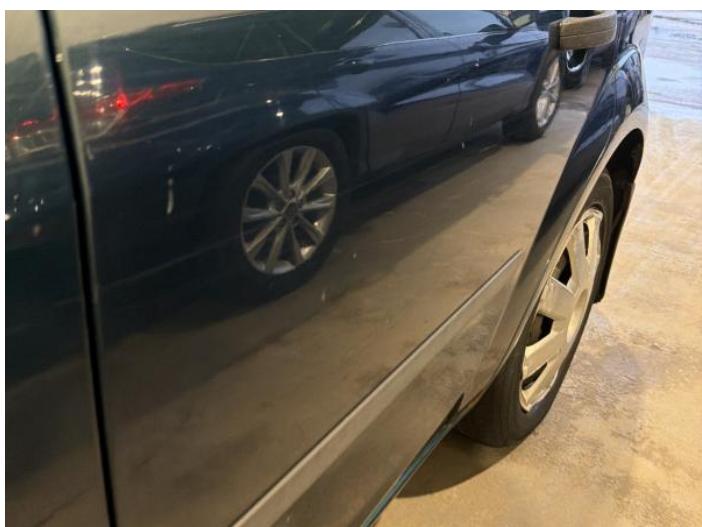
7: Door nsr  
Dented  
With Paint Damage

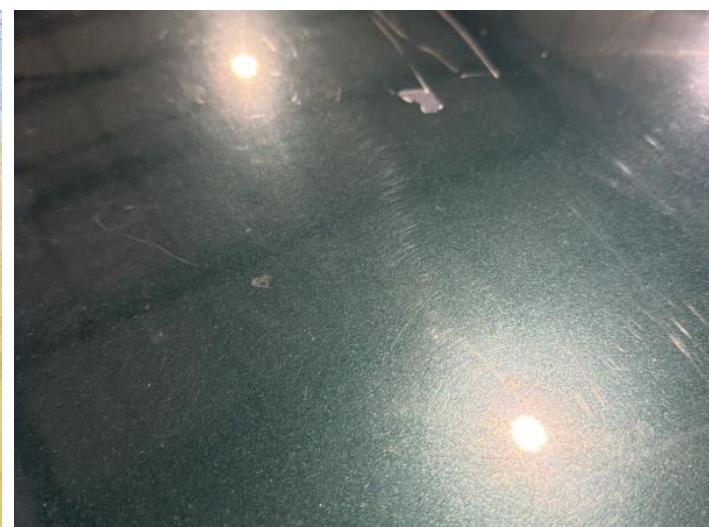
8: Roof  
Poor Previous Repair  
Paint Flake

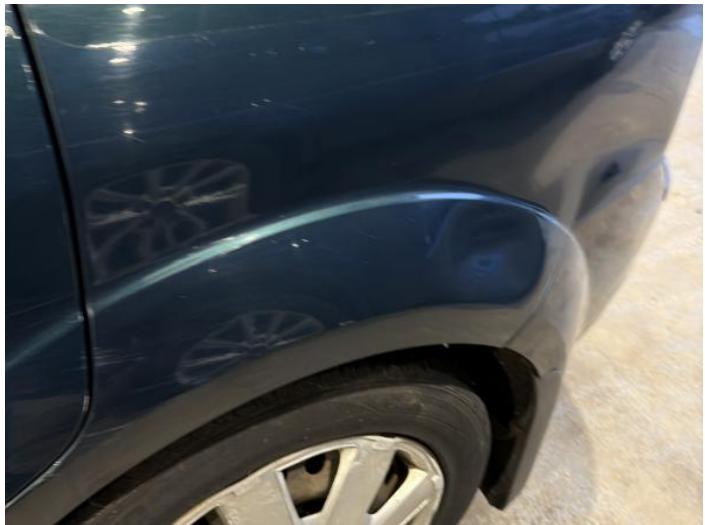
9: Qtr Panel nsr  
Dented  
With Paint Damage

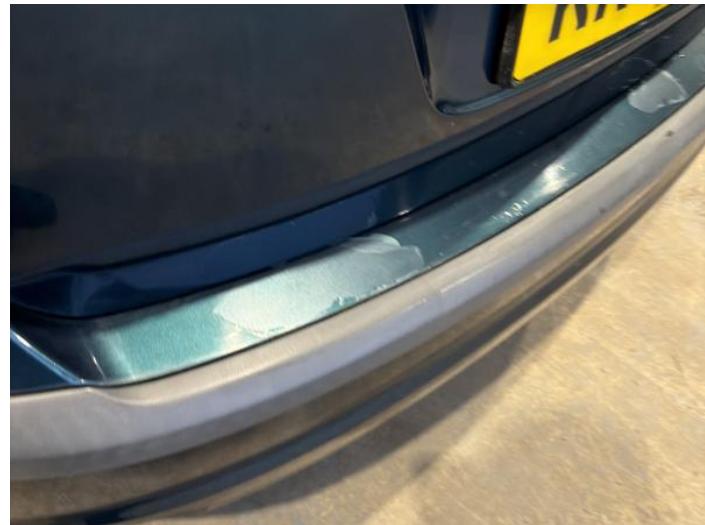
10: Bumper Rear  
Poor Previous Repair  
Paint Flake

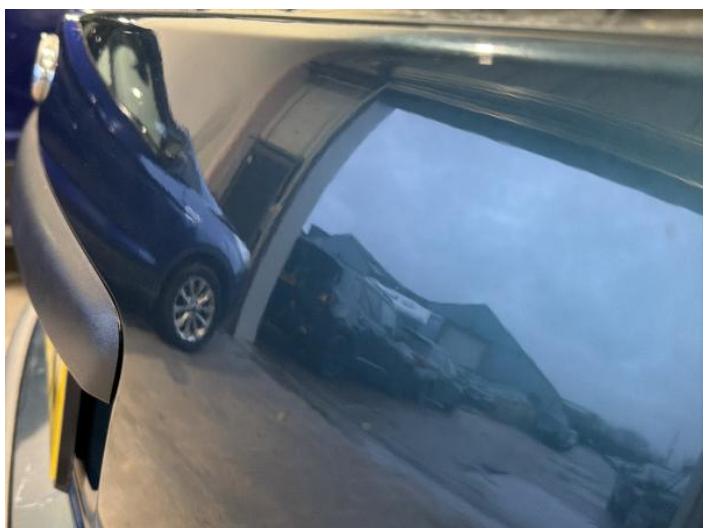
12: Boot Lid  
Scratched  
Over 25mm Not Thru Paint

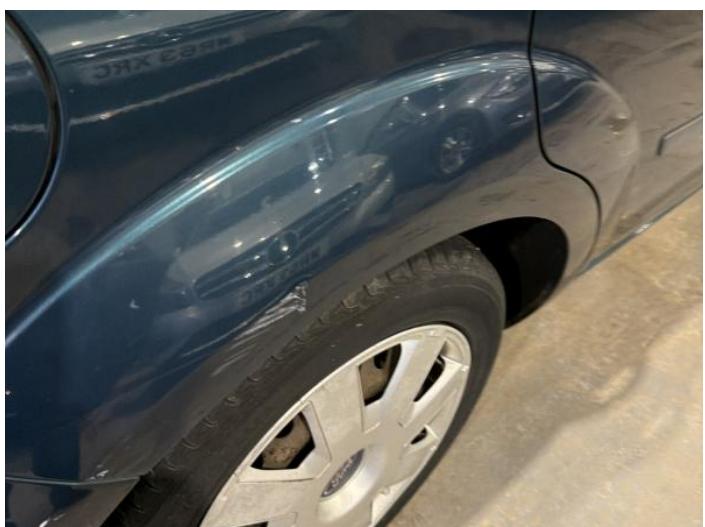
13: Qtr Panel osr  
Dented  
With Paint Damage

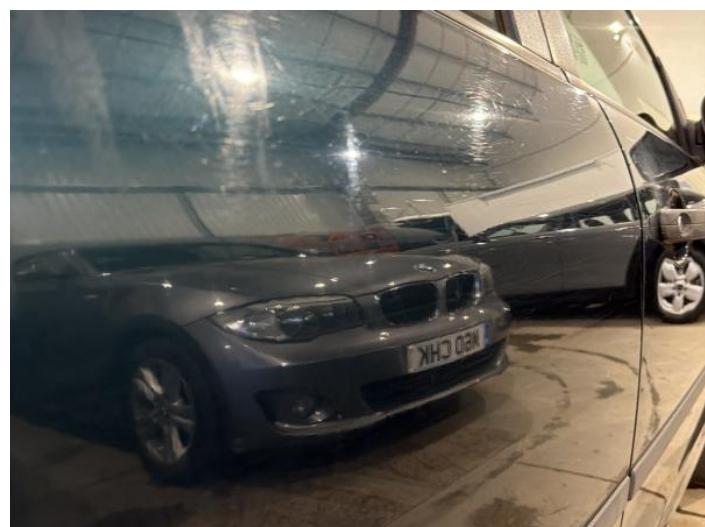
14: Door osr  
Poor Previous Repair  
Poor Paint

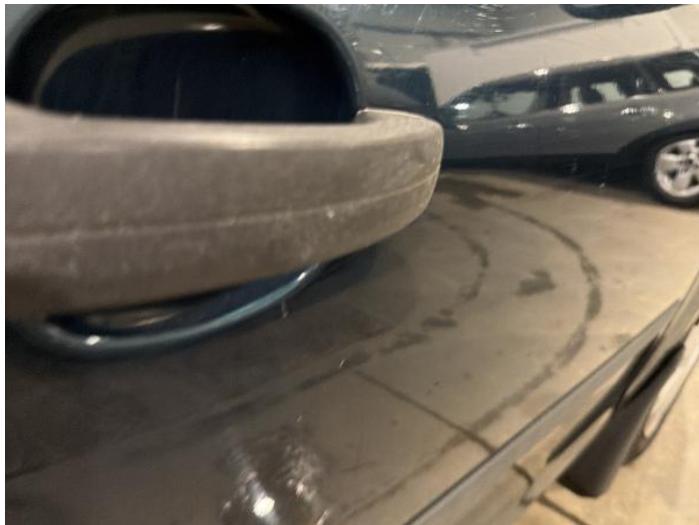
15: Door osf  
Dented  
Over 30mm

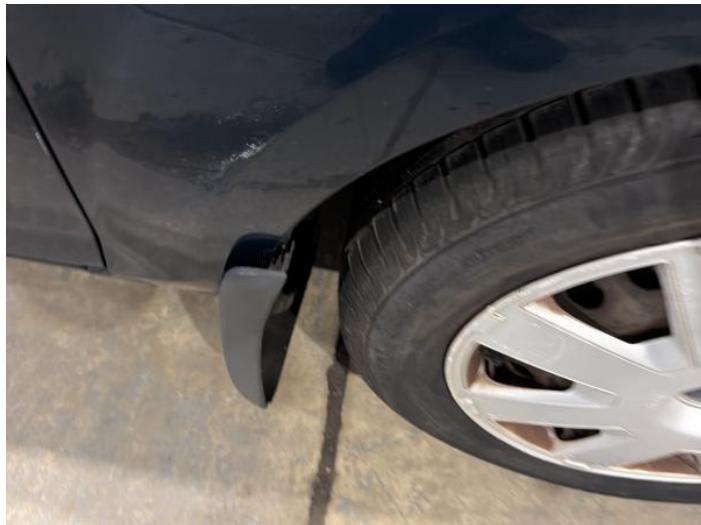
16: Moulding osf Wing  
Broken  
Replace

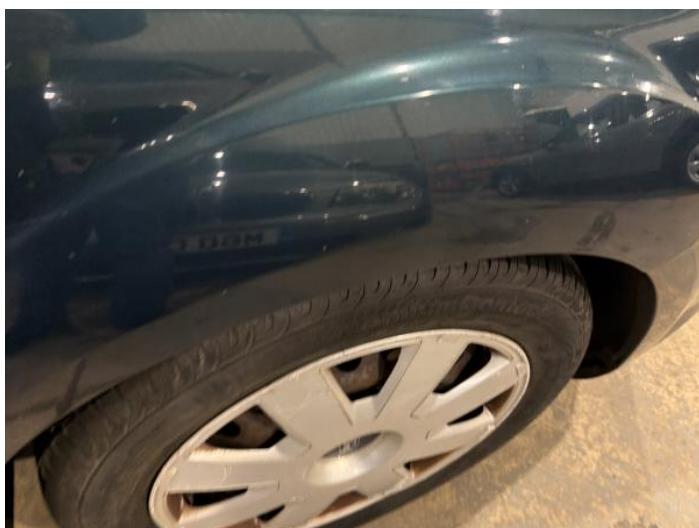
17: Wing osf  
Chipped  
Multiple Chips

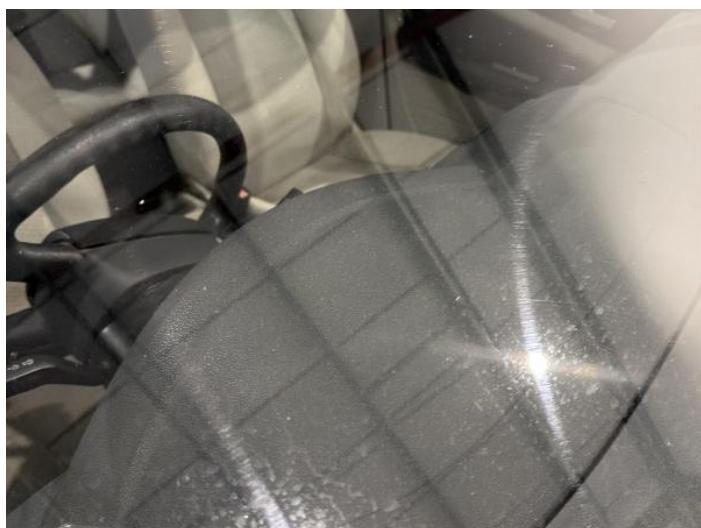
18: Screen Front  
Chipped  
UpTo 10mm
