VEHICLE INSPECTION REPORT

LC09FVP

Volkswagen Tiguan 2.0 TDi Sport 5dr Auto

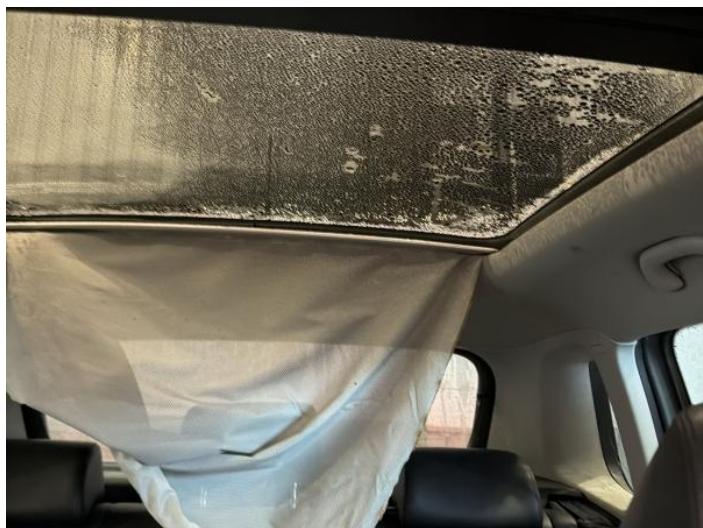
1: Roof Lining
Torn
Over 3mm

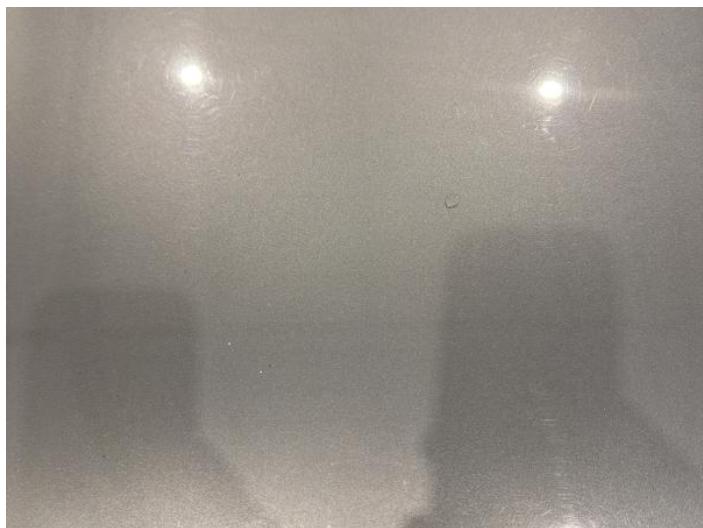
2: Bonnet
Chipped
Multiple Chips

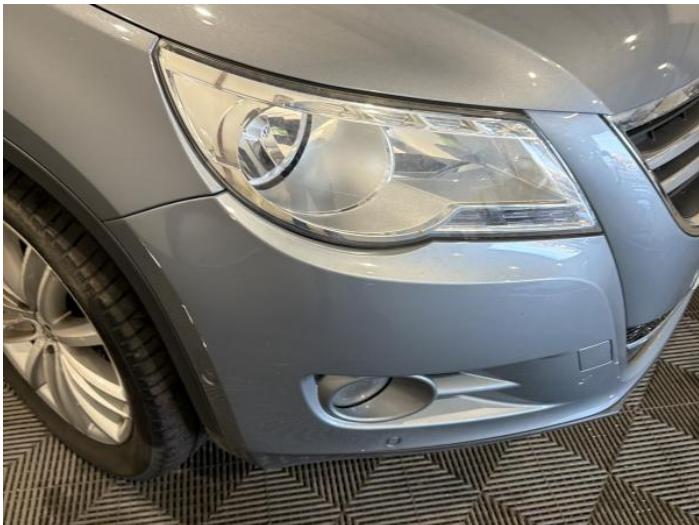
3: Bumper Front
Scratched
Over 100mm Thru Paint

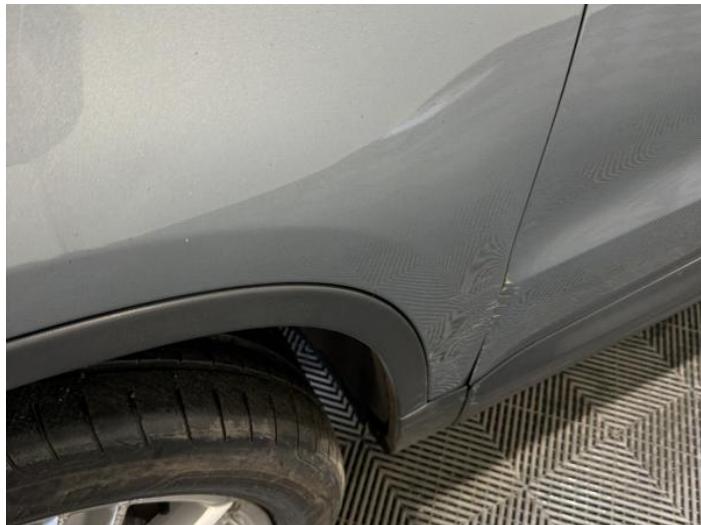
4: Wing nsf
Dented
With Paint Damage

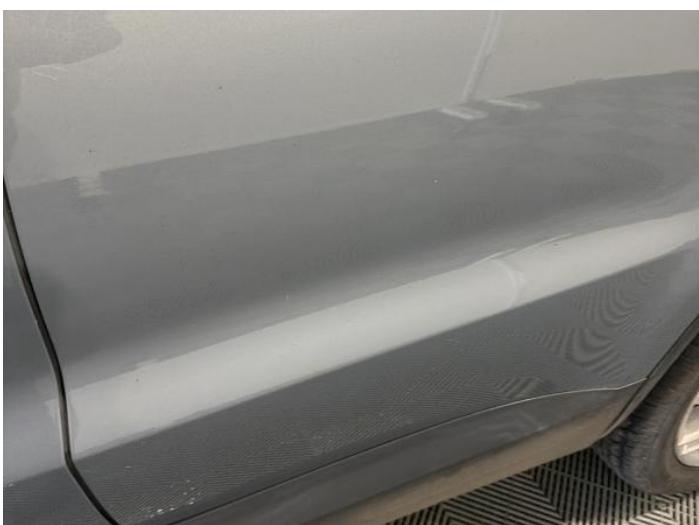
7: Door nsr
Scratched
Over 25mm Thru Paint

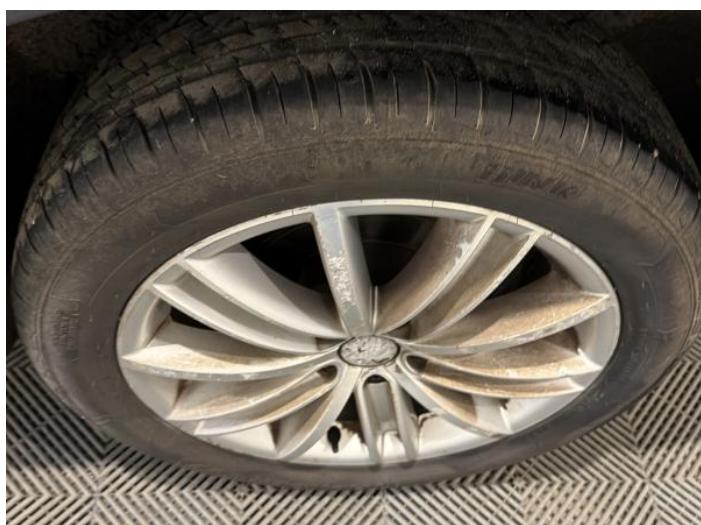
8: Wheel nsr
Scratched
Over 50mm

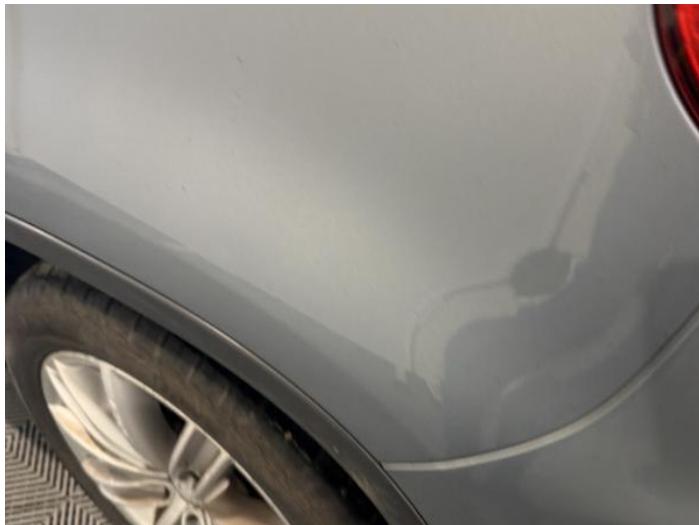
9: Qtr Panel nsr
Dented
Over 30mm

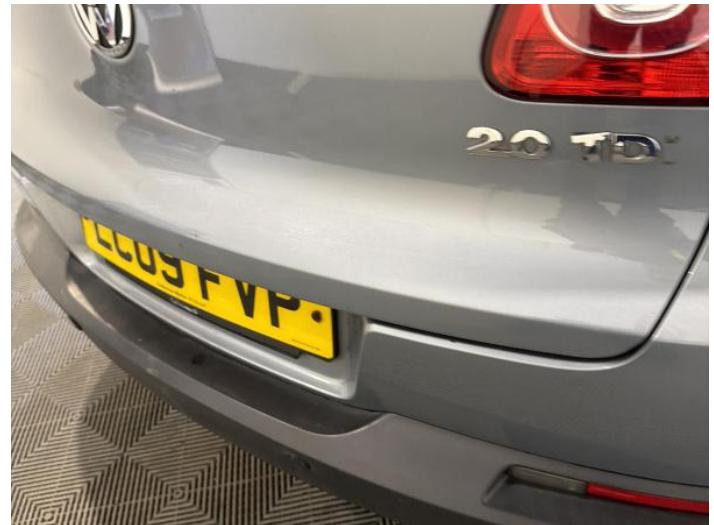
10: Bumper Rear
Chipped
Multiple Chips

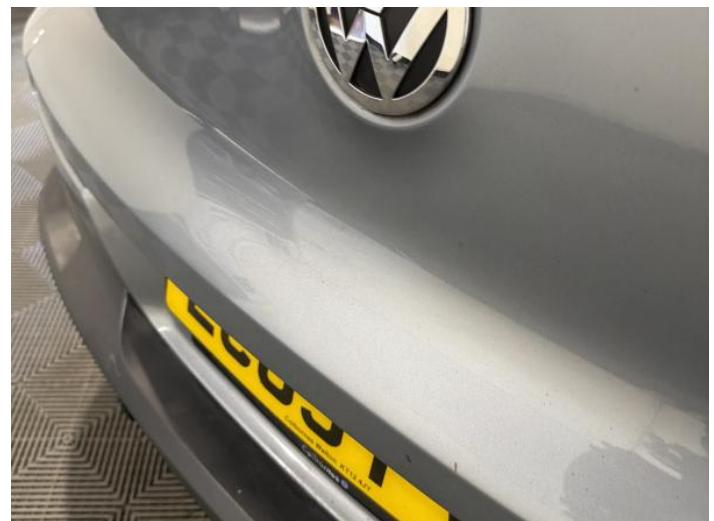
12: Boot Lid
Chipped
Multiple Chips

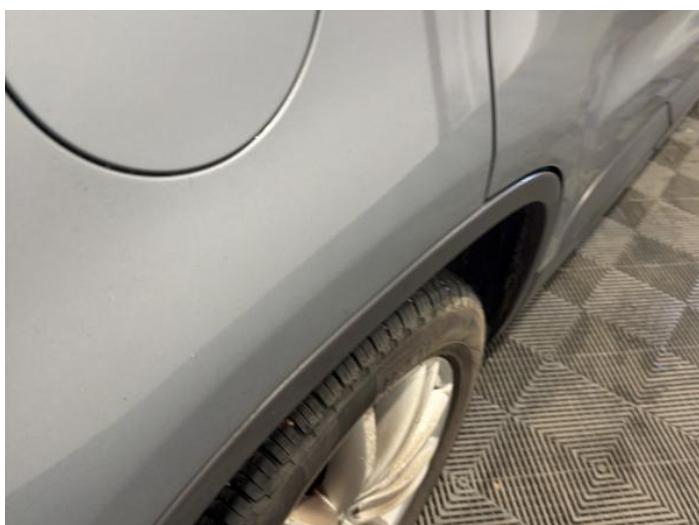
13: Qtr Panel osr
Dented
2 Or Less UpTo 10mm

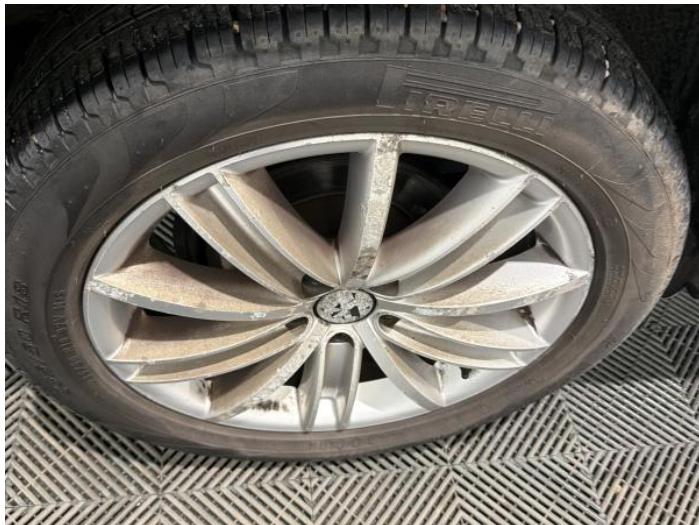
15: Wheel osr
Scratched
Over 50mm

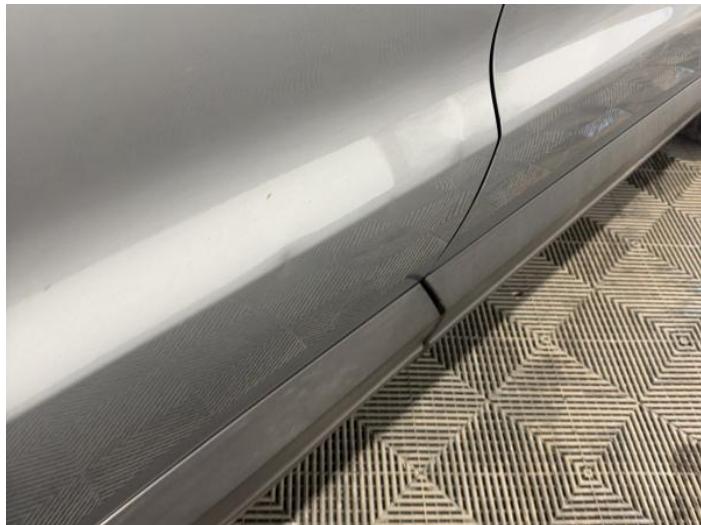
16: Door osr
Dented
Over 30mm

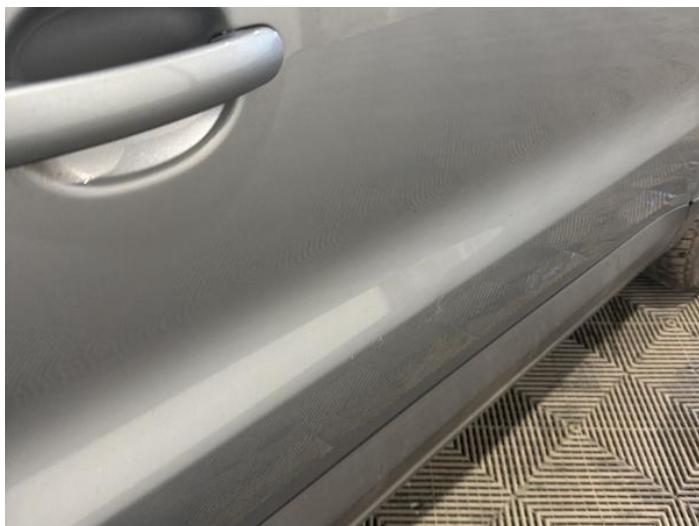
17: Door osf
Dented
With Paint Damage

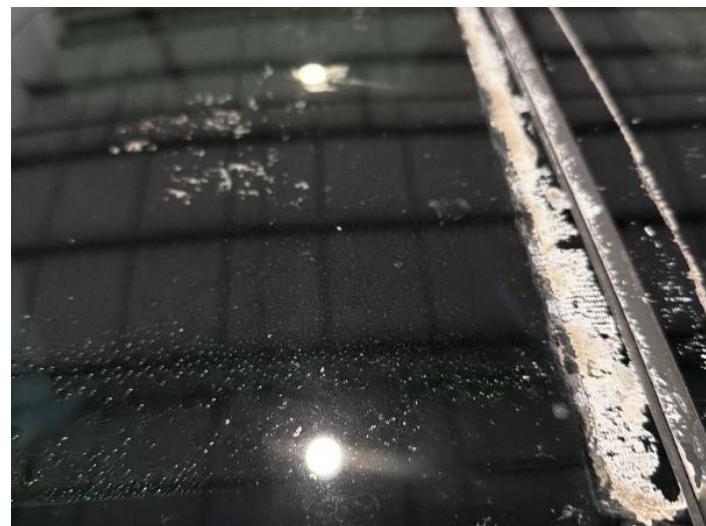
18: Roof
Poor Previous Repair
Poor Paint

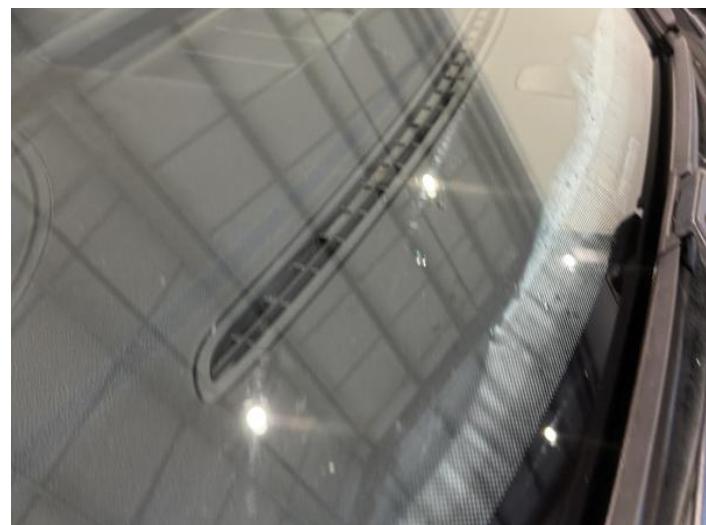
20: Screen Front
Chipped
UpTo 10mm
