VEHICLE INSPECTION REPORT

HN66OJZ

Fiat 500x 1.6 E-torQ Lounge 5dr [Start Stop]

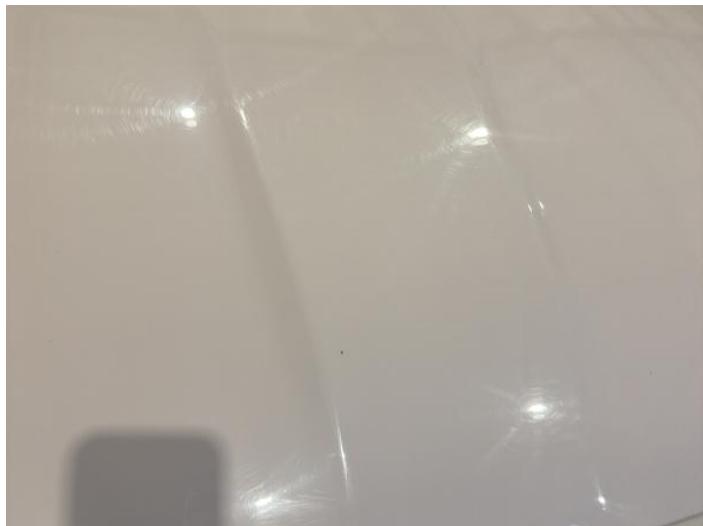
1: Bonnet
Chipped
Multiple Chips

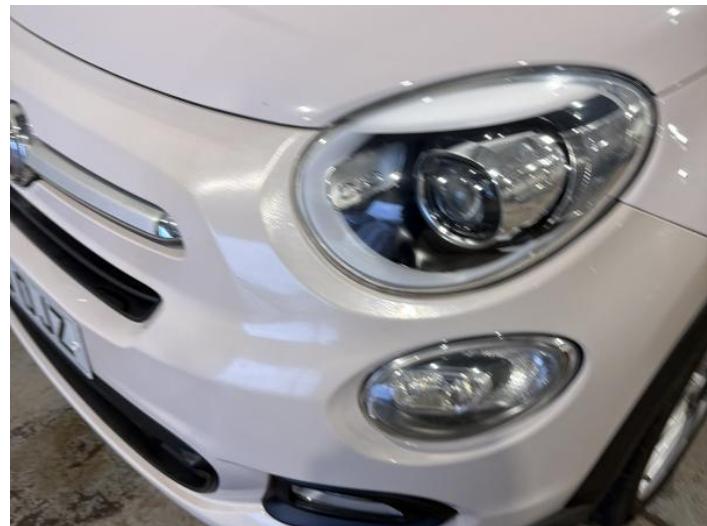
2: Bumper Front
Poor Previous Repair
Poor Colour

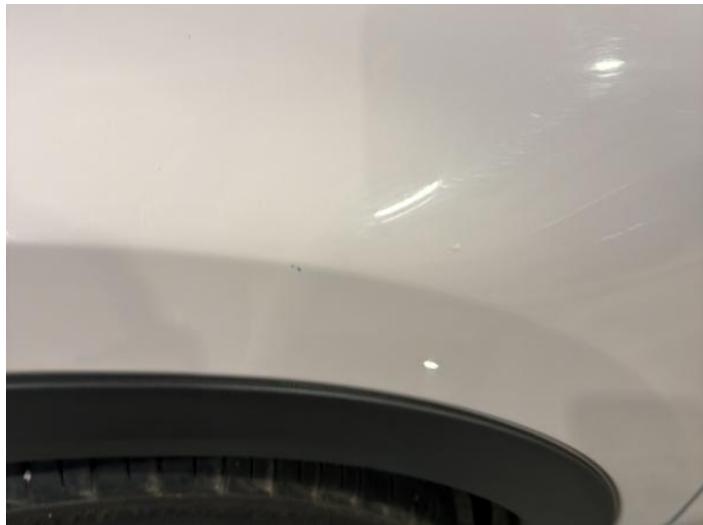
4: Wing nsf
Chipped
1 To 5

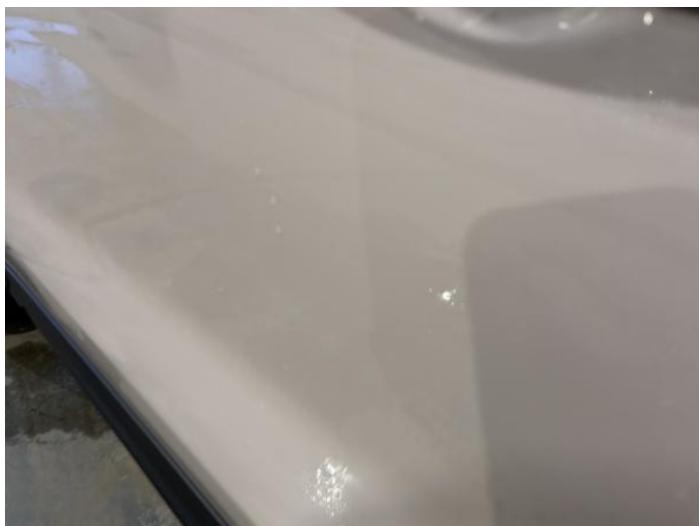
5: Door nsf
Chipped
1 To 5

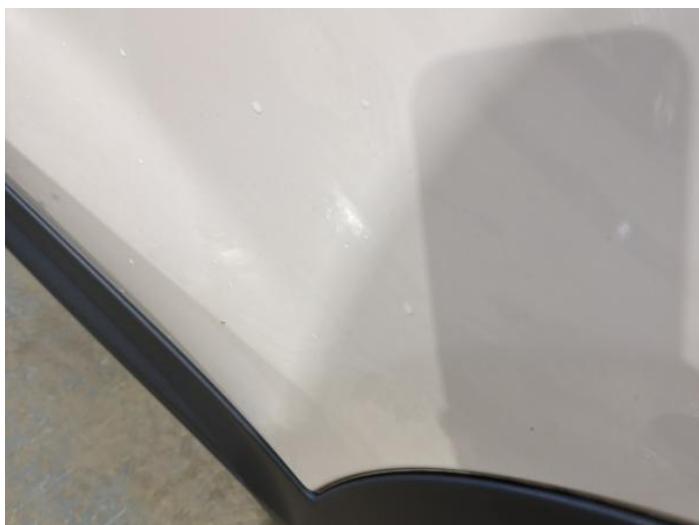
7: Door nsr
Dented
2 Or Less UpTo 10mm

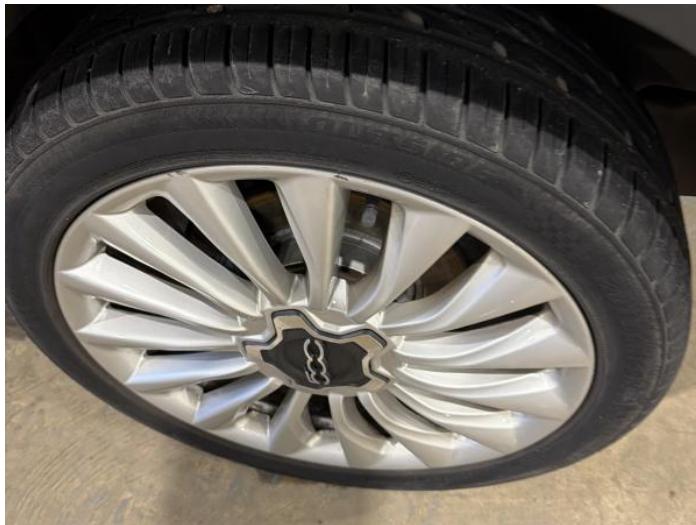
9: Wheel nsr
Scratched
Up To 50mm

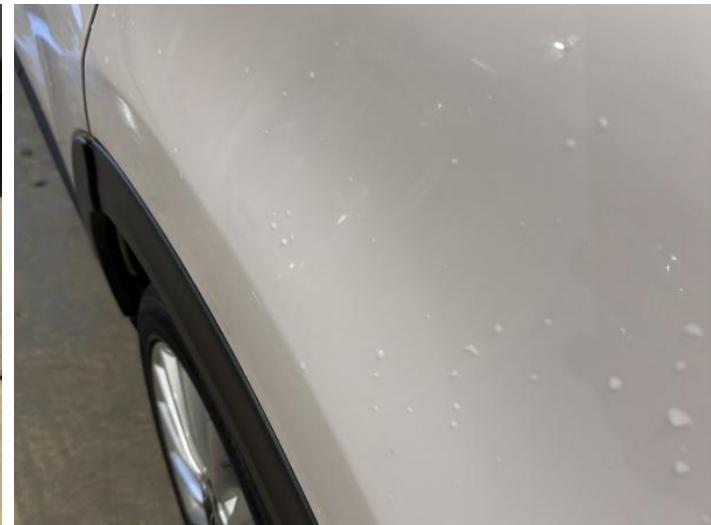
10: Qtr Panel nsr
Dented
2 Or Less UpTo 10mm

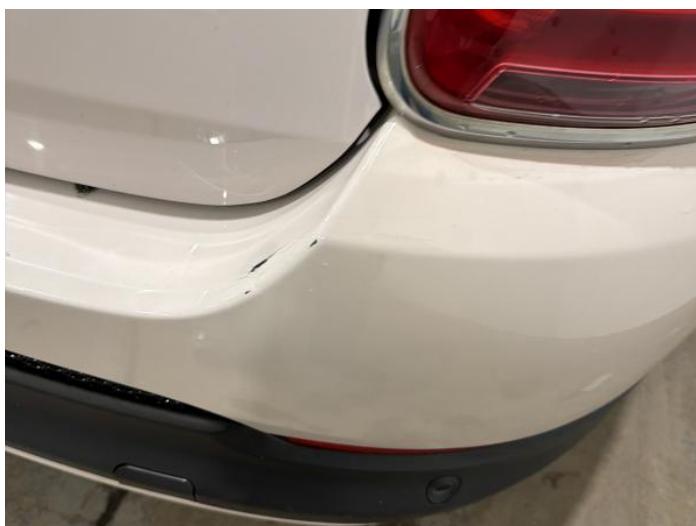
11: Bumper Rear
Cracked
UpTo 25mm

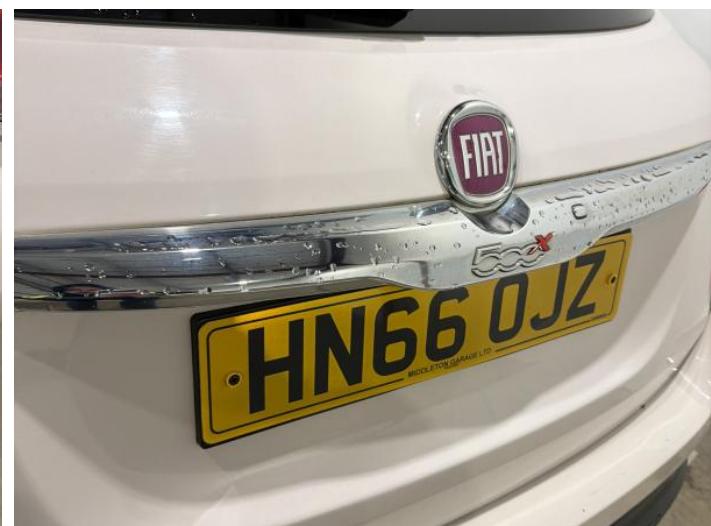
12: Boot Lid
Poor Previous Repair
Poor Paint

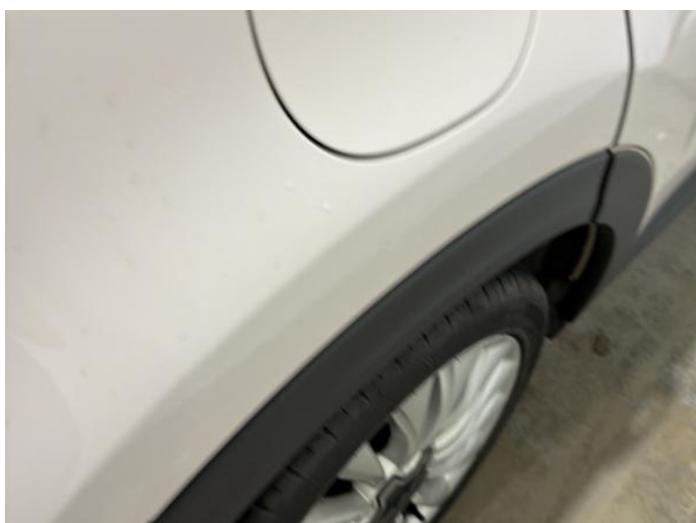
13: Qtr Panel osr
Chipped
1 To 5

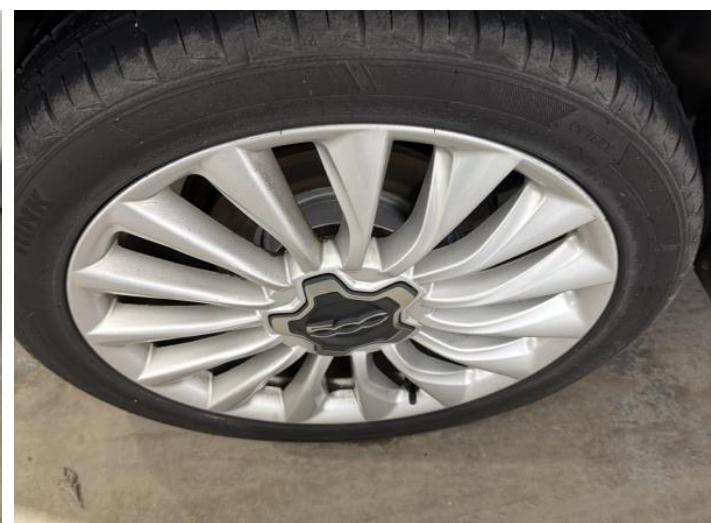
14: Wheel osr
Scratched
Up To 50mm

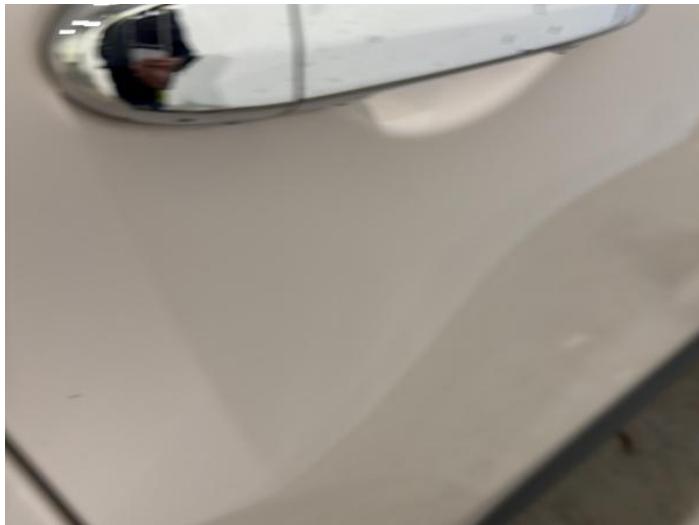
15: Door osr
Chipped
1 To 5

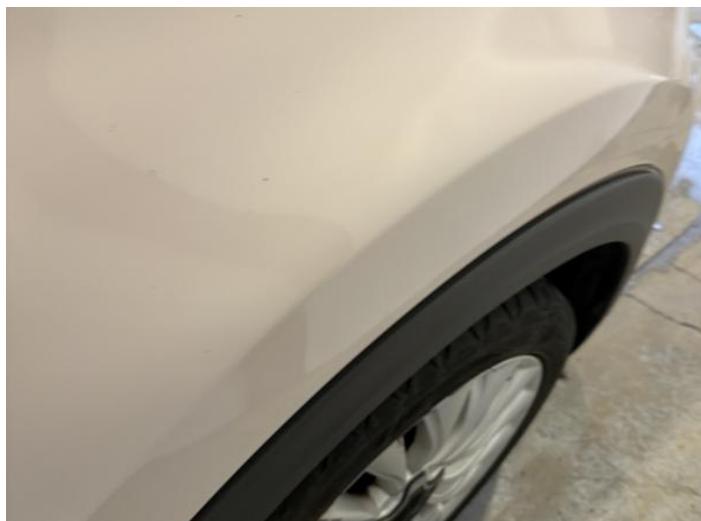
18: Wing osf
Dented
Over 2 UpTo 10mm

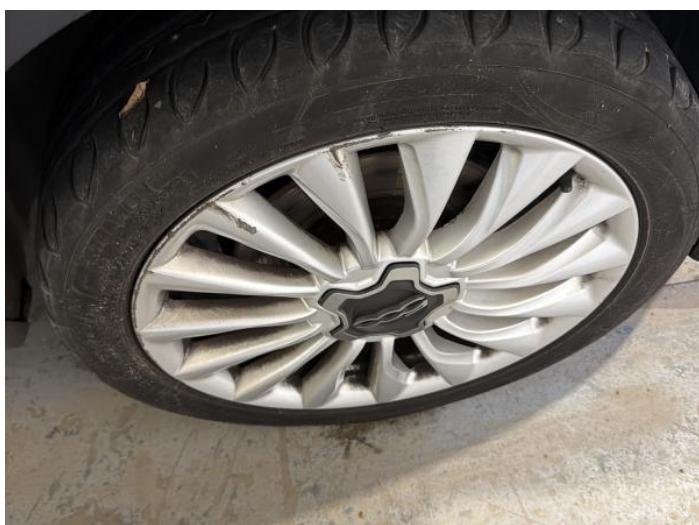
19: Wheel osf
Scratched
Over 50mm

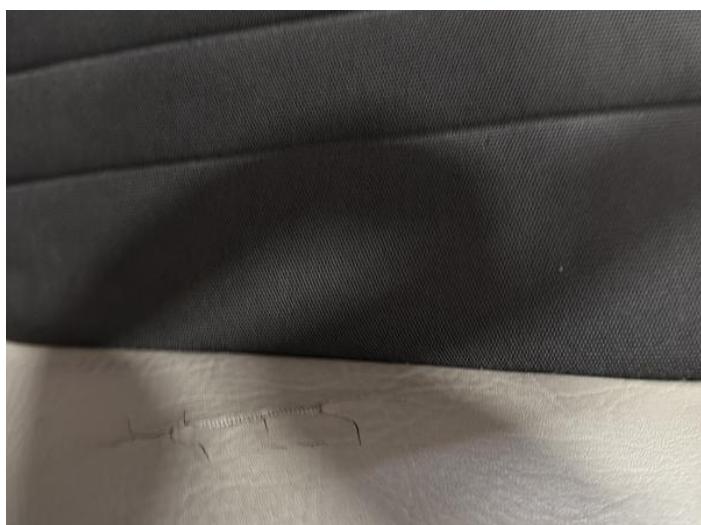
20: Seat Base Cover osf
Torn
Over 3mm
