VEHICLE INSPECTION REPORT

EF15JVH

Fiat 500x 1.4 Multiair Cross 5dr

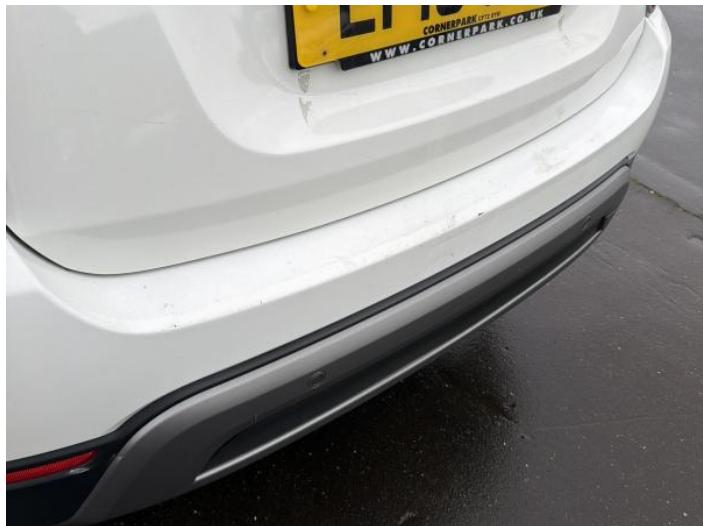
1: Bumper Rear
Scratched
Over 100mm Thru Paint

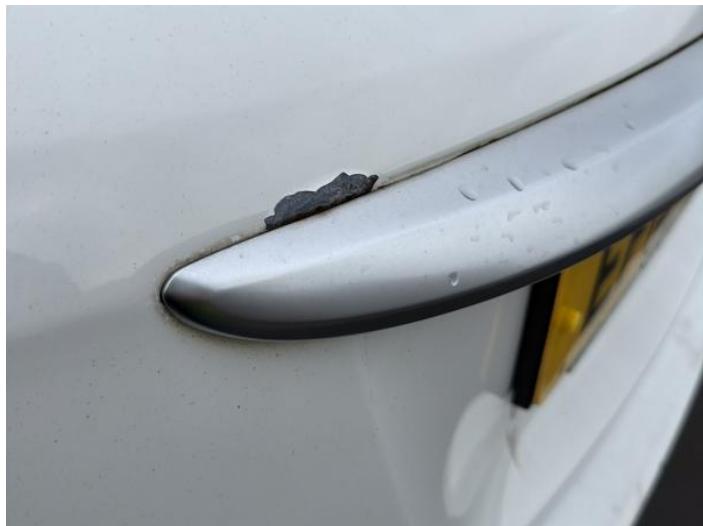
2: Boot Lid
Poor Previous Repair
Paint Flake

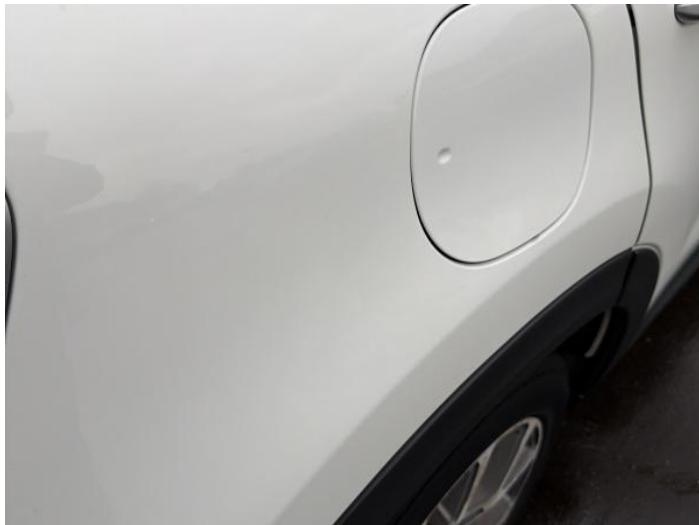
3: Qtr Panel osr
Dented
With Paint Damage

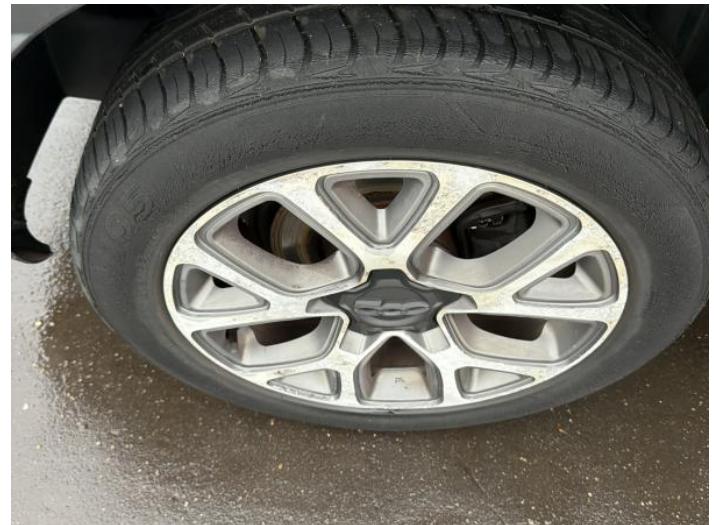
4: Wheel osr
Scratched
Over 50mm

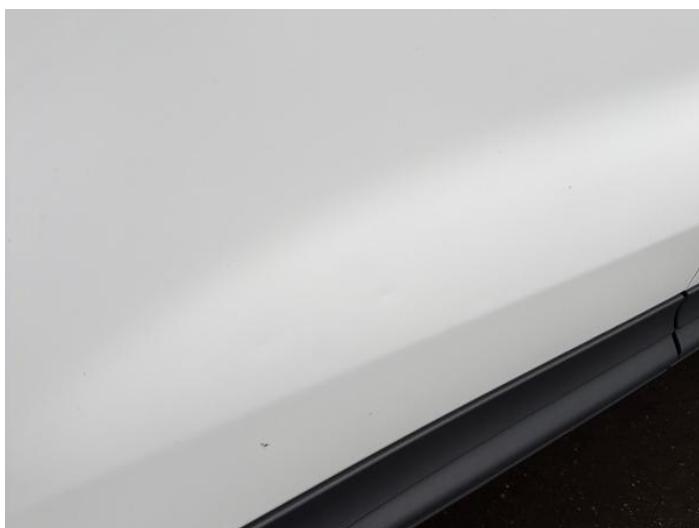
5: Door osr
Dented
With Paint Damage

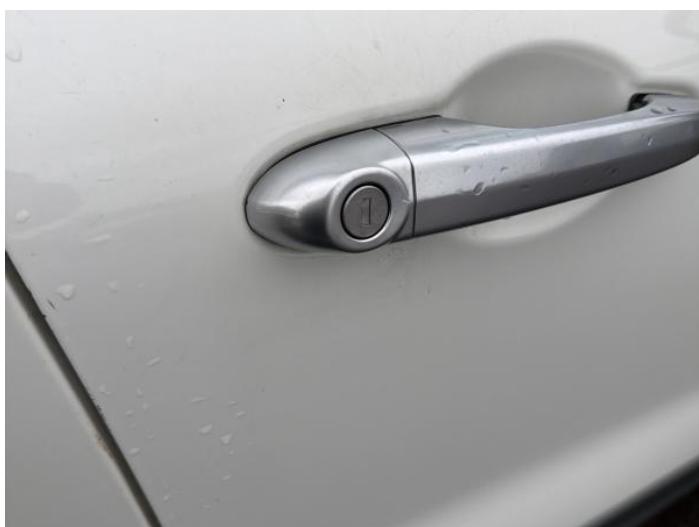
7: Door osf
Chipped
1 To 5

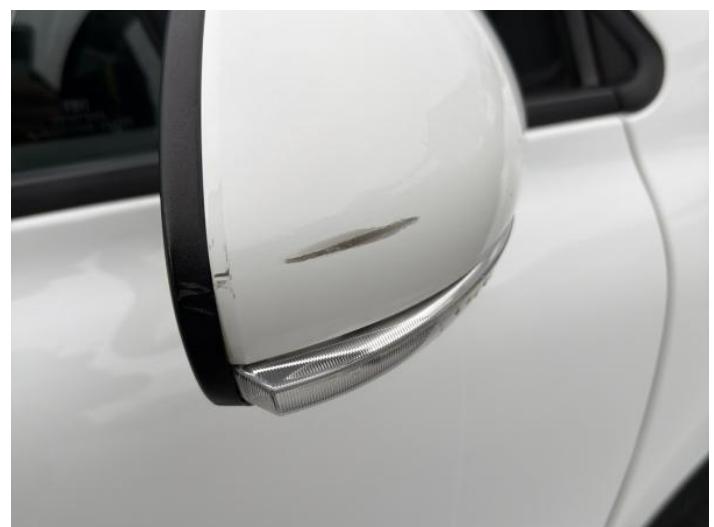
8: Door Mirror Assy osf
Scratched (Painted)
Over 25mm Thru Paint

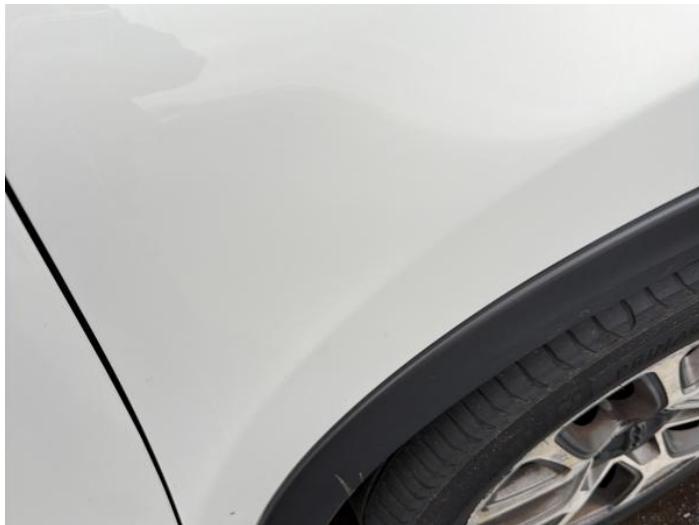
9: Wing osf
Chipped
1 To 5

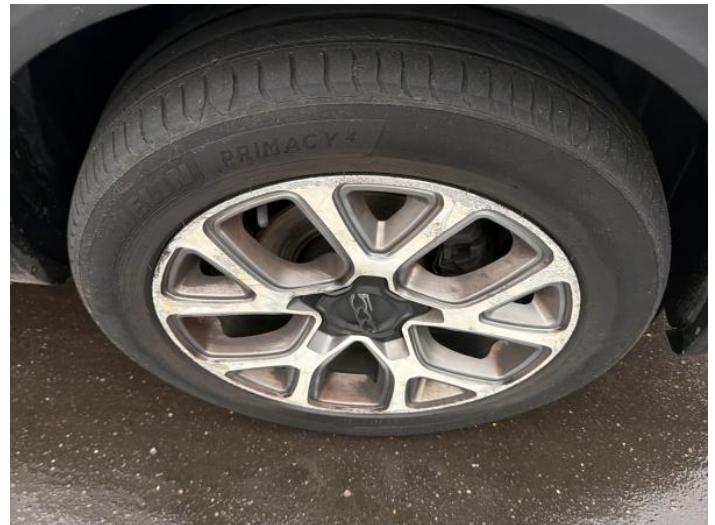
10: Wheel osf
Scratched
Over 50mm

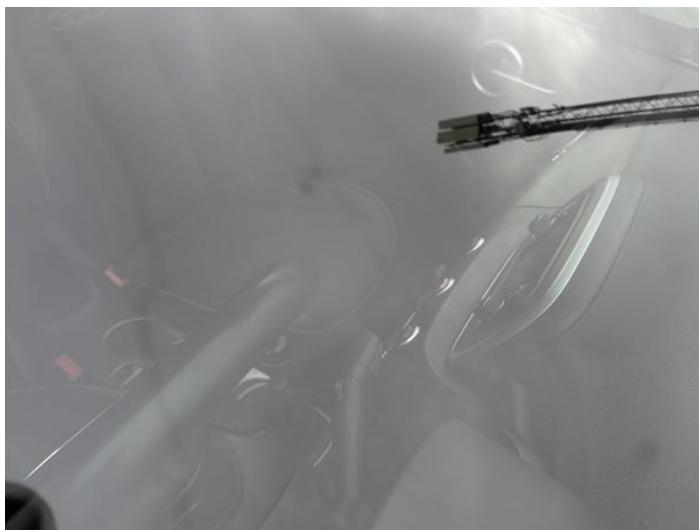
11: Screen Front
Chipped
UpTo 10mm

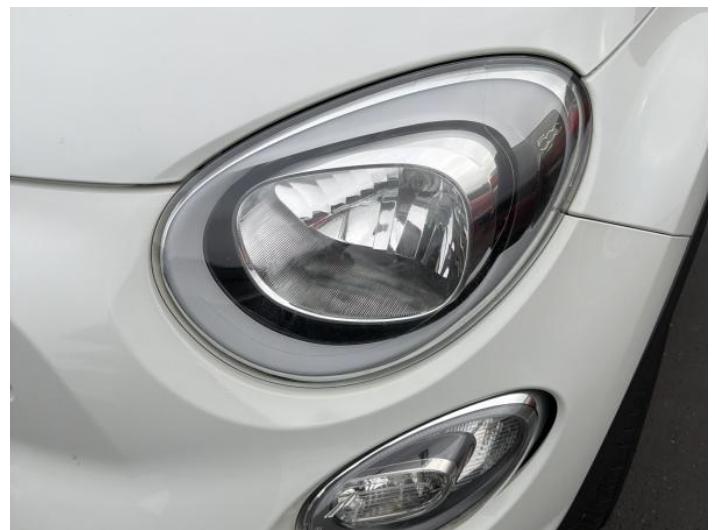
12: Bumper Front
Poor Previous Repair
Poor Colour

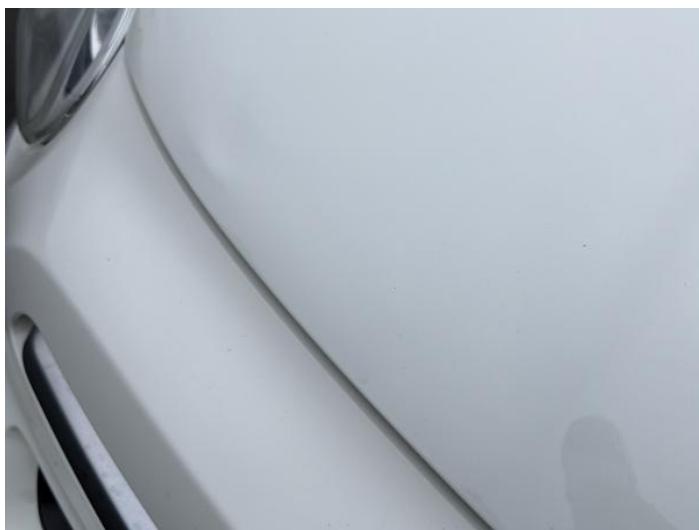
13: Bonnet
Dented
With Paint Damage

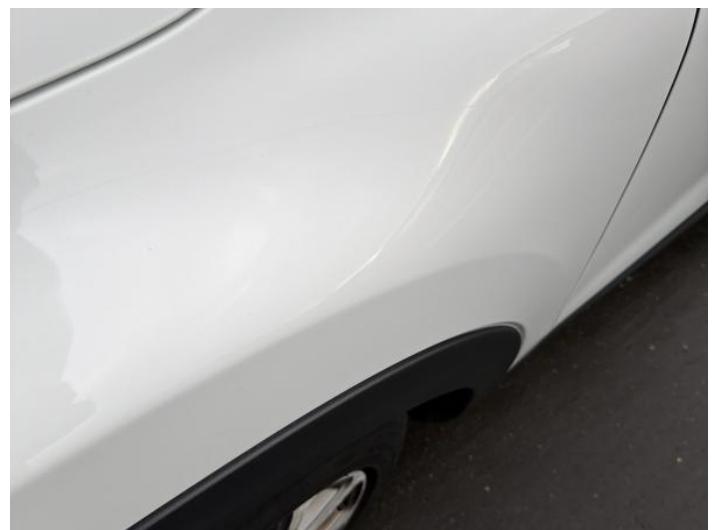
14: Wing nsf
Chipped
1 To 5

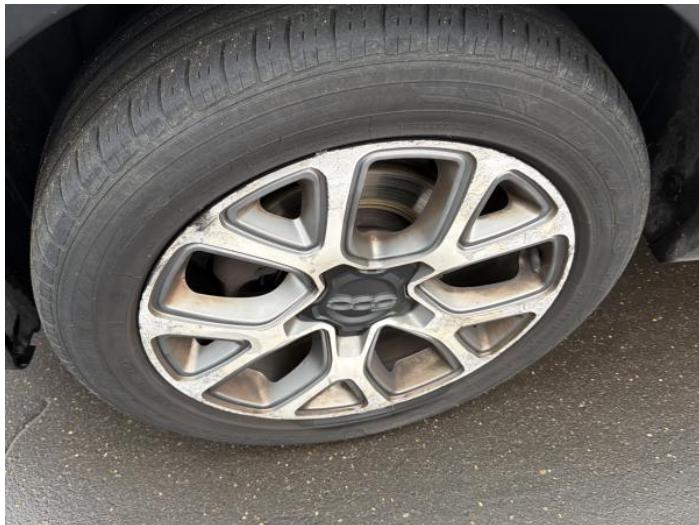
15: Wheel nsf
Scratched
Over 50mm

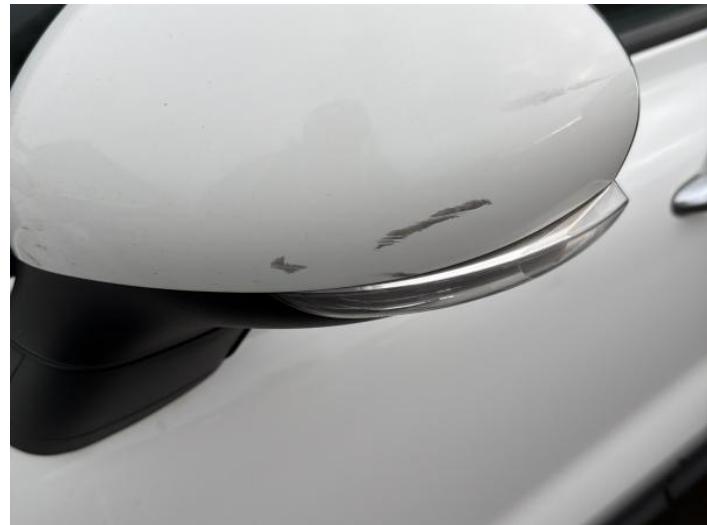
16: Door Mirror Assy nsf
Scratched (Painted)
Over 25mm Thru Paint

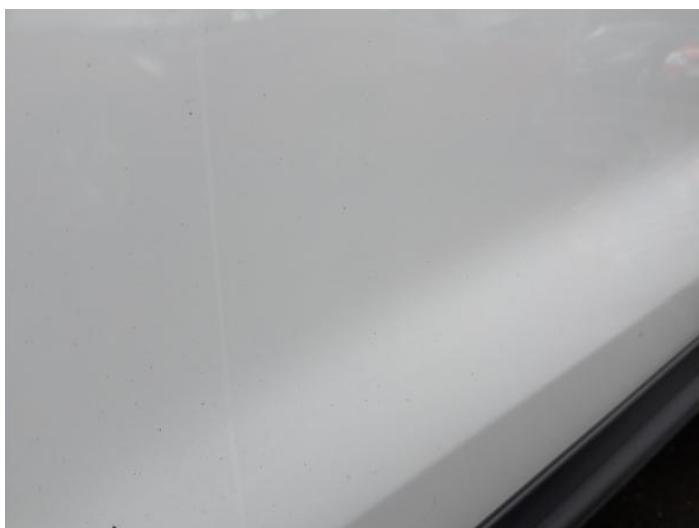
17: Door nsf
Poor Previous Repair
Poor Paint

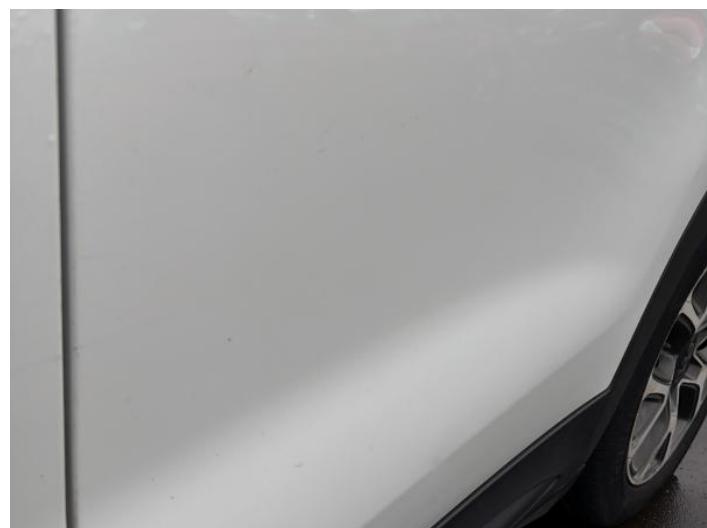
18: Door nsr
Dented
With Paint Damage

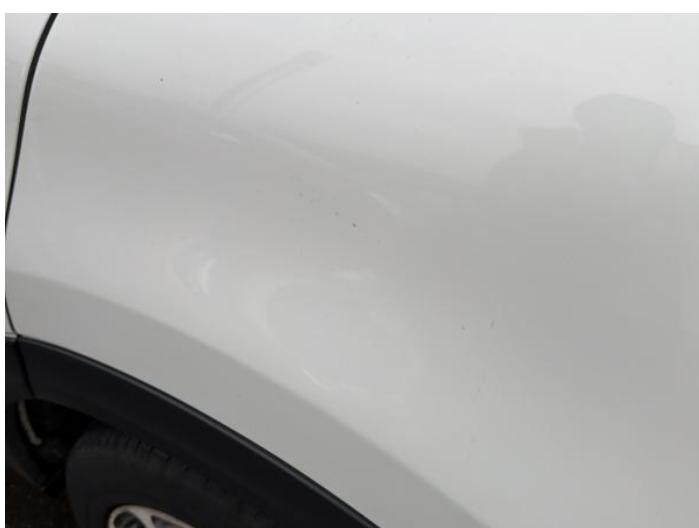
19: Qtr Panel nsr
Chipped
1 To 5

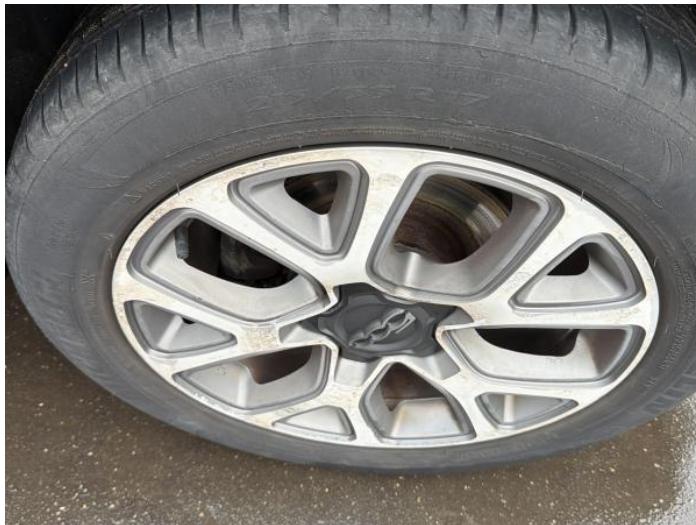
21: Wheel nsr
Scratched
Over 50mm

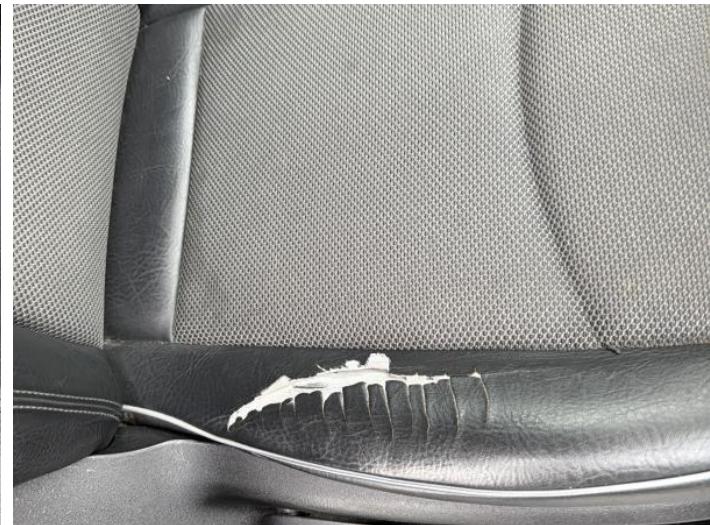
22: Seat Base Cover osf
Torn
Over 3mm

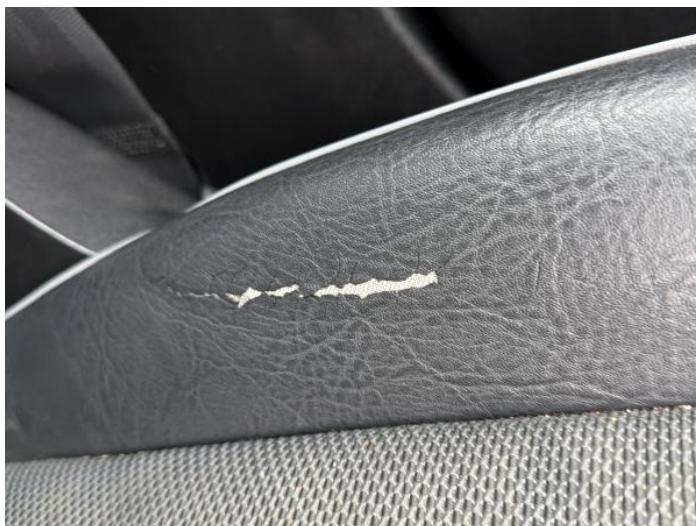
23: Seat Base Cover nsf
Torn
Over 3mm

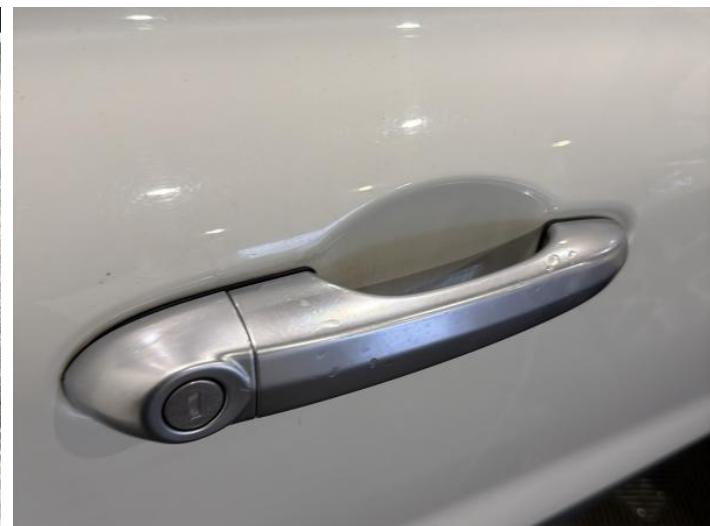
24: Handle Outer osf
Broken
Replace
