## VEHICLE INSPECTION REPORT

RF71MYA

### Hyundai Kona 150kW Premium 64kWh 5dr Auto

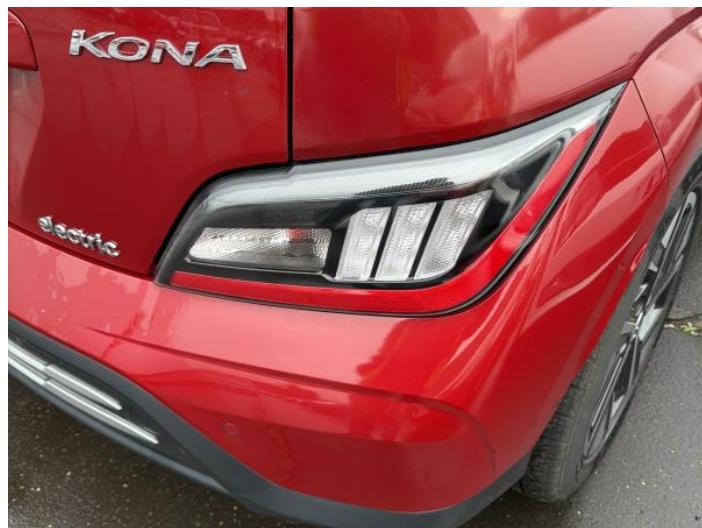
1: Bumper Rear  
Scratched  
25 to 100mm Thru Paint

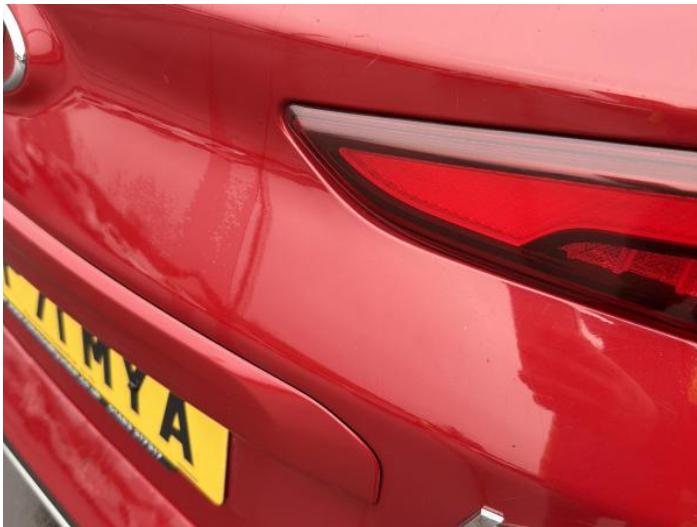
2: Bumper Rear  
Scratched  
Over 25mm Not Thru Paint

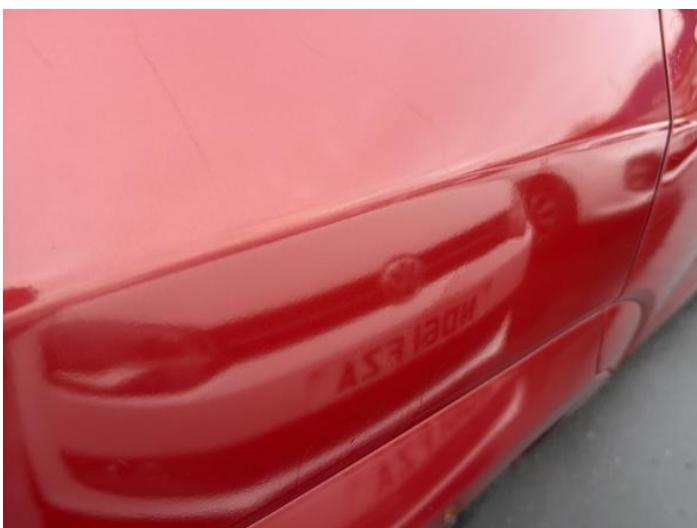
4: Boot Lid  
Scratched  
Over 25mm Not Thru Paint

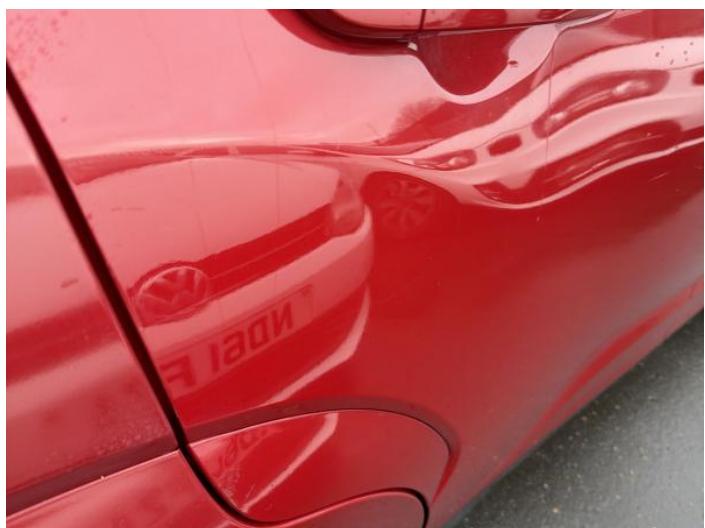
5: Qtr Panel osr  
Poor Previous Repair  
Poor Paint

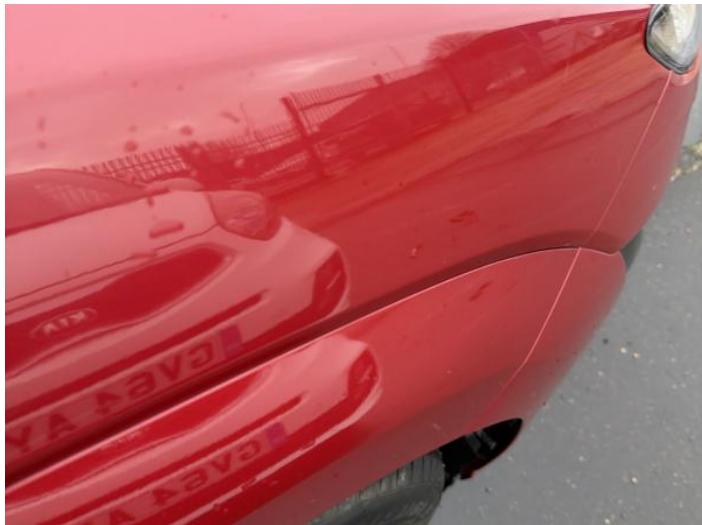
8: Door osf  
Poor Previous Repair  
Poor Paint

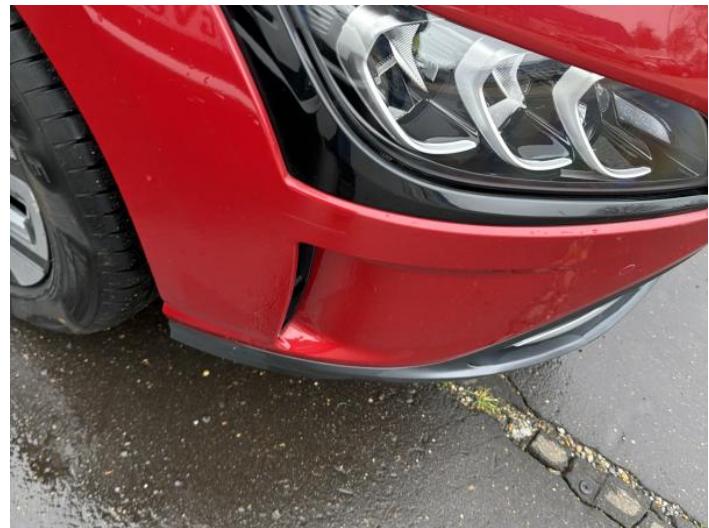
11: Bumper Front  
Scratched  
UpTo 25mm Thru Paint

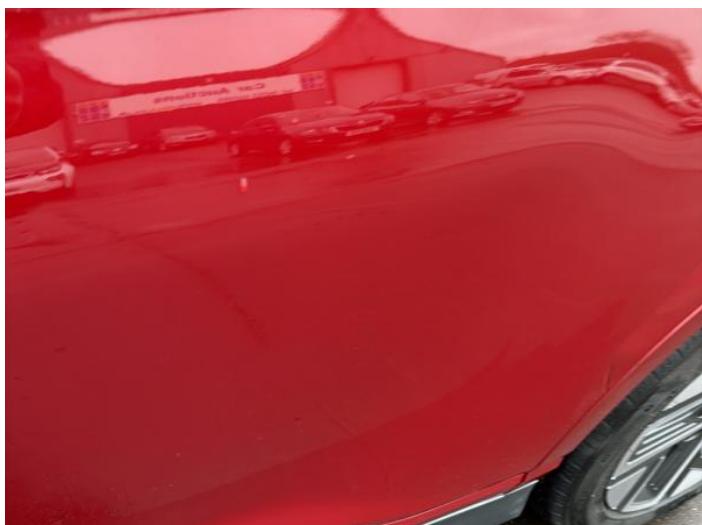
18: Door nsf  
Scratched  
Over 25mm Not Thru Paint

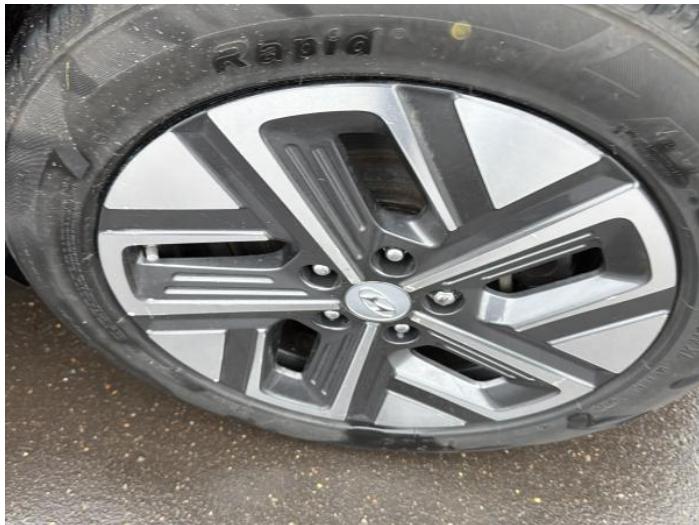
20: Qtr Panel nsr  
Chipped  
1 To 5

21: Wheel nsr  
Scratched  
Up To 50mm
