## VEHICLE INSPECTION REPORT

EO11FRL

### Ford Grand C-Max 2.0 TDCi Titanium 5dr

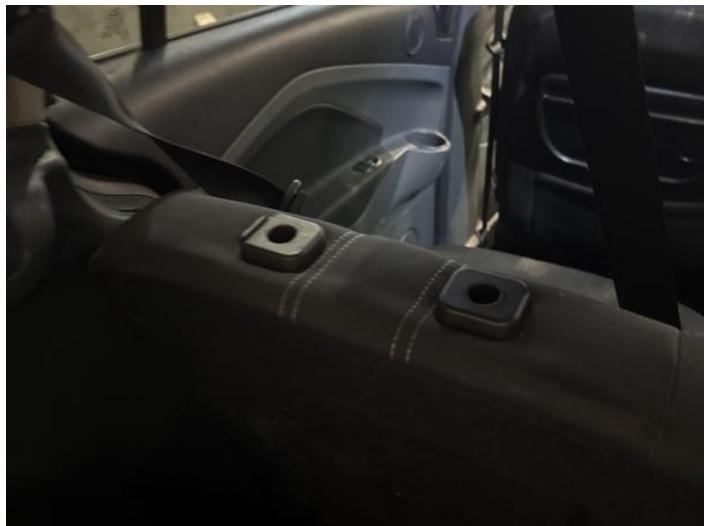
1: Headrest Assy Rear Seat ns  
Missing  
Replace

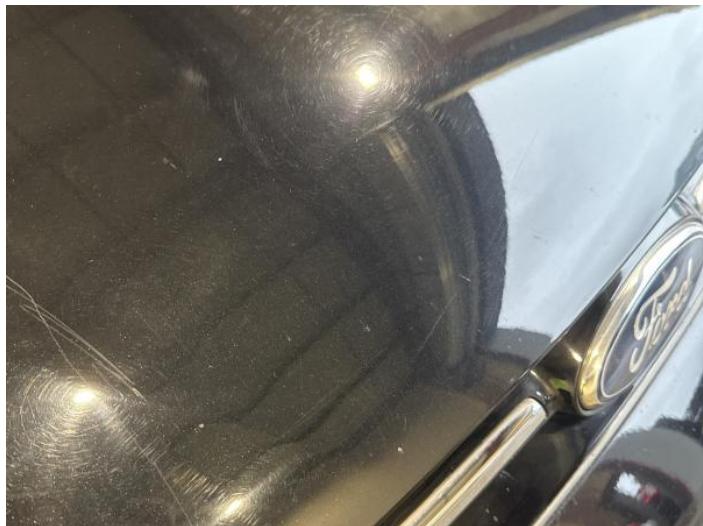
2: Bonnet  
Scratched  
Over 25mm Thru Paint

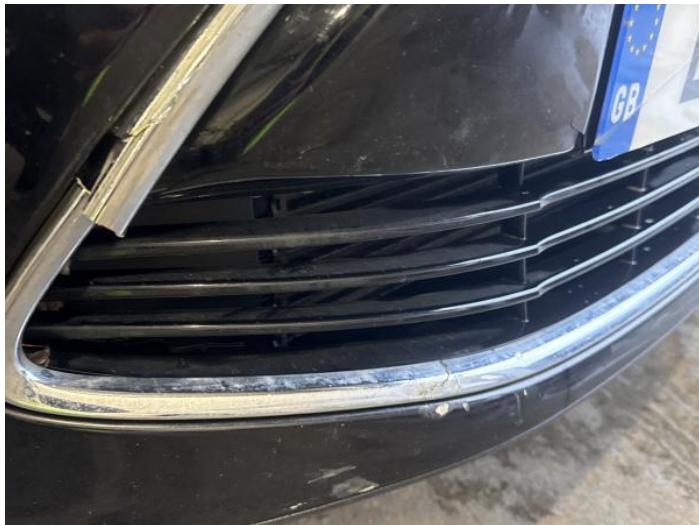
3: Bumper Front Grill  
Broken  
Replace

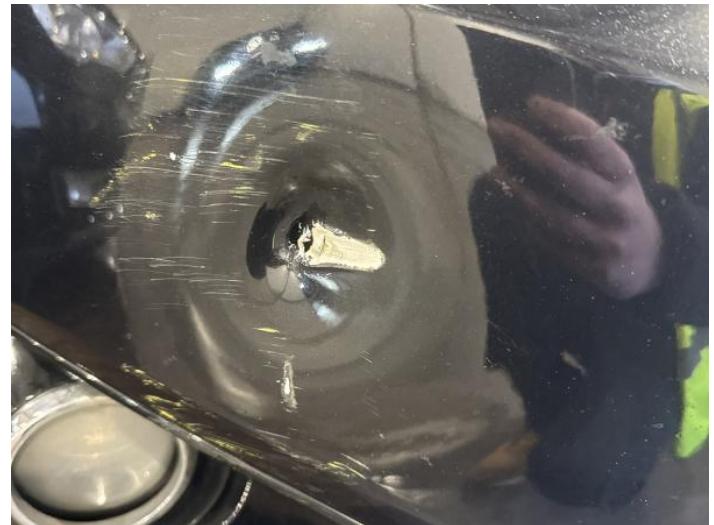
4: Bumper Front  
Hole  
Over 25mm

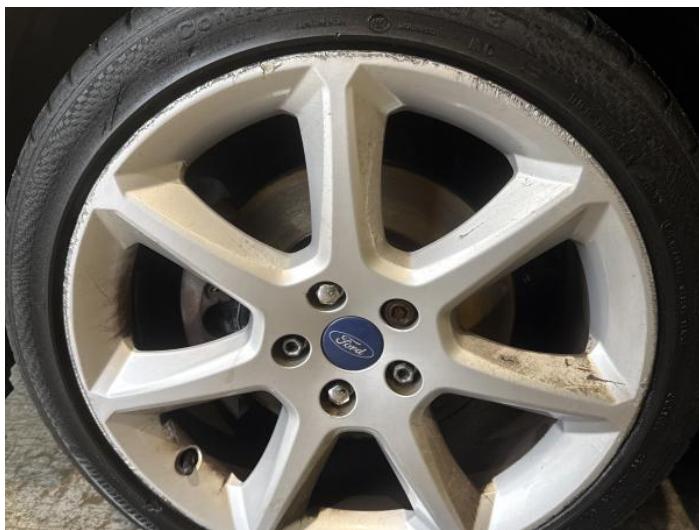
5: Wheel nsf  
Scratched  
Over 50mm

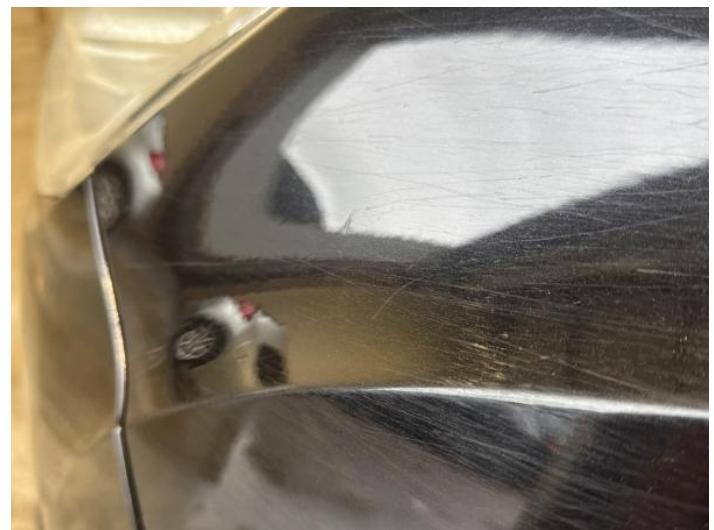
6: Wing nsf  
Scratched  
UpTo 25mm Thru Paint

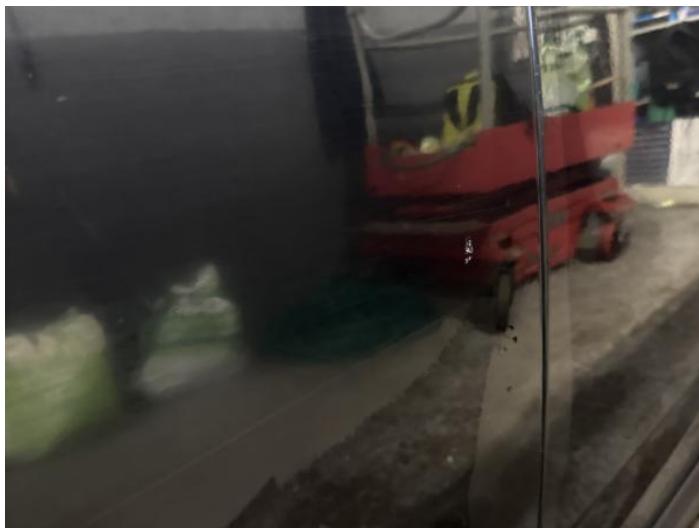
7: Door nsf  
Scratched  
Over 25mm Thru Paint

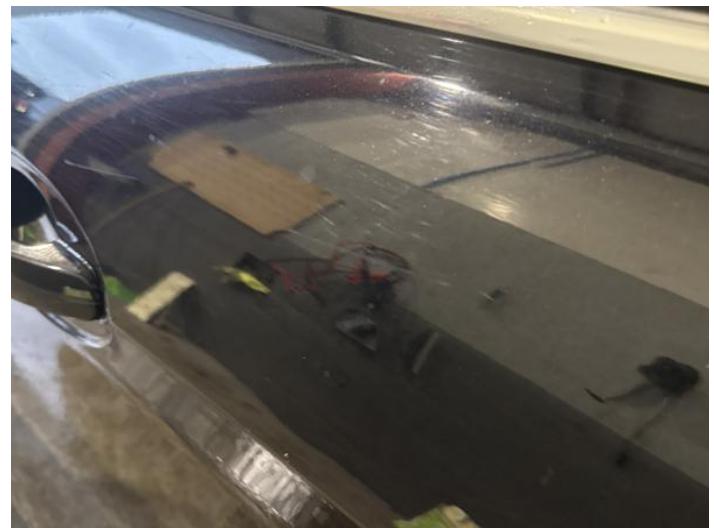
8: Door nsr  
Dented  
Between 10mm + 30mm

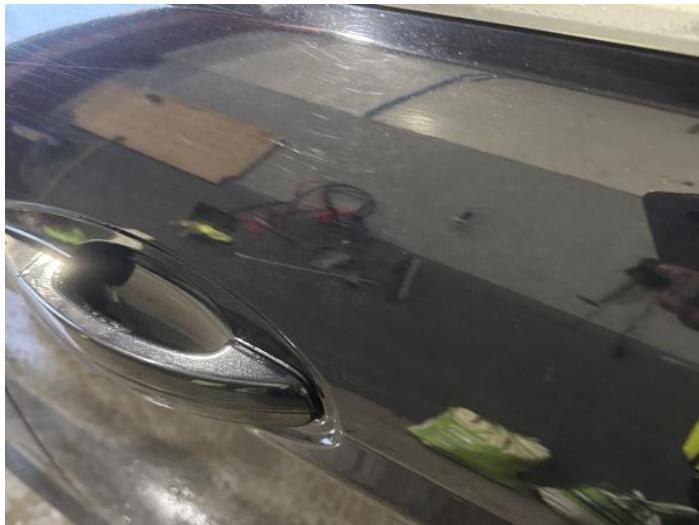
9: Door nsr  
Scratched  
Over 25mm Thru Paint

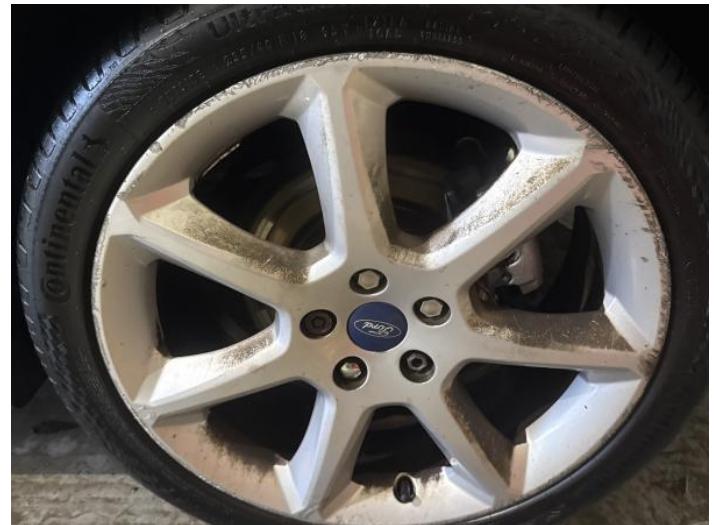
10: Wheel nsr  
Scratched  
Over 50mm

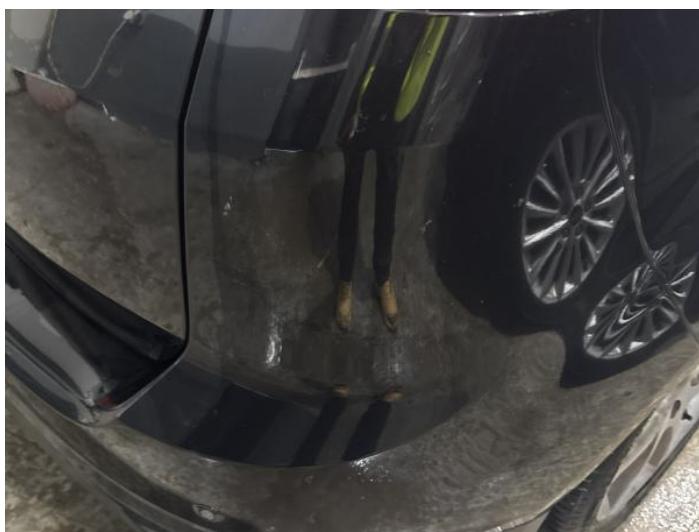
11: Bumper Rear  
Scratched  
25 to 100mm Thru Paint

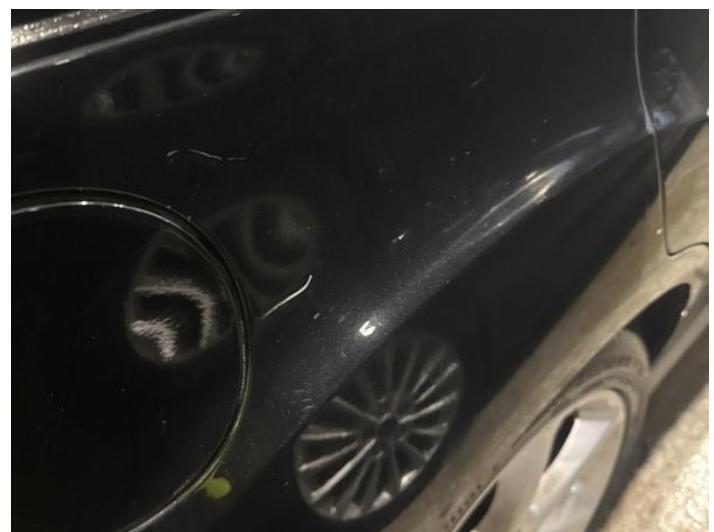
12: Qtr Panel osr  
Scratched  
Over 25mm Thru Paint

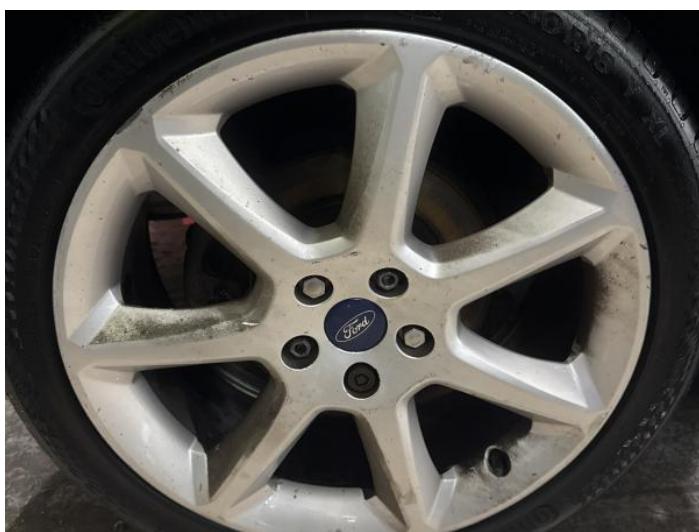
13: Wheel osr  
Scratched  
Over 50mm

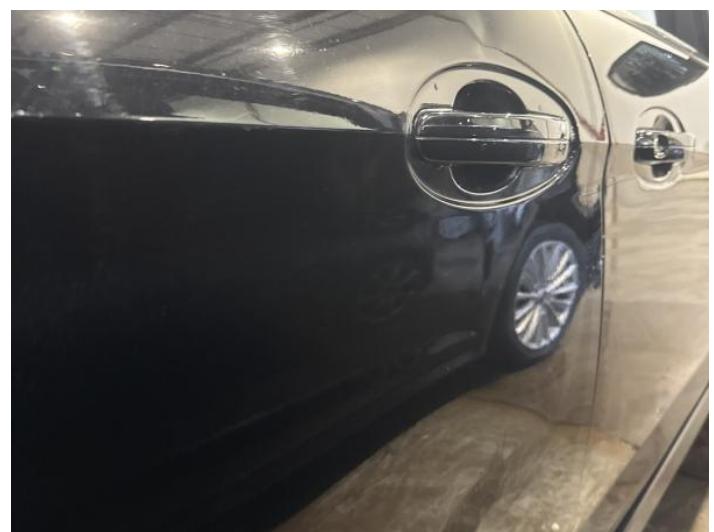
14: Door osr  
Dented  
With Paint Damage

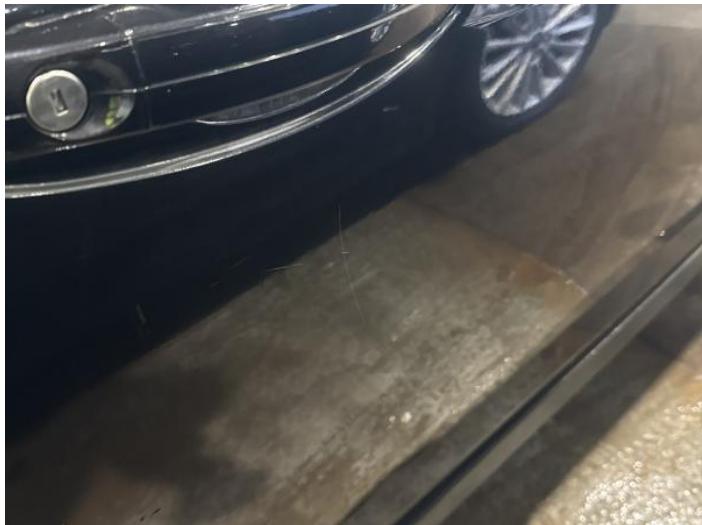
15: Door osf  
Scratched  
Over 25mm Thru Paint

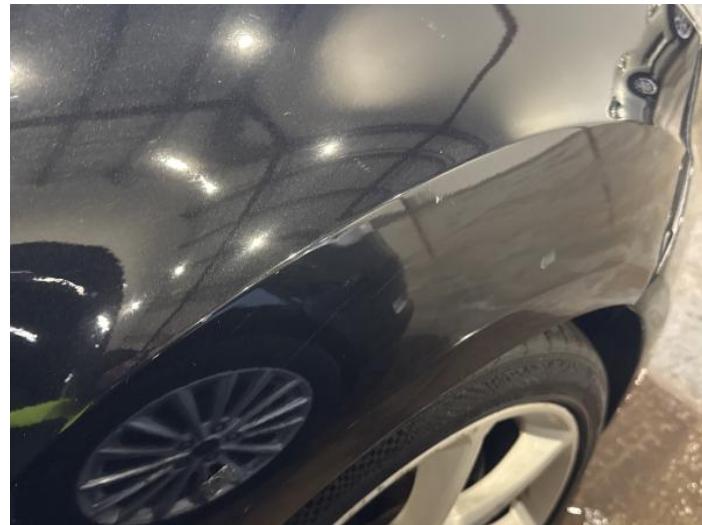
16: Wing osf  
Scratched  
Over 25mm Thru Paint

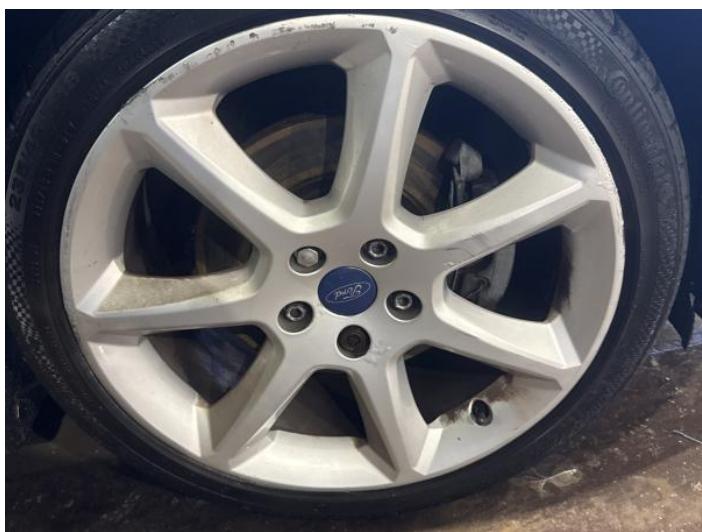
17: Wheel osf  
Scratched  
Over 50mm

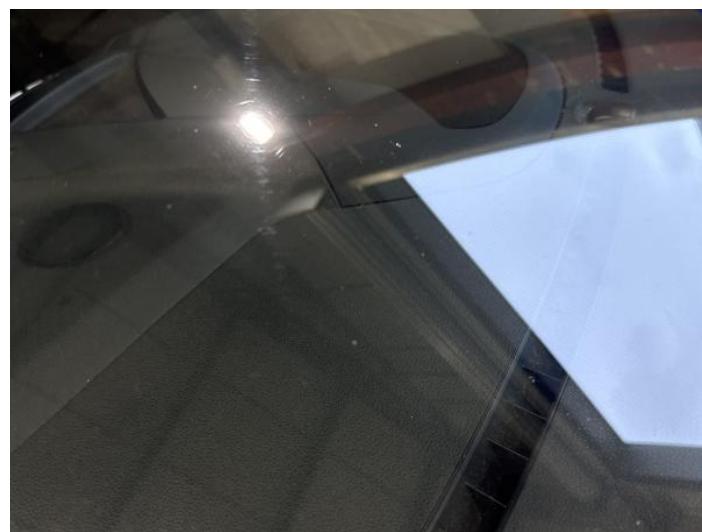
18: Screen Front  
Chipped  
UpTo 10mm

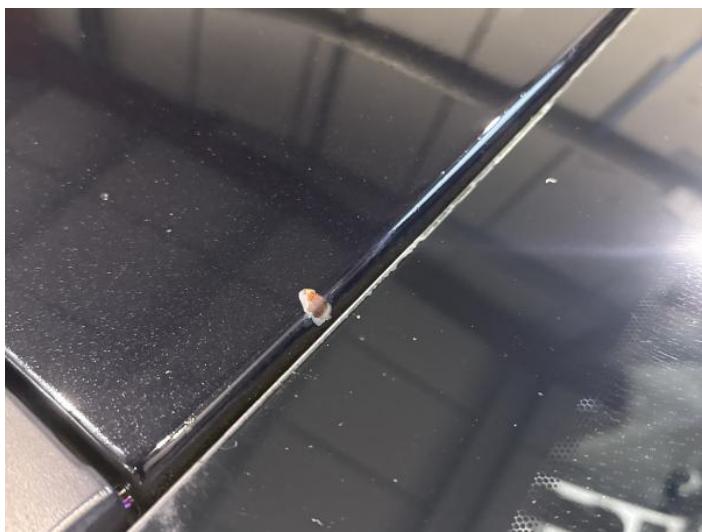
19: Roof  
Chipped  
Over 5mm

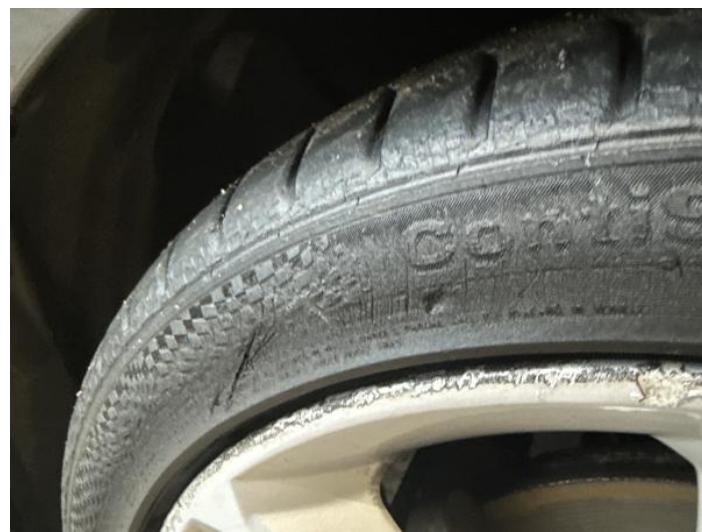
NSF	CONTINENTAL	Damaged
NSR	CONTINENTAL	5.0mm
OSF	CONTINENTAL	5.0mm
OSR	CONTINENTAL	5.0mm
Spare

20: Tyre nsf  
Damaged  
Replace

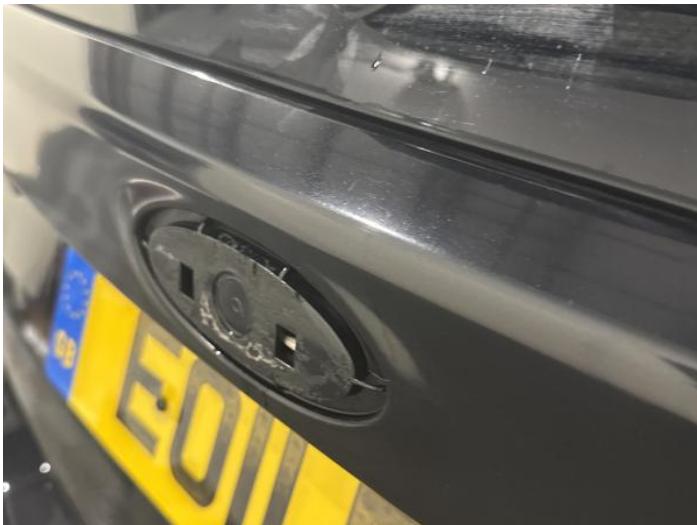
21: Badgedecal Rear

Missing  
Replace
