## VEHICLE INSPECTION REPORT

OV58GXW

### Honda FR-V 1.8 i-VTEC EX 5dr

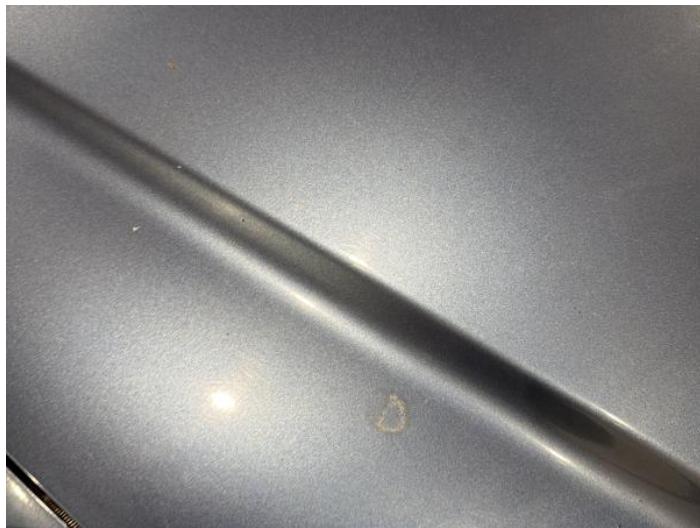
1: Bonnet  
Dented  
With Paint Damage

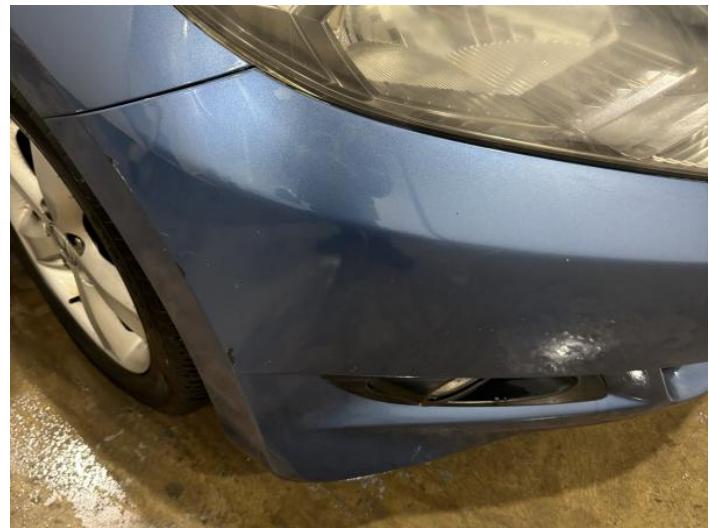
2: Bumper Front  
Scratched  
Over 100mm Thru Paint

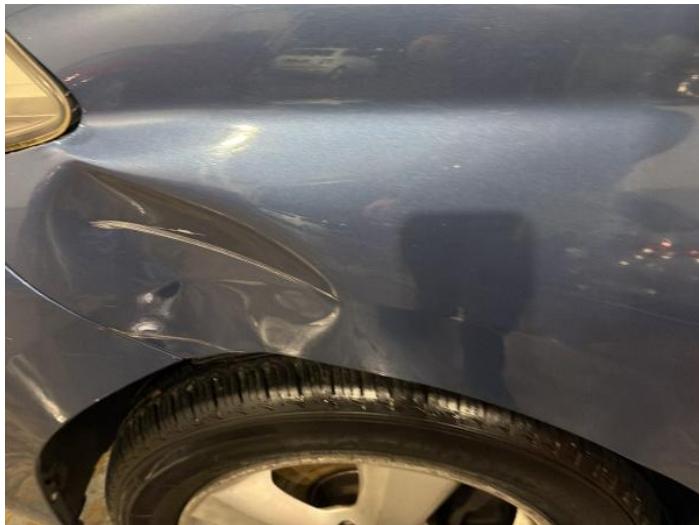
3: Wing nsf  
Dented  
With Paint Damage

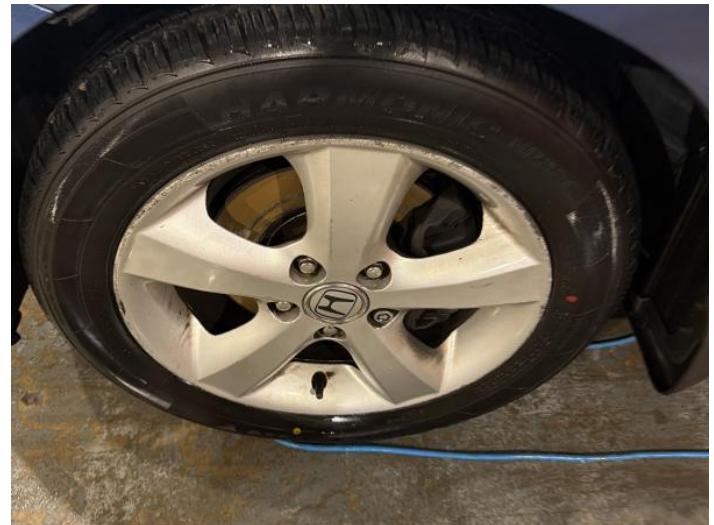
4: Wheel nsf  
Scratched  
Over 50mm

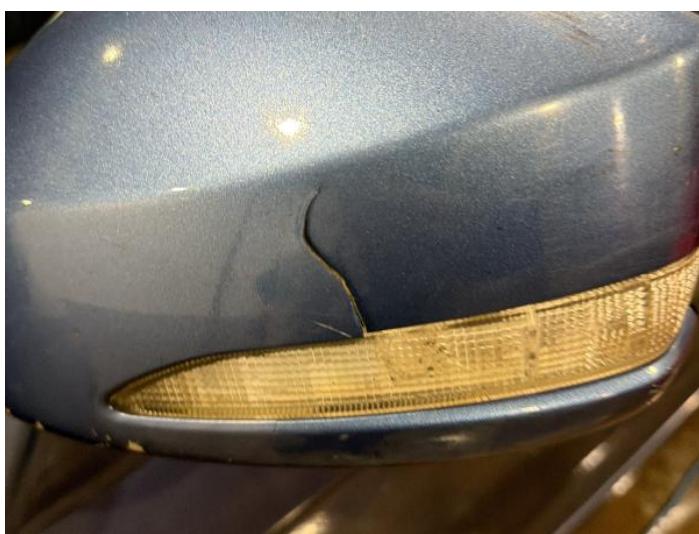
5: Door Mirror Assy nsf  
Broken  
Replace

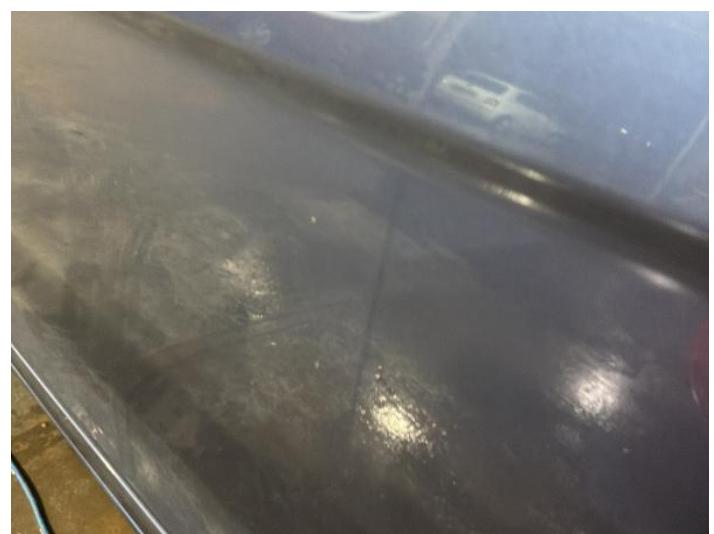
6: Door nsf  
Chipped  
Multiple Chips

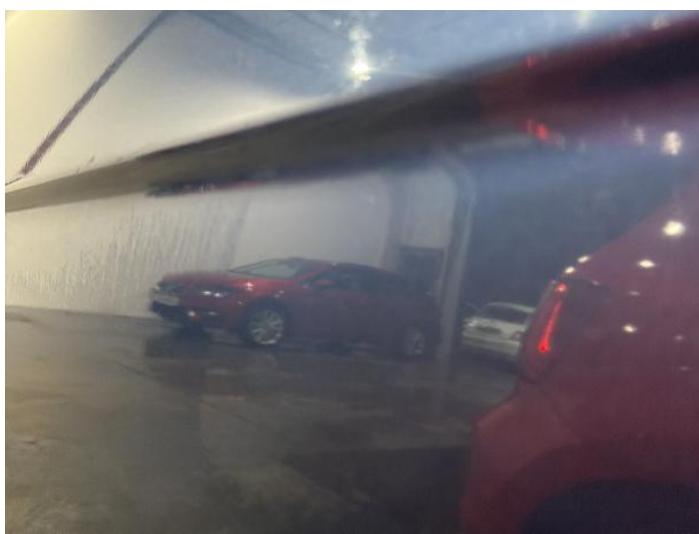
7: Door nsr  
Chipped  
Multiple Chips

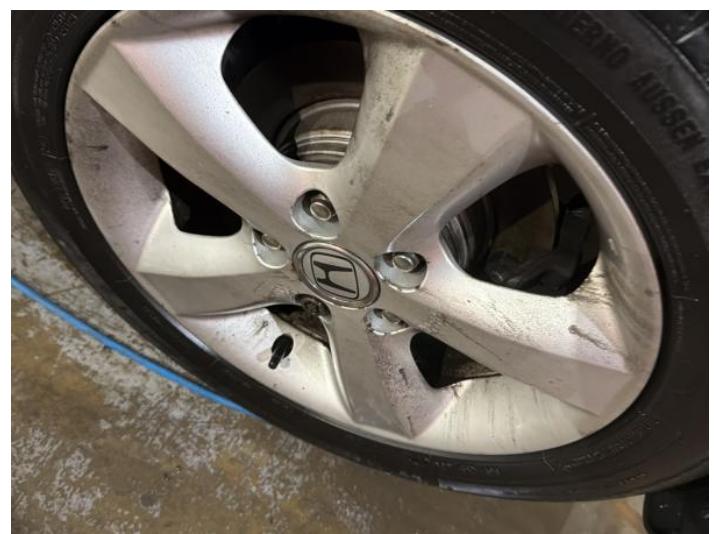
8: Wheel nsr  
Scratched  
Over 50mm

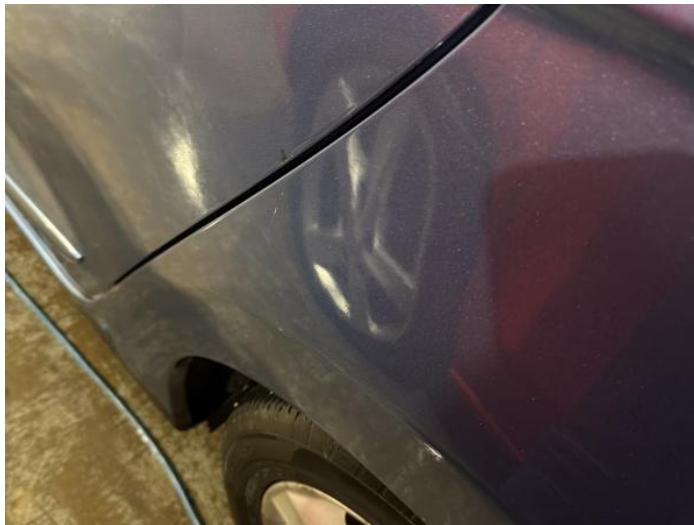
9: Qtr Panel nsr  
Dented  
With Paint Damage

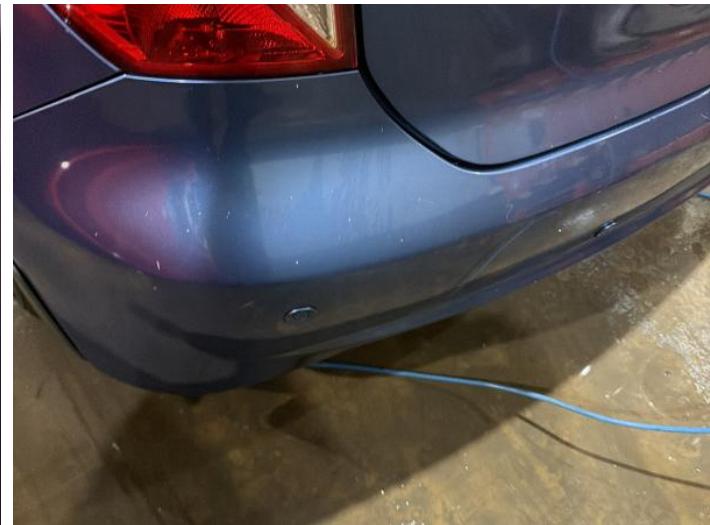
10: Bumper Rear  
Chipped  
Multiple Chips

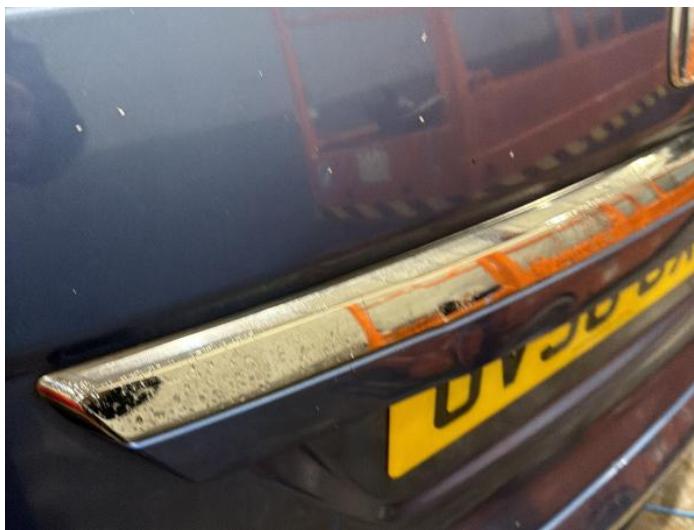
11: Boot Lid  
Chipped  
Multiple Chips

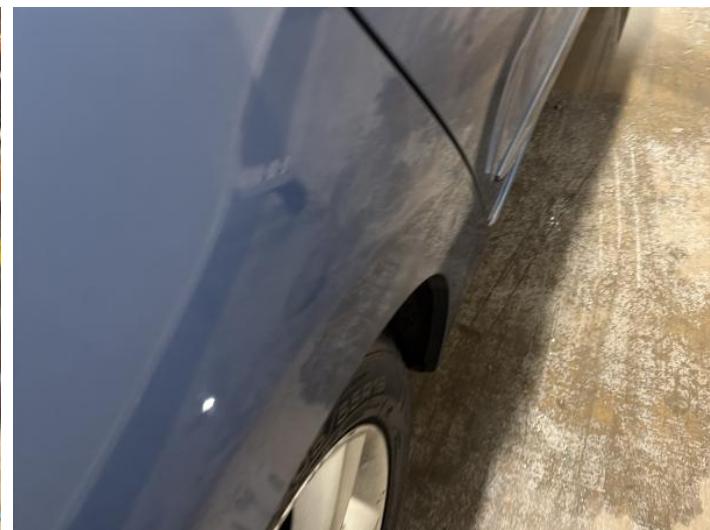
12: Qtr Panel osr  
Dented  
Over 30mm

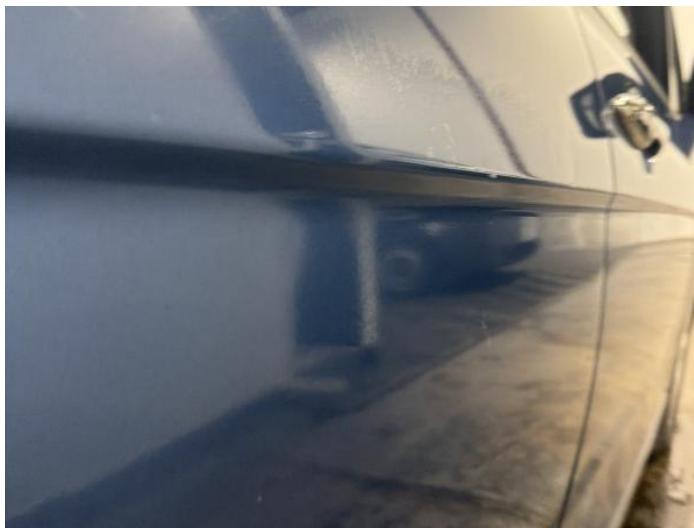
13: Door osr  
Dented  
With Paint Damage

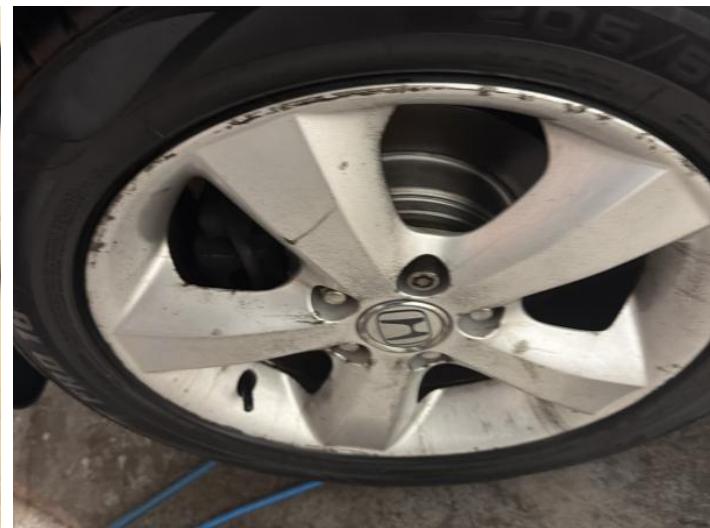
14: Wheel osr  
Scratched  
Over 50mm

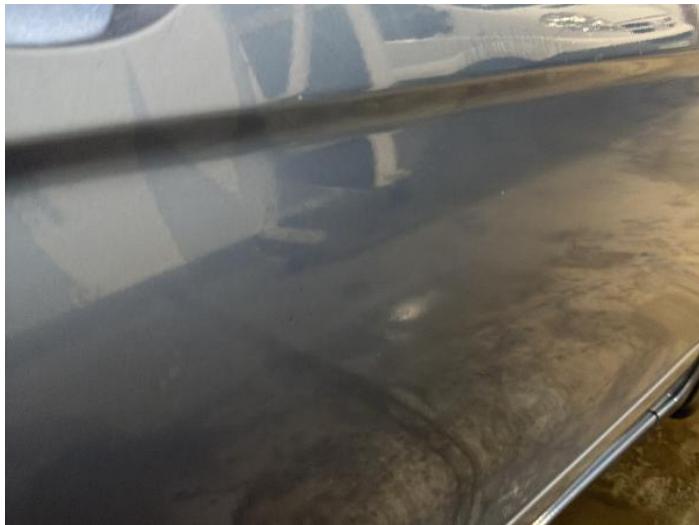
15: Door osf  
Chipped  
Multiple Chips

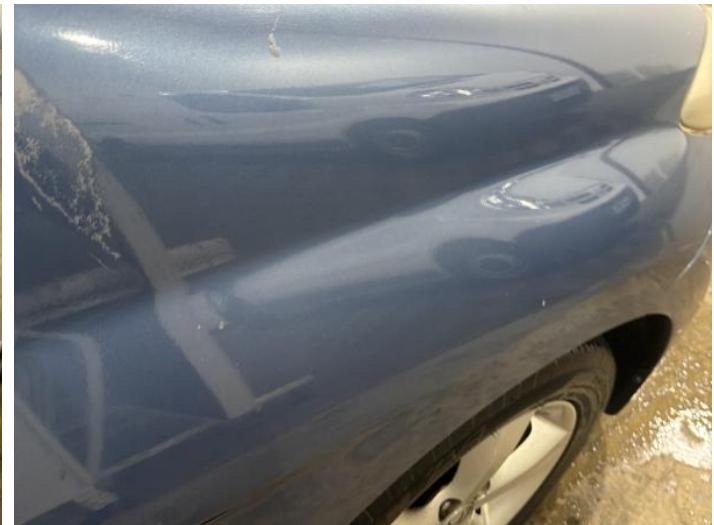
16: Wing osf  
Poor Previous Repair  
Poor Paint

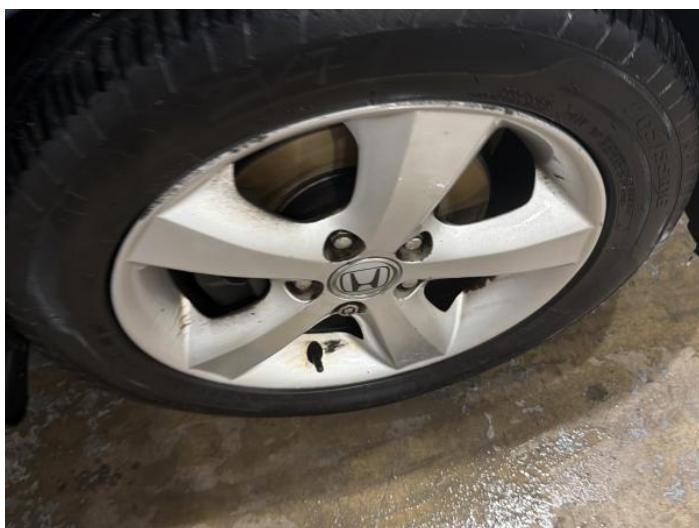
17: Wheel osf  
Scratched  
Over 50mm

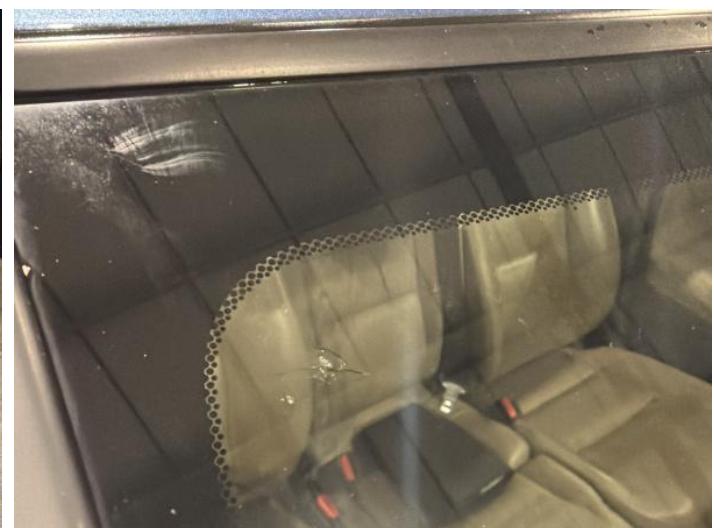
18: Screen Front  
Chipped  
UpTo 10mm
