## VEHICLE INSPECTION REPORT

**GX67MTE**

### Kia Sportage 1.7 CRDi ISG 3 5dr

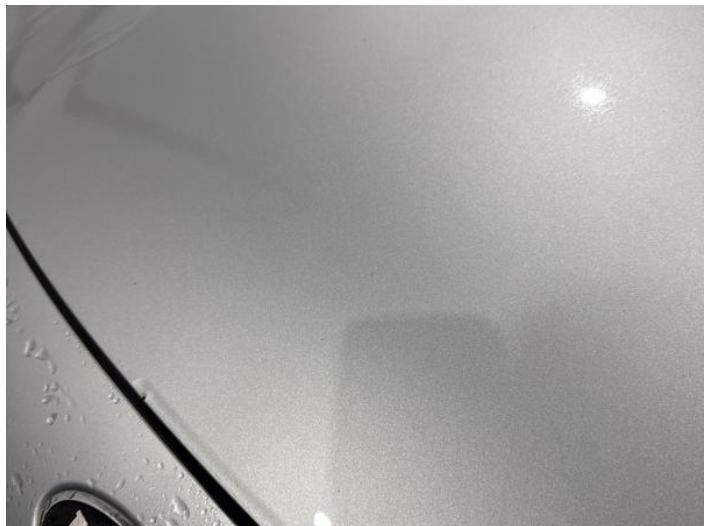
1: Bonnet  
Chipped  
Multiple Chips

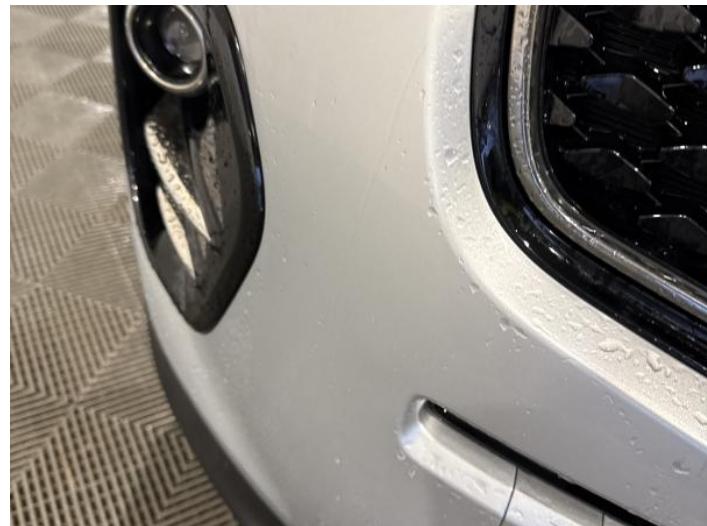
2: Bumper Front  
Chipped  
1 To 5

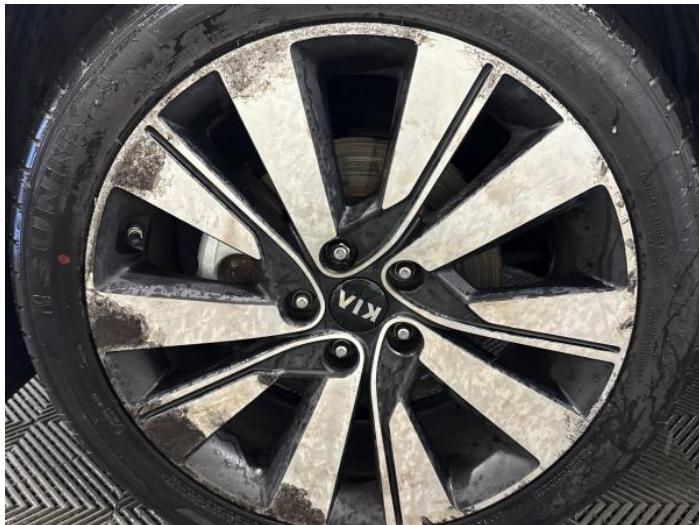
3: Wheel nsf  
Scratched  
Over 50mm

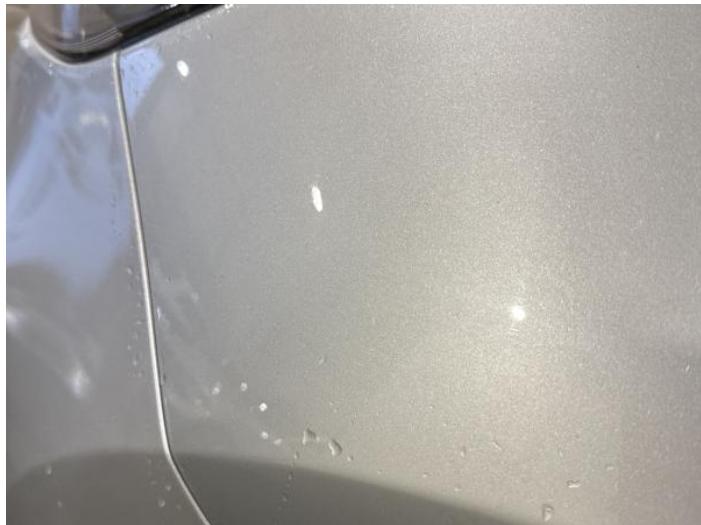
4: Wing nsf  
Chipped  
1 To 5

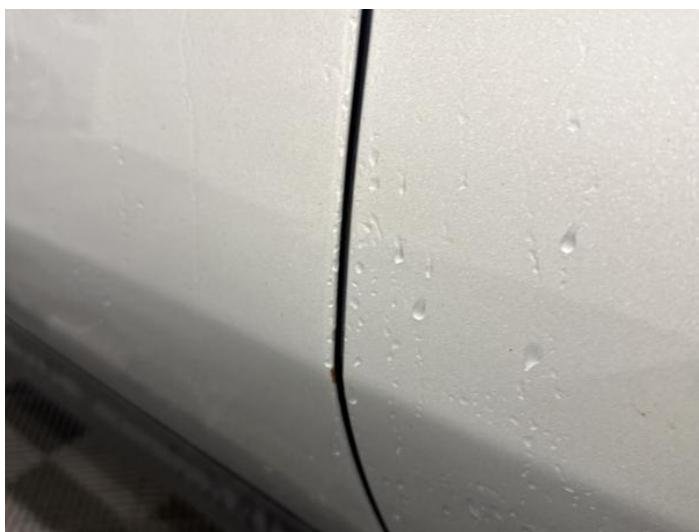
5: Door nsf  
Chipped  
Edge Chip

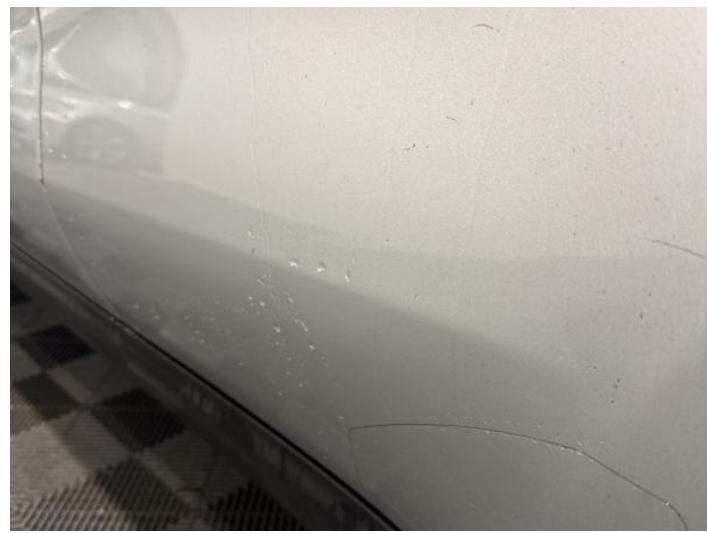
6: Door nsr  
Chipped  
1 To 5

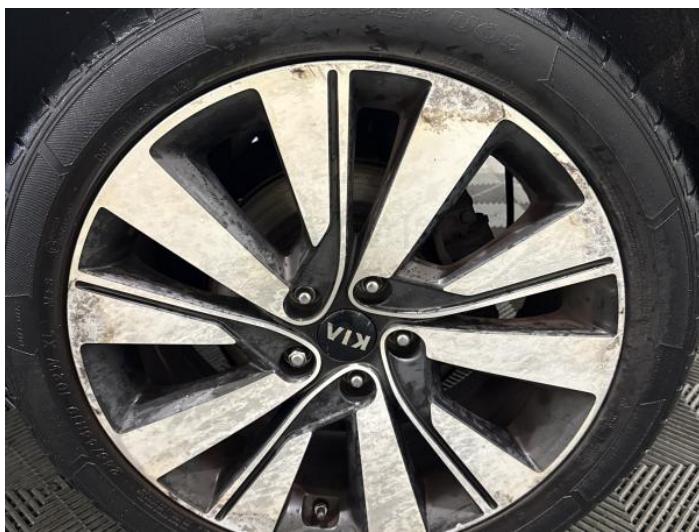
7: Wheel nsr  
Scratched  
Over 50mm

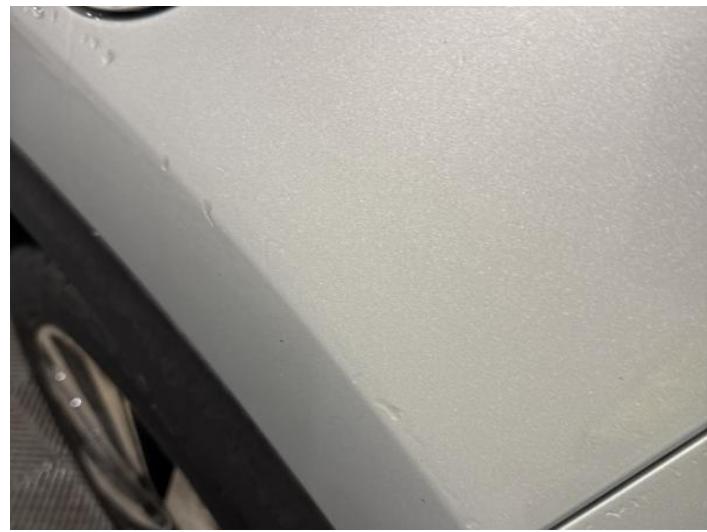
8: Qtr Panel nsr  
Scratched  
UpTo 25mm Thru Paint

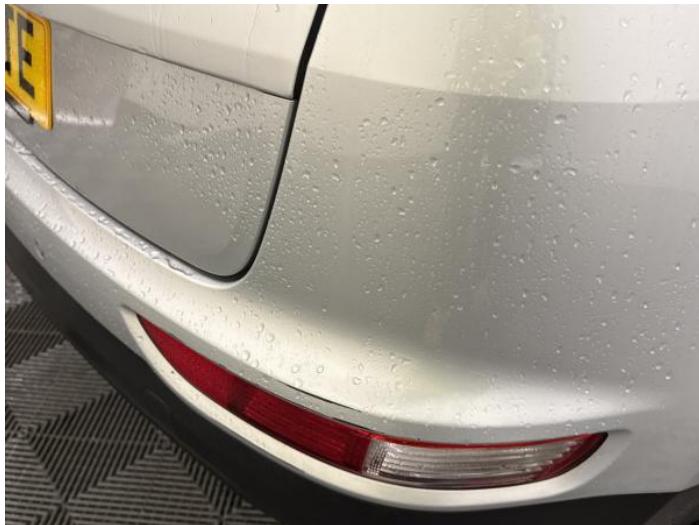
9: Bumper Rear  
Scratched  
25 to 100mm Thru Paint

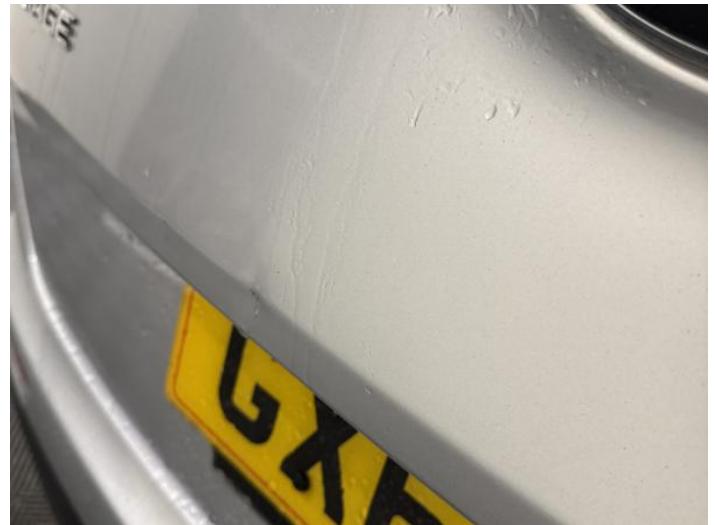
10: Tailgate  
Dented  
Over 30mm

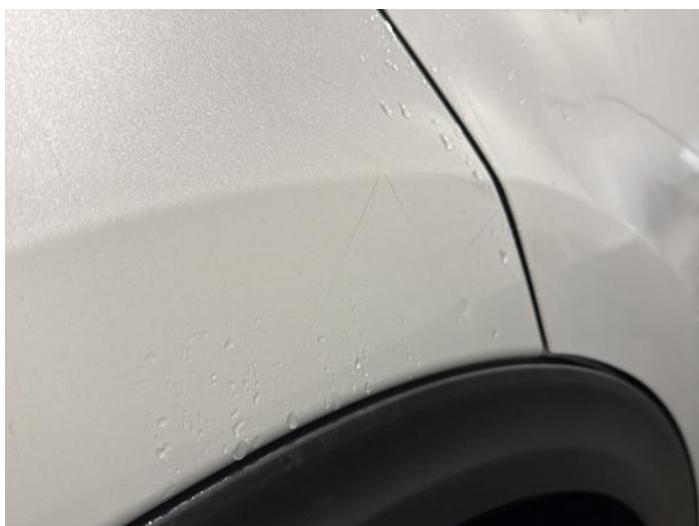
11: Qtr Panel osr  
Scratched  
Over 25mm Thru Paint

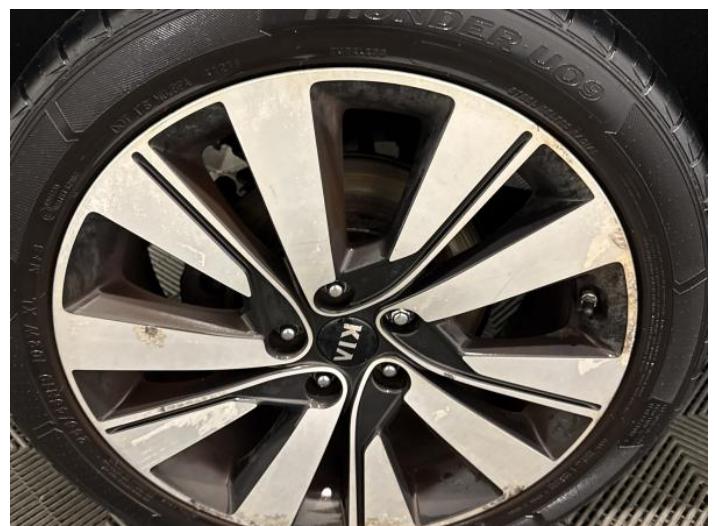
12: Wheel osr  
Scratched  
Over 50mm

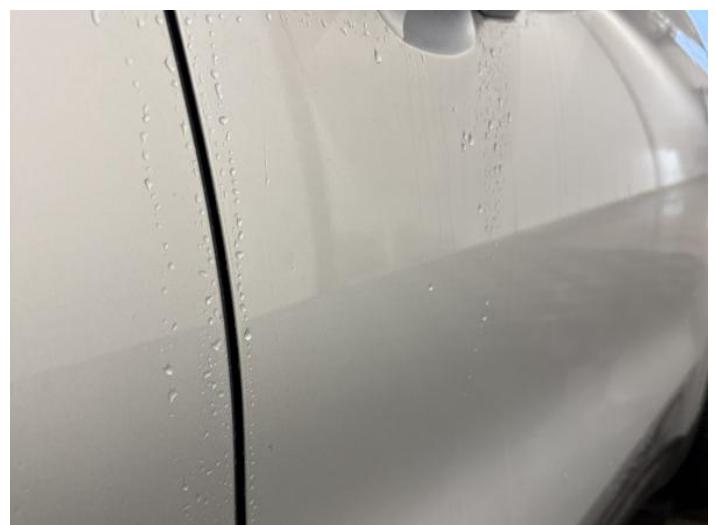
14: Door osf  
Dented  
Between 10mm + 30mm

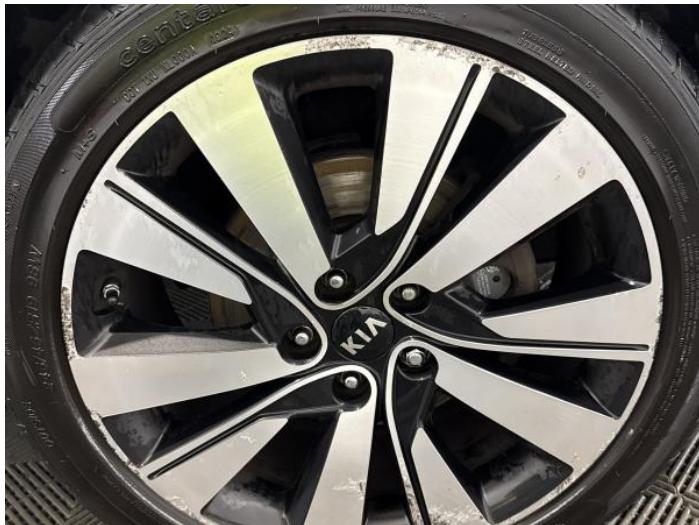
15: Wheel osf  
Scratched  
Over 50mm

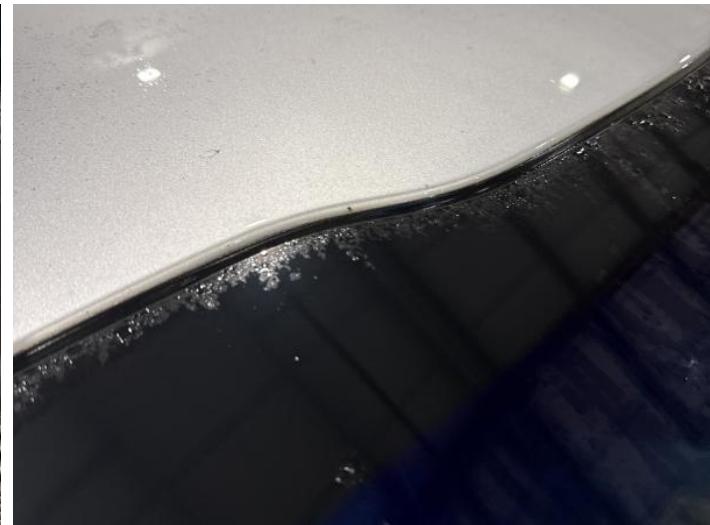
16: Roof  
Chipped  
Edge Chip

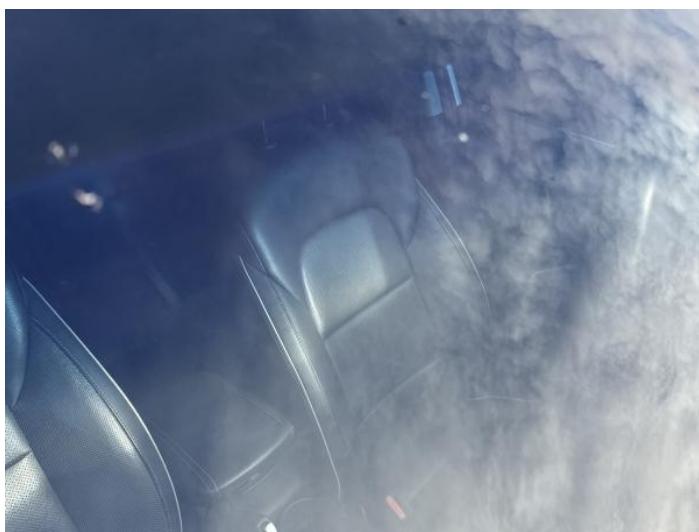
17: Screen Front  
Cracked  
Replace
