VEHICLE INSPECTION REPORT

OV13UAP

Audi A6 Allroad 3.0 TDI Quattro 204 5dr S Tronic

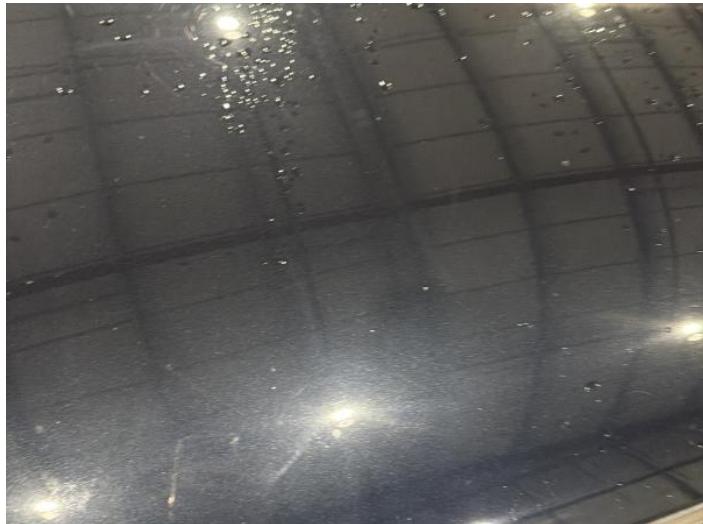
1: Bonnet
Chipped
Multiple Chips

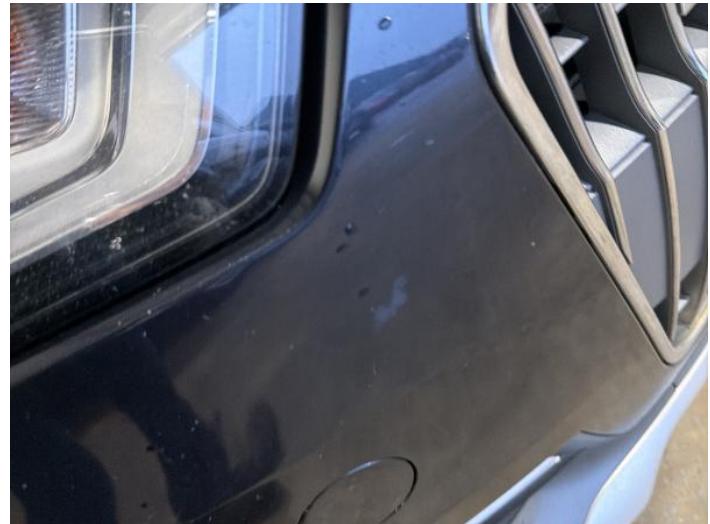
2: Bumper Front
Poor Previous Repair
Poor Paint

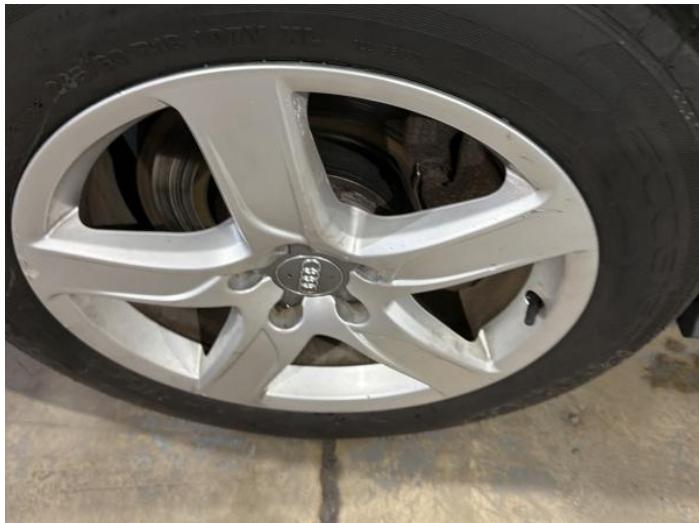
3: Wheel nsf
Scratched
Over 50mm

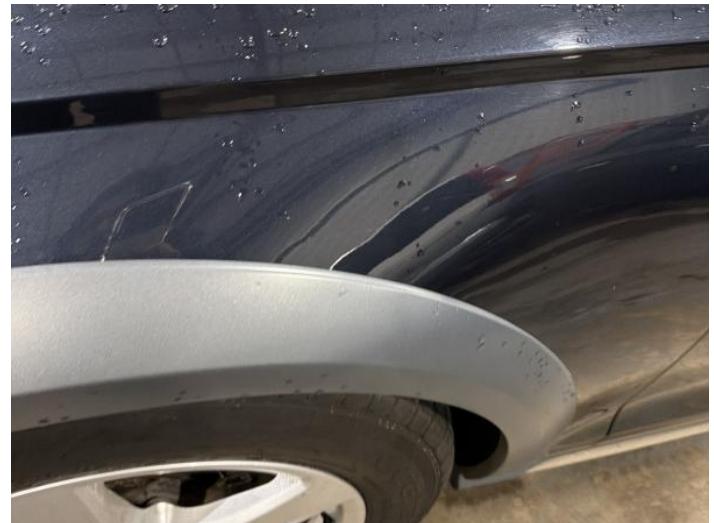
4: Wing nsf
Chipped
1 To 5

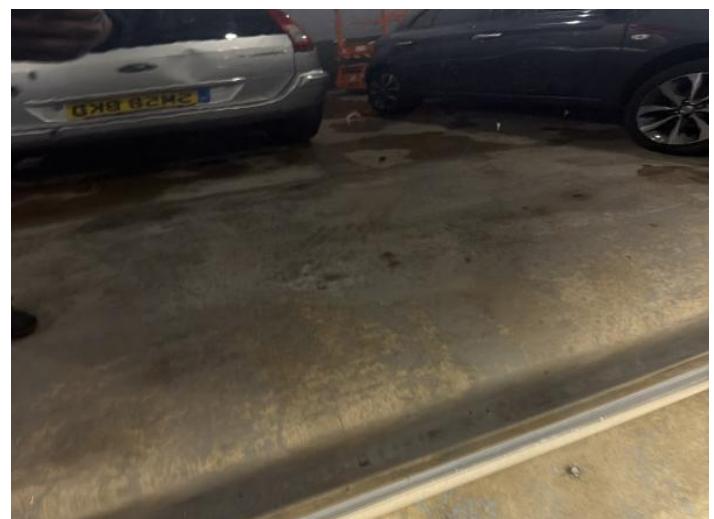
6: Door nsf
Dented
Over 2 UpTo 10mm

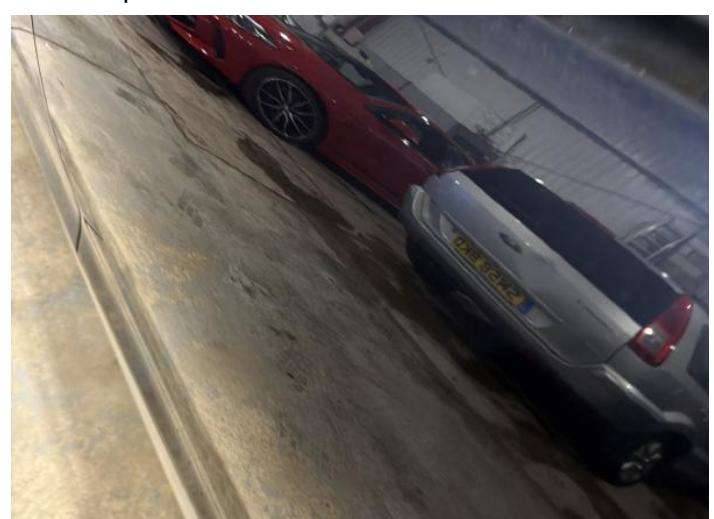
8: Door nsr
Dented
2 Or Less UpTo 10mm

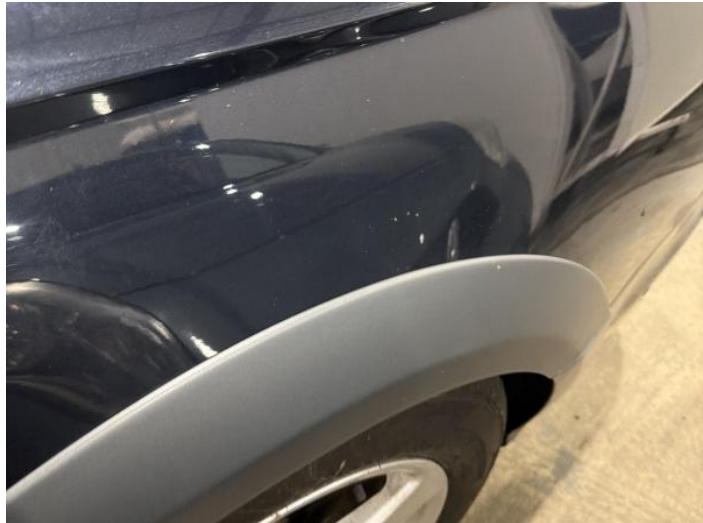
10: Qtr Panel nsr
Chipped
1 To 5

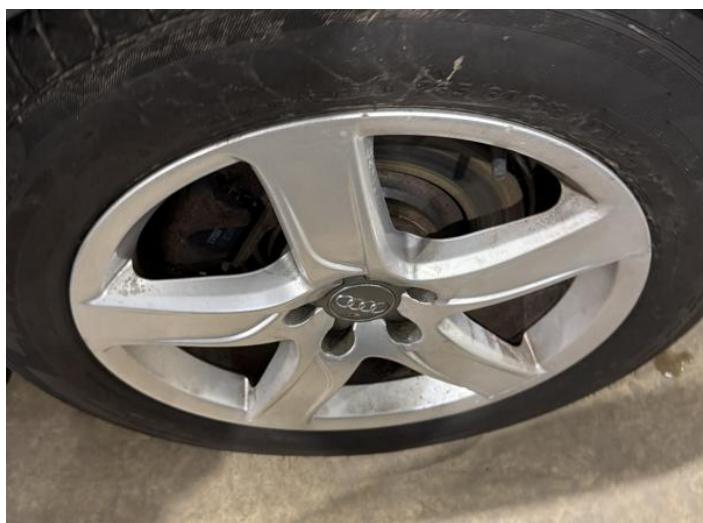
12: Wheel nsr
Scratched
Over 50mm

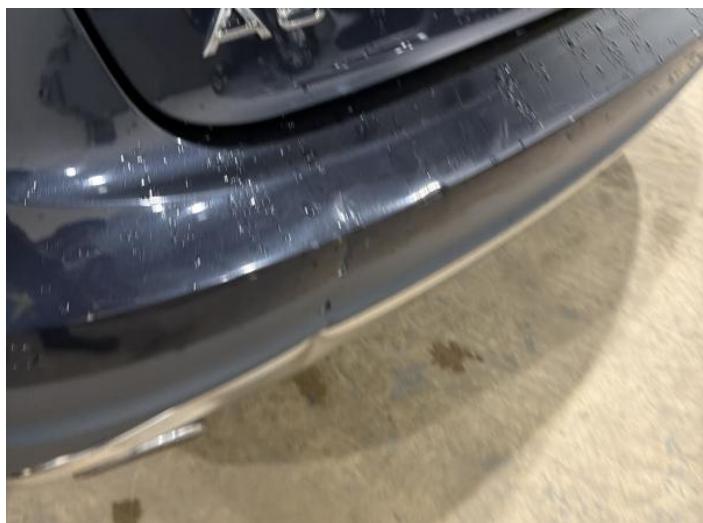
13: Bumper Rear
Dented
With Paint Damage

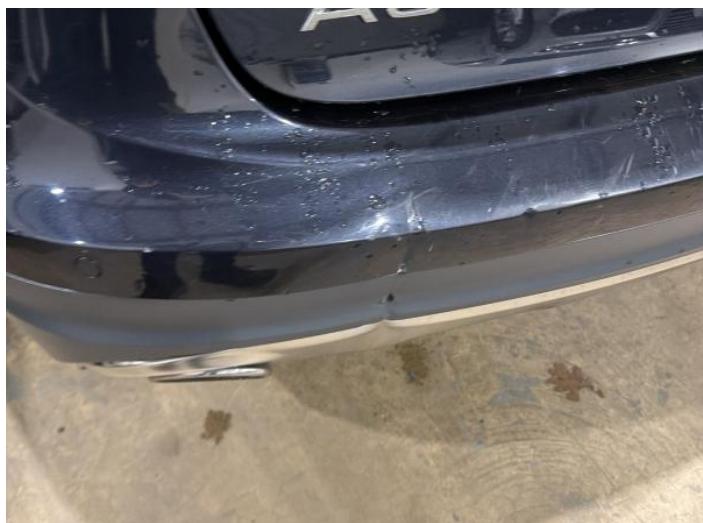
14: Bumper Rear Moulding
Broken
Replace

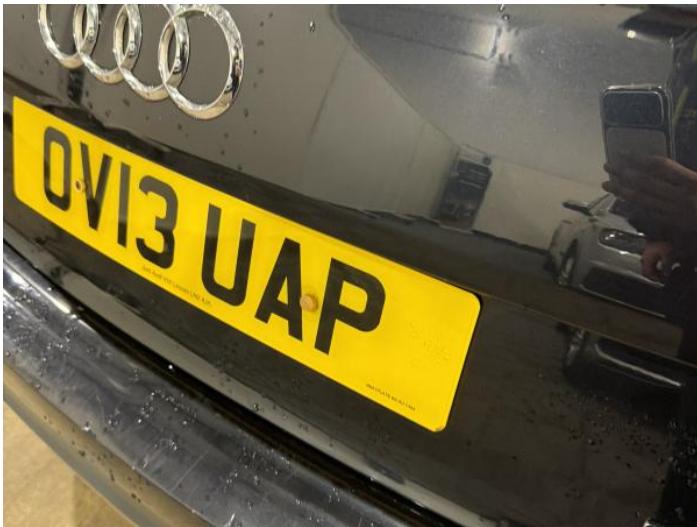
15: Boot Lid
Dented
Over 2 UpTo 10mm

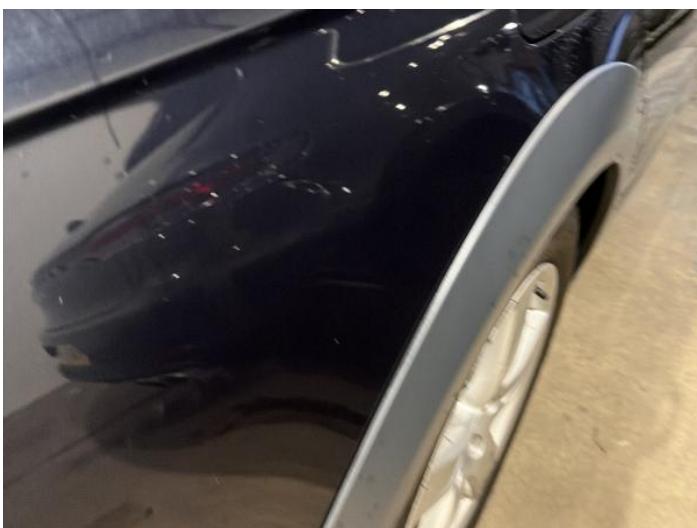
17: Qtr Panel osr
Chipped
1 To 5

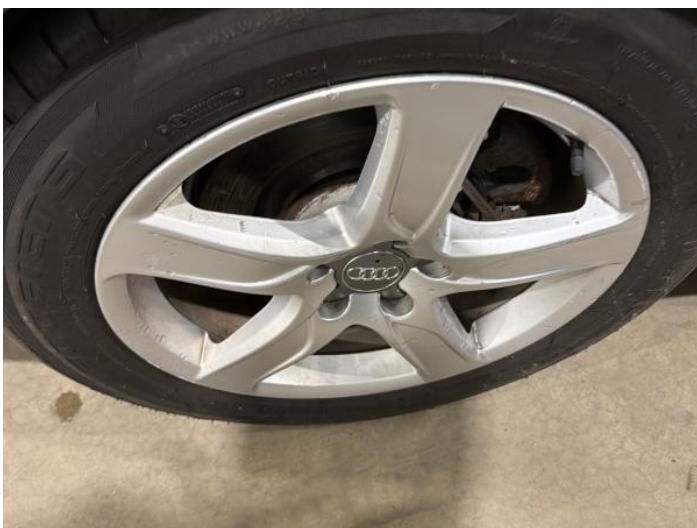
19: Wheel osr
Scratched
Over 50mm

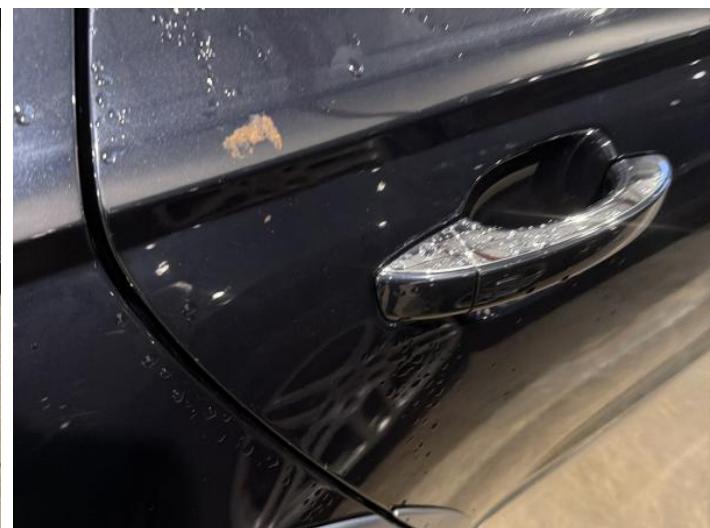
20: Door osr
Rusted
Over 5mm

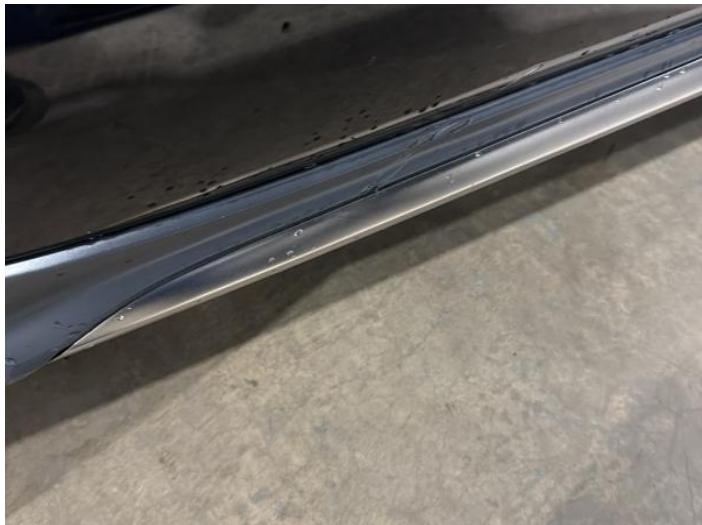
21: Sill Panel Trim os
Scuffed (Unpainted)
UpTo 100mm

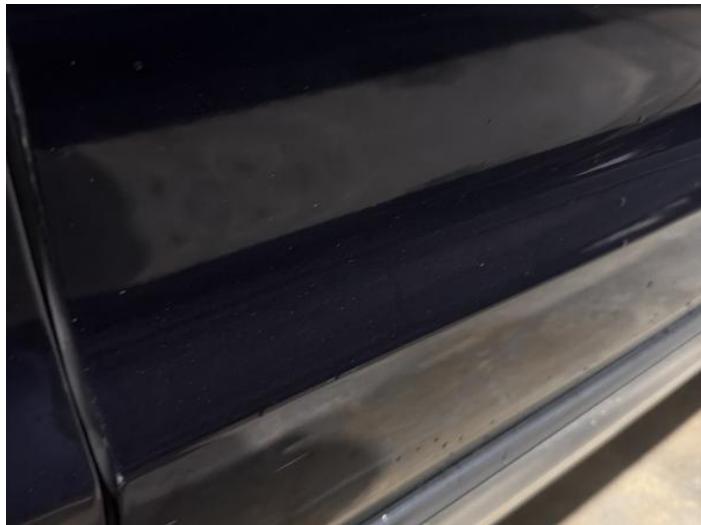
22: Door osf
Scratched
UpTo 25mm Thru Paint

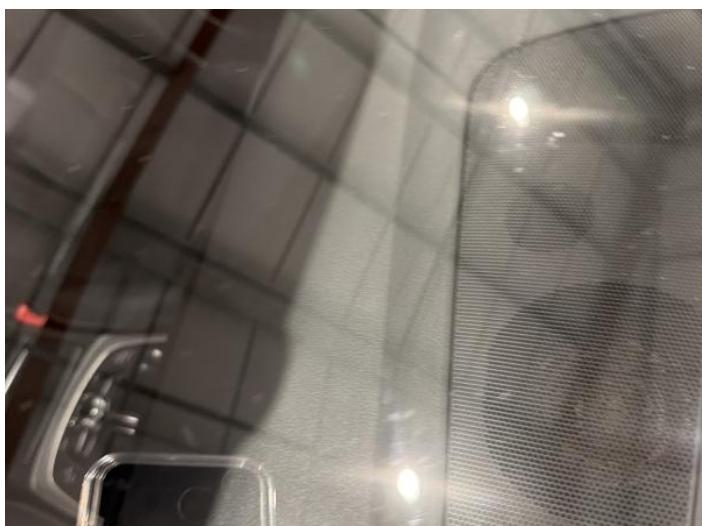
23: Screen Front
Chipped
UpTo 10mm

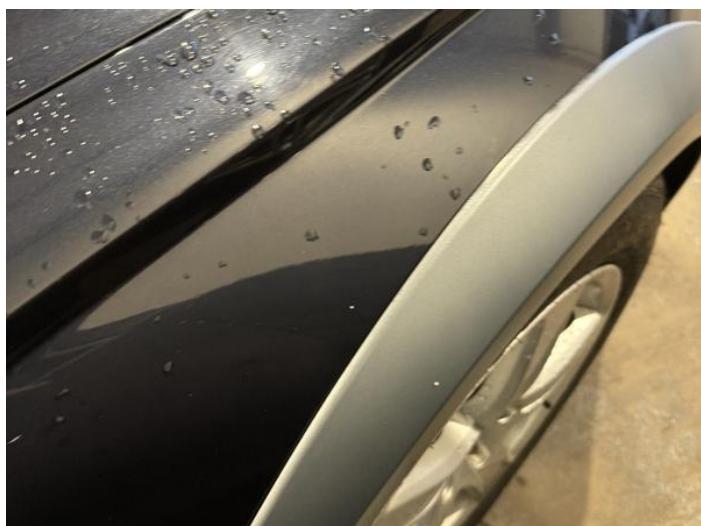
24: Wing osf
Chipped
1 To 5

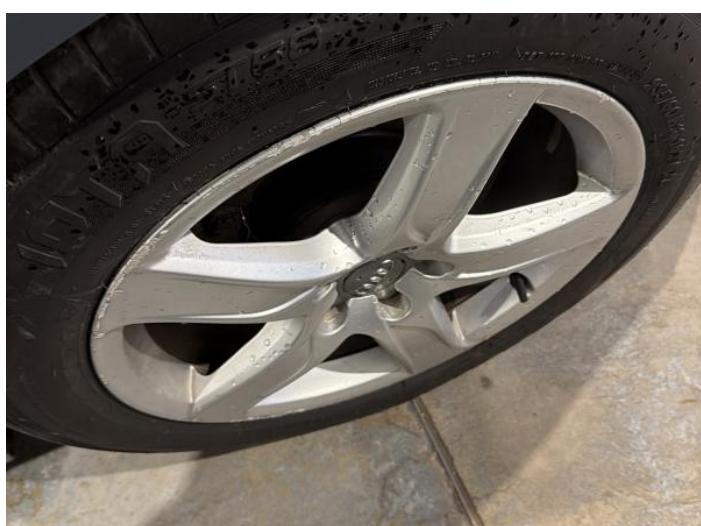
26: Wheel osf
Scratched
Over 50mm
