VEHICLE INSPECTION REPORT

GK18FFJ

Nissan Qashqai 1.6 DiG-T Tekna 5dr

Inspection	Vehicle		GRADE 2
Serious Damage?	VAT	Margin	
No	V5	Present

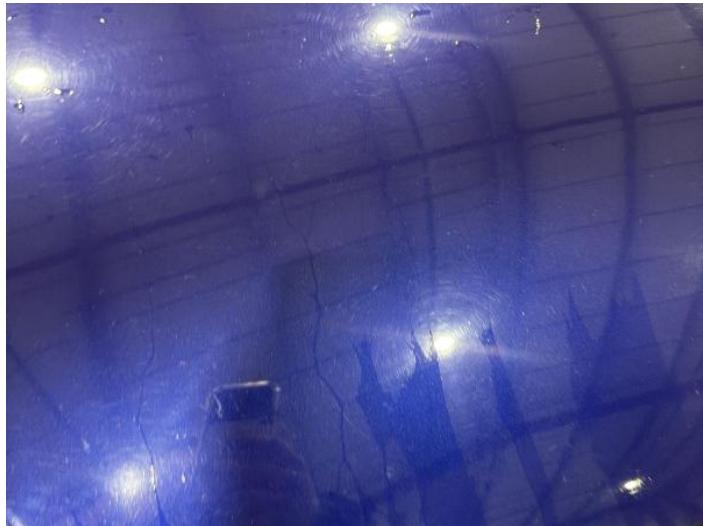
1: Bonnet
Chipped
1 To 5

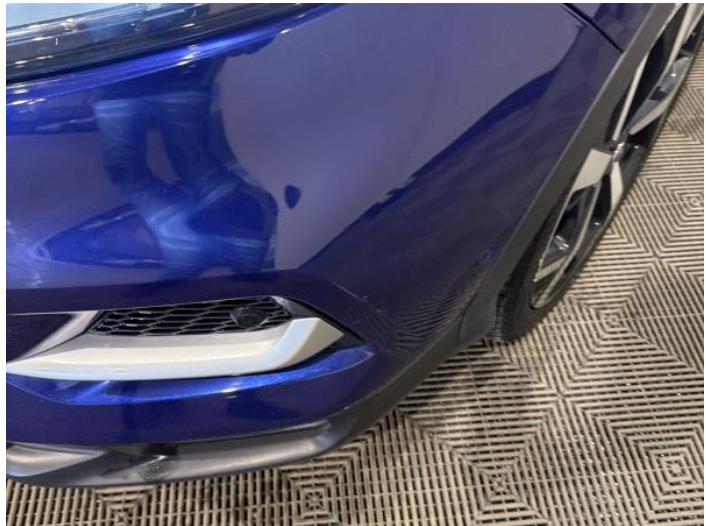
2: Bumper Front
Scratched
25 to 100mm Thru Paint

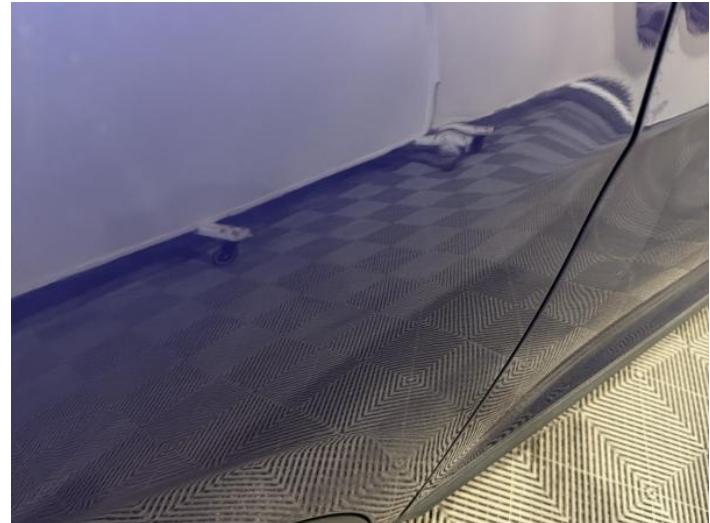
5: Wing nsf
Scratched
Over 25mm Not Thru Paint

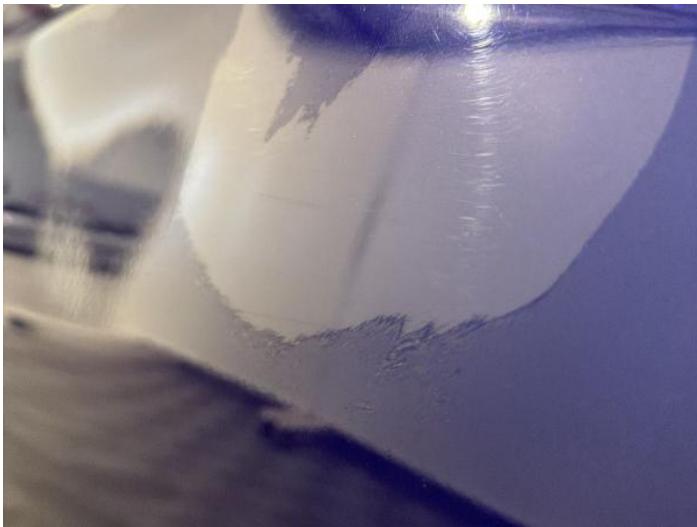
9: Door nsr
Chipped
1 To 5

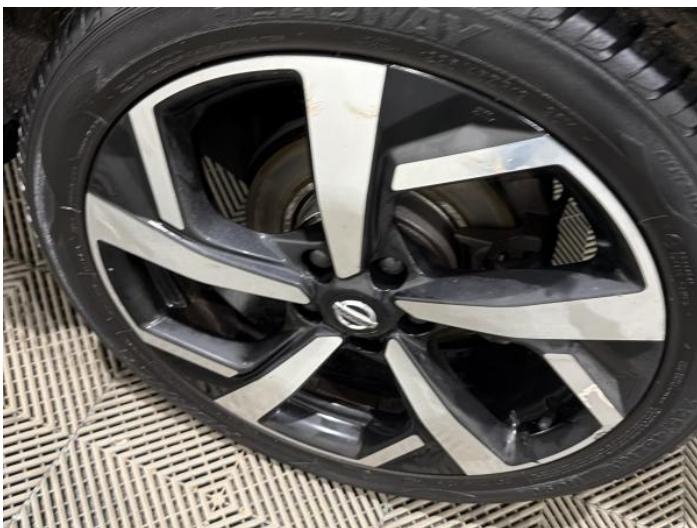
11: Wheel nsr
Scratched
Over 50mm

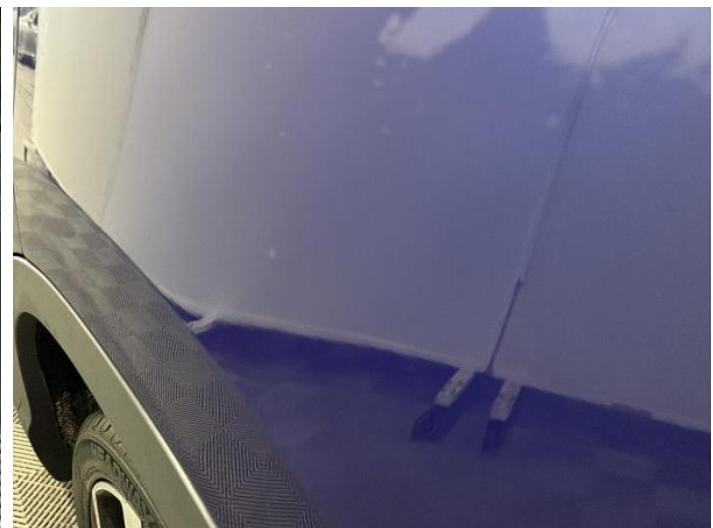
12: Qtr Panel nsr
Dented
2 Or Less UpTo 10mm

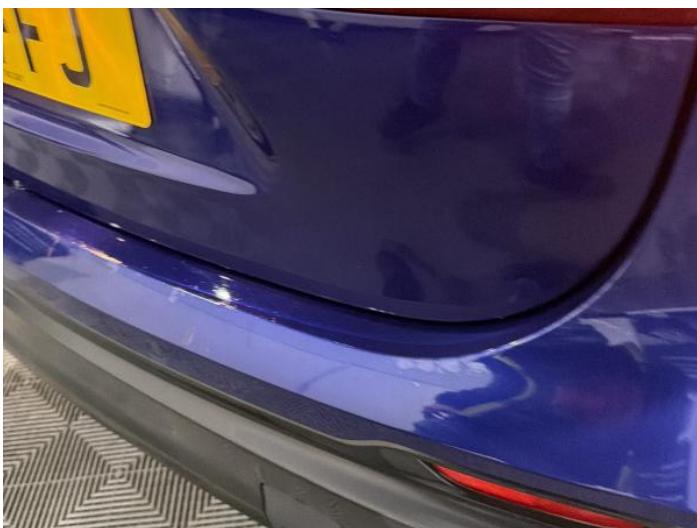
13: Bumper Rear
Chipped
Multiple Chips

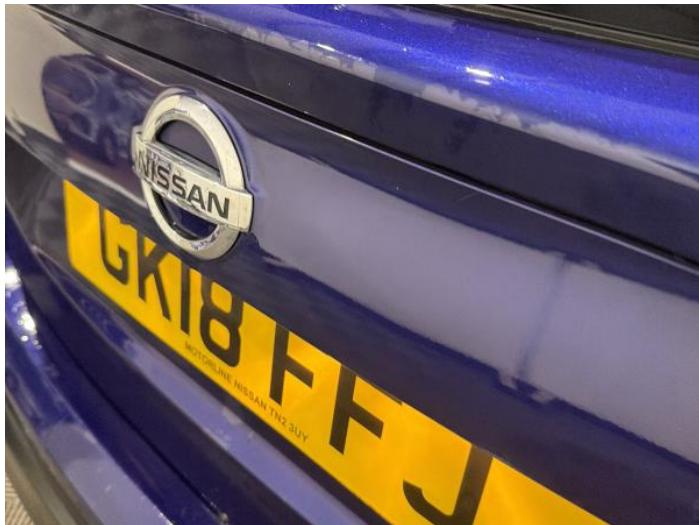
15: Boot Lid
Dented
Over 2 UpTo 10mm

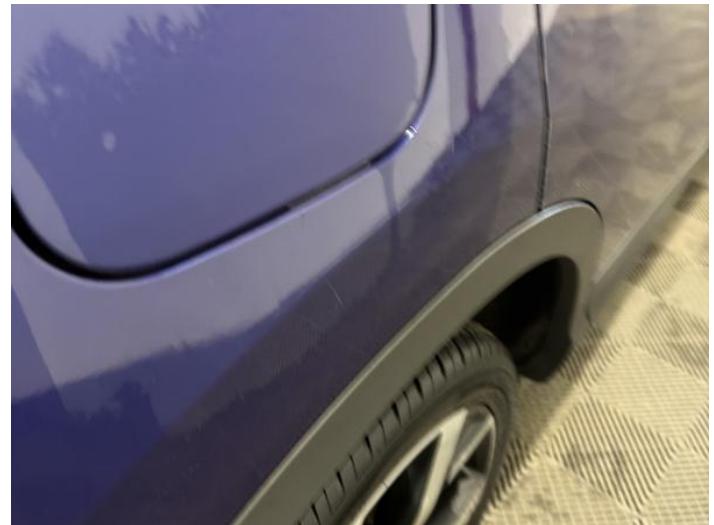
16: Qtr Panel osr
Chipped
1 To 5

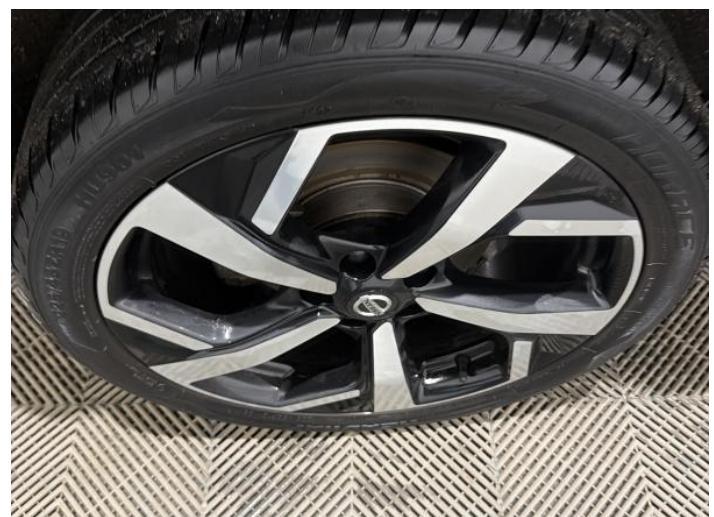
18: Wheel osr
Corroded
Light

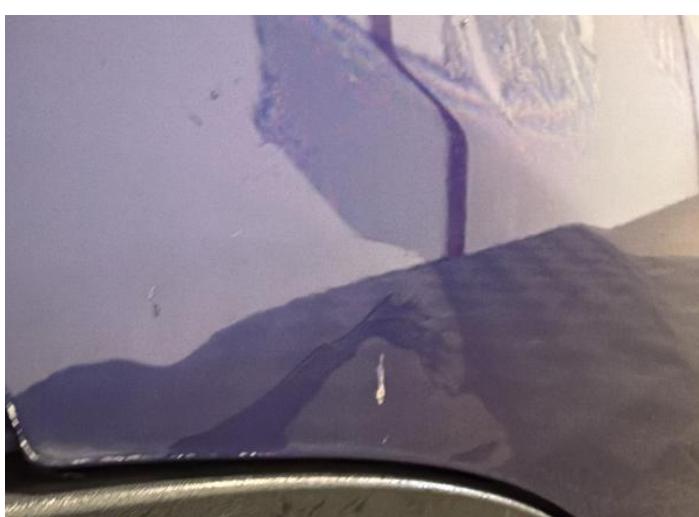
19: Door osr
Dented
Over 2 UpTo 10mm

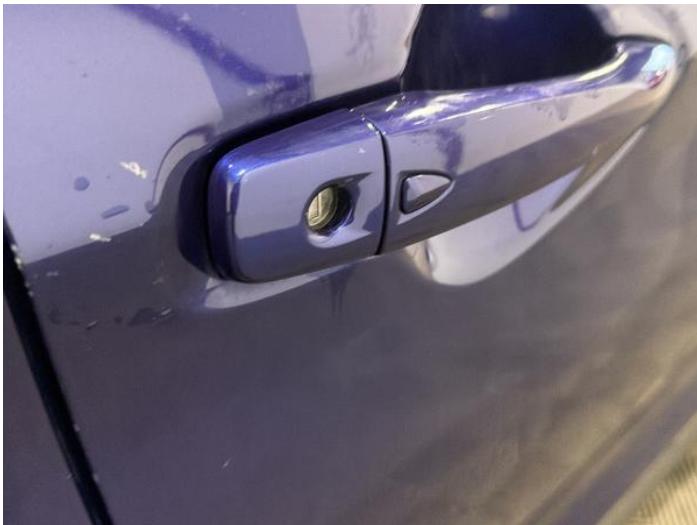
21: Door osf
Chipped
1 To 5

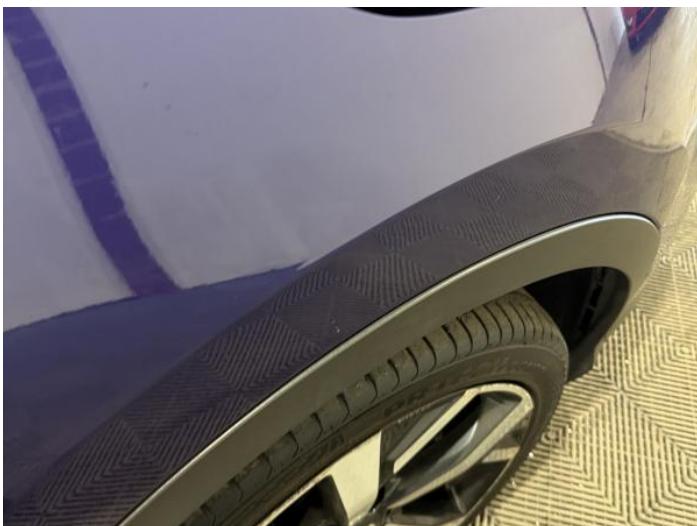
23: Wing osf
Chipped
1 To 5

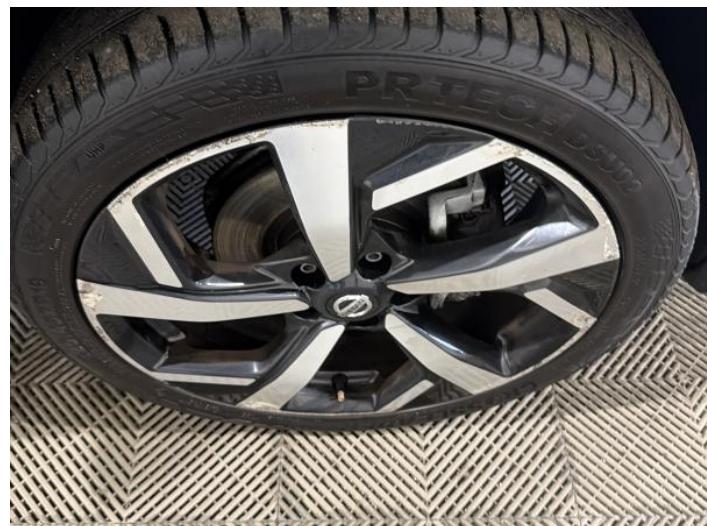
24: Wheel osf
Scratched
Over 50mm
