## VEHICLE INSPECTION REPORT

GL62CAV

### Citroen DS3 1.6 VTi 16V DStyle Plus 3dr

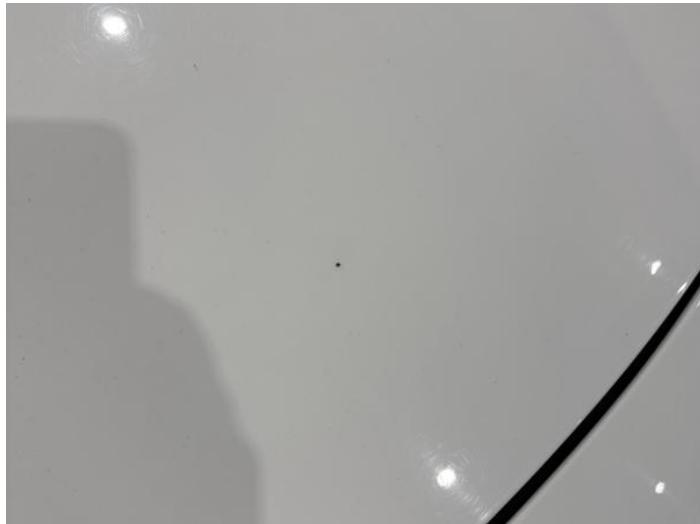
1: Bonnet  
Chipped  
1 To 5

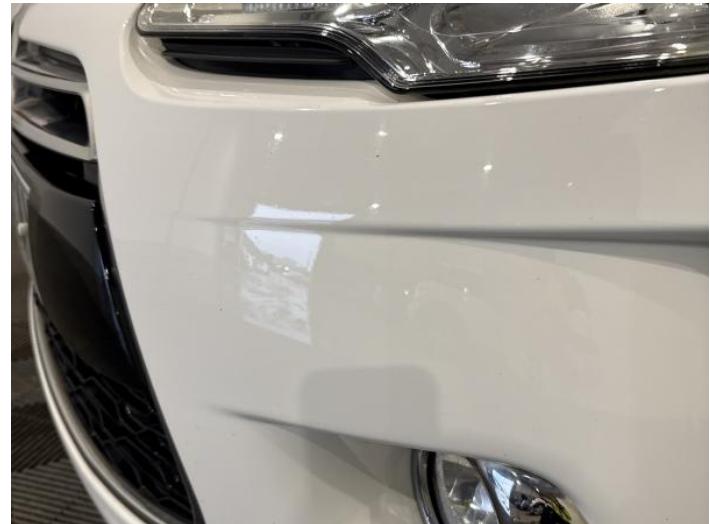
2: Bumper Front  
Chipped  
1 To 5

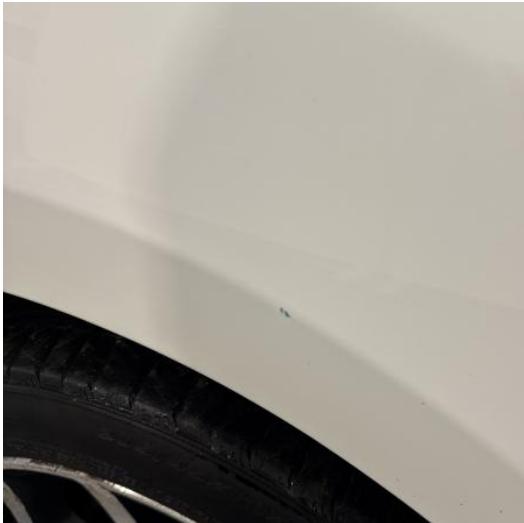
3: Wing nsf  
Chipped  
1 To 5

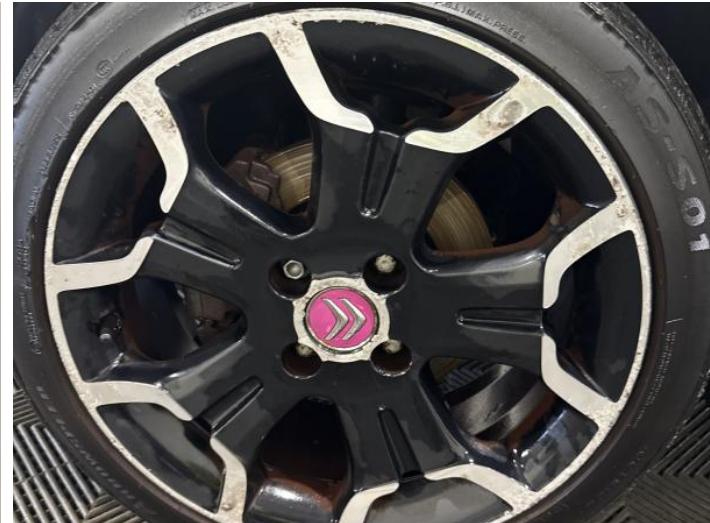
4: Wheel nsf  
Scratched  
Over 50mm

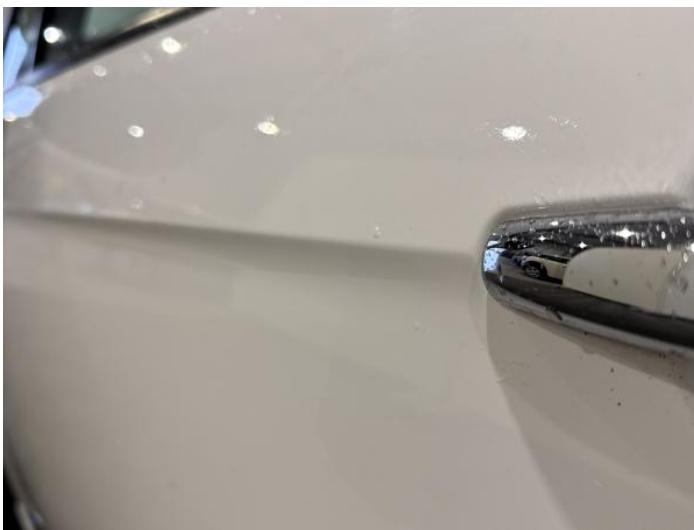
5: Door nsf  
Dented  
Between 10mm + 30mm

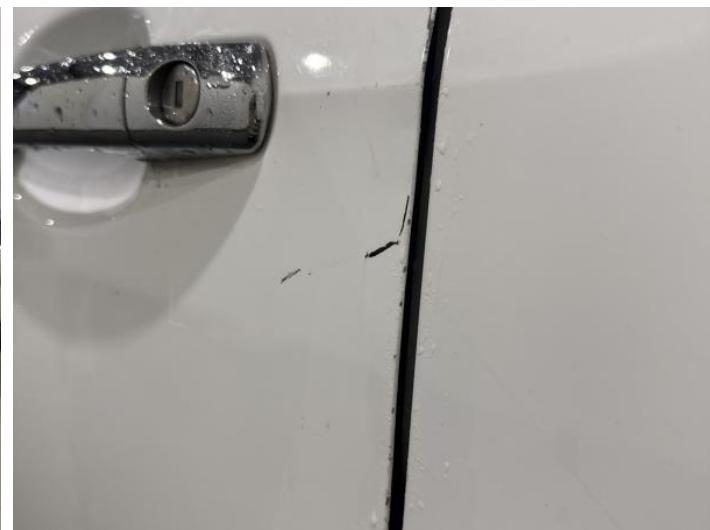
6: Door nsf  
Scratched  
Over 25mm Thru Paint

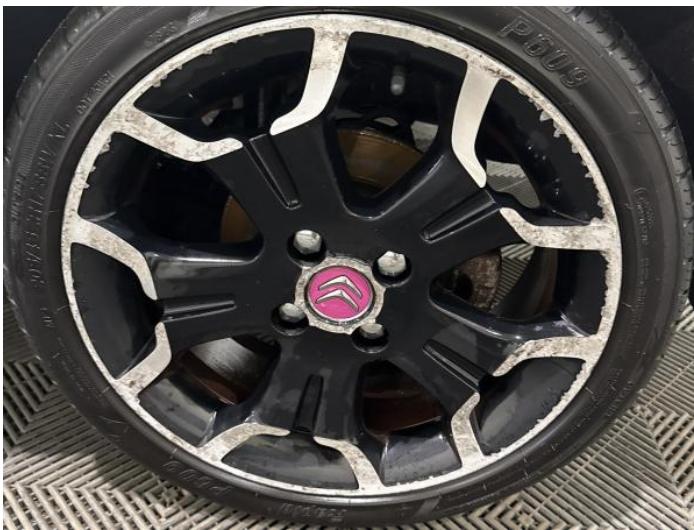
7: Wheel nsr  
Scratched  
Over 50mm

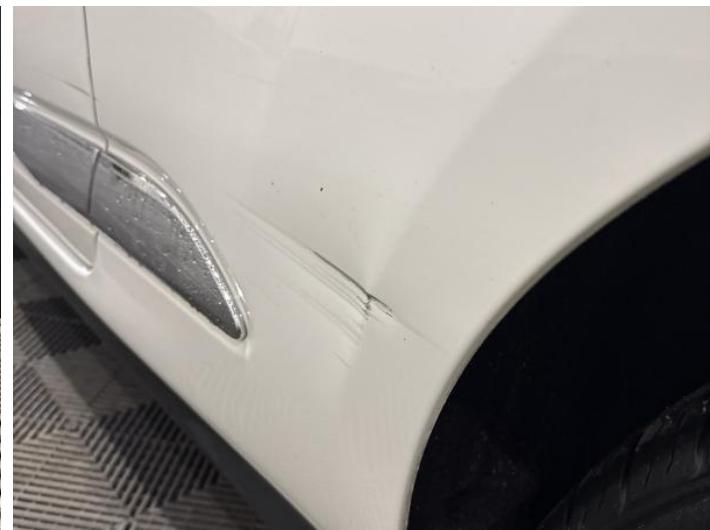
8: Qtr Panel nsr  
Dented  
With Paint Damage

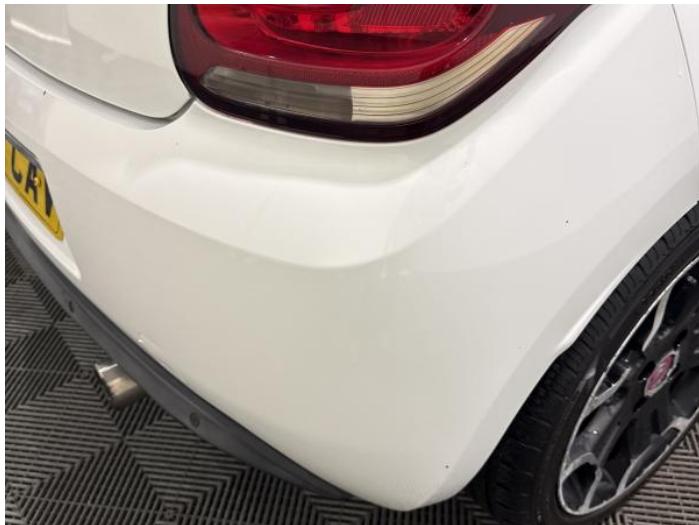
9: Bumper Rear  
Chipped  
1 To 5

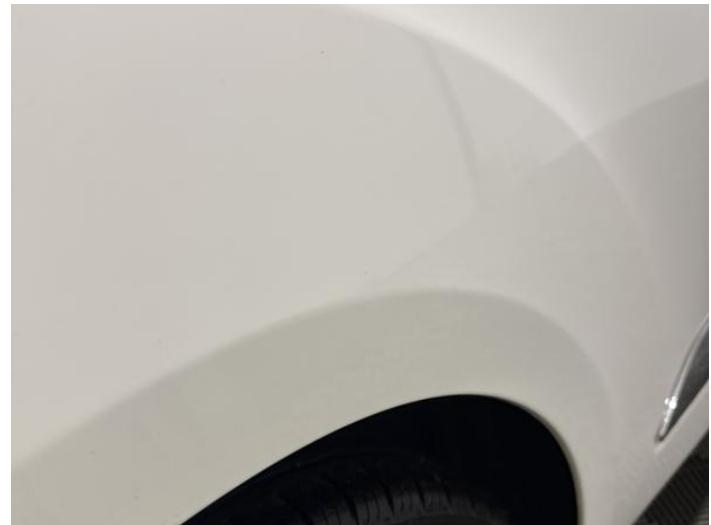
10: Qtr Panel osr  
Dented  
Between 10mm + 30mm

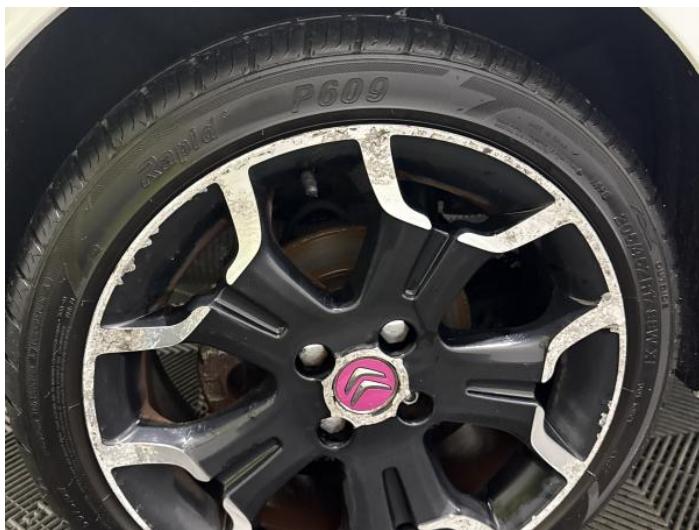
11: Wheel osr  
Scratched  
Over 50mm

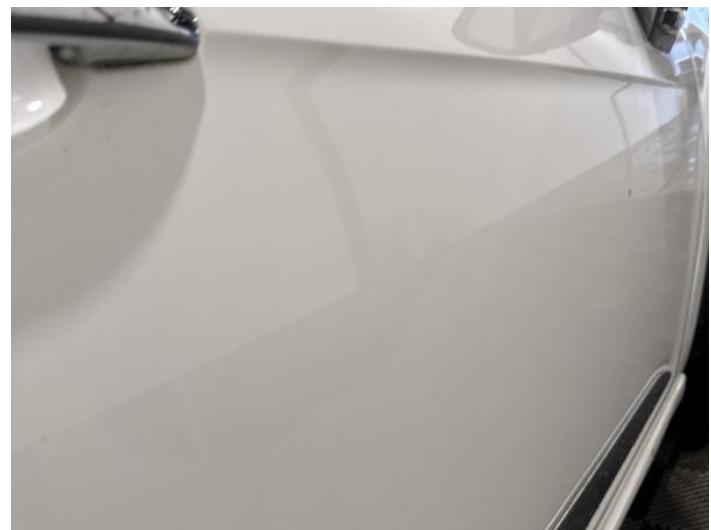
12: Door osf  
Dented  
2 Or Less UpTo 10mm

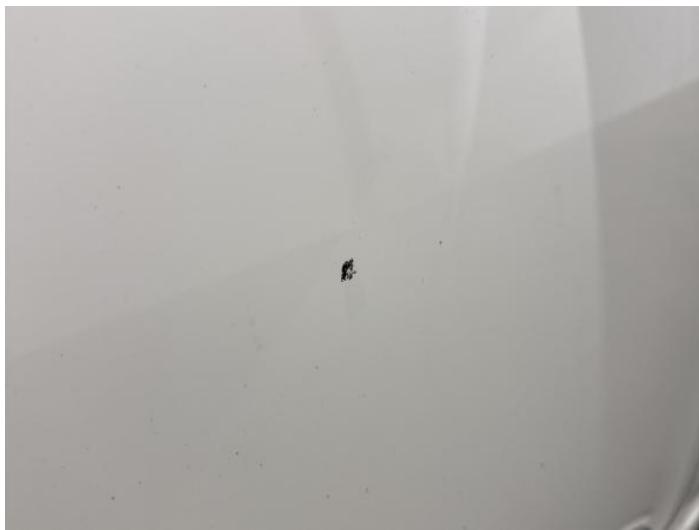
13: Door osf  
Chipped  
1 To 5

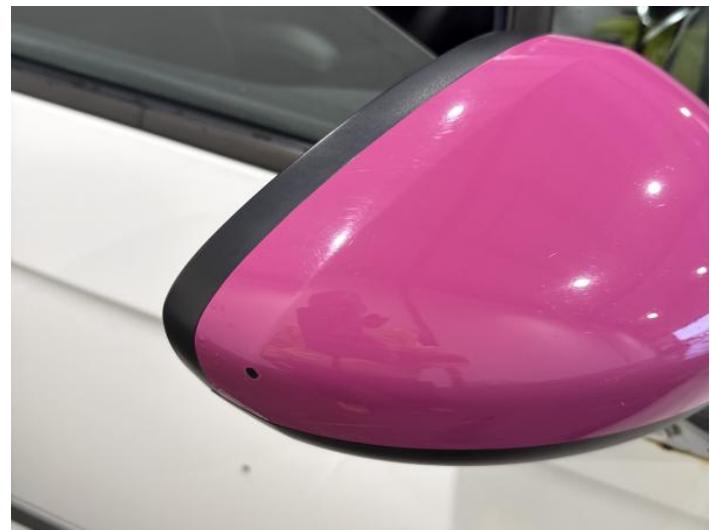
14: Door osf  
Scratched  
UpTo 25mm Thru Paint

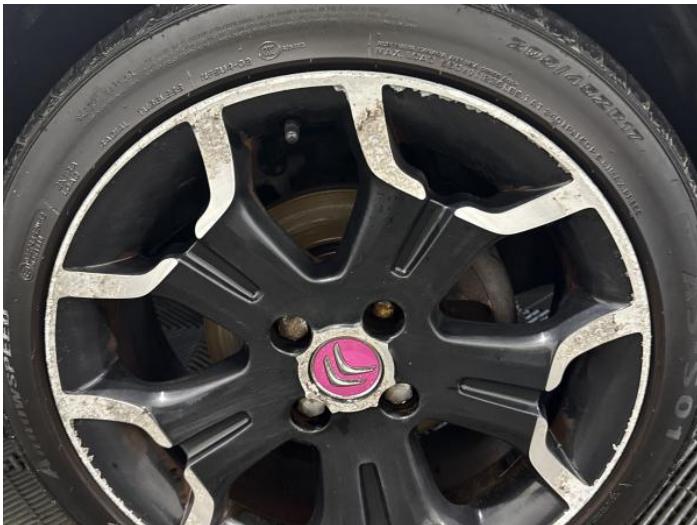
15: Wheel osf  
Scratched  
Over 50mm

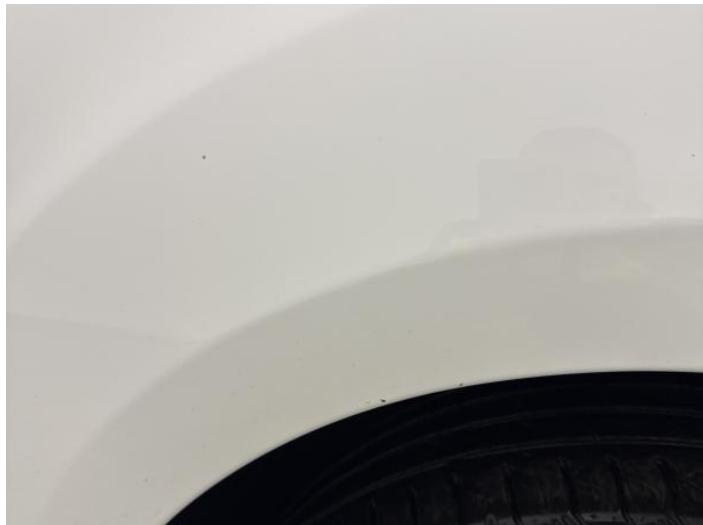
16: Wing osf  
Chipped  
1 To 5

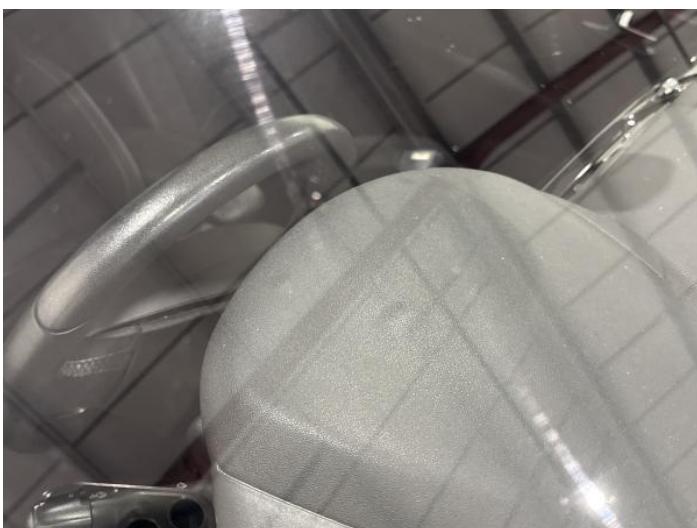
17: Screen Front  
Chipped  
UpTo 10mm

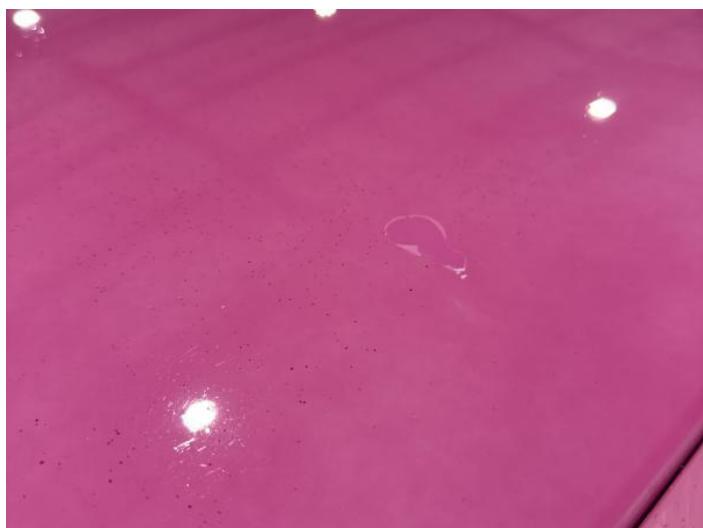
18: Roof  
Poor Previous Repair  
Paint Flake
