VEHICLE INSPECTION REPORT

LF19ALB

Ford Mondeo 1.5 EcoBoost 165 Titanium Edition 5dr

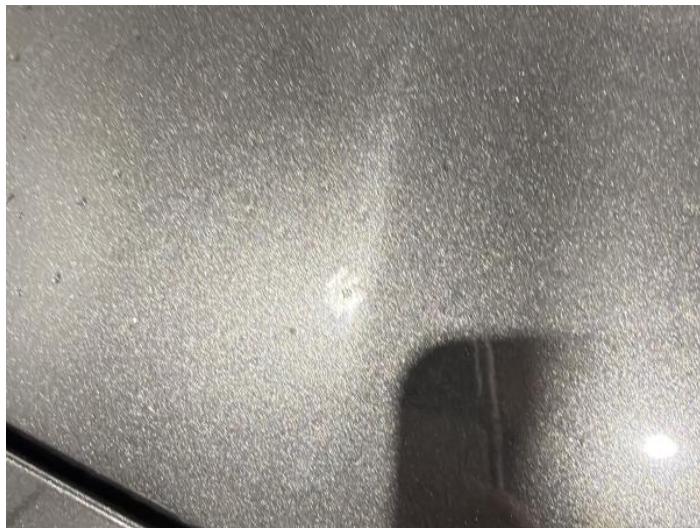
1: Bonnet
Chipped
1 To 5

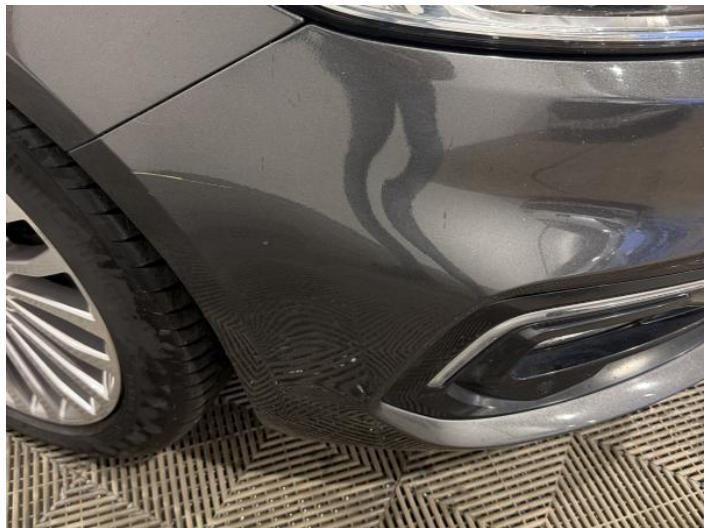
2: Bumper Front
Scratched
Over 100mm Thru Paint

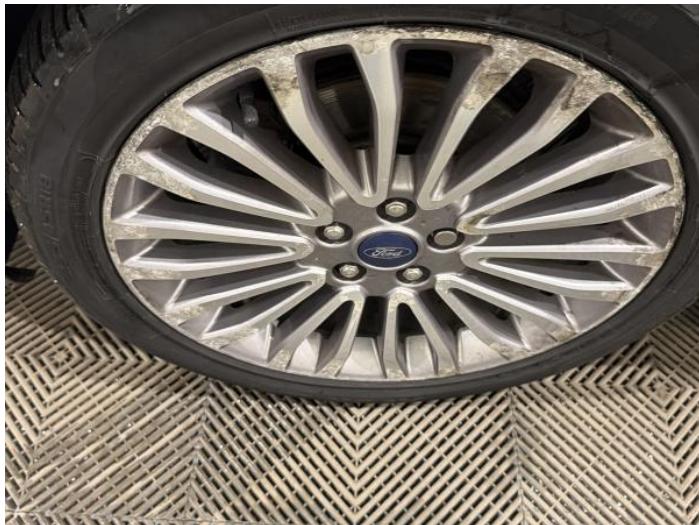
3: Wheel nsf
Scratched
Over 50mm

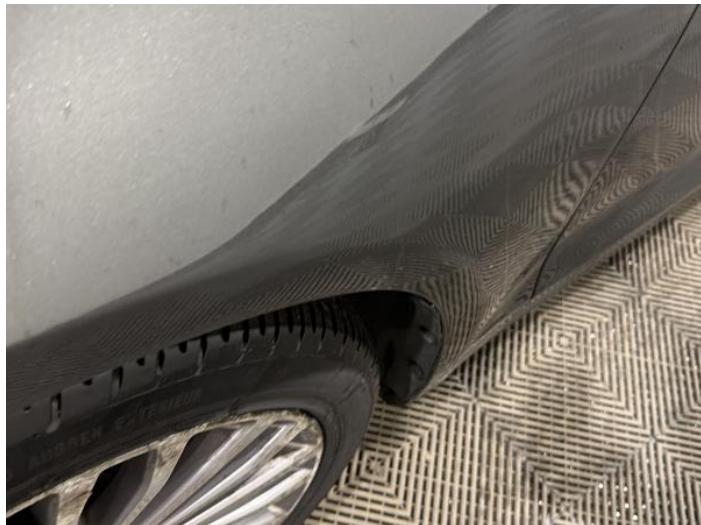
4: Wing nsf
Chipped
1 To 5

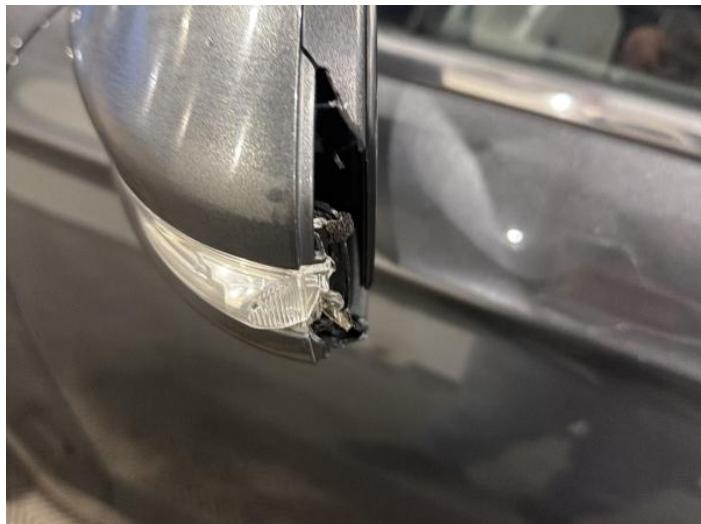
6: Door Mirror Assy nsf
Broken
Replace

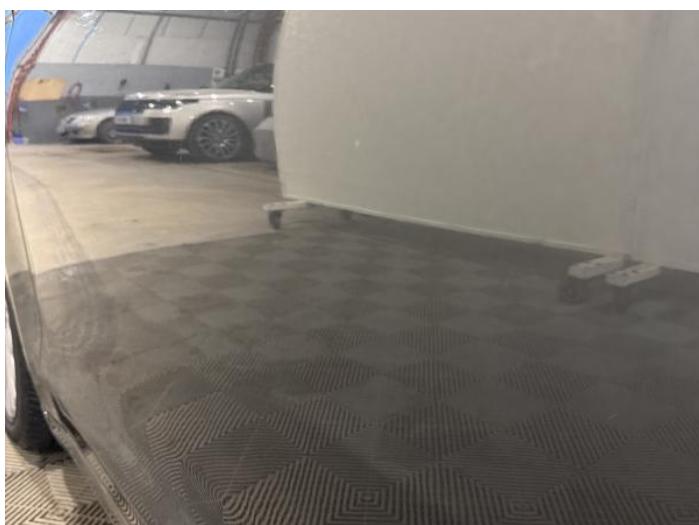
7: Door nsf
Poor Previous Repair
Poor Paint

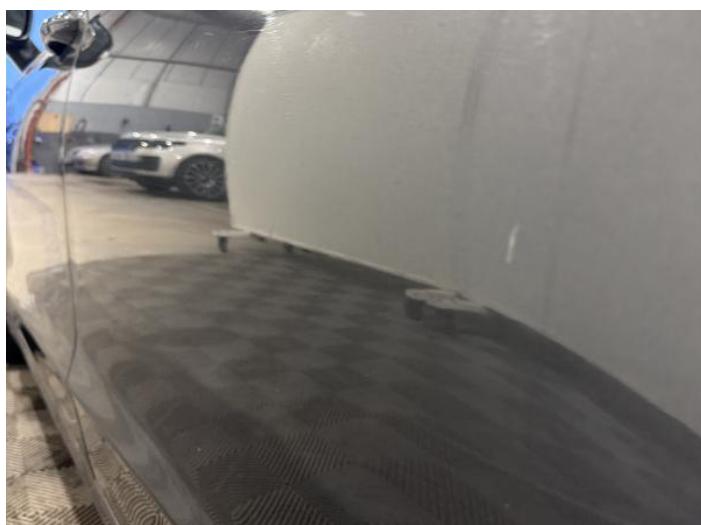
8: Door nsf
Chipped
1 To 5

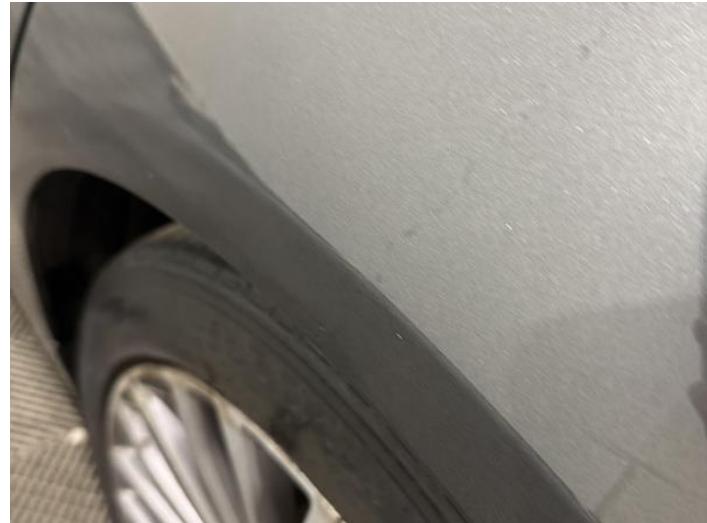
10: Qtr Panel nsr
Chipped
1 To 5

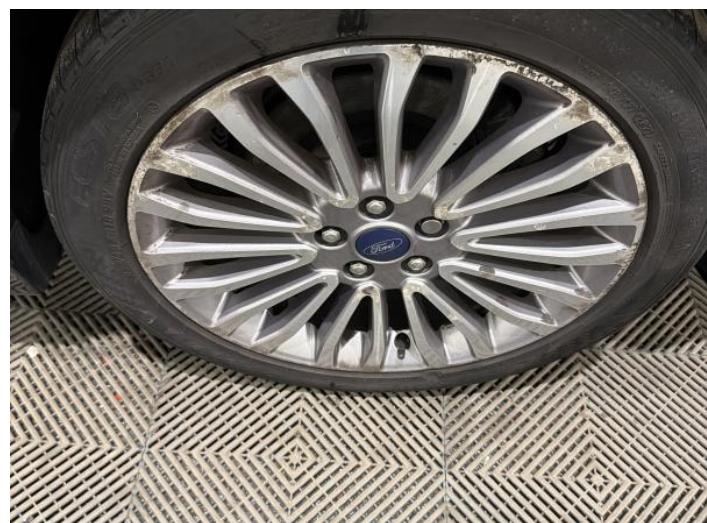
12: Wheel nsr
Scratched
Over 50mm

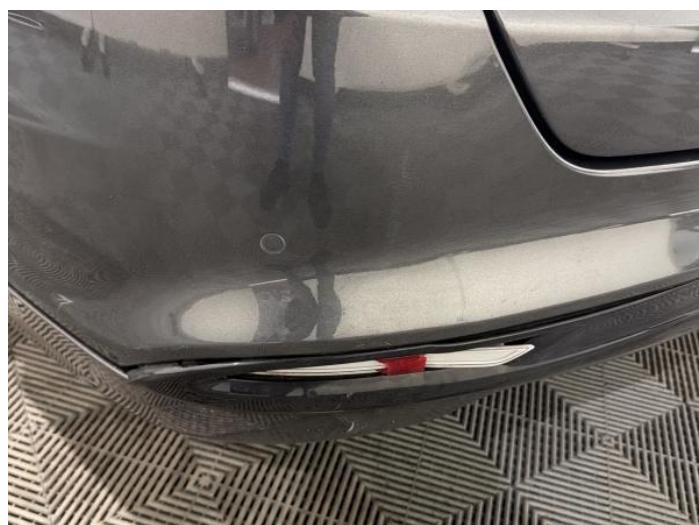
13: Bumper Rear
Scratched
Over 100mm Thru Paint

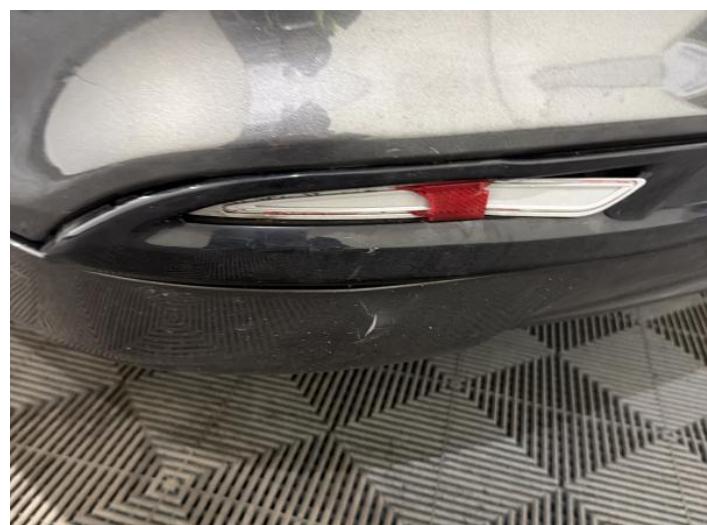
14: Bumper Rear Moulding
Broken
Replace

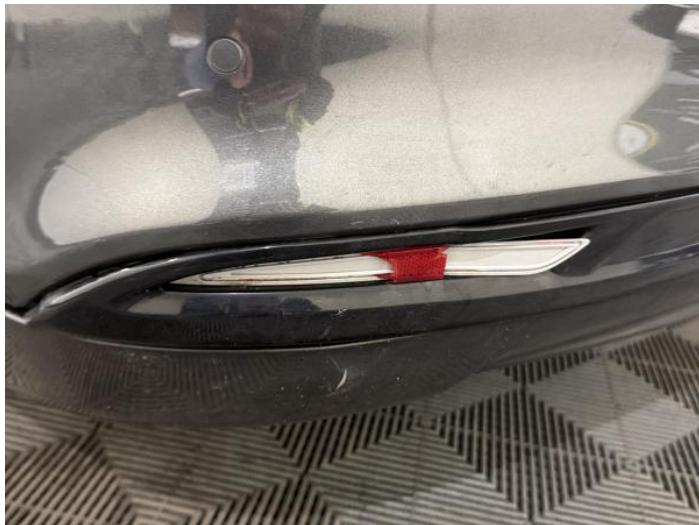
15: Reflector nsr
Broken
Replace

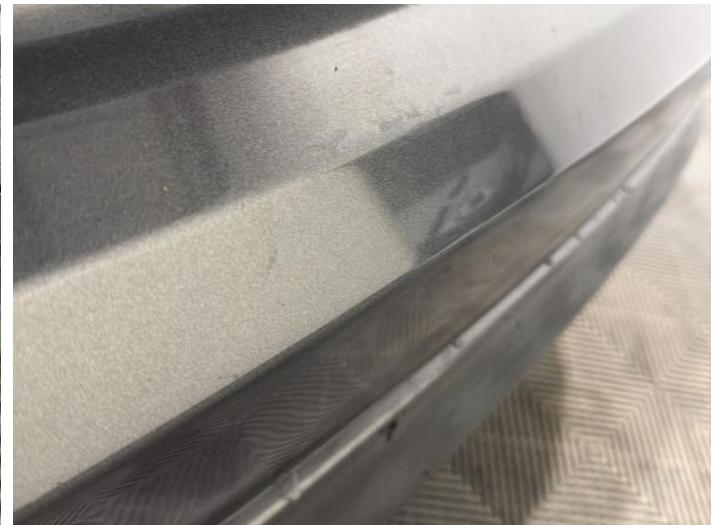
16: Boot Lid
Dented
Over 2 UpTo 10mm

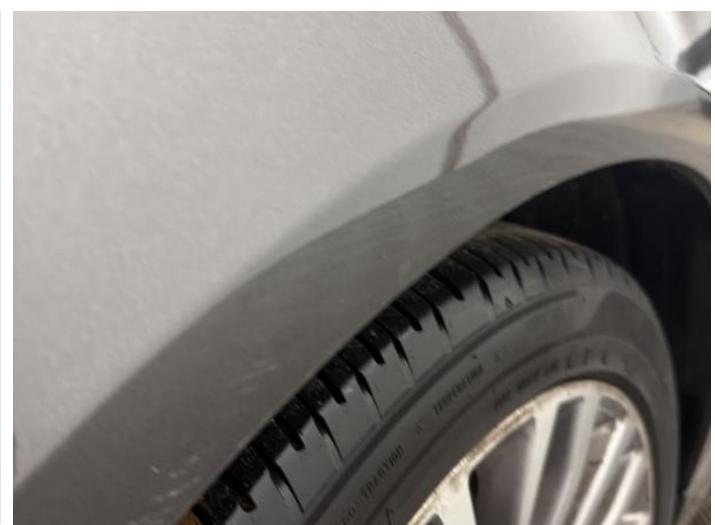
18: Qtr Panel osr
Chipped
1 To 5

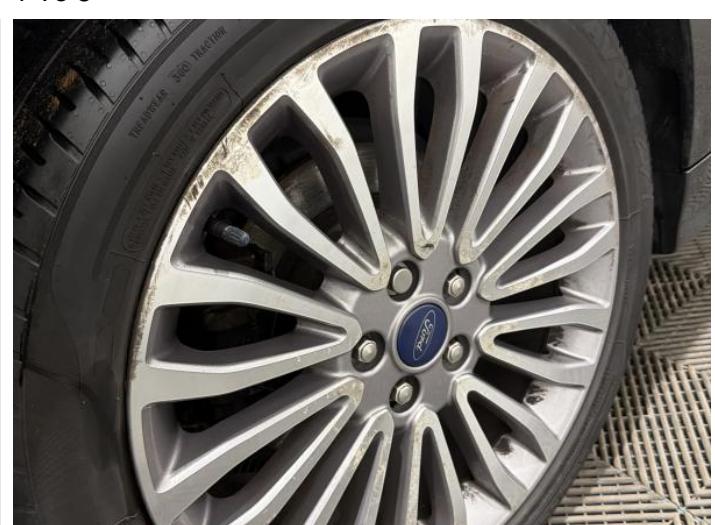
20: Wheel osr
Scratched
Over 50mm

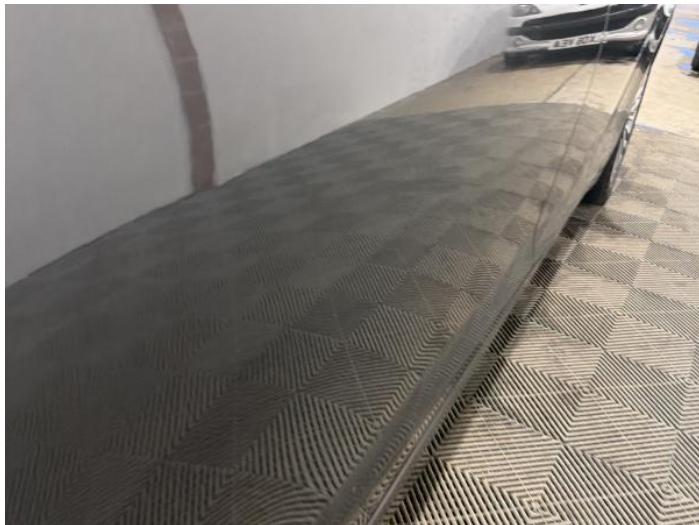
21: Door osr
Poor Previous Repair
Poor Paint

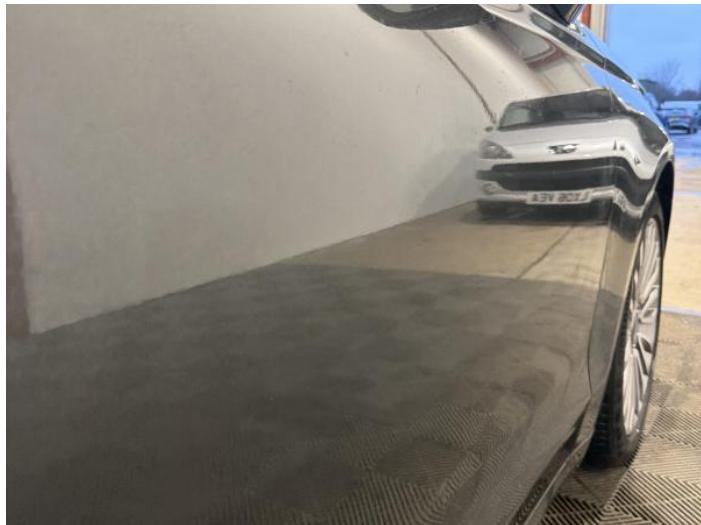
22: Door osf
Chipped
1 To 5

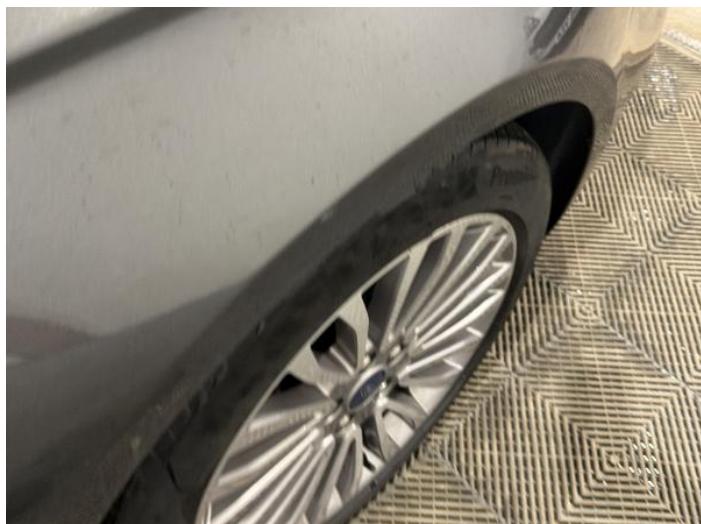
24: Wing osf
Chipped
1 To 5

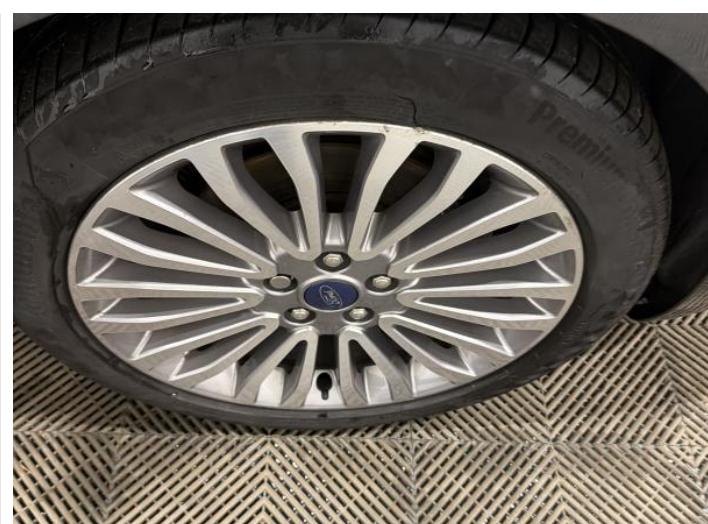
26: Wheel osf
Scratched
Over 50mm

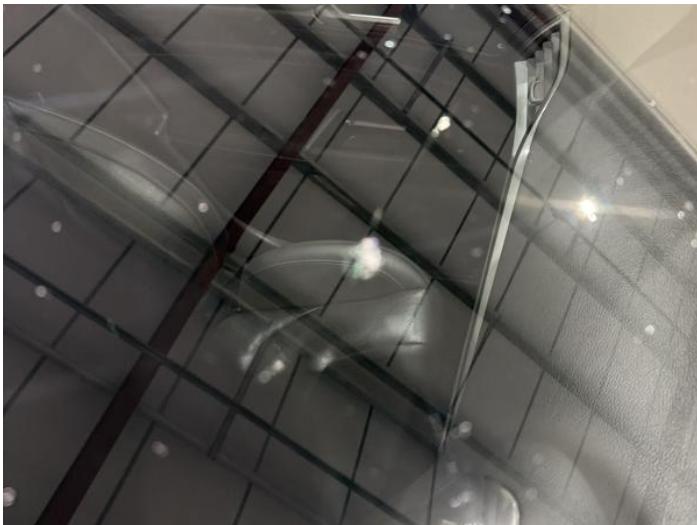
27: Screen Front
Cracked
Replace

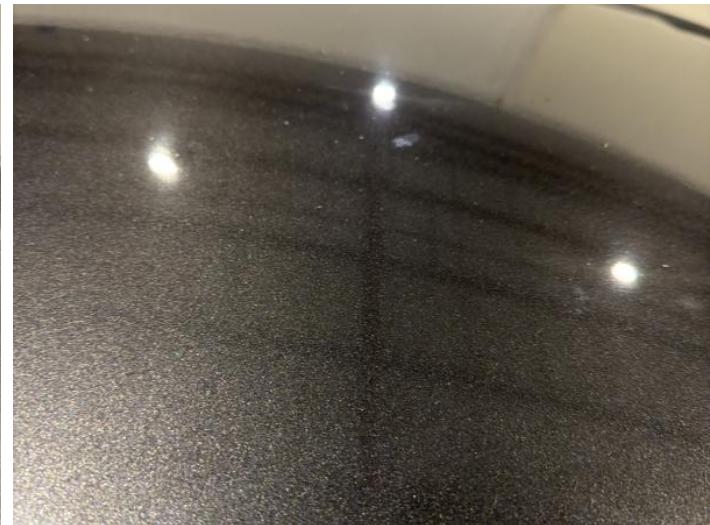
28: Roof
Dented
Between 10mm + 30mm

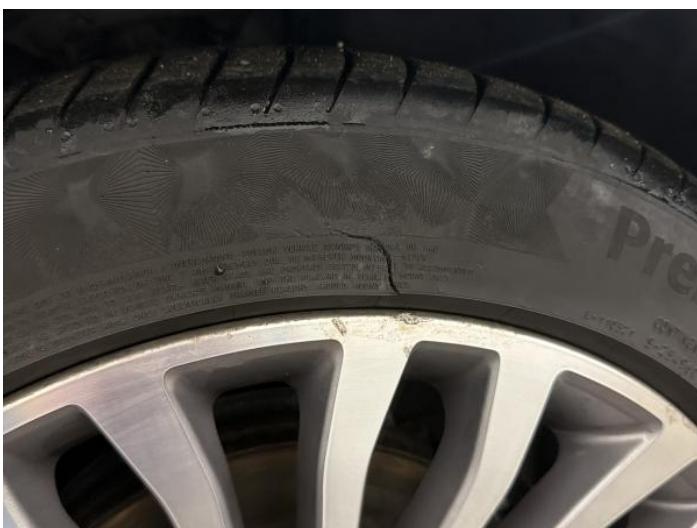
NSF	AVON	2.0mm
NSR	BUDGET	Worn
OSF	CONTINENTAL	Damaged
OSR	AVON	2.0mm
Spare

29: Tyre osf
Damaged
Replace
