VEHICLE INSPECTION REPORT

CA09HBL

Vauxhall Astra 1.4i 16V Active Plus 5dr

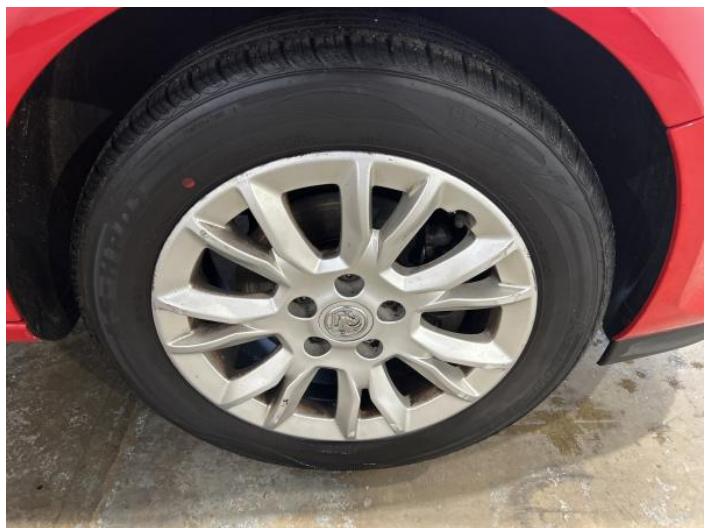
1: Wheel osf
Scratched
Over 50mm

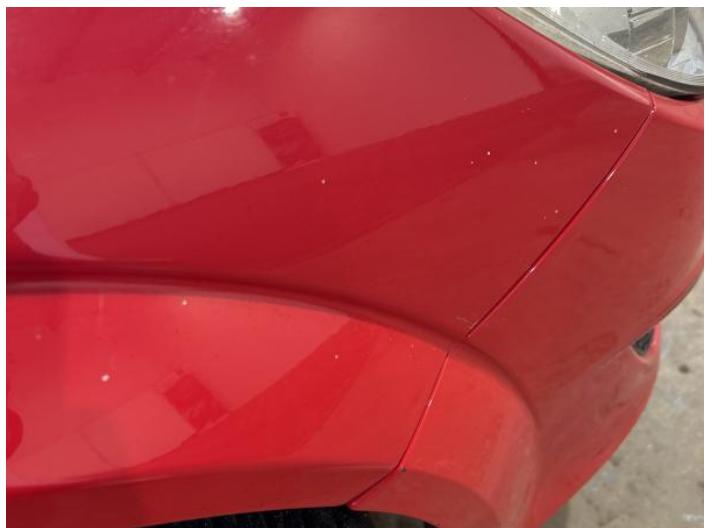
2: Wing osf
Chipped
Multiple Chips

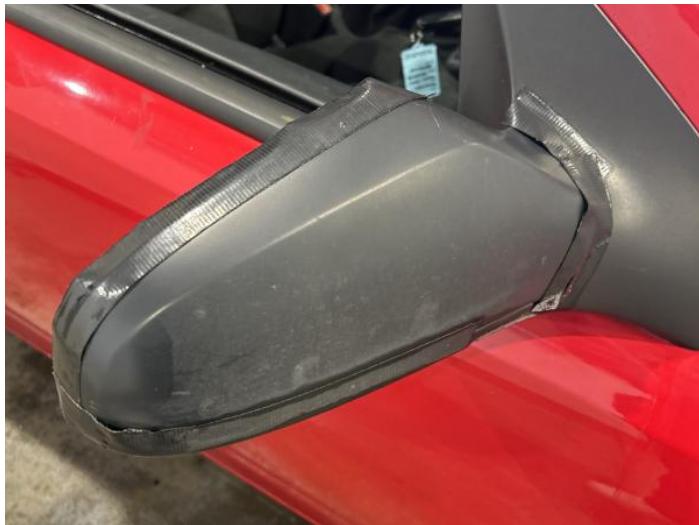
3: Door Mirror Assy osf
Broken
Replace

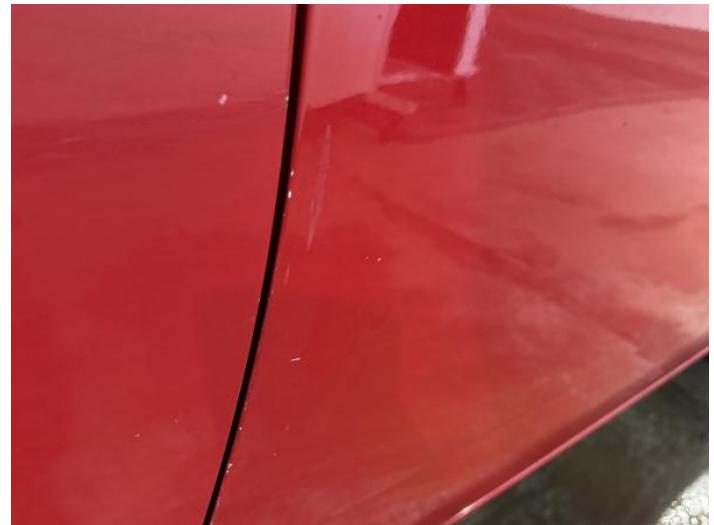
4: Door osf
Chipped
Edge Chip

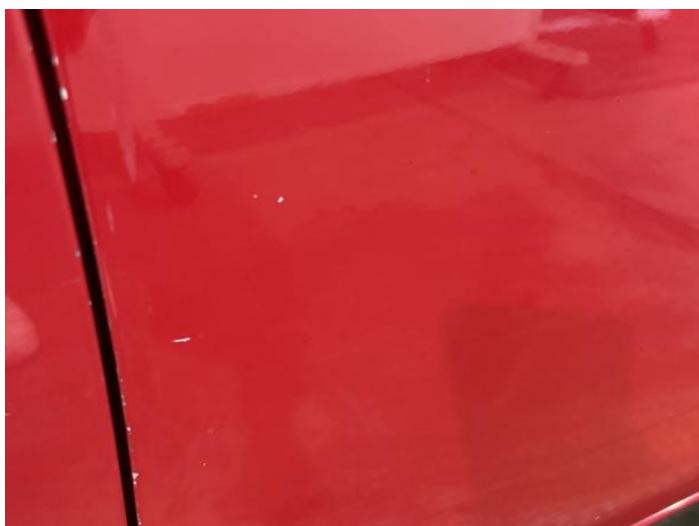
5: Door osf
Chipped
1 To 5

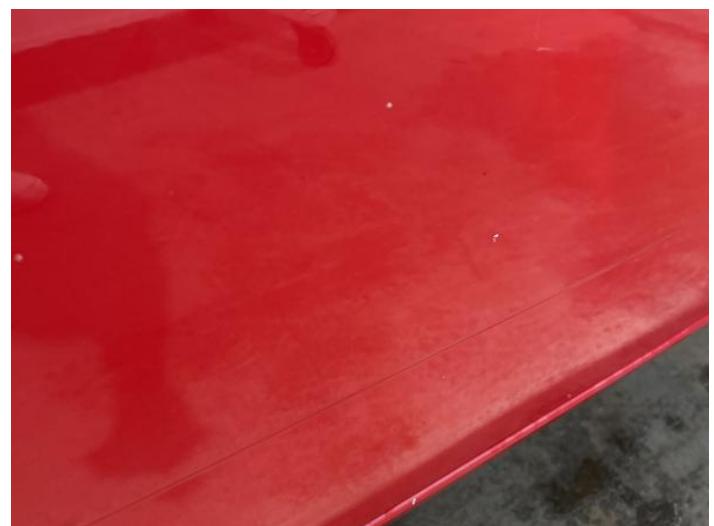
6: Door osr
Chipped
1 To 5

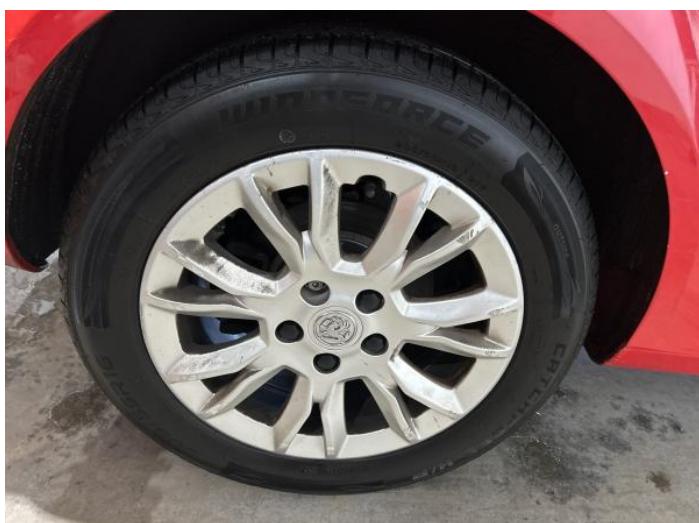
7: Wheel osr
Scratched
Over 50mm

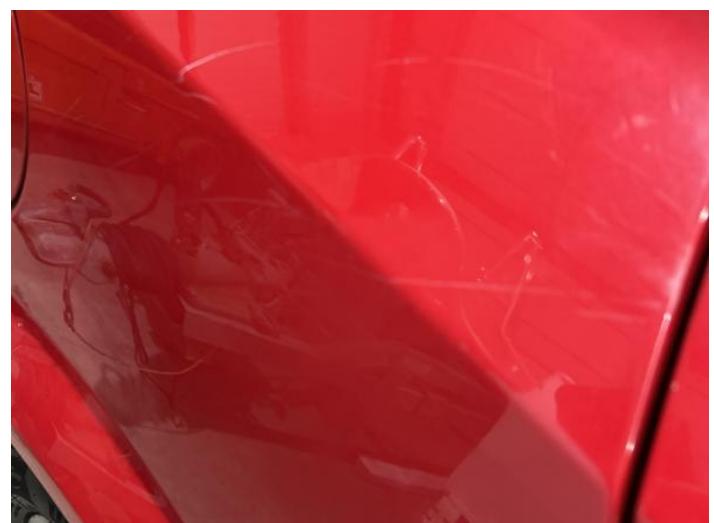
8: Qtr Panel osr
Scratched
Over 25mm Thru Paint

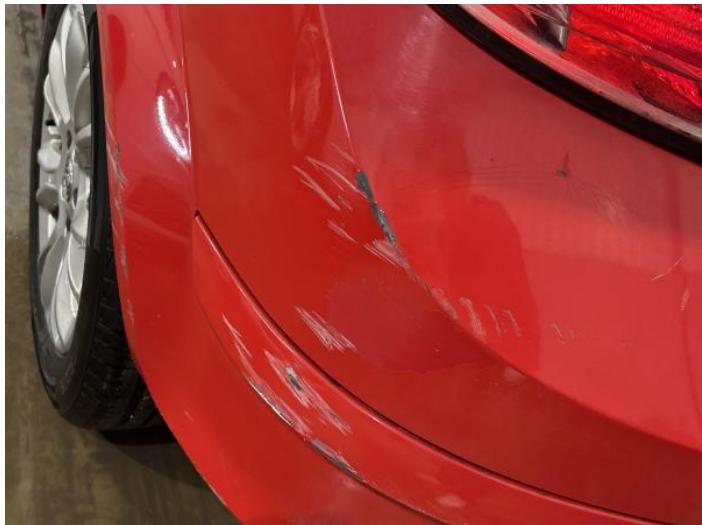
9: Bumper Rear
Scratched
Over 100mm Thru Paint

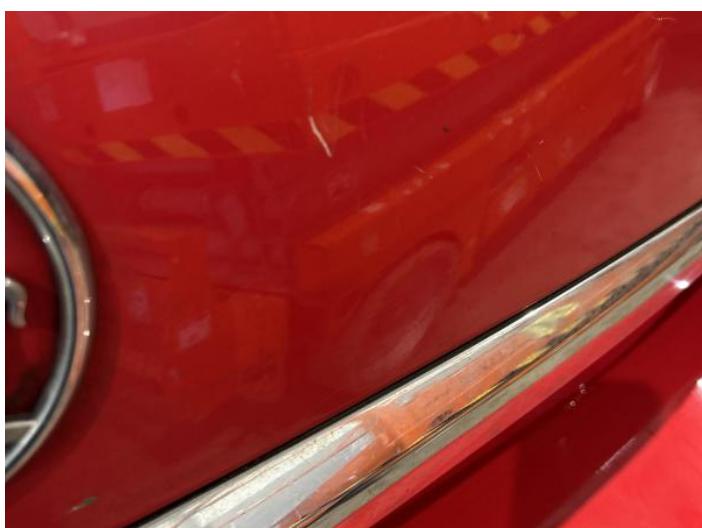
11: Boot Lid
Scratched
UpTo 25mm Thru Paint

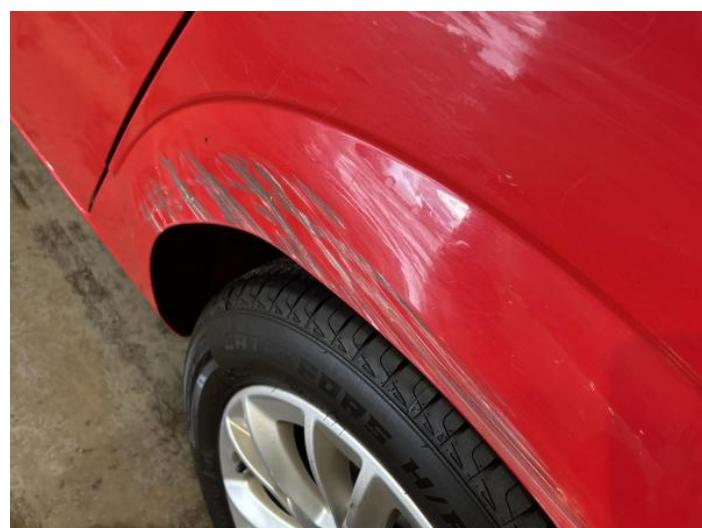
12: Qtr Panel nsr
Dented
With Paint Damage

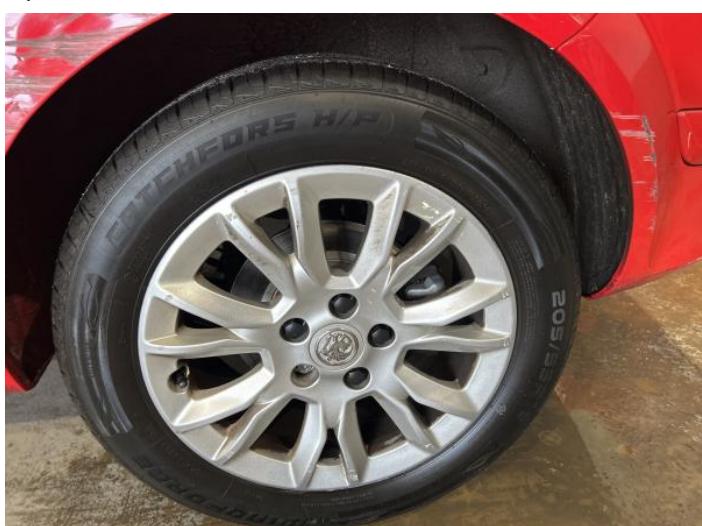
13: Wheel nsr
Scratched
Over 50mm

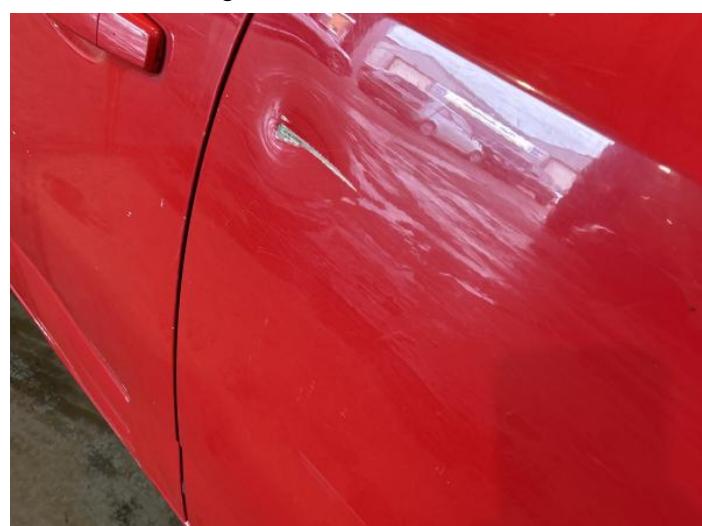
14: Door nsr
Dented
With Paint Damage

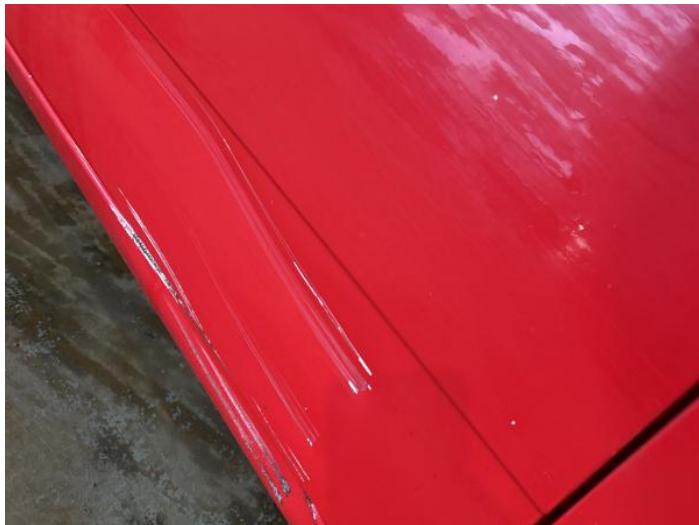
15: Door nsf
Dented
With Paint Damage

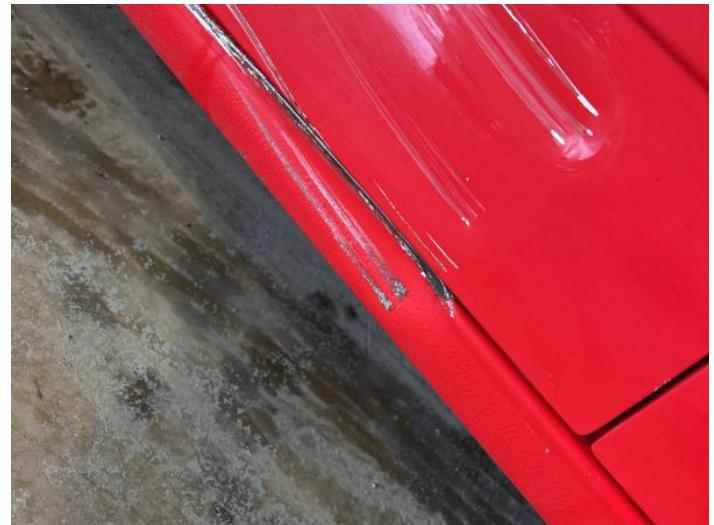
16: Sill ns
Dented
With Paint Damage

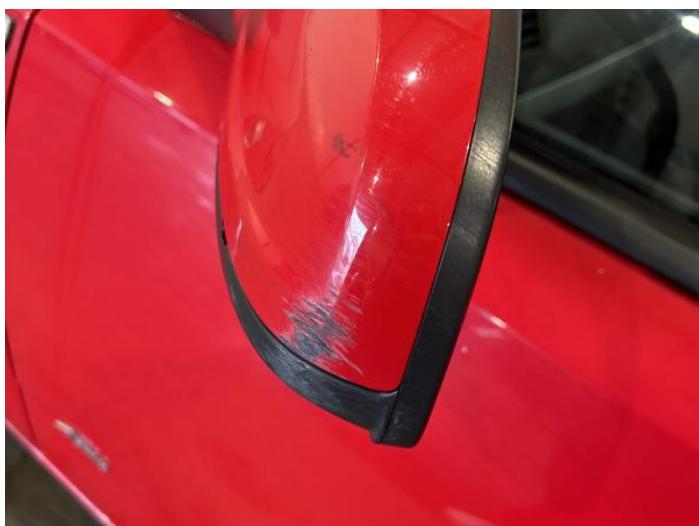
17: Door Mirror Assy nsf
Scratched (Painted)
UpTo 25mm Thru Paint

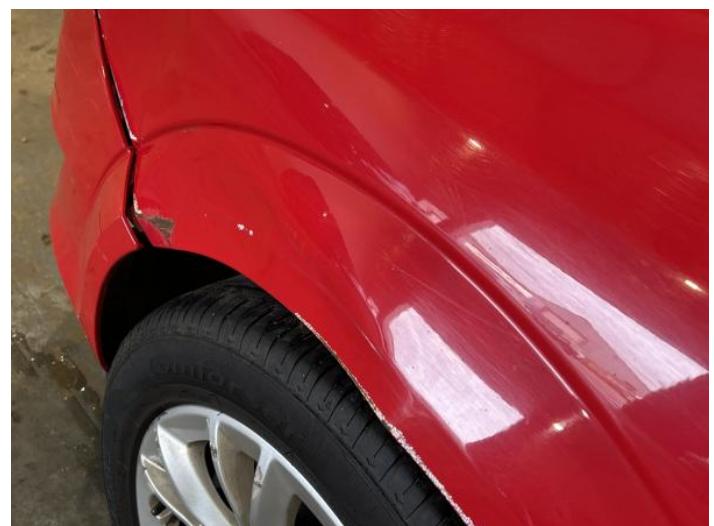
18: Wing nsf
Dented
With Paint Damage

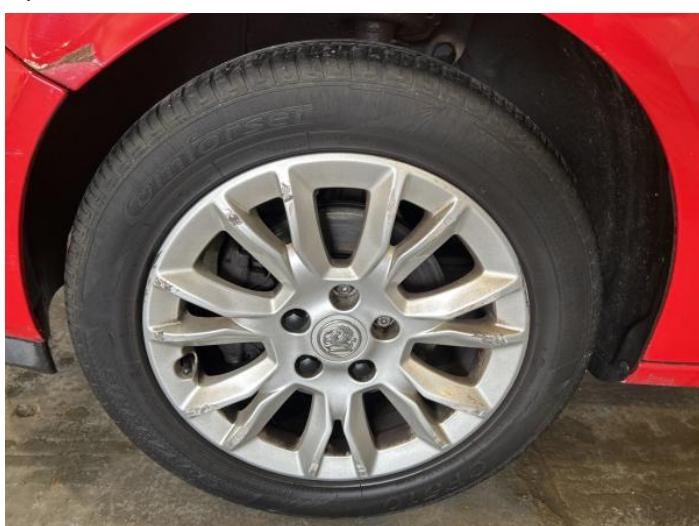
19: Wheel nsf
Scratched
Over 50mm

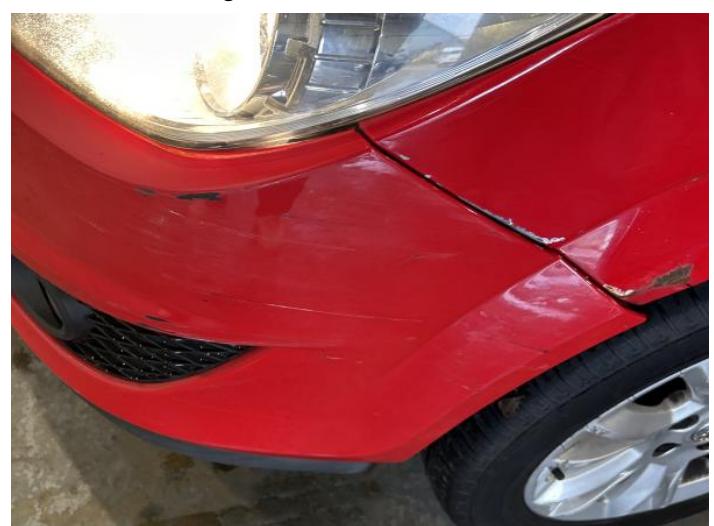
20: Bumper Front
Scratched
Over 100mm Thru Paint

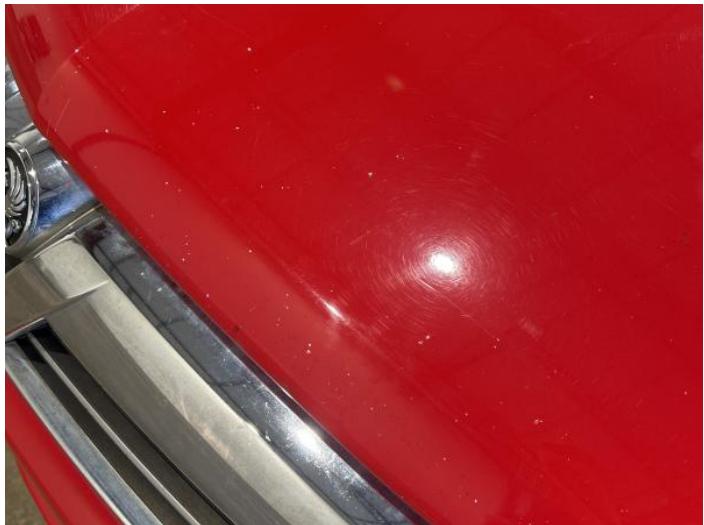
21: Bonnet
Chipped
Multiple Chips

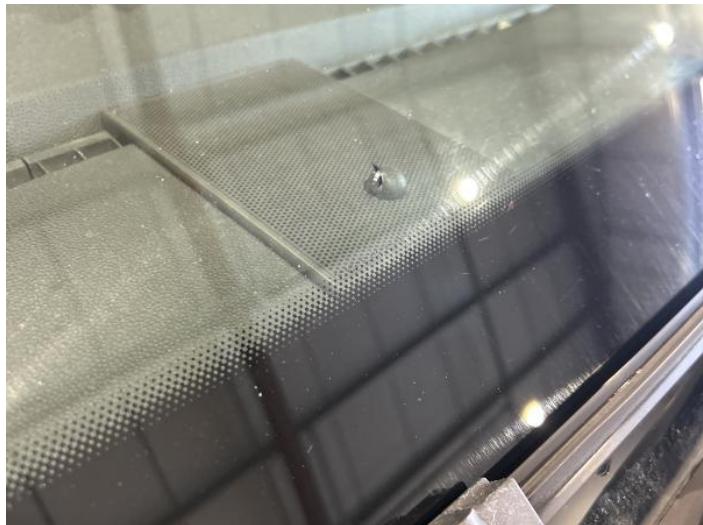
22: Screen Front
Chipped
UpTo 10mm

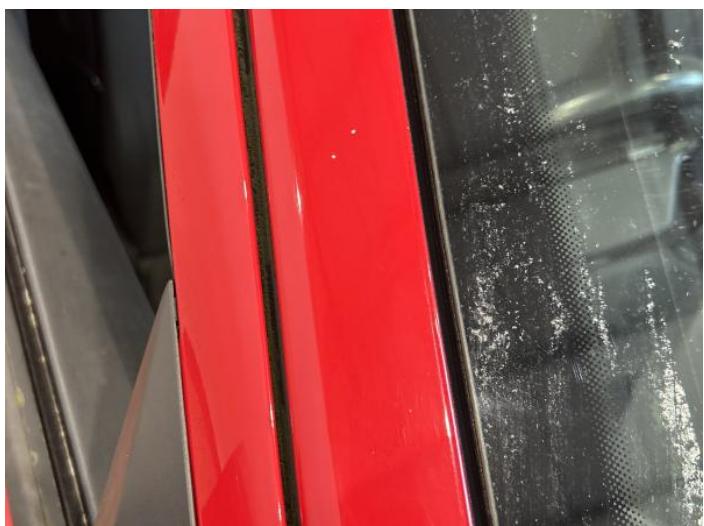
23: A Post os
Chipped
1 To 5

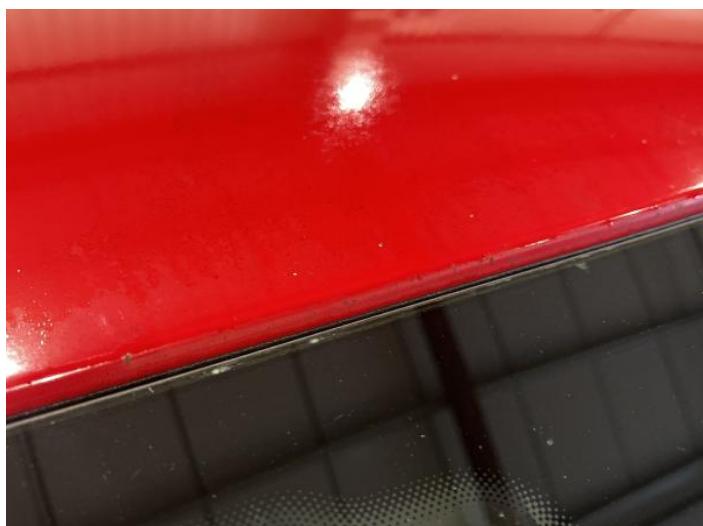
24: Roof
Chipped
1 To 5

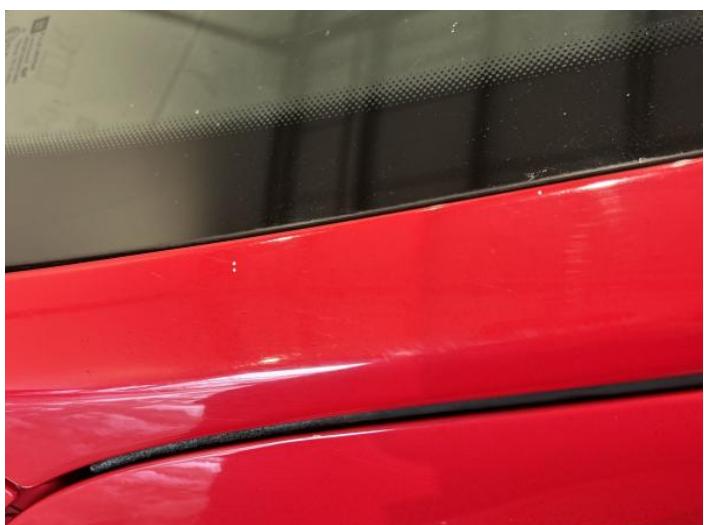
25: A Post ns
Chipped
1 To 5

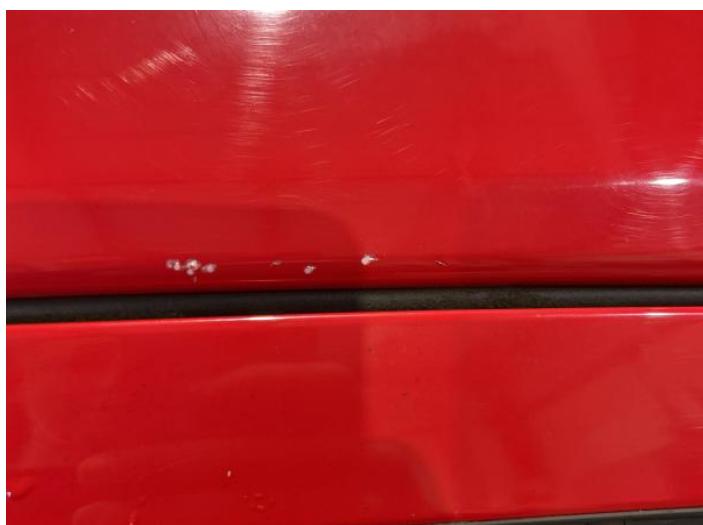
26: C Post ns
Chipped
1 To 5

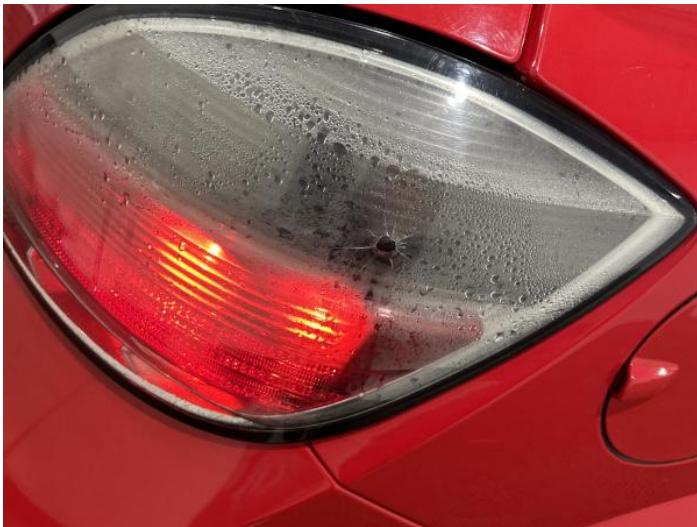
27: Lamp osr

Broken

Replace
