## VEHICLE INSPECTION REPORT

LX64NJJ

### Vauxhall Zafira 2.0 CDTi [165] SRi 5dr Auto

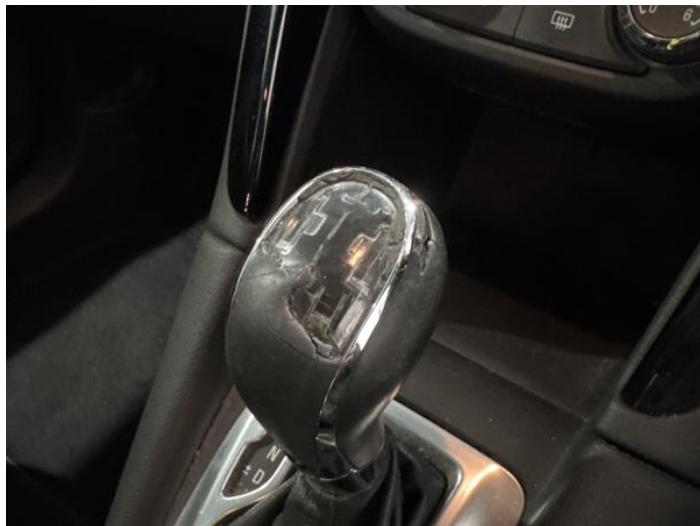
1: Switches And Controls  
Broken  
Replace

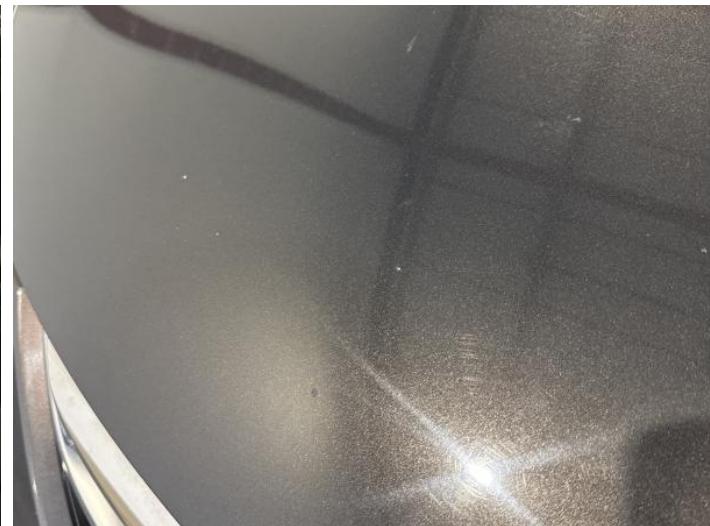
2: Bonnet  
Chipped  
Multiple Chips

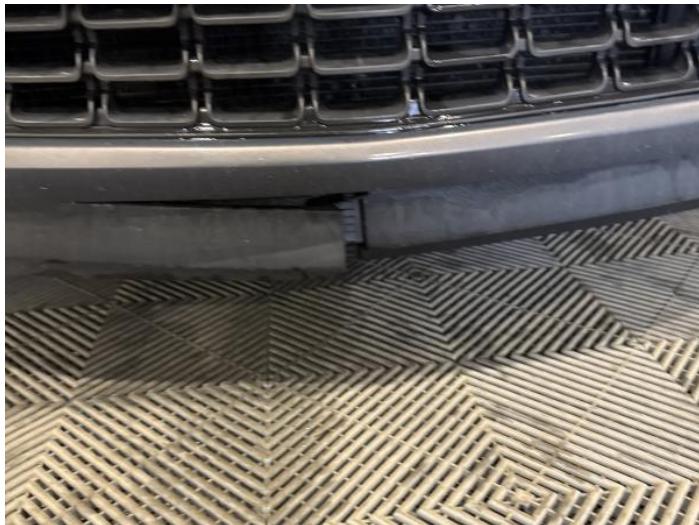
3: Bumper Front Moulding  
Broken  
Replace

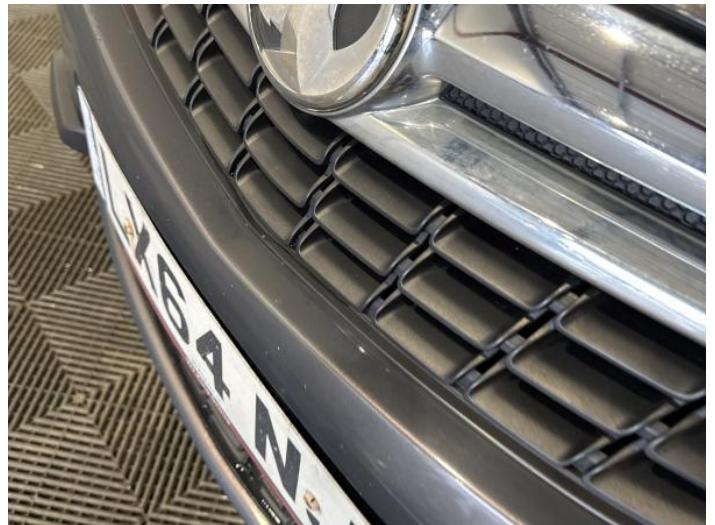
4: Bumper Front  
Chipped  
Multiple Chips

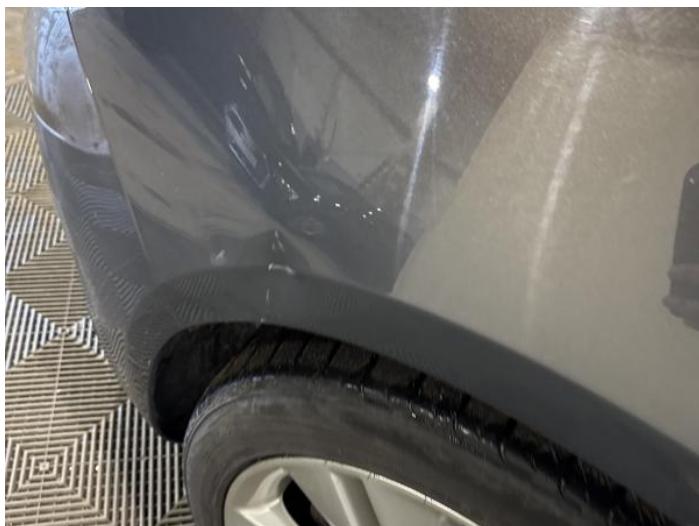
5: Wing osf  
Dented  
With Paint Damage

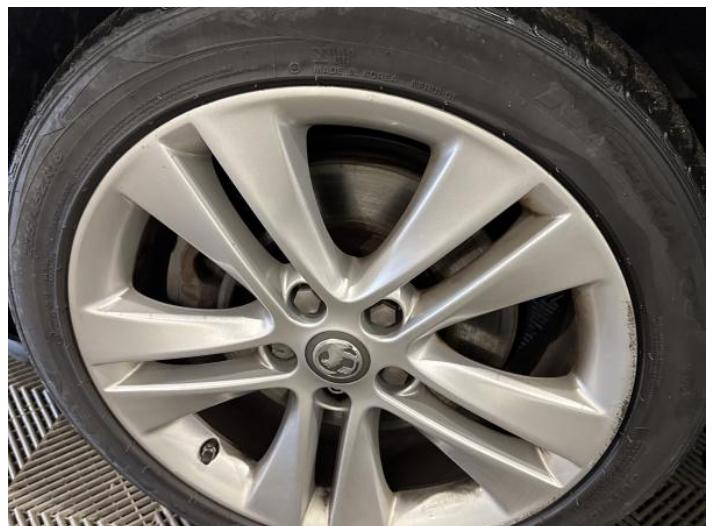
6: Wheel nsf  
Scratched  
Over 50mm

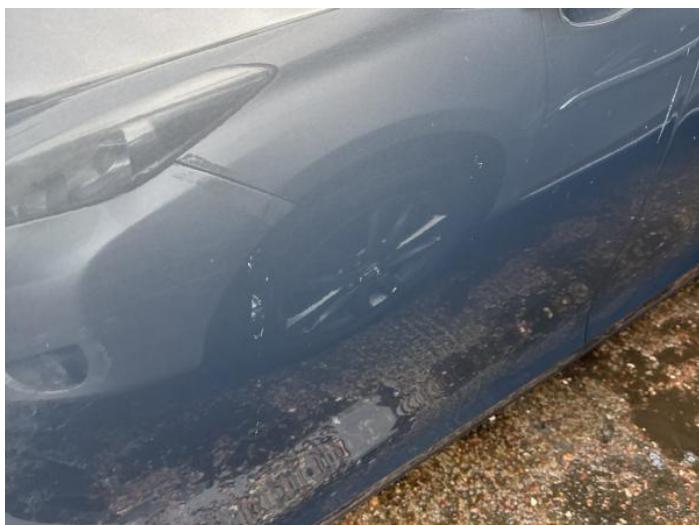
7: Door nsf  
Scratched  
Over 25mm Thru Paint

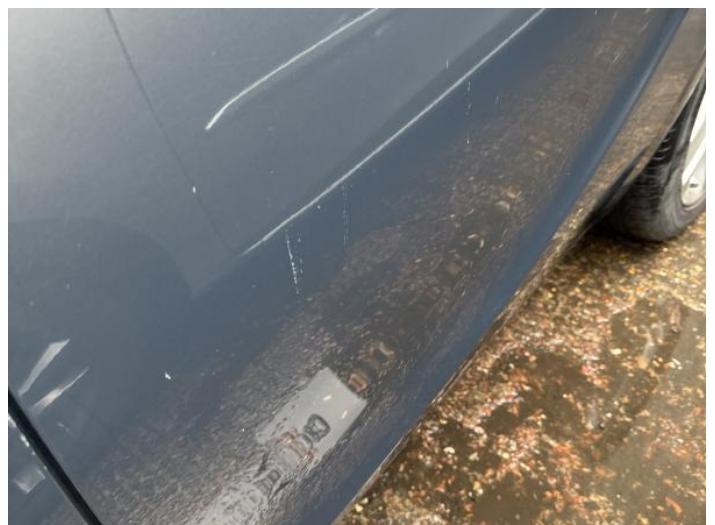
8: Door nsr  
Scratched  
Over 25mm Thru Paint

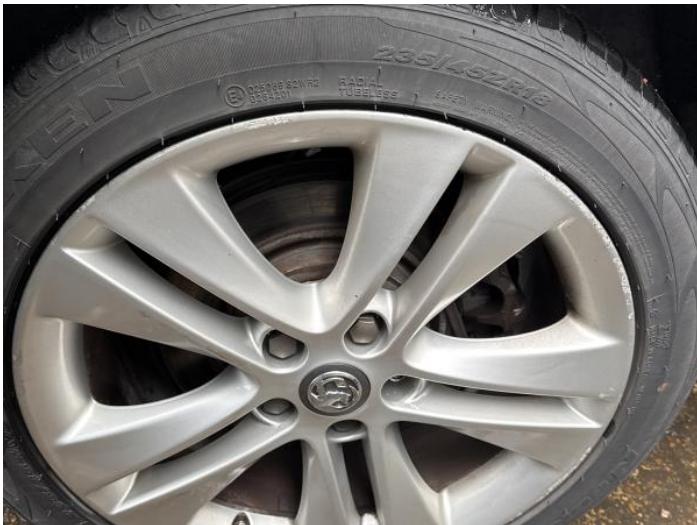
9: Wheel nsr  
Scratched  
Over 50mm

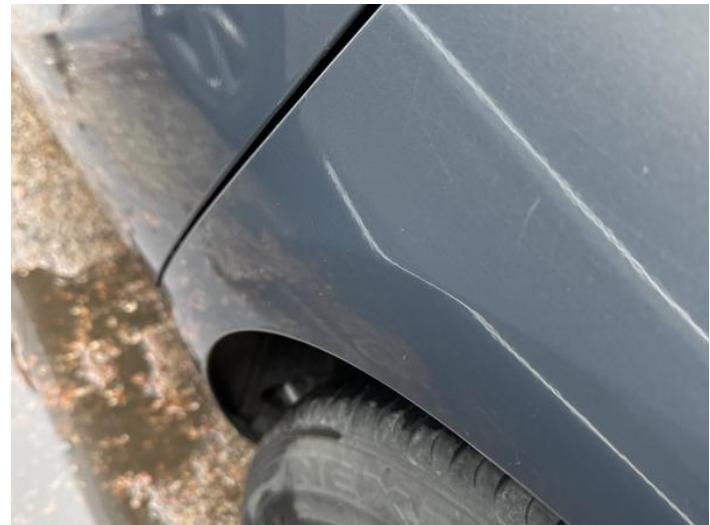
10: Qtr Panel nsr  
Dented  
Between 10mm + 30mm

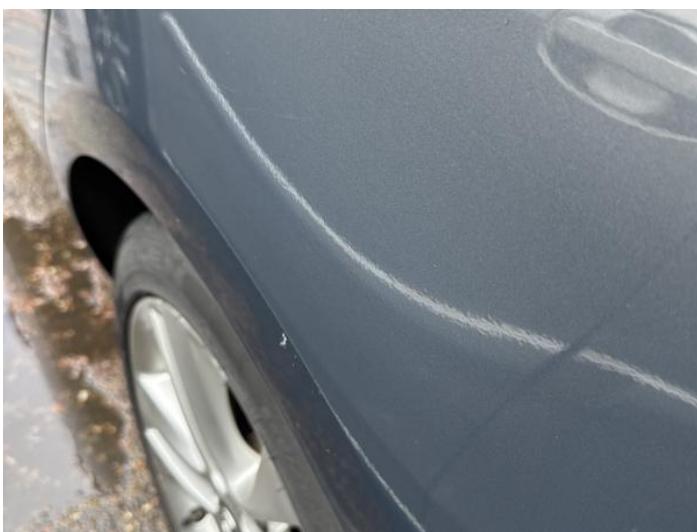
11: Qtr Panel nsr  
Scratched  
UpTo 25mm Thru Paint

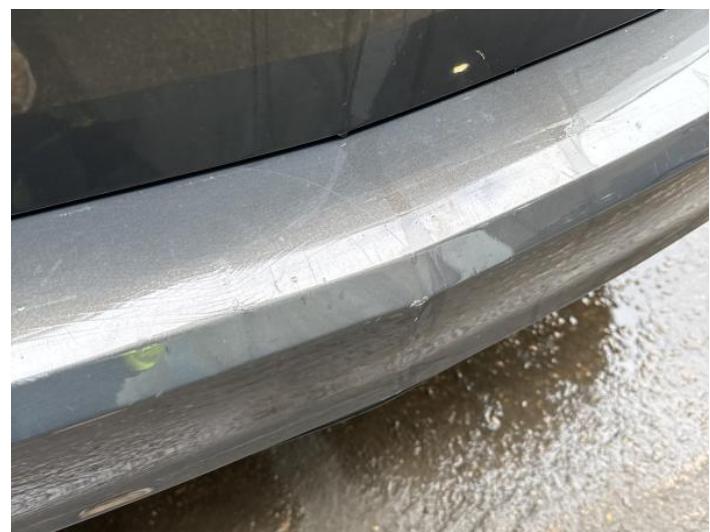
12: Bumper Rear  
Dented  
With Paint Damage

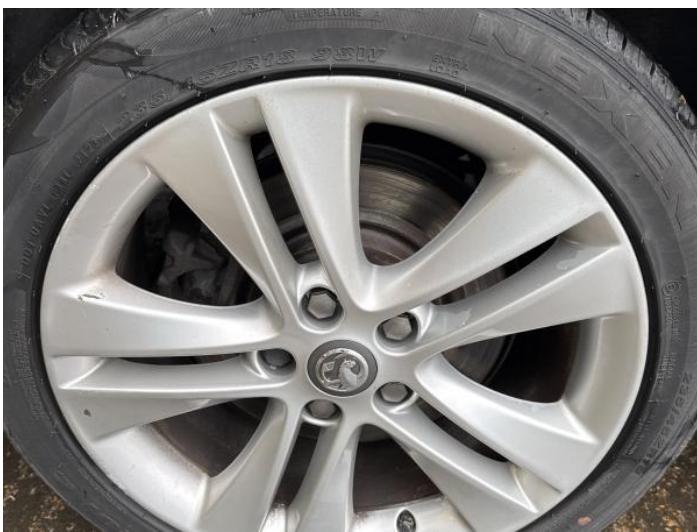
13: Wheel osr  
Scratched  
Over 50mm

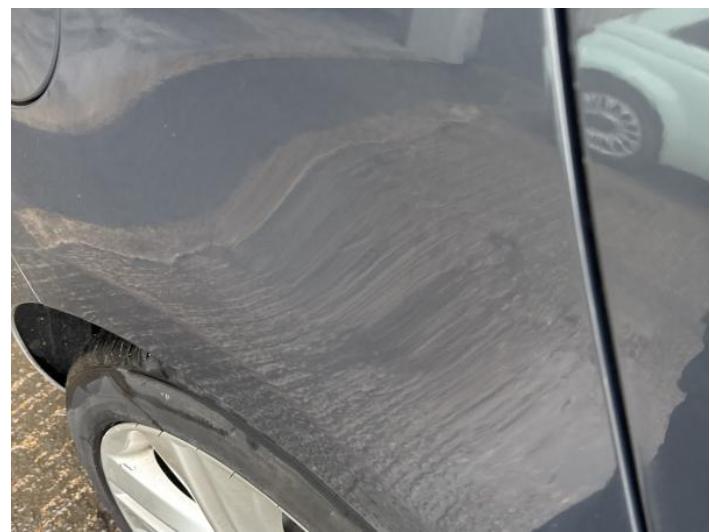
14: Qtr Panel osr  
Scratched  
UpTo 25mm Thru Paint

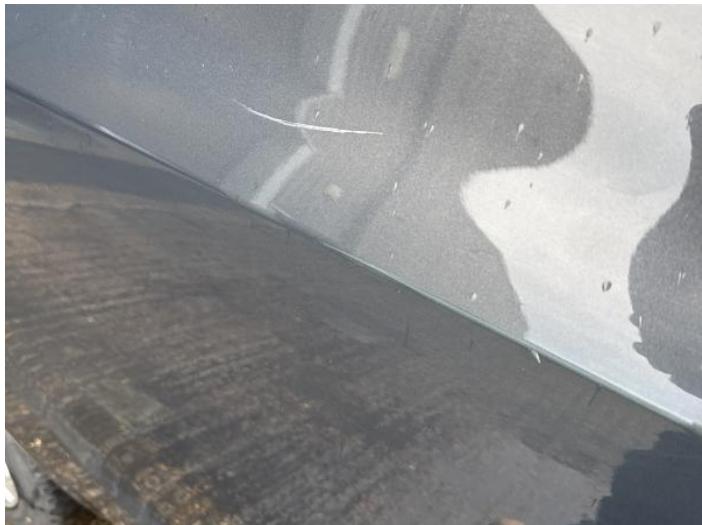
15: Door osr  
Scratched  
Over 25mm Thru Paint

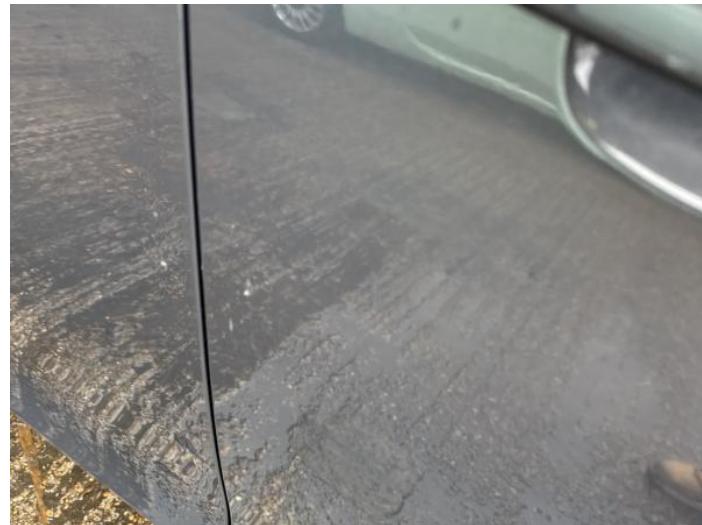
16: Door osf  
Scratched  
UpTo 25mm Thru Paint

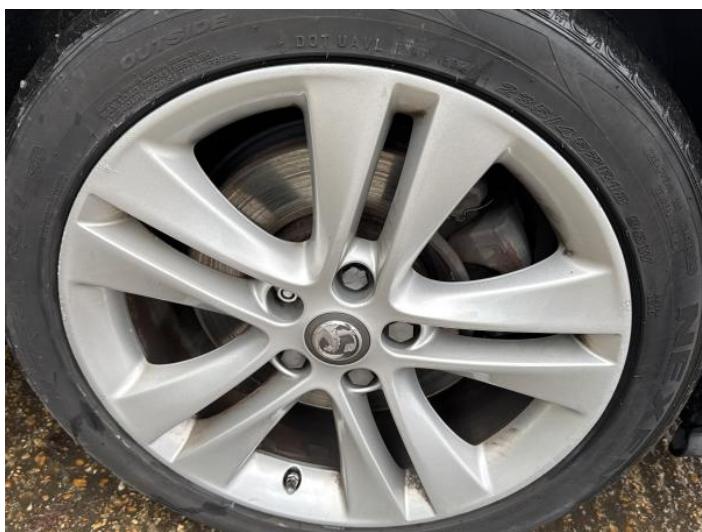
17: Wheel osf  
Scratched  
Over 50mm

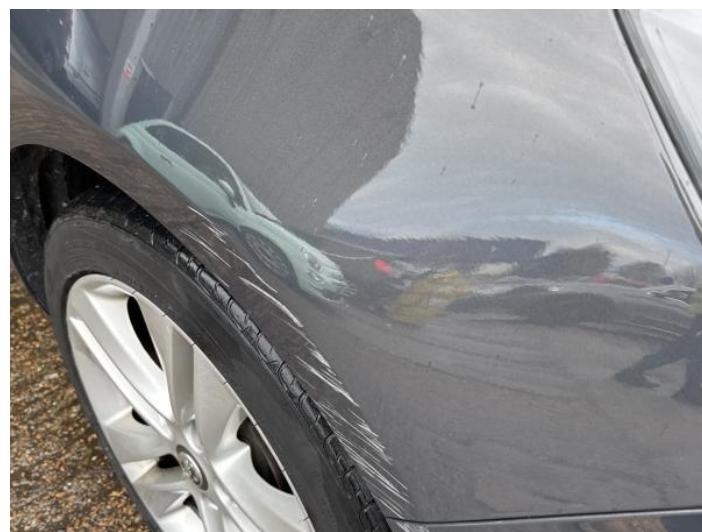
18: Wing osf  
Dented  
With Paint Damage

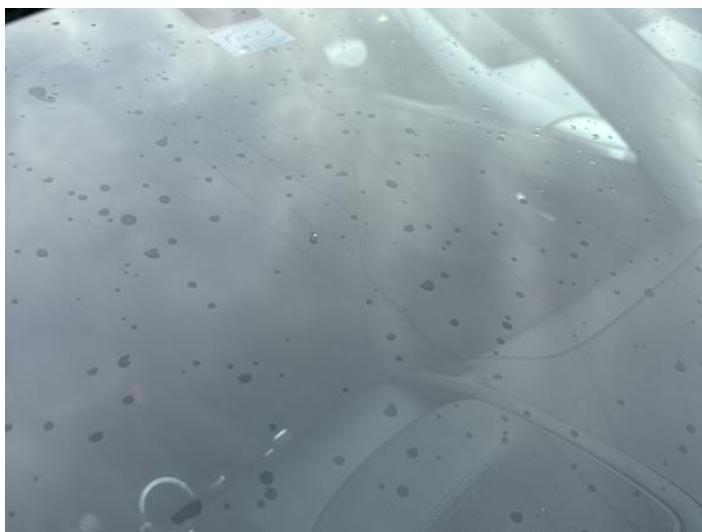
19: Screen Front  
Chipped  
UpTo 10mm
