## VEHICLE INSPECTION REPORT

CK63YNL

### Peugeot 2008 1.6 e-HDi Allure 5dr EGC

Inspection	Vehicle		GRADE 3
Serious Damage?	VAT	Margin	
No	V5	Present

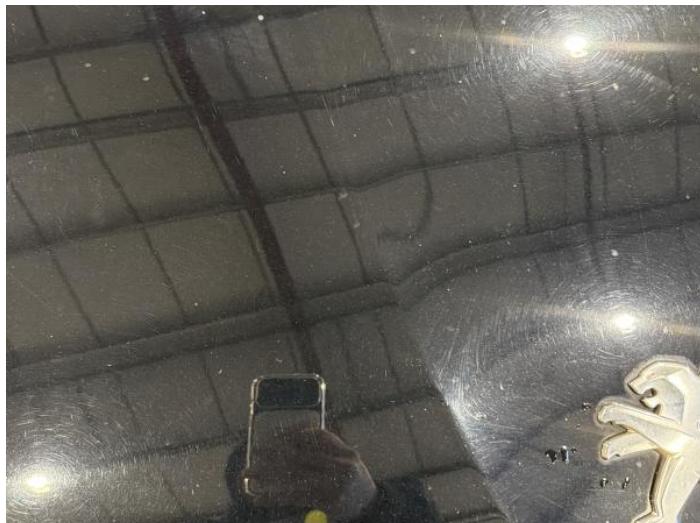
1: Bonnet  
Chipped  
Multiple Chips

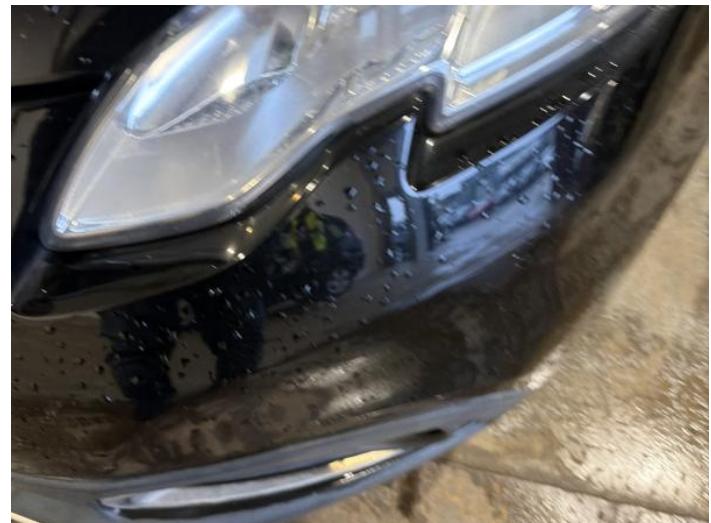
2: Bumper Front  
Poor Previous Repair  
Poor Paint

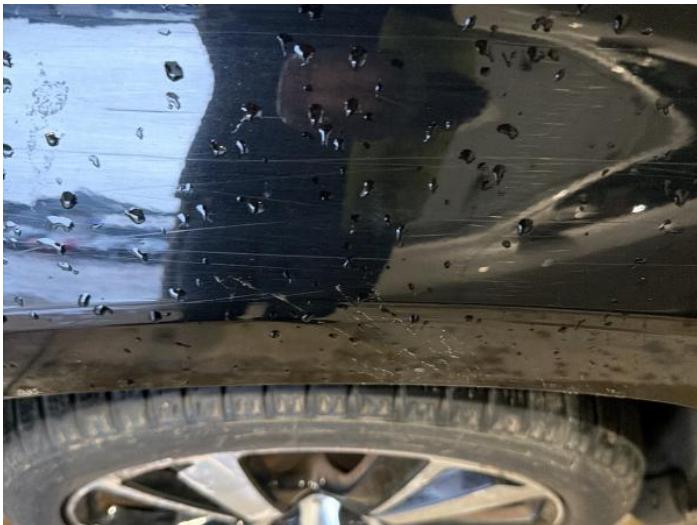
3: Wing nsf  
Dented  
Over 2 UpTo 10mm

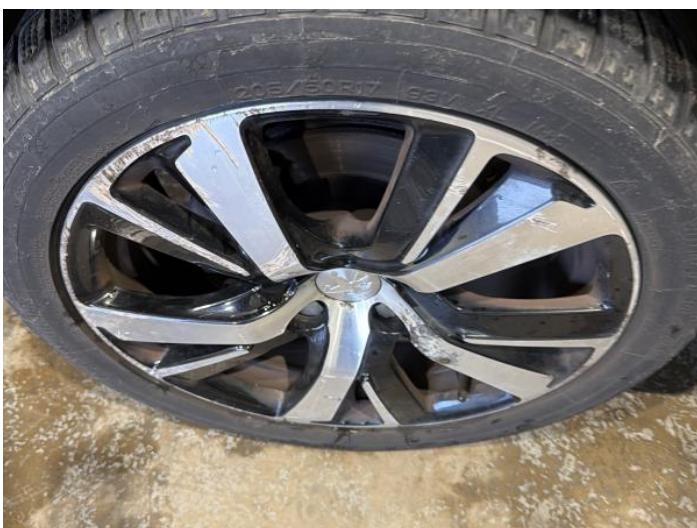
5: Wheel nsf  
Scratched  
Over 50mm

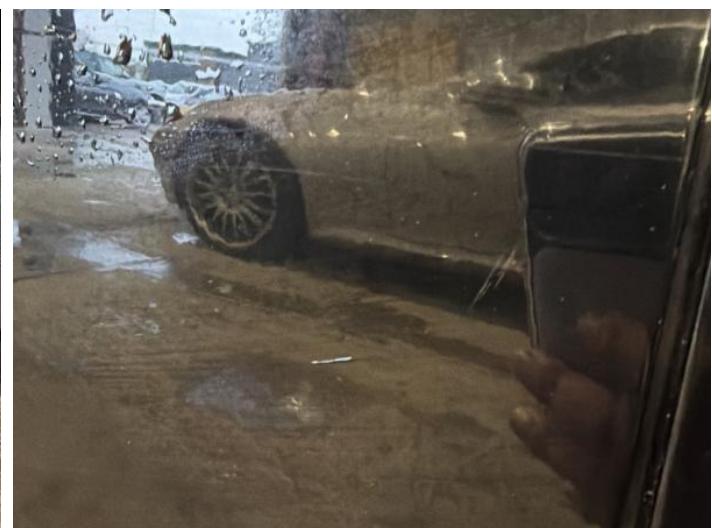
6: Door nsf  
Dented  
Over 2 UpTo 10mm

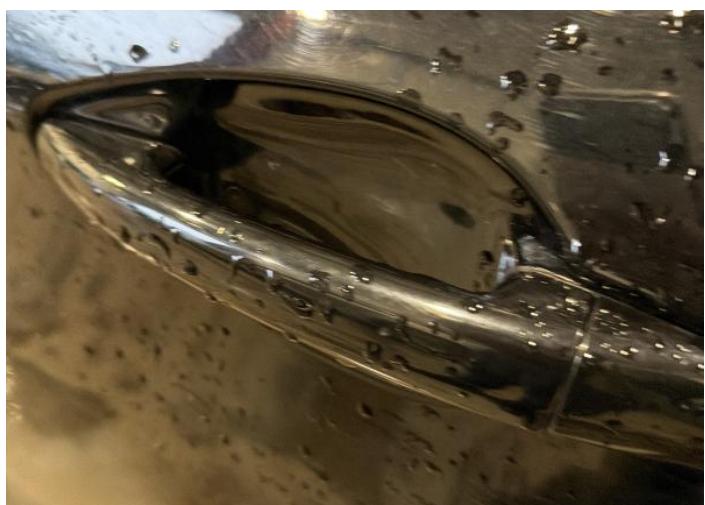
8: Door nsr  
Dented  
With Paint Damage

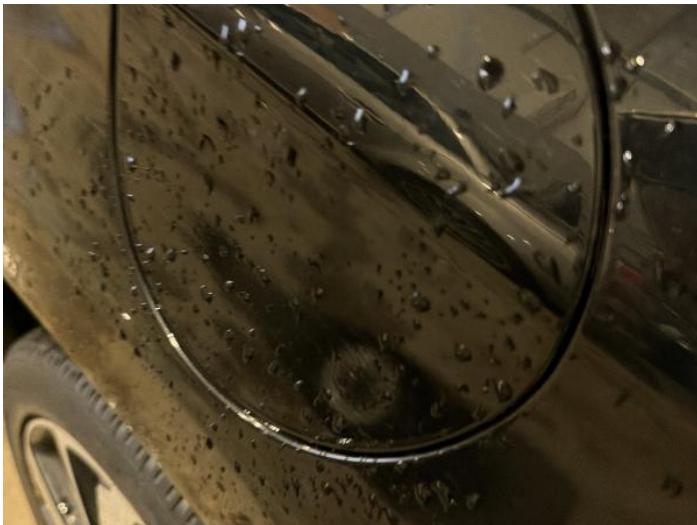
9: Qtr Panel nsr  
Dented  
Over 2 UpTo 10mm

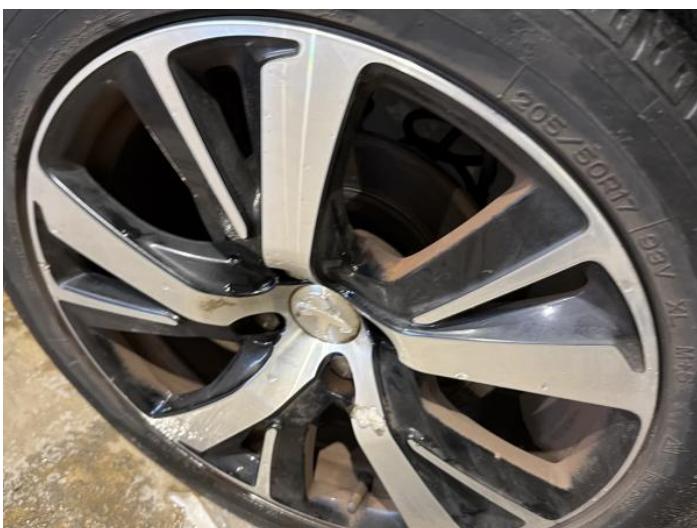
11: Wheel nsr  
Scratched  
Over 50mm

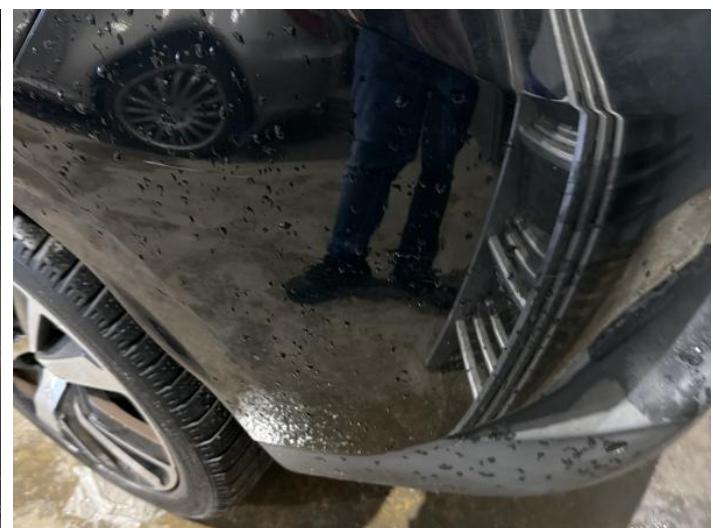
12: Bumper Rear  
Scratched  
25 to 100mm Thru Paint

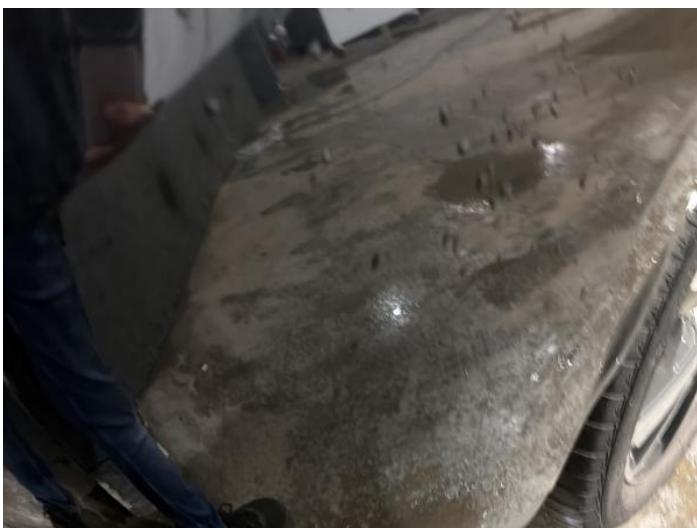
13: Bumper Rear  
Chipped  
Multiple Chips

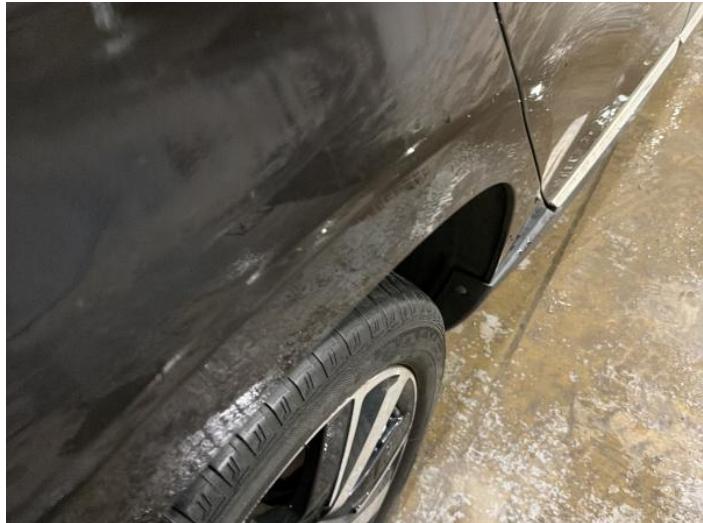
16: Qtr Panel osr  
Dented  
2 Or Less UpTo 10mm

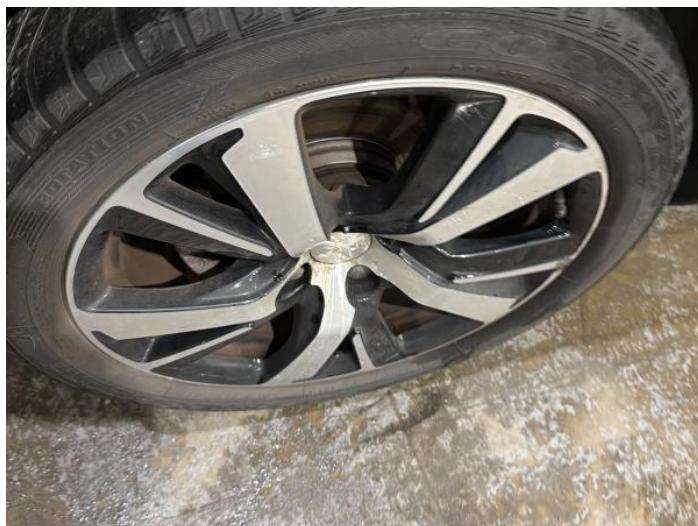
17: Wheel osr  
Scratched  
Over 50mm

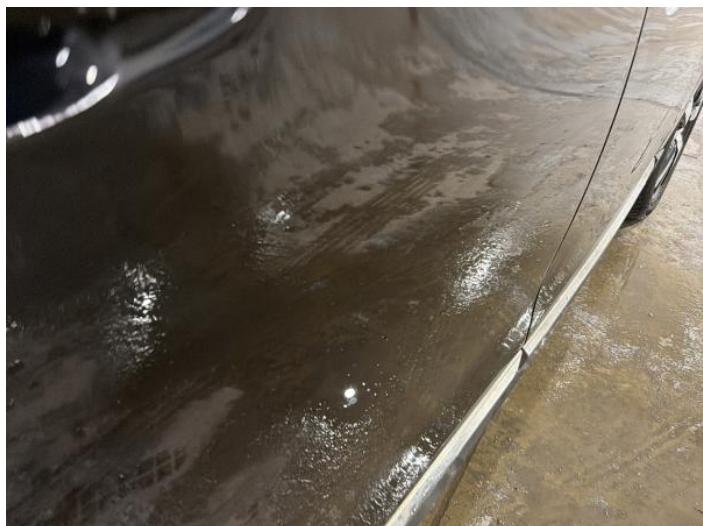
18: Door osr  
Dented  
Over 2 UpTo 10mm

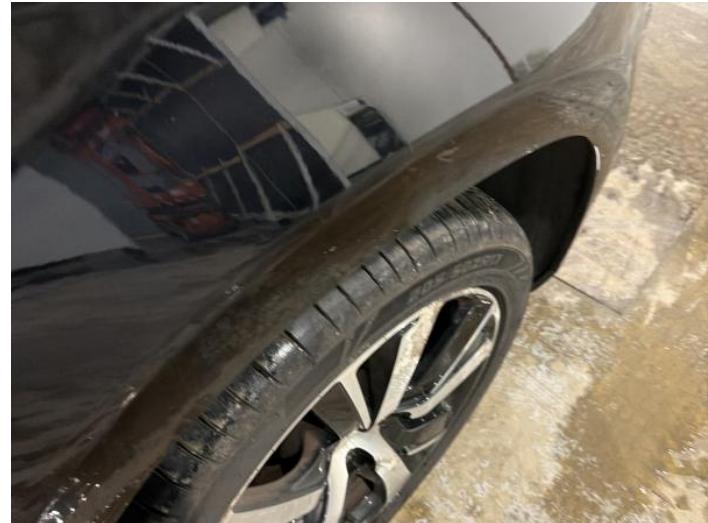
22: Wing osf  
Chipped  
1 To 5

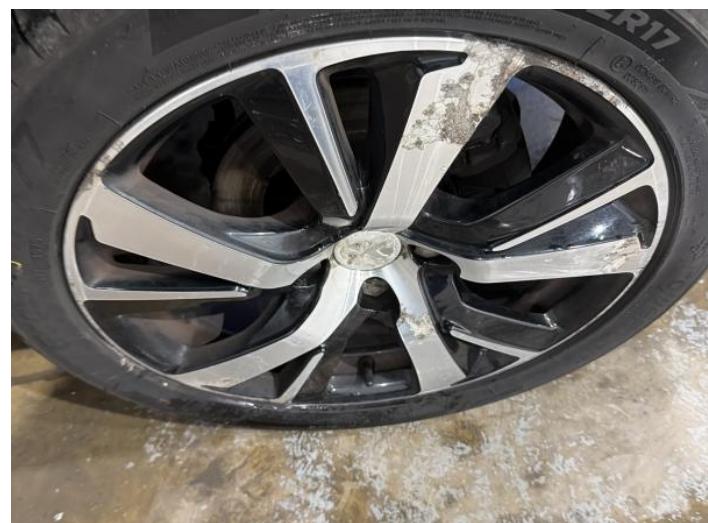
24: Wheel osf  
Scratched  
Over 50mm
