## VEHICLE INSPECTION REPORT

GP16SZV

### Ford Fiesta 1.0 EcoBoost Titanium X 5dr Powershift

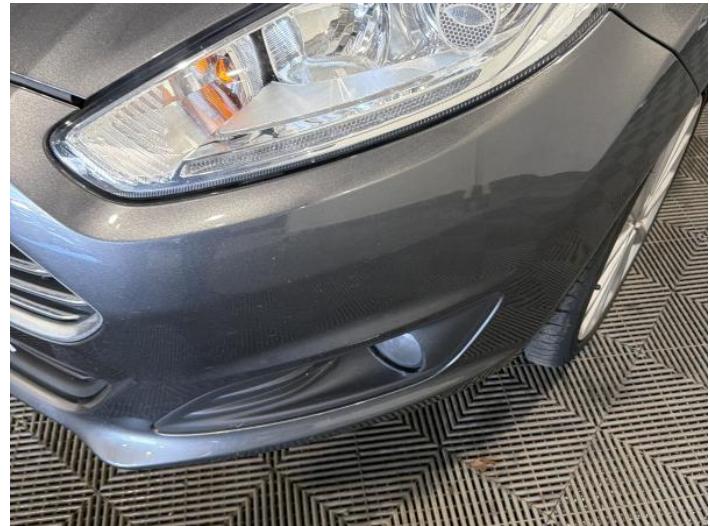
2: Bumper Front  
Scratched  
25 to 100mm Thru Paint

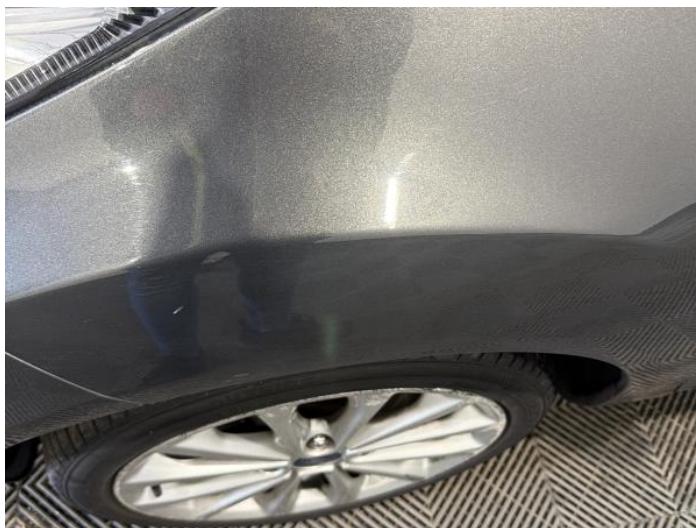
5: Wing nsf  
Chipped  
1 To 5

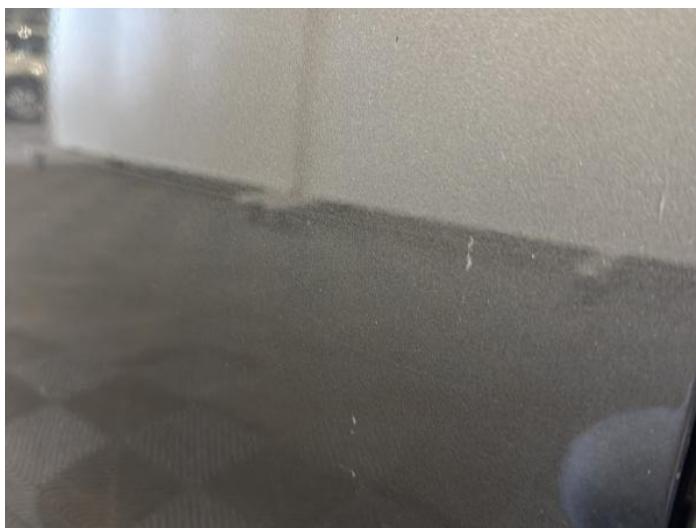
7: Door nsf  
Chipped  
1 To 5

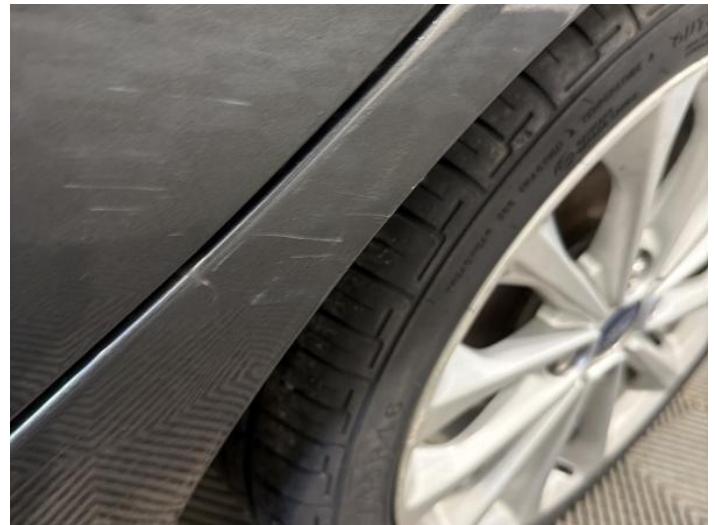
10: Qtr Panel nsr  
Dented  
With Paint Damage

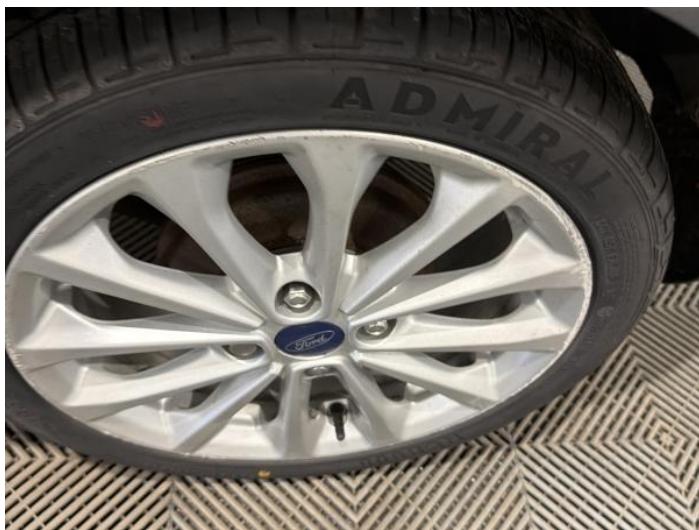
11: Wheel nsr  
Scratched  
Over 50mm

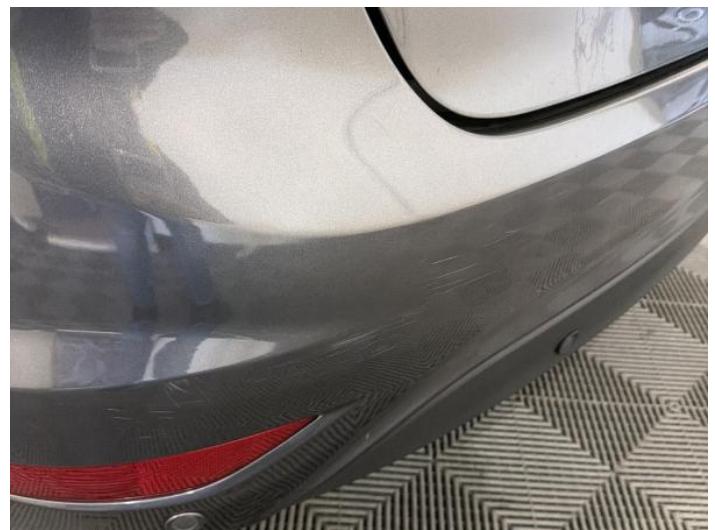
12: Bumper Rear  
Scratched  
25 to 100mm Thru Paint

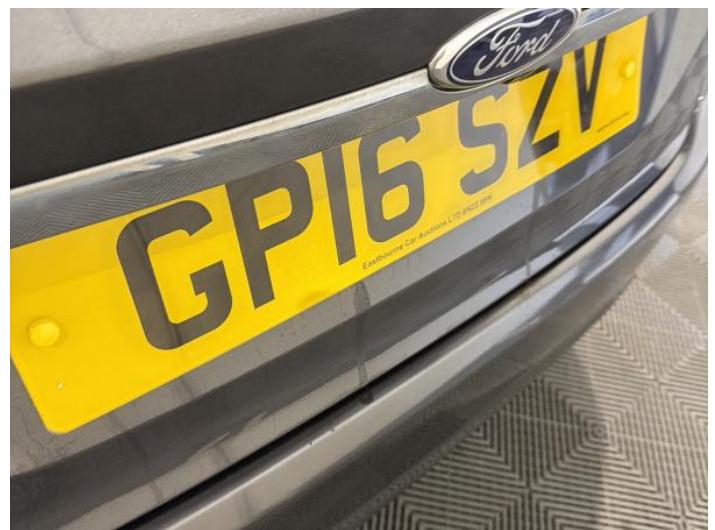
14: Boot Lid  
Dented  
Over 2 UpTo 10mm

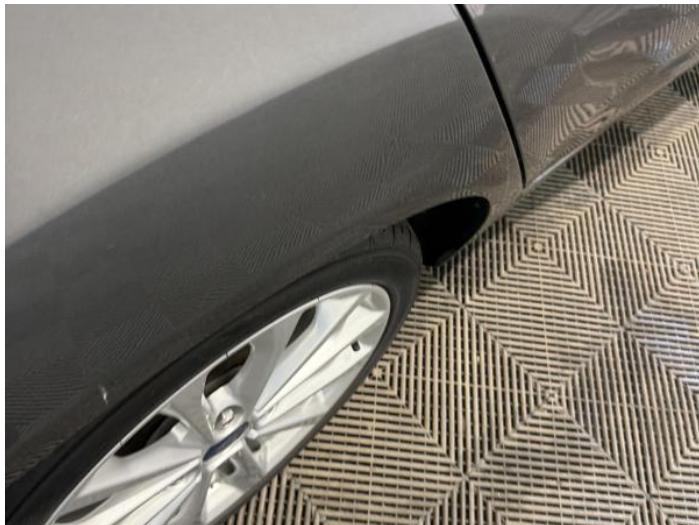
15: Qtr Panel osr  
Dented  
Over 30mm

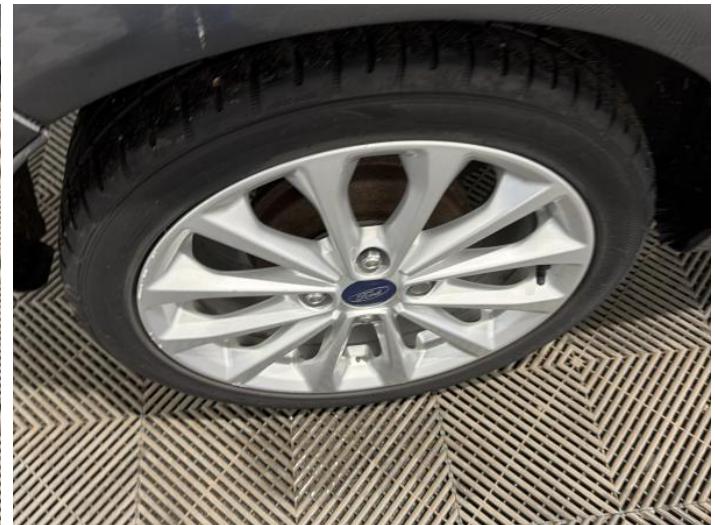
16: Wheel osr  
Scratched  
Over 50mm

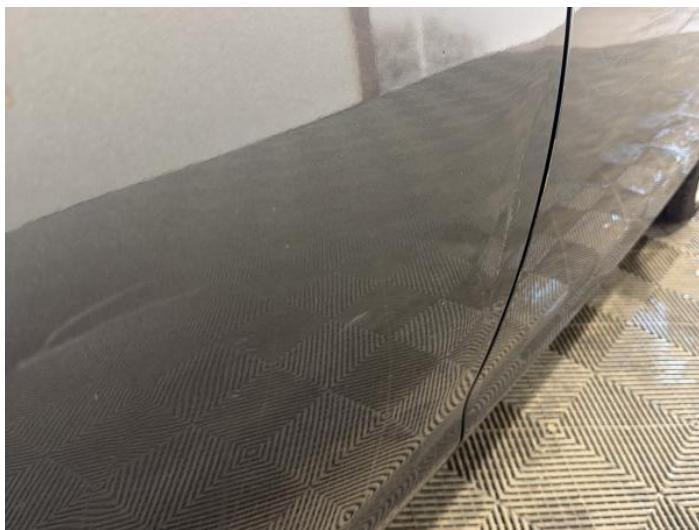
17: Door osr  
Dented  
With Paint Damage

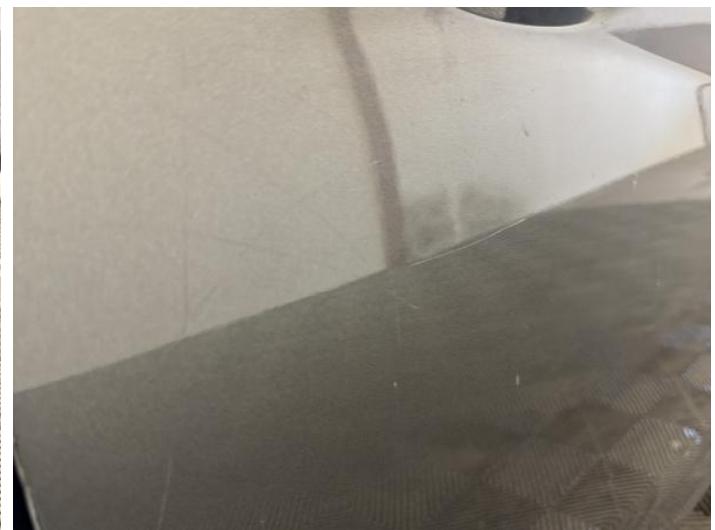
18: Door osr  
Scratched  
Over 25mm Thru Paint

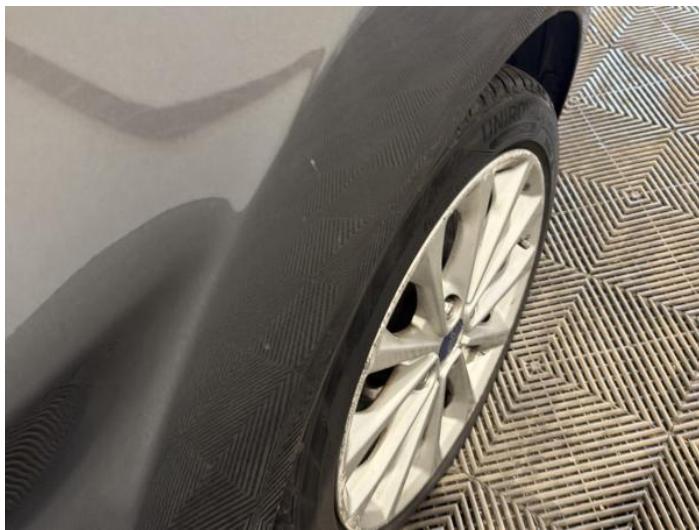
19: Wing osr  
Dented  
Over 2 UpTo 10mm

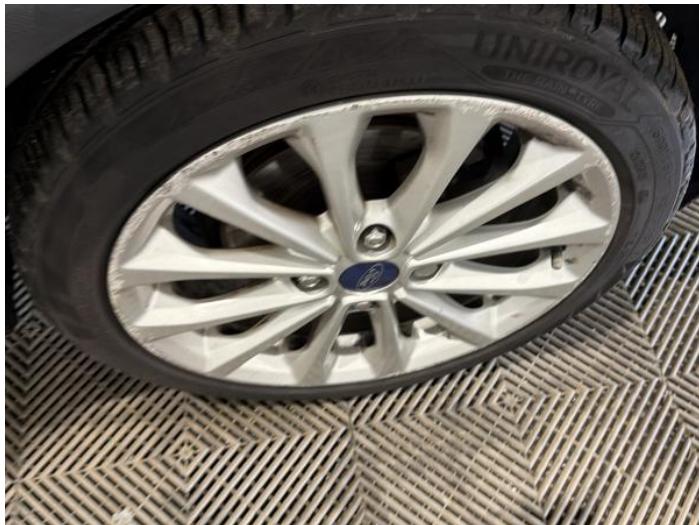
21: Wheel osf  
Scratched  
Over 50mm
