VEHICLE INSPECTION REPORT

GU20DFZ

Volkswagen T-Cross 1.0 TSI 115 SE 5dr

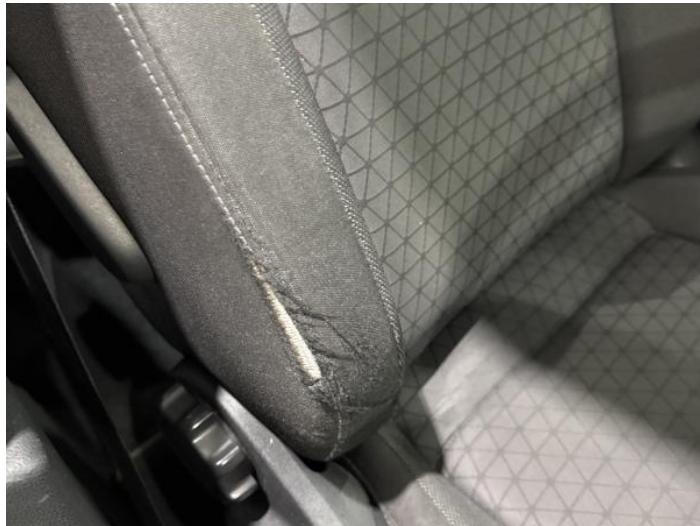
1: Seat Back Cover osf
Scuffed
Over 25mm

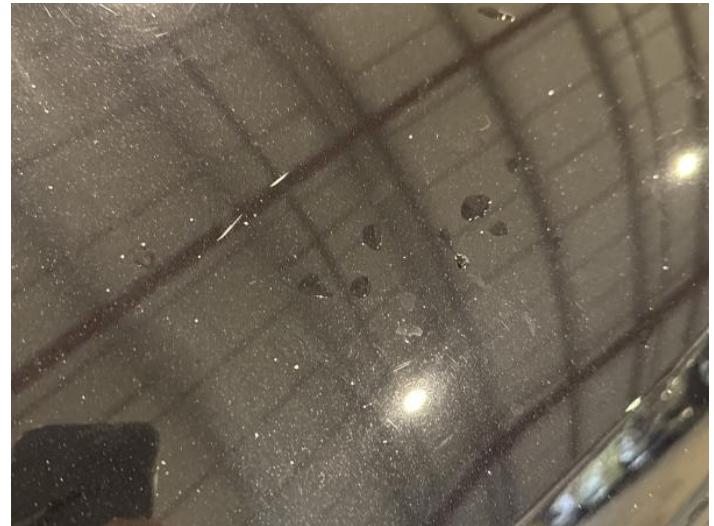
2: Bonnet
Chipped
Multiple Chips

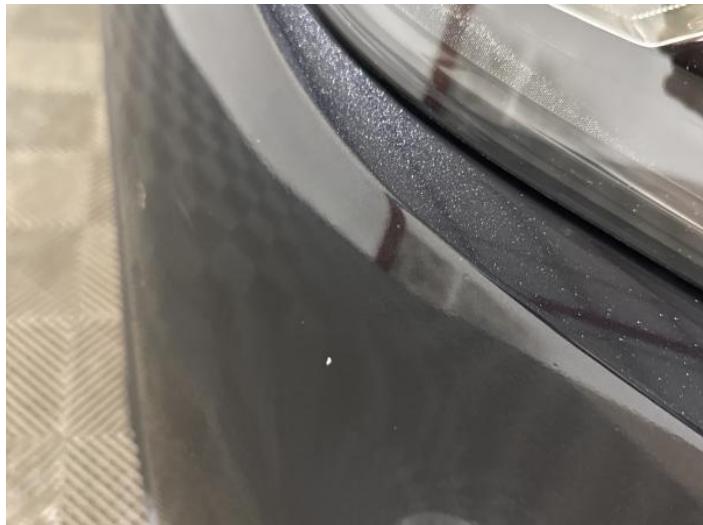
3: Bumper Front
Chipped
1 To 5

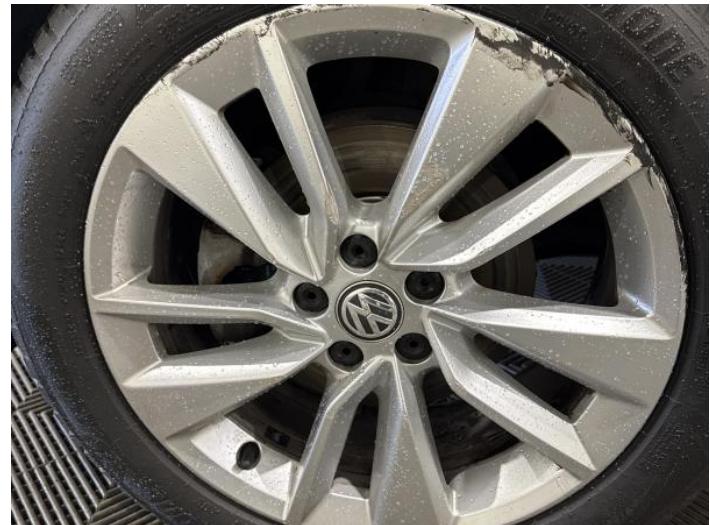
4: Wheel nsf
Scratched
Over 50mm

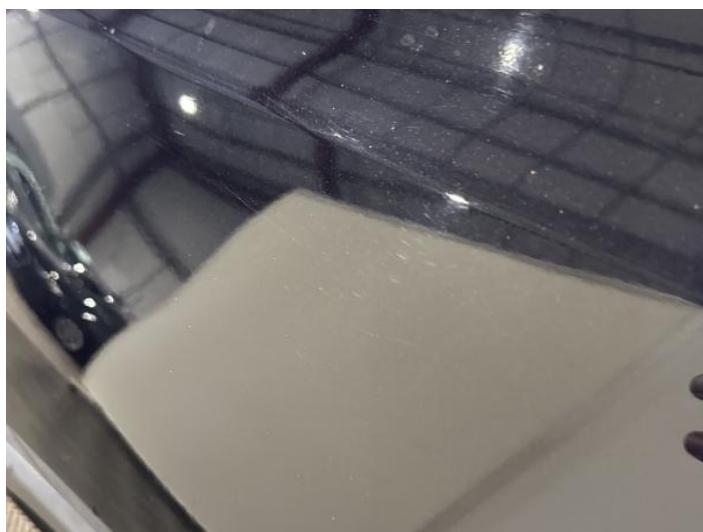
5: Wing nsf
Scratched
UpTo 25mm Thru Paint

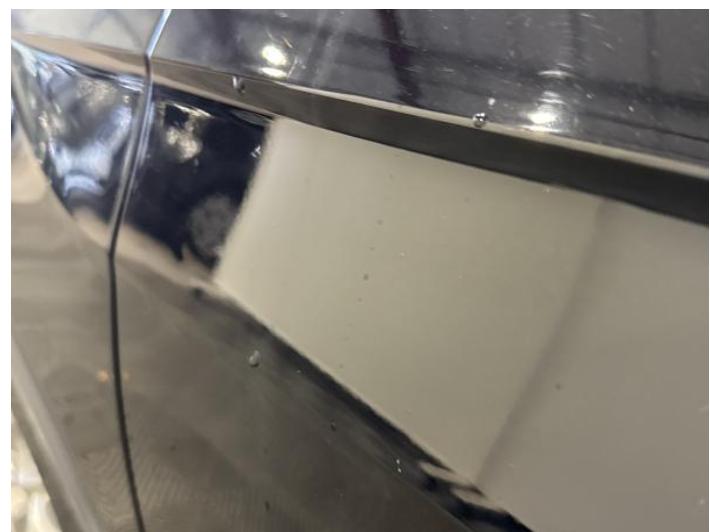
6: Door nsf
Dented
Between 10mm + 30mm

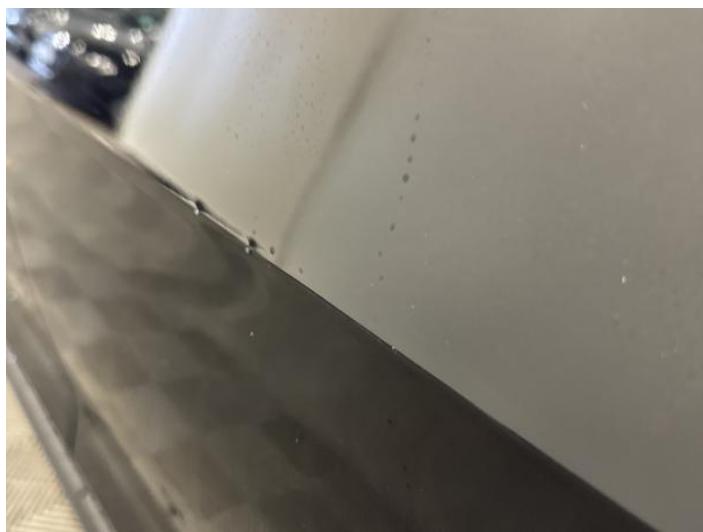
7: Door nsr
Dented
Between 10mm + 30mm

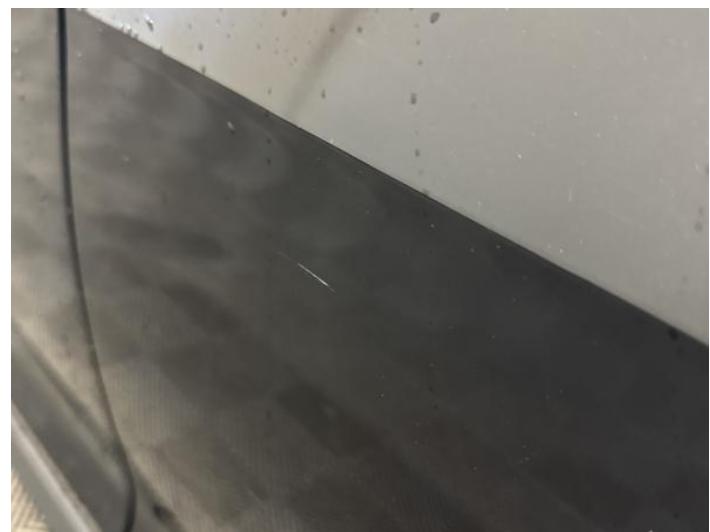
8: Door nsr
Scratched
UpTo 25mm Thru Paint

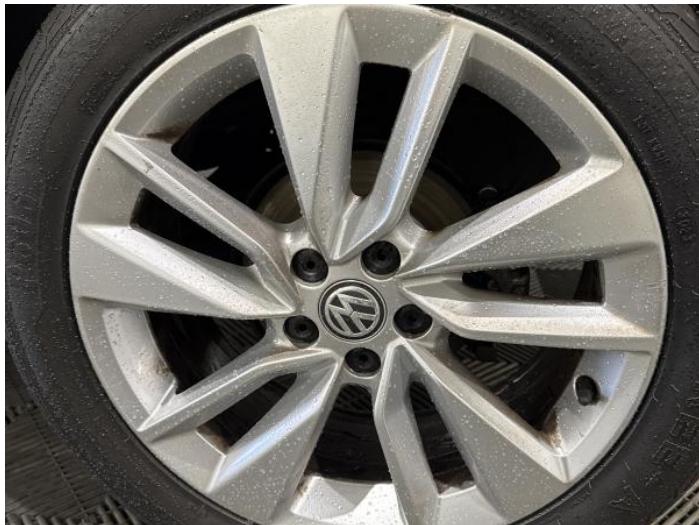
9: Wheel nsr
Scratched
Over 50mm

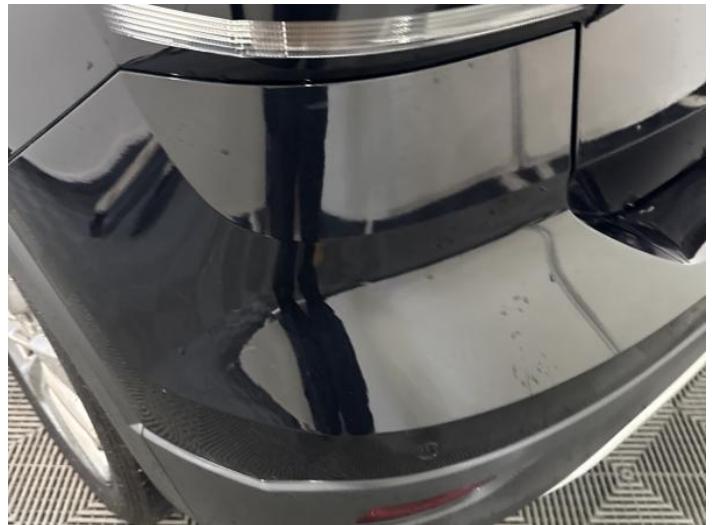
10: Bumper Rear
Scratched
25 to 100mm Thru Paint

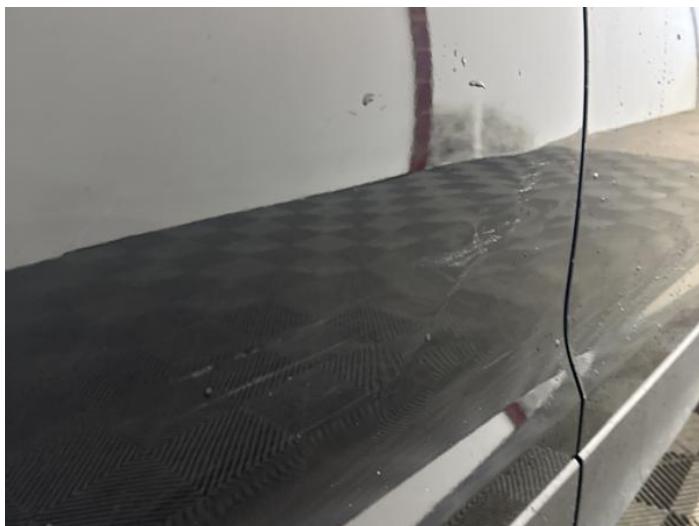
11: Door osr
Dented
With Paint Damage

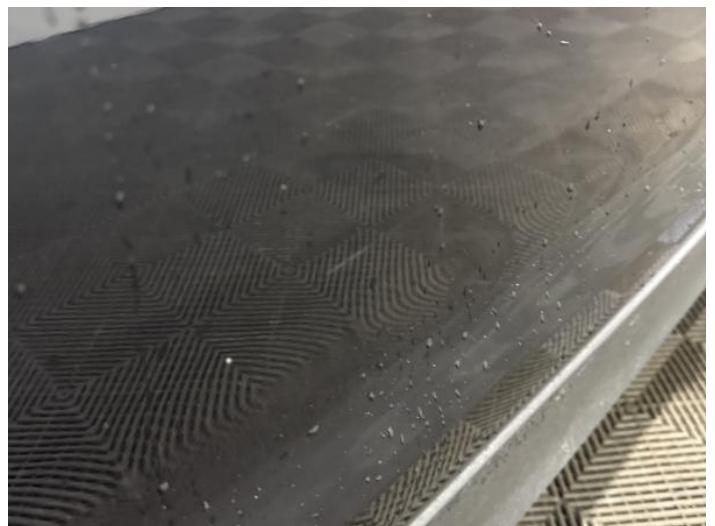
12: Door osf
Scratched
UpTo 25mm Thru Paint

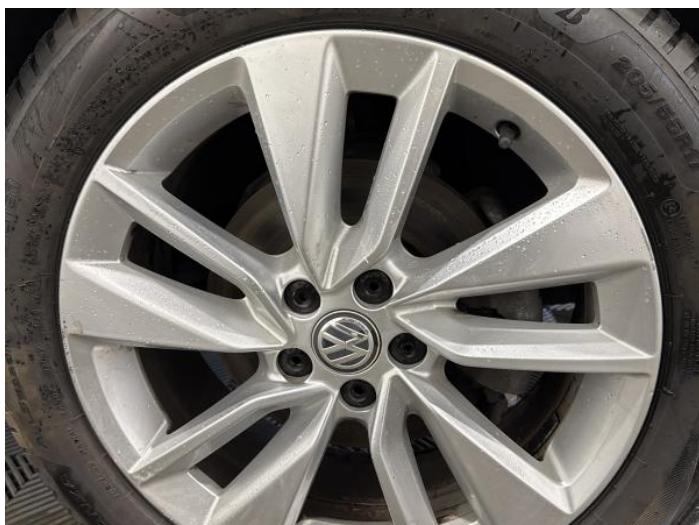
13: Wheel osf
Scratched
Over 50mm

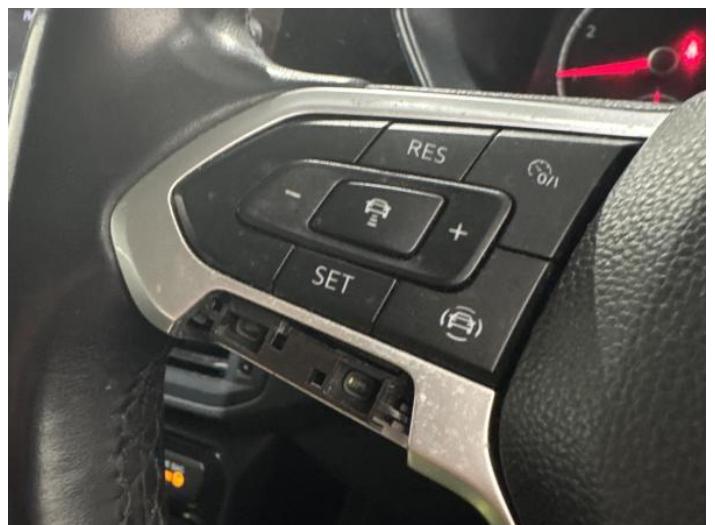
14: Switches And Controls
Missing
Replace
