## VEHICLE INSPECTION REPORT

**EY68UNV**

### Ford Transit Connect 1.5 EcoBlue 120ps Limited Van Powershift

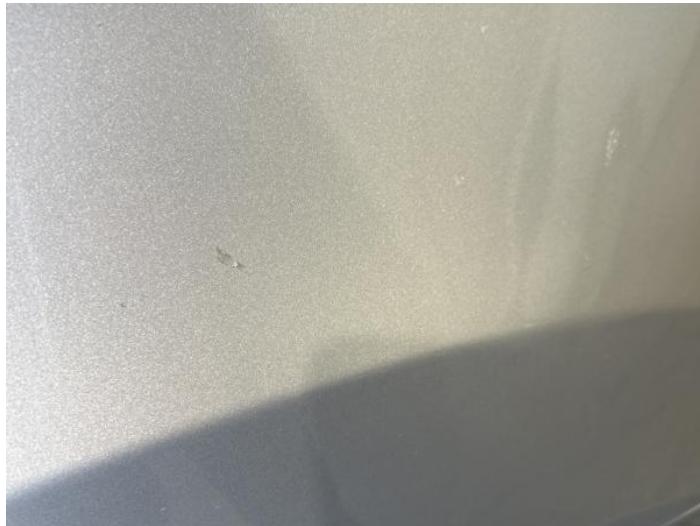
1: Wing osf  
Chipped  
1 To 5

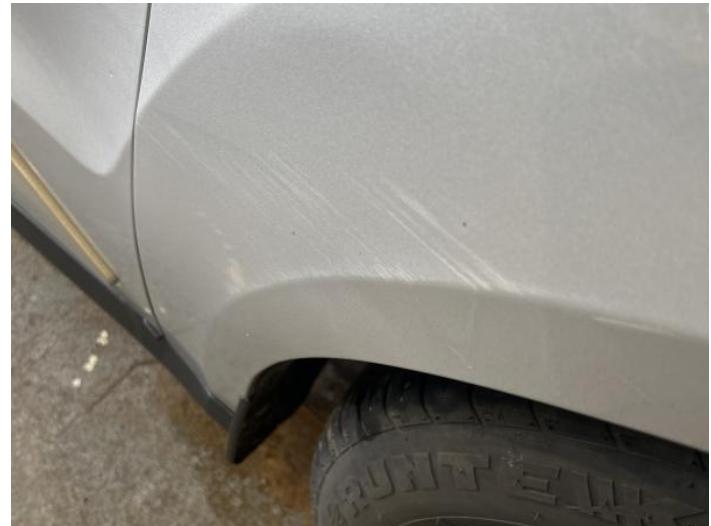
2: Wing osf  
Scratched  
Over 25mm Not Thru Paint

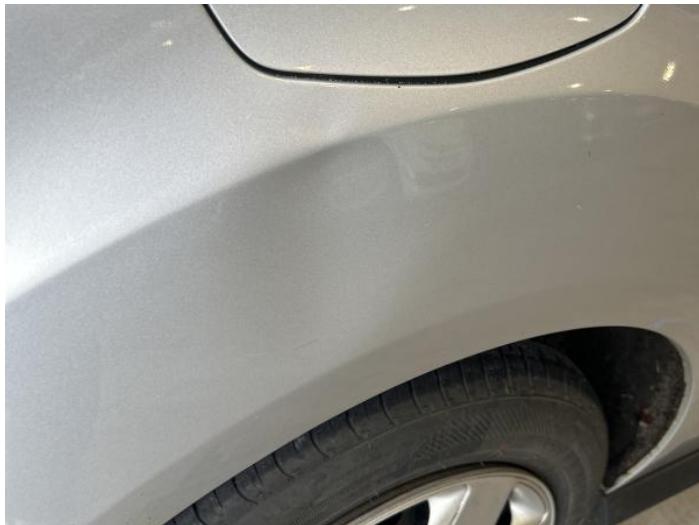
3: Qtr Panel osr  
Dented  
Over 30mm

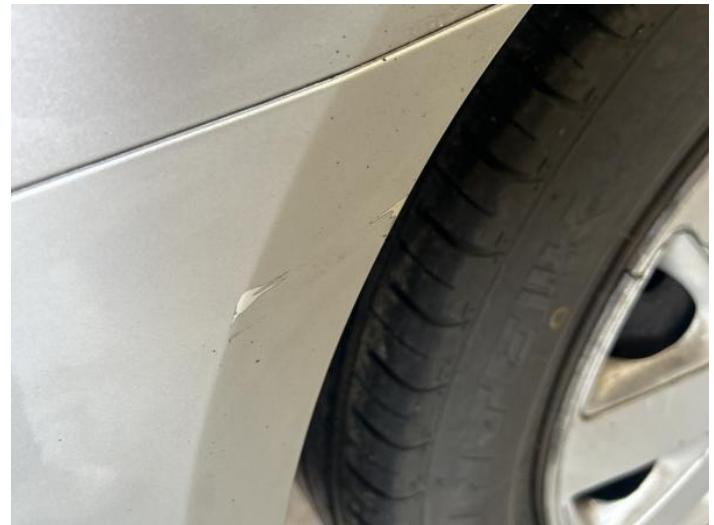
4: Bumper Rear  
Scratched  
Up To 25mm Thru Paint

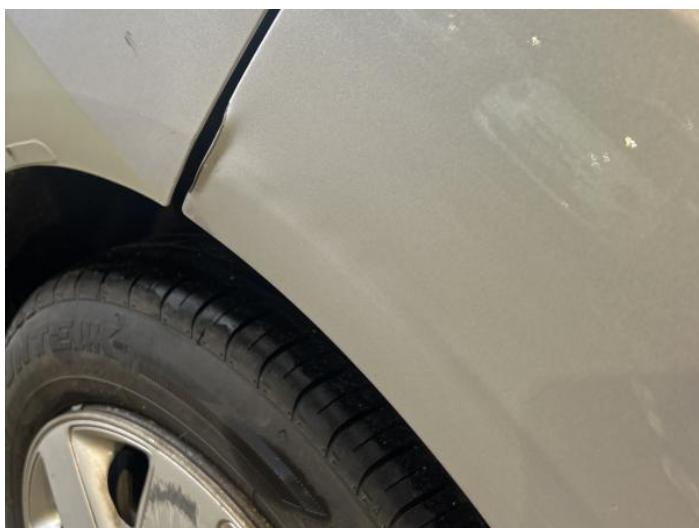
5: Qtr Panel nsr  
Dented  
With Paint Damage

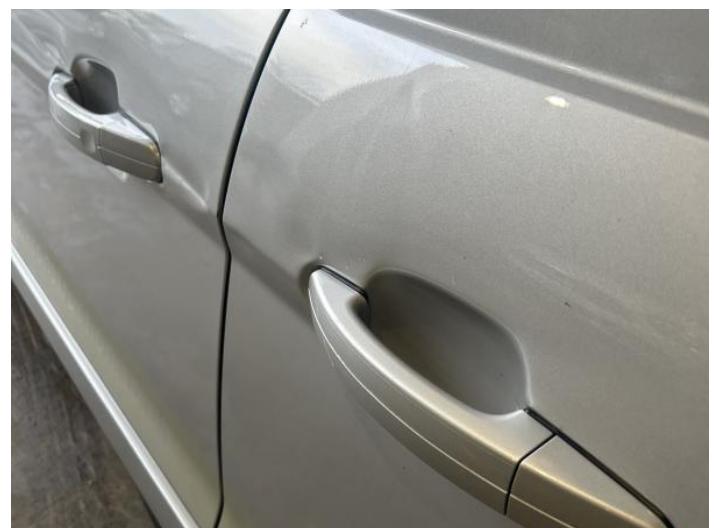
6: Door nsr  
Dented  
Over 30mm

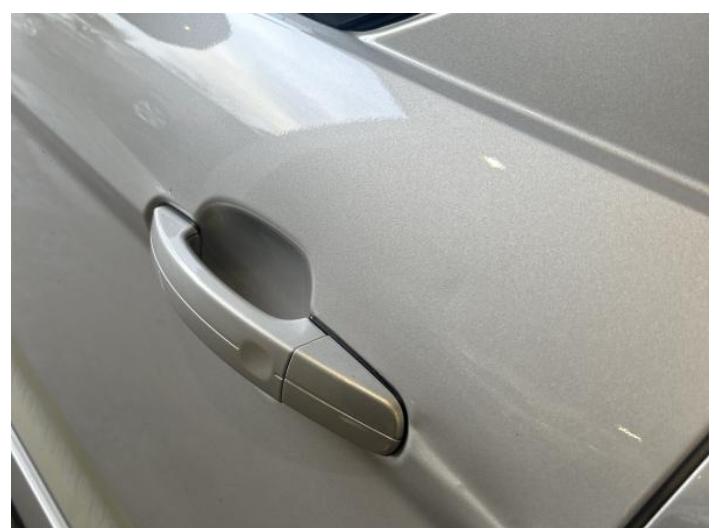
8: Door nsf  
Dented  
Over 30mm

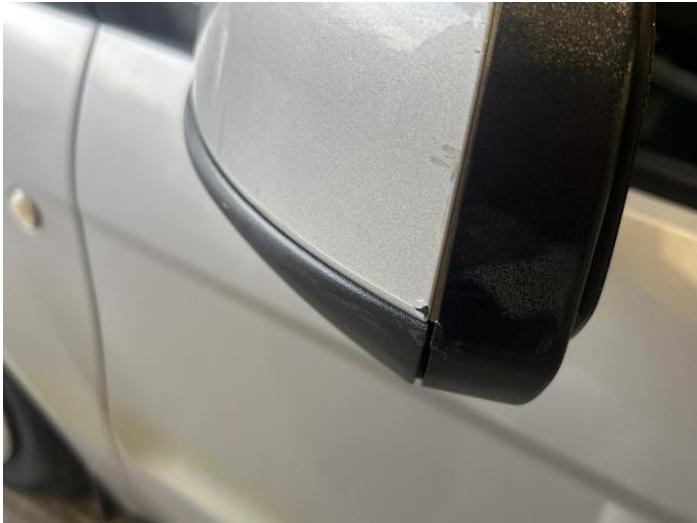
9: Door Mirror Assy nsf  
Scratched (Painted)  
UpTo 25mm Thru Paint

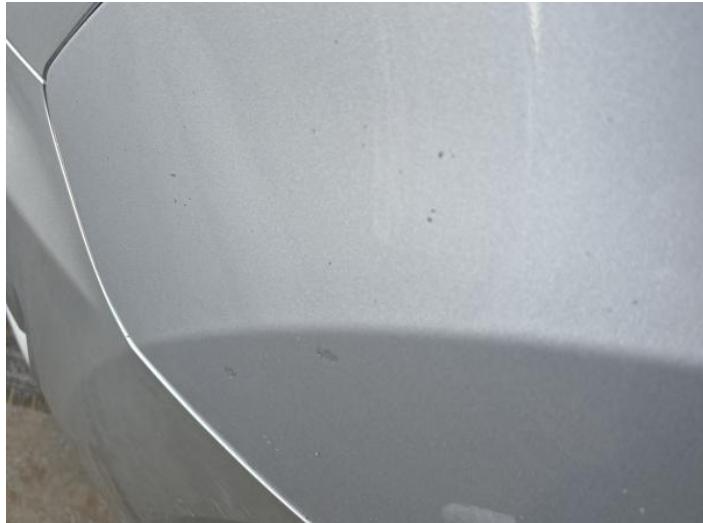
10: Wing nsf  
Chipped  
Multiple Chips

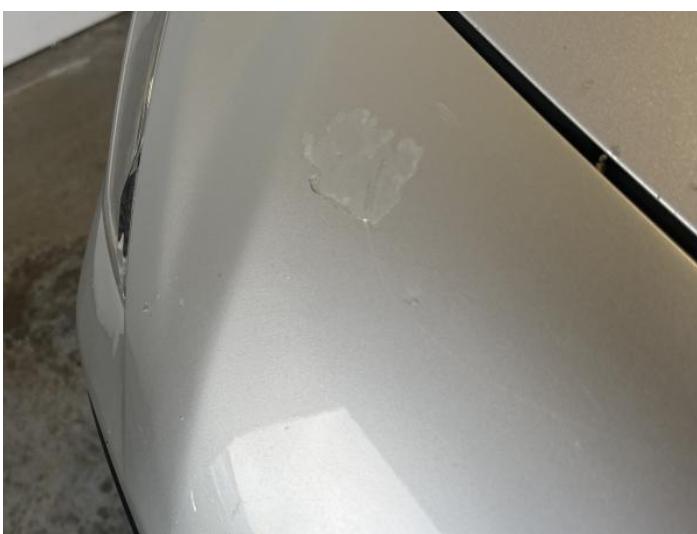
11: Bumper Front  
Poor Previous Repair  
Paint Flake

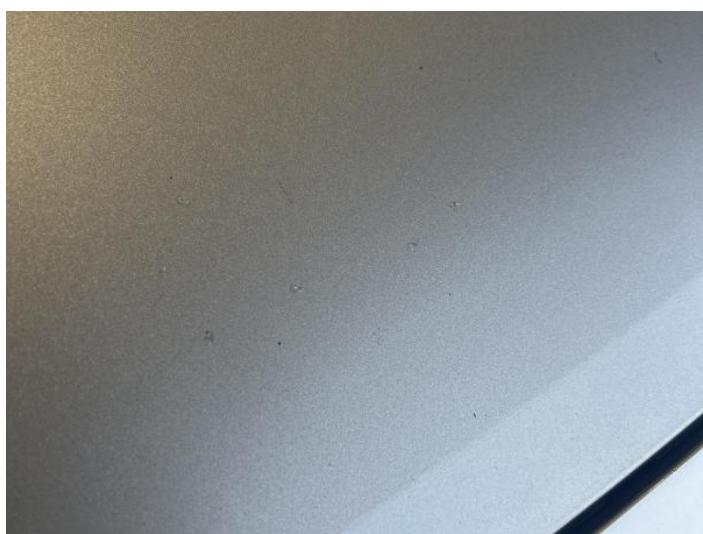
12: Bonnet  
Chipped  
Multiple Chips

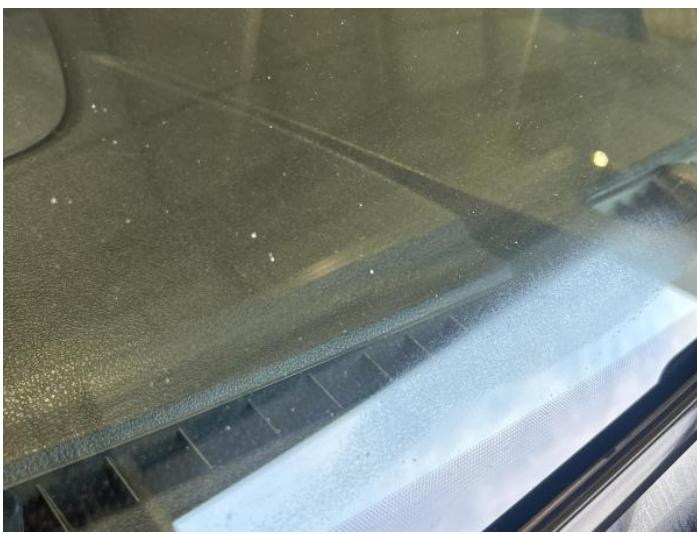
13: Screen Front  
Chipped  
UpTo 10mm

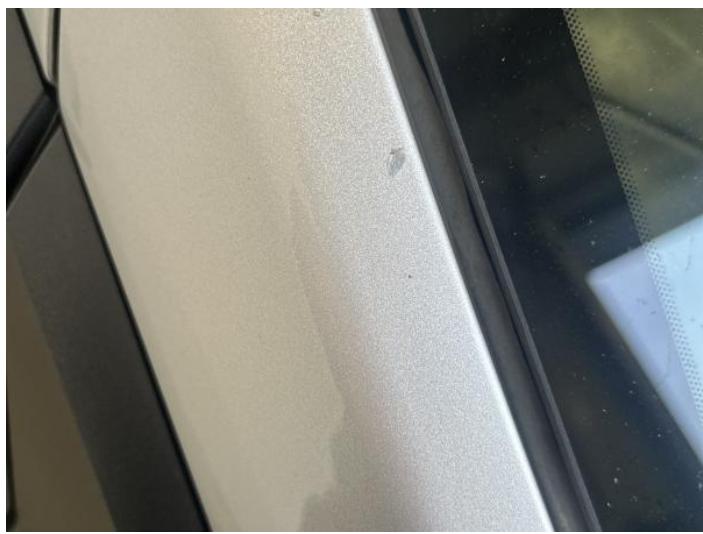
14: A Post os  
Chipped  
1 To 5

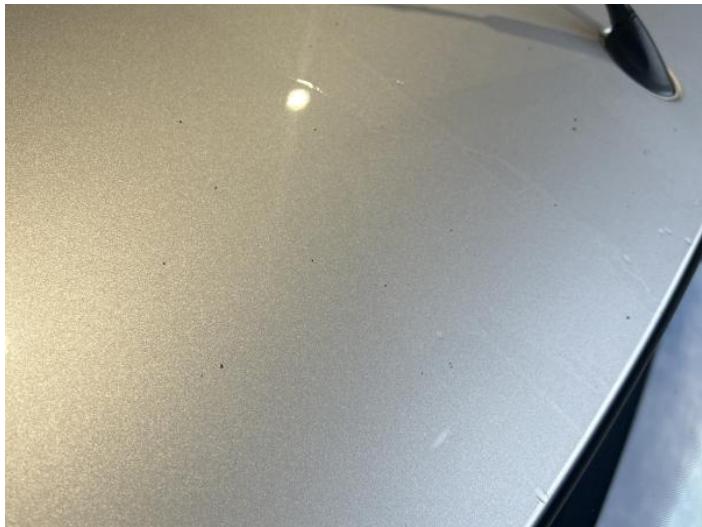
15: Roof  
Chipped  
Multiple Chips

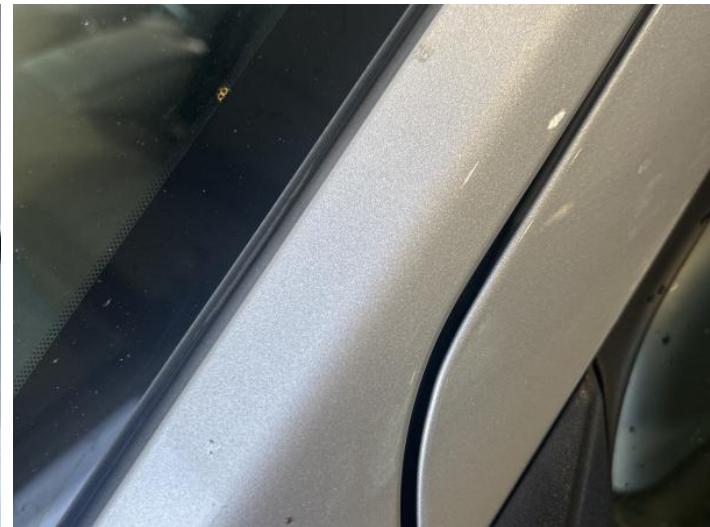
16: A Post ns  
Chipped  
1 To 5
