VEHICLE INSPECTION REPORT

GY14UBM

Toyota Auris 1.6 V-Matic Excel 5dr Multidrive S

Inspection	Vehicle		GRADE 3
Serious Damage?	VAT	Margin	
No	V5	Present

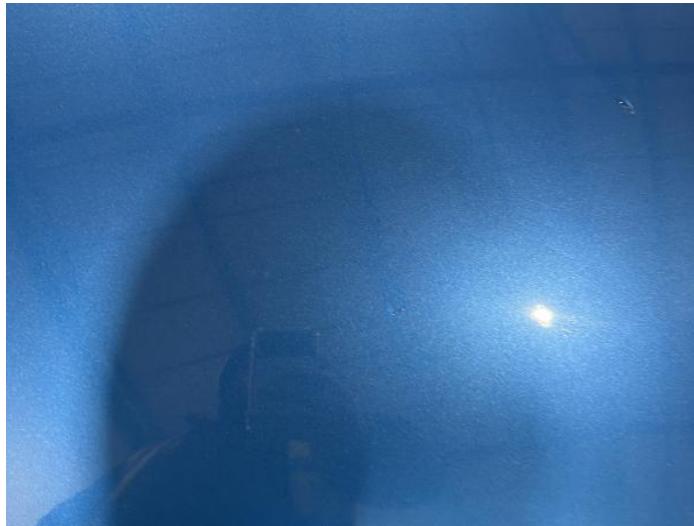
1: Bonnet
Chipped
1 To 5

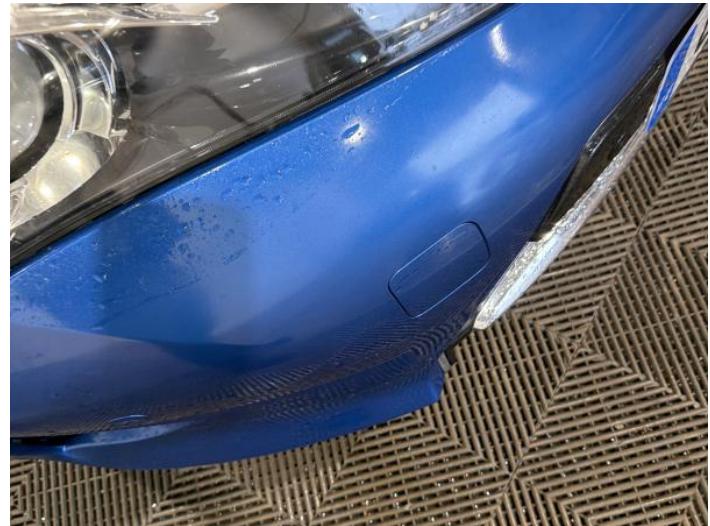
2: Bumper Front
Poor Previous Repair
Poor Paint

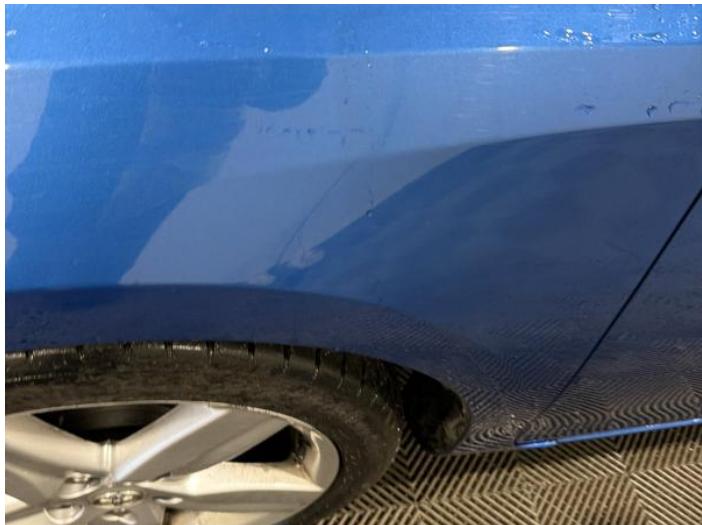
3: Wing nsf
Chipped
1 To 5

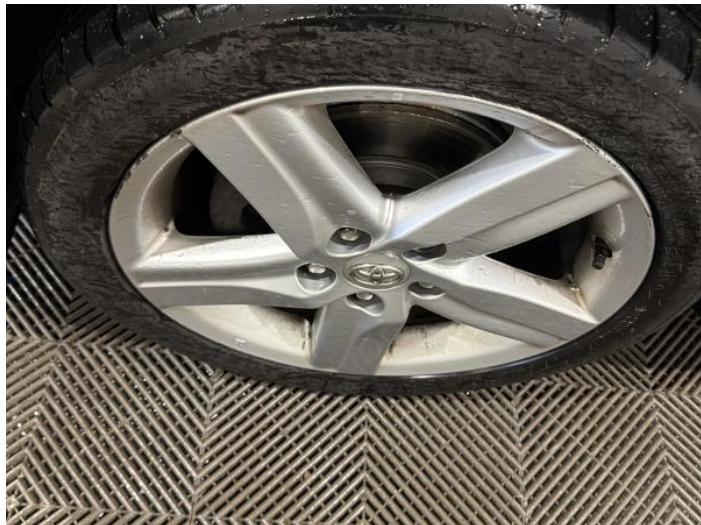
4: Wheel nsf
Scratched
Over 50mm

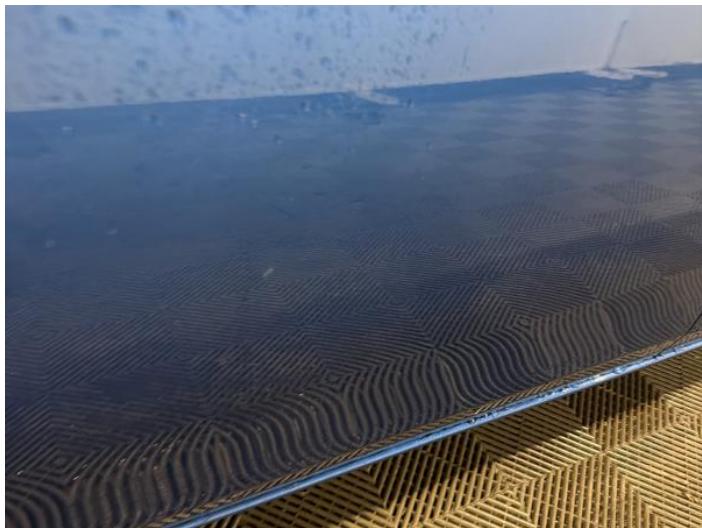
6: Door nsf
Scratched
Over 25mm Not Thru Paint

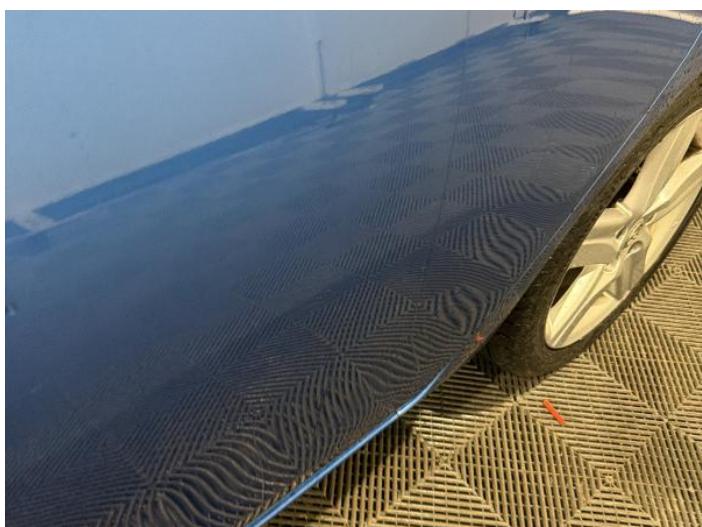
8: Door nsr
Scratched
Over 25mm Not Thru Paint

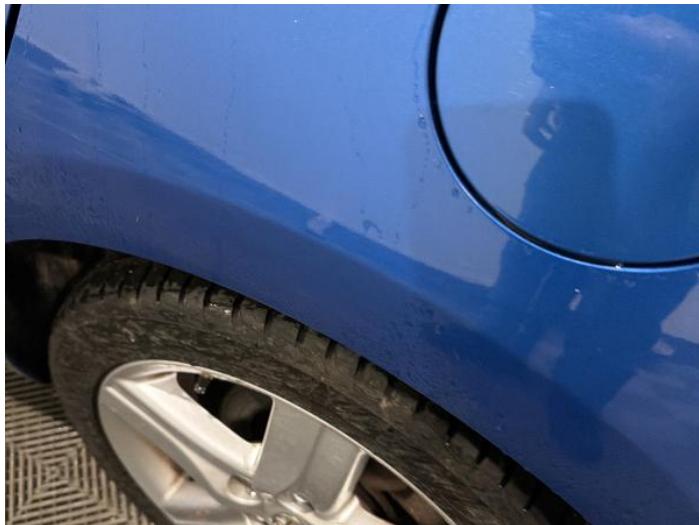
9: Qtr Panel nsr
Dented
With Paint Damage

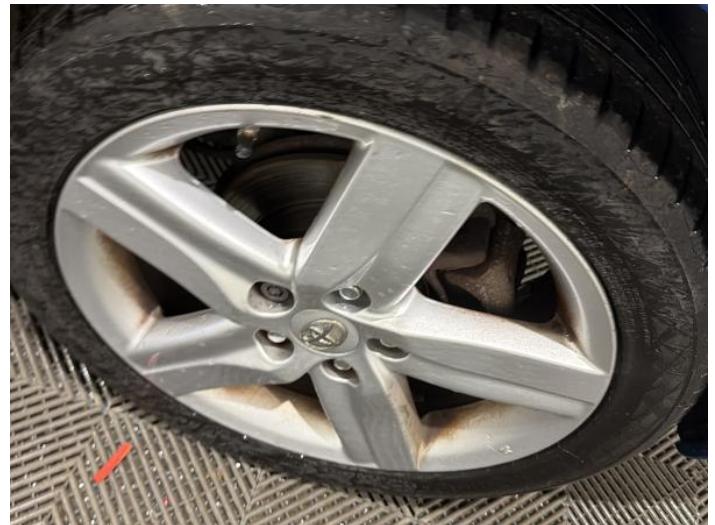
10: Wheel nsr
Scratched
Up To 50mm

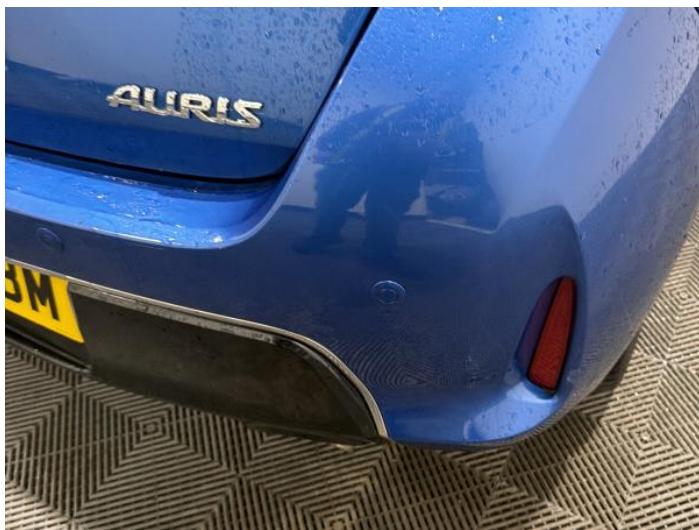
12: Bumper Rear
Scratched
Over 25mm Not Thru Paint

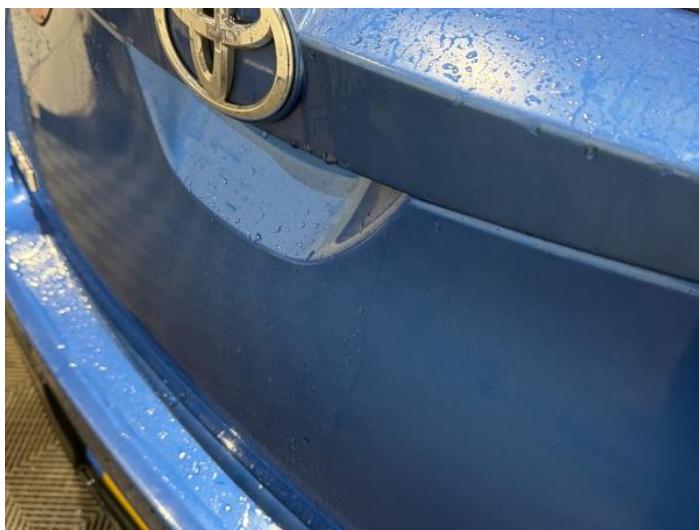
13: Boot Lid
Dented
Over 2 UpTo 10mm

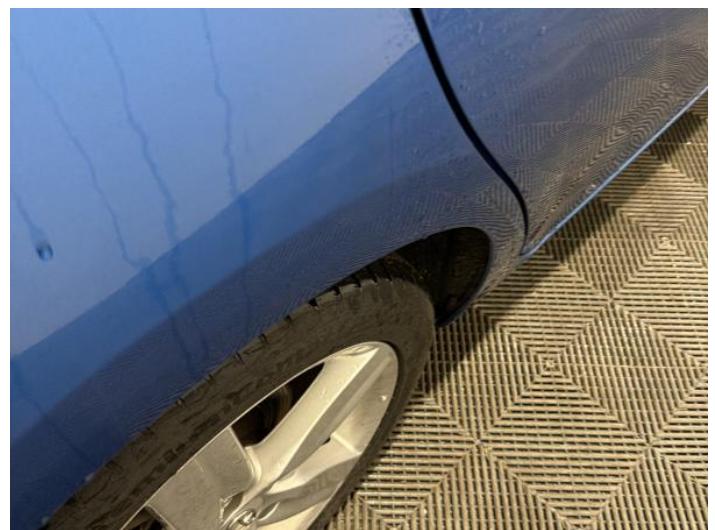
14: Qtr Panel osr
Dented
2 Or Less UpTo 10mm

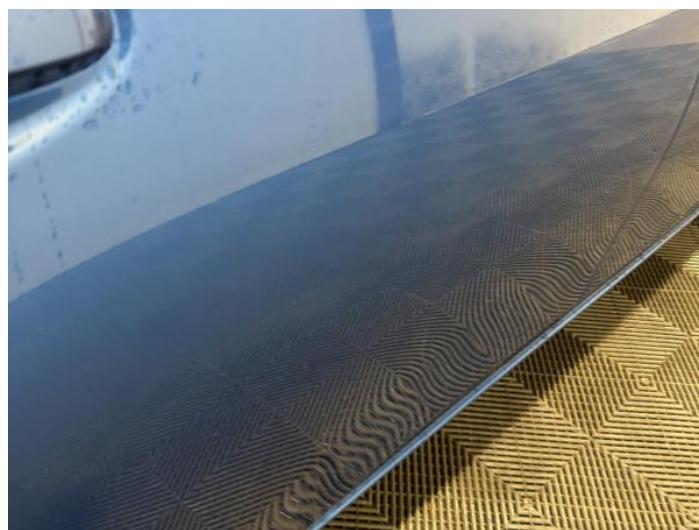
18: Door osr
Scratched
Over 25mm Not Thru Paint

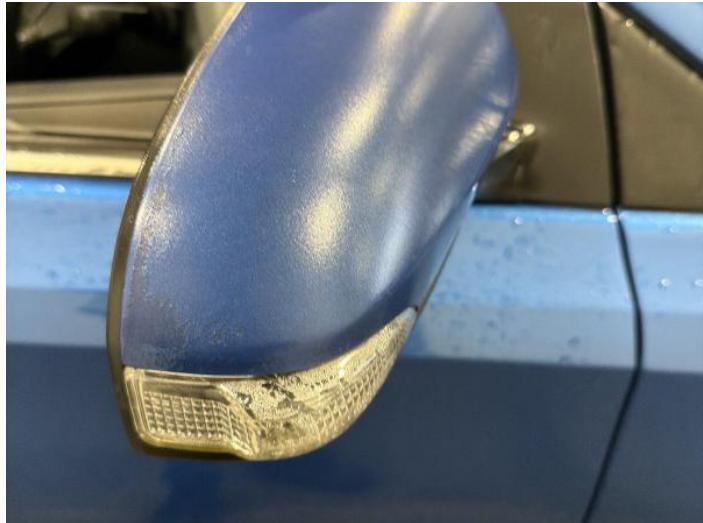
22: Door Mirror Assy osf
Scratched (Painted)
Over 25mm Thru Paint

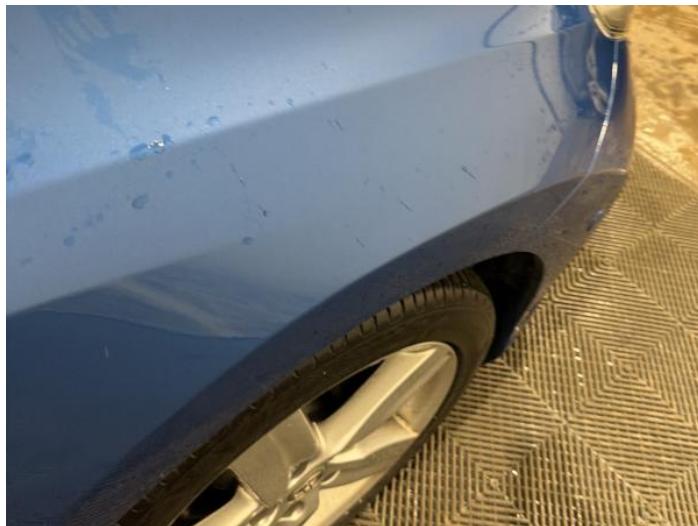
24: Wing osf
Scratched
Over 25mm Not Thru Paint

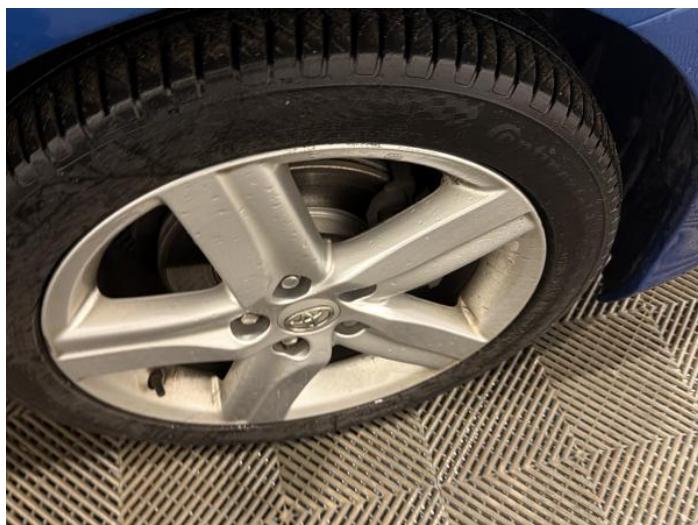
25: Wheel osf
Scratched
Over 50mm

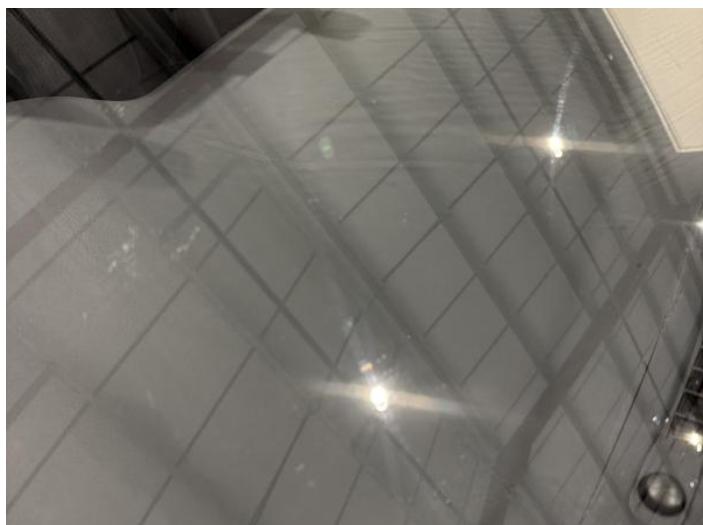
26: Screen Front
Chipped
UpTo 10mm
