VEHICLE INSPECTION REPORT

YD67XAM

Land Rover Range Rover Evoque 2.0 TD4 SE Tech 5dr Auto

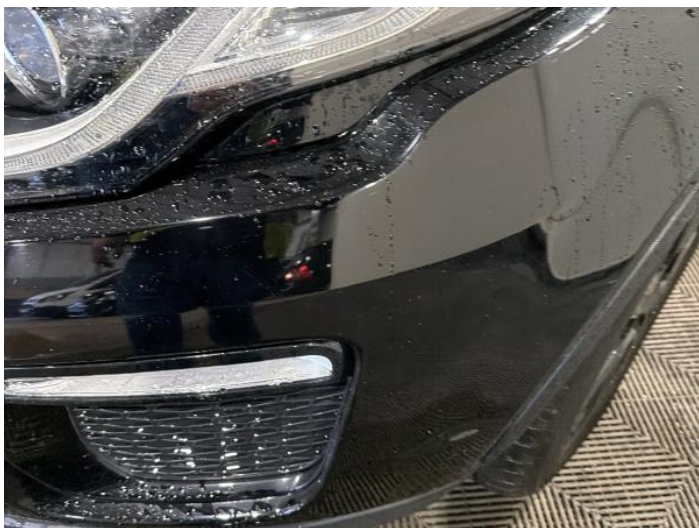
1: Bumper Front
Chipped
Multiple Chips

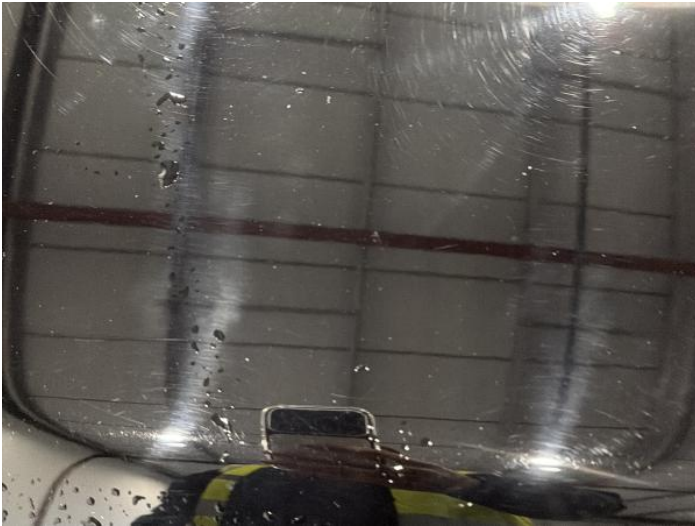
3: Bonnet
Chipped
Multiple Chips

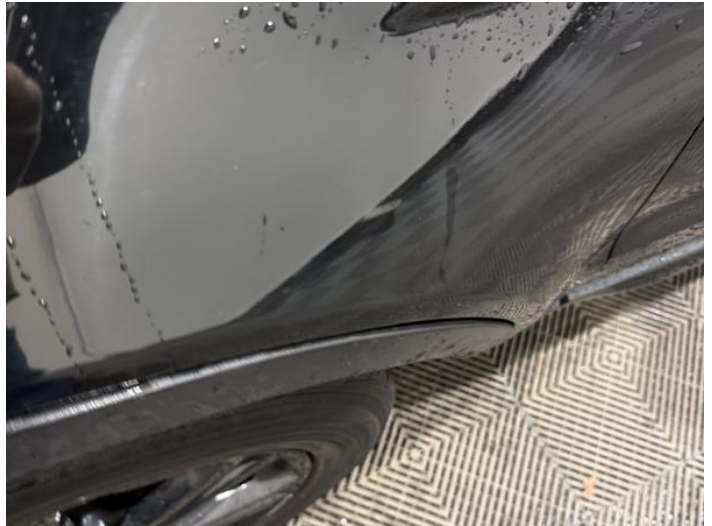
4: Wing nsf
Poor Previous Repair
Poor Paint

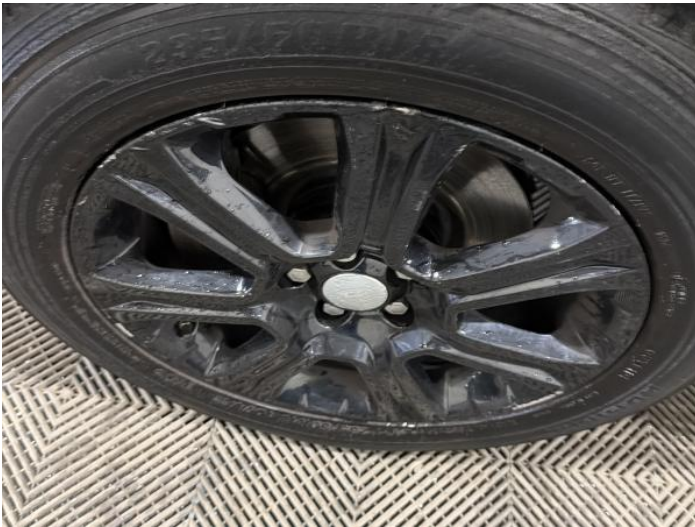
5: Wheel nsf
Scratched
Over 50mm

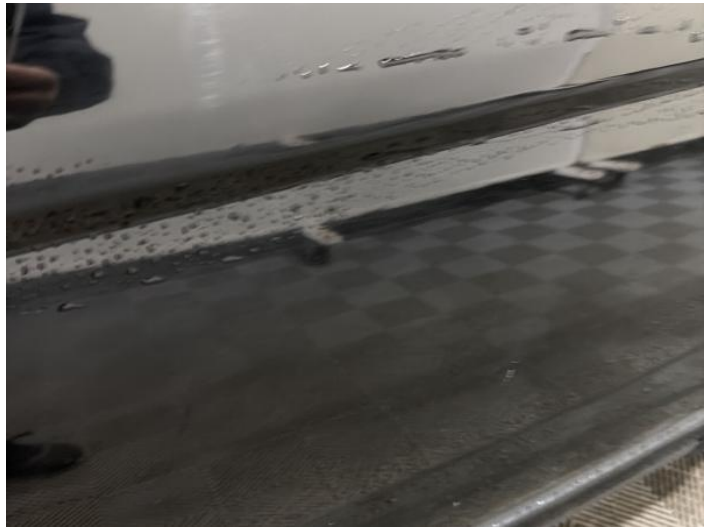
6: Door nsf
Poor Previous Repair
Poor Paint

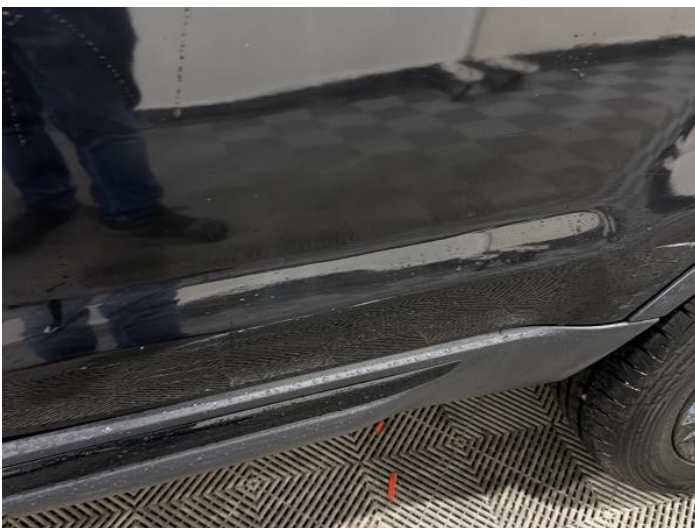
7: Door nsr
Dented
With Paint Damage

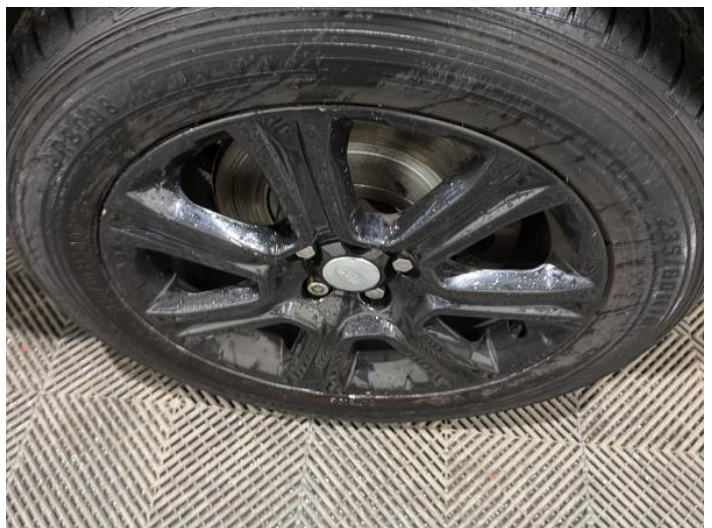
8: Wheel nsr
Scratched
Up To 50mm

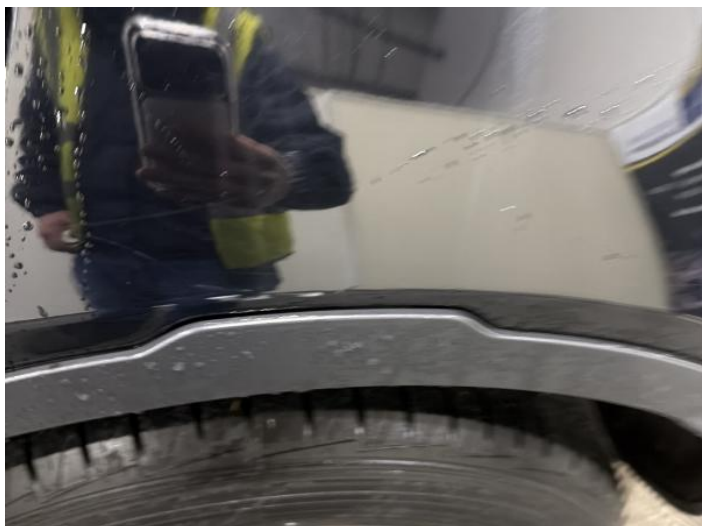
9: Qtr Panel nsr
Scratched
Over 25mm Thru Paint

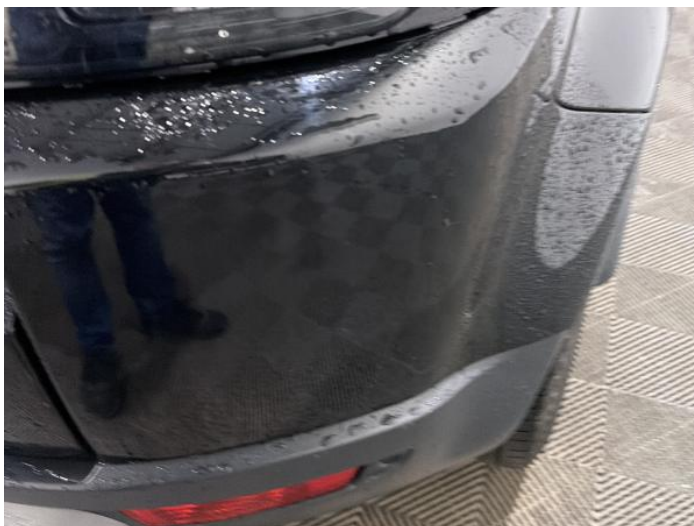
10: Bumper Rear
Chipped
Multiple Chips

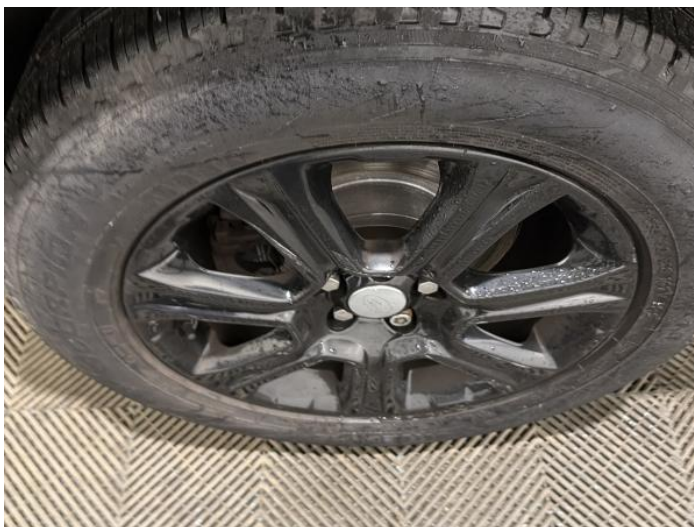
14: Wheel osr
Scratched
Up To 50mm

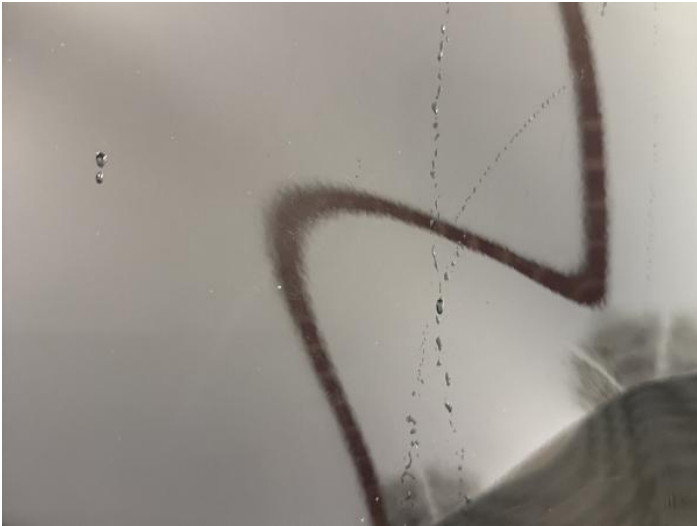
15: Door osr
Chipped
1 To 5

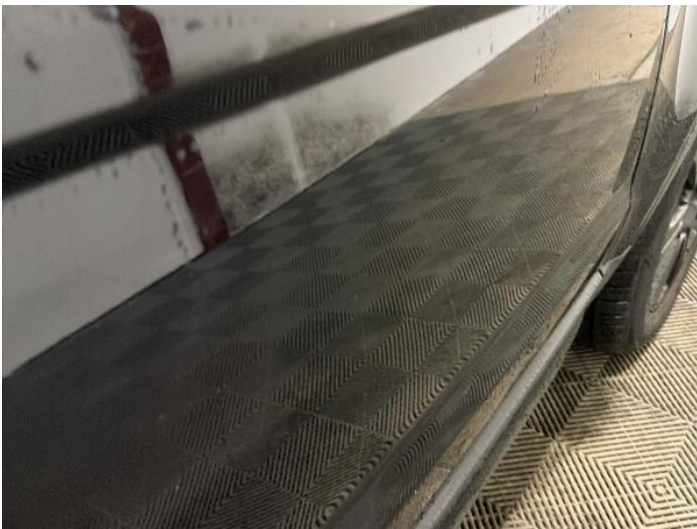
17: Door osf
Dented
Over 2 UpTo 10mm

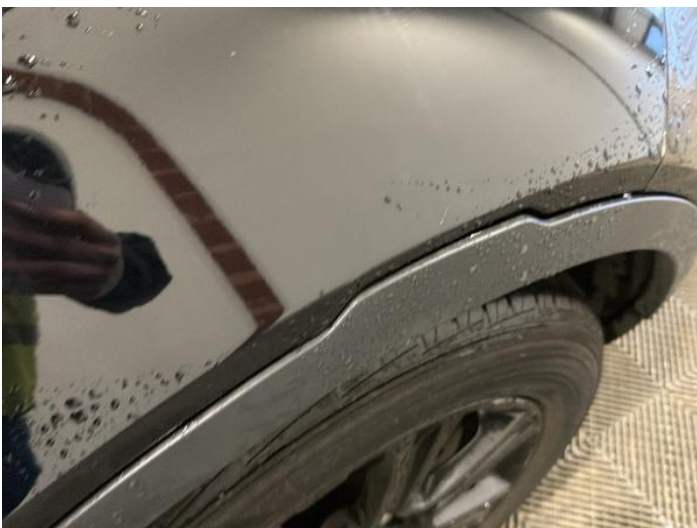
19: Wing osf
Chipped
1 To 5
