## VEHICLE INSPECTION REPORT

**BG19SOA**

### Ford Galaxy 2.0 EcoBlue 150 Titanium 5dr

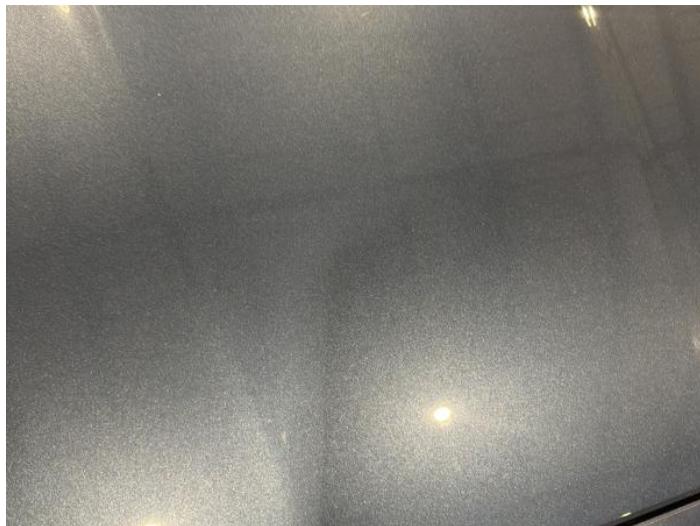
1: Bonnet  
Chipped  
1 To 5

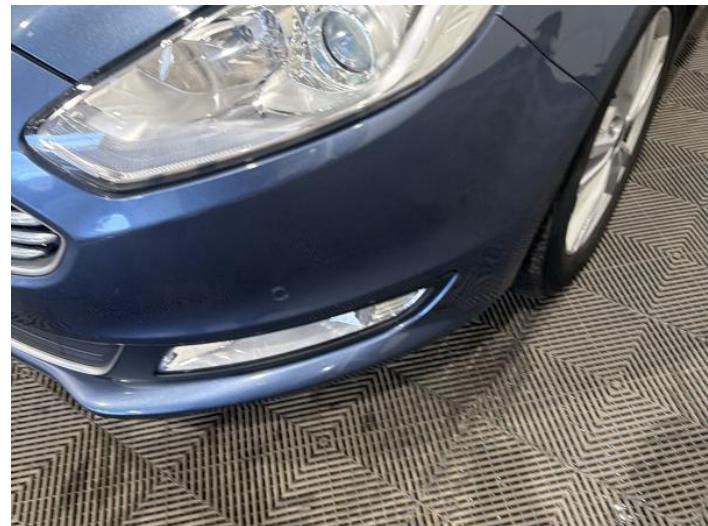
2: Bumper Front  
Chipped  
Multiple Chips

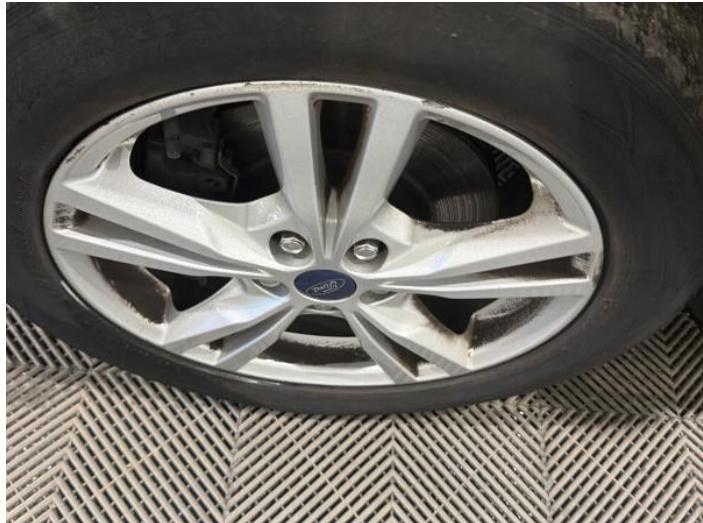
4: Wheel nsf  
Scratched  
Up To 50mm

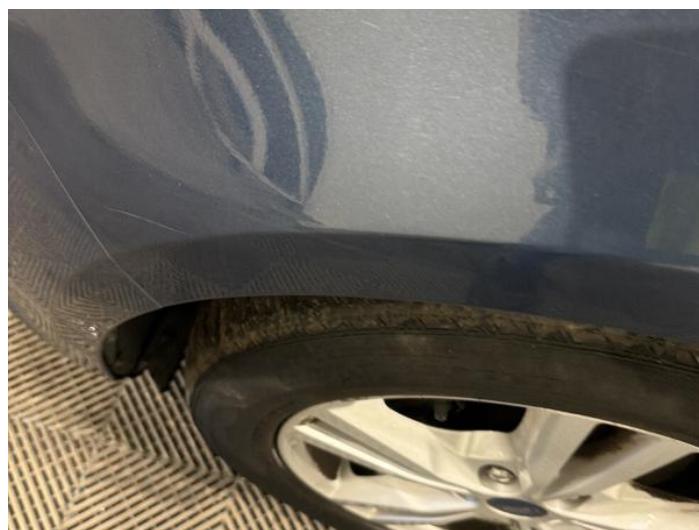
5: Wing nsf  
Scratched  
UpTo 25mm Thru Paint

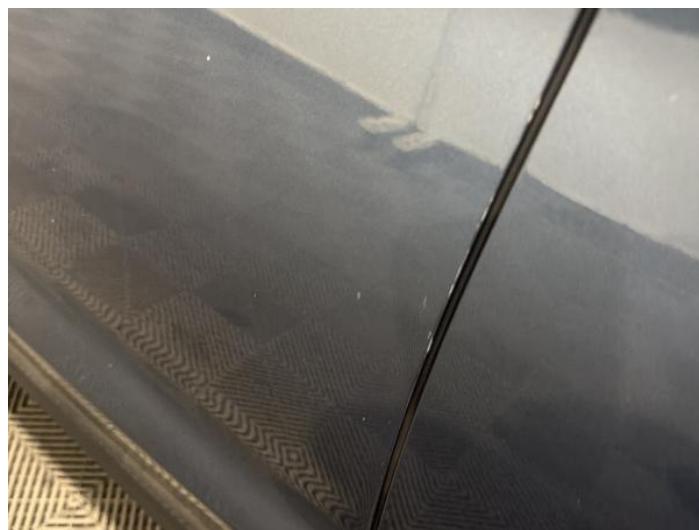
7: Door nsf  
Chipped  
1 To 5

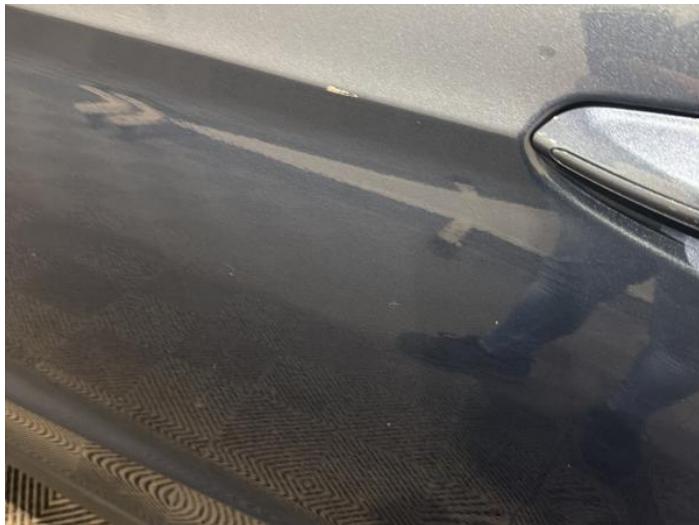
9: Door nsr  
Scratched  
Over 25mm Thru Paint

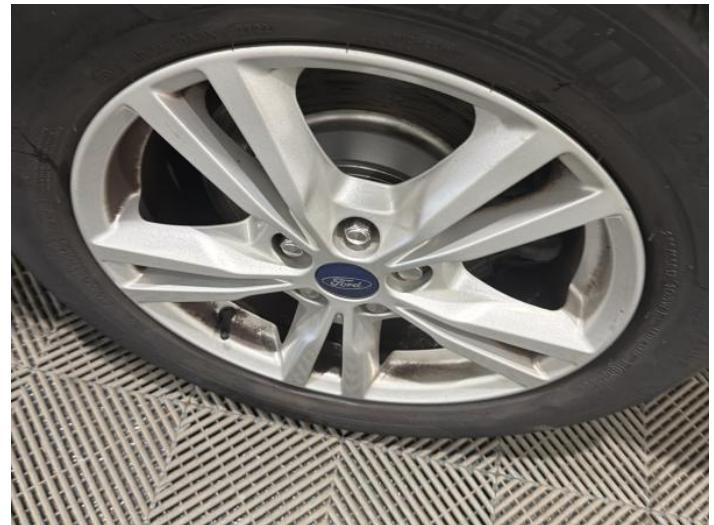
10: Wheel nsr  
Scratched  
Up To 50mm

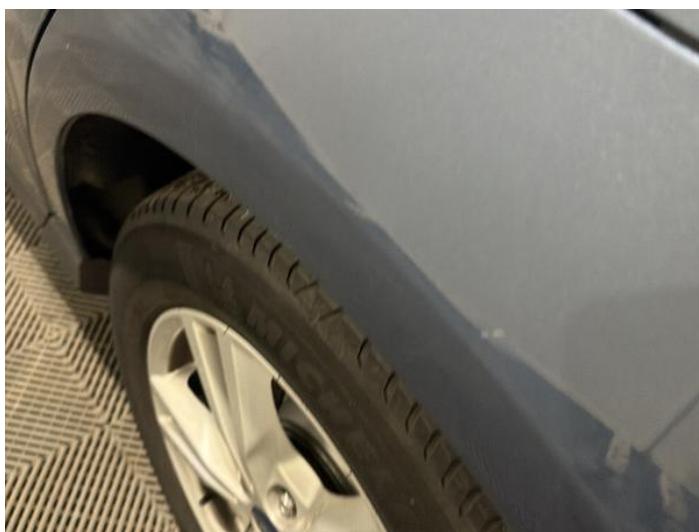
11: Qtr Panel nsr  
Dented  
With Paint Damage

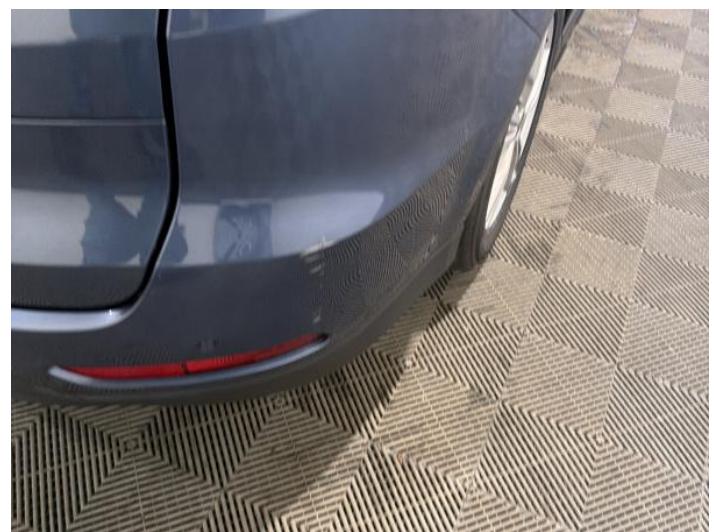
12: Bumper Rear  
Scratched  
Over 100mm Thru Paint

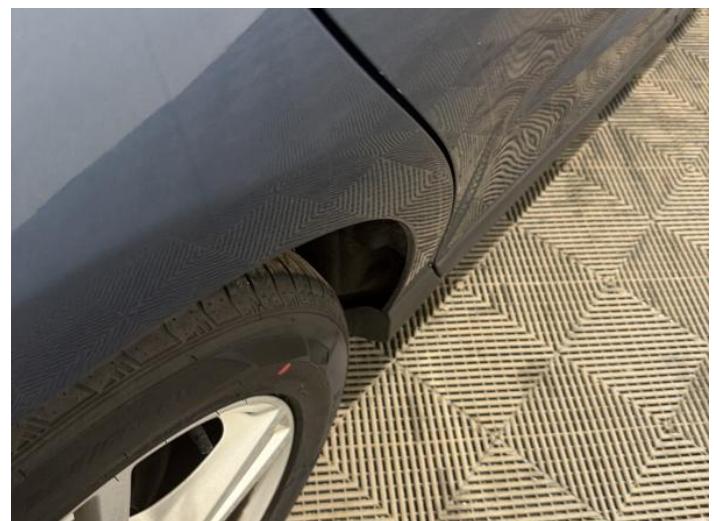
14: Qtr Panel osr  
Dented  
2 Or Less UpTo 10mm

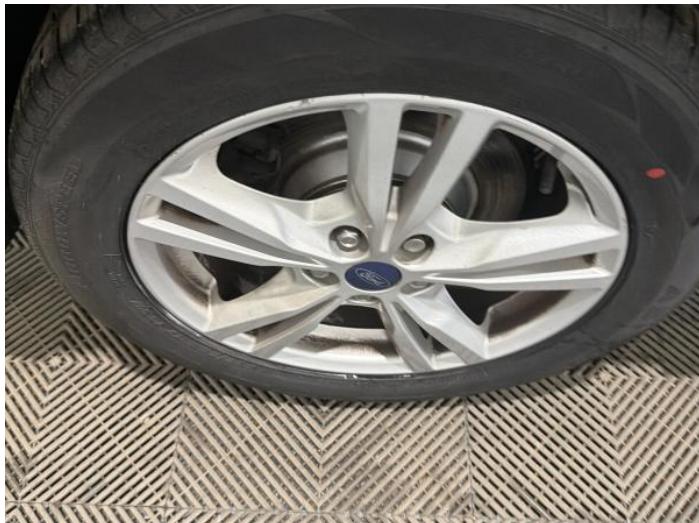
15: Wheel osr  
Scratched  
Up To 50mm

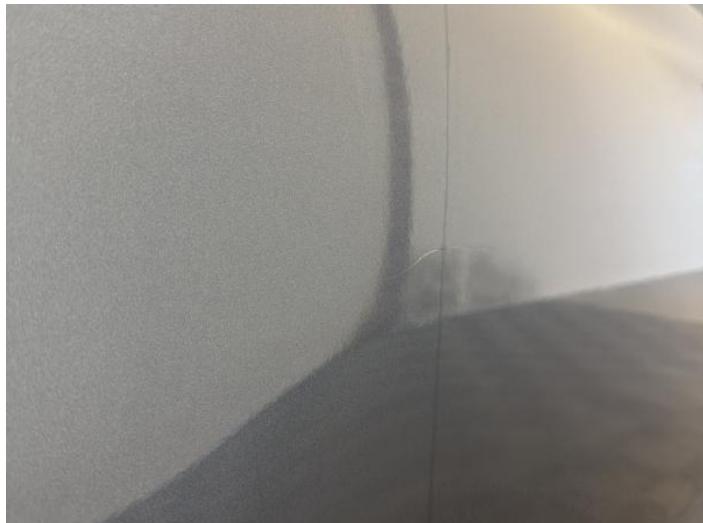
16: Door osr  
Scratched  
UpTo 25mm Thru Paint

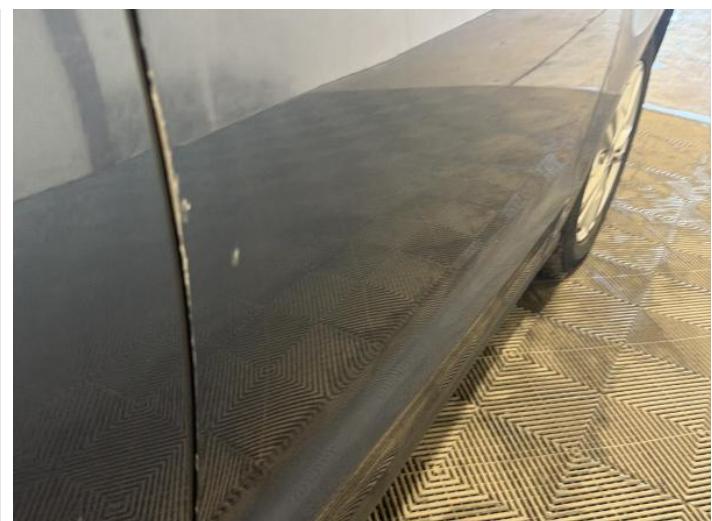
18: Door osf  
Scratched  
Over 25mm Thru Paint

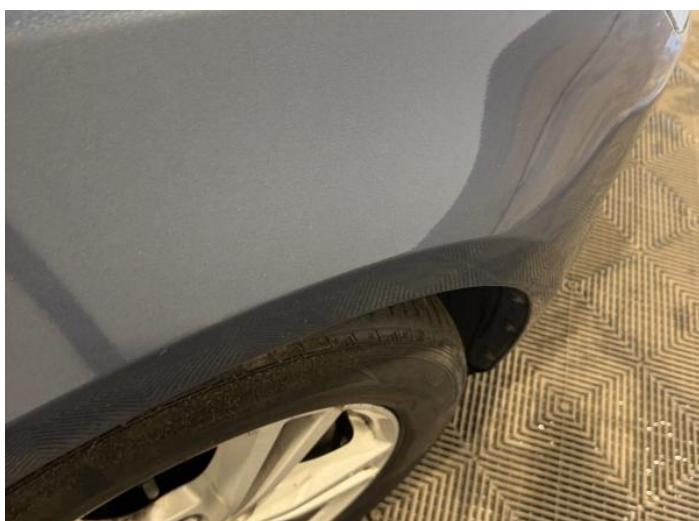
19: Wing osf  
Dented  
Between 10mm + 30mm

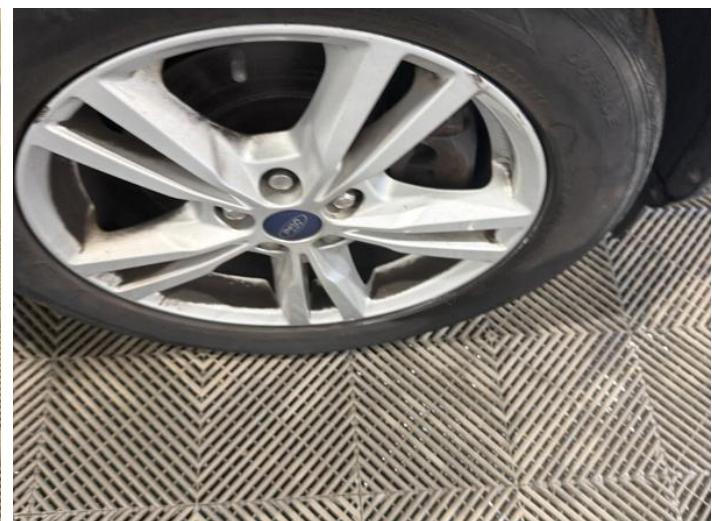
20: Wheel osf  
Scratched  
Over 50mm

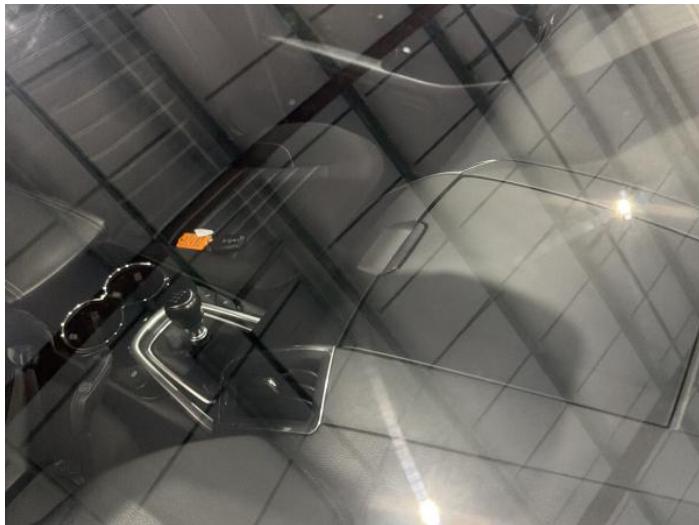
21: Screen Front  
Chipped  
UpTo 10mm

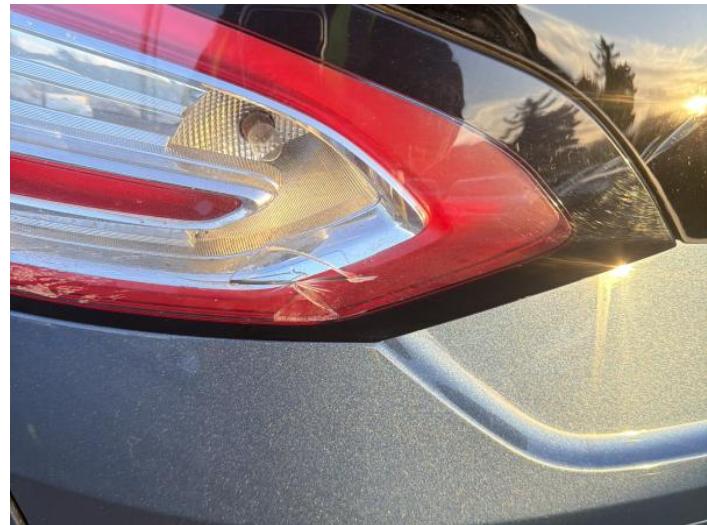
22: Lamp nsr  
Broken  
Replace

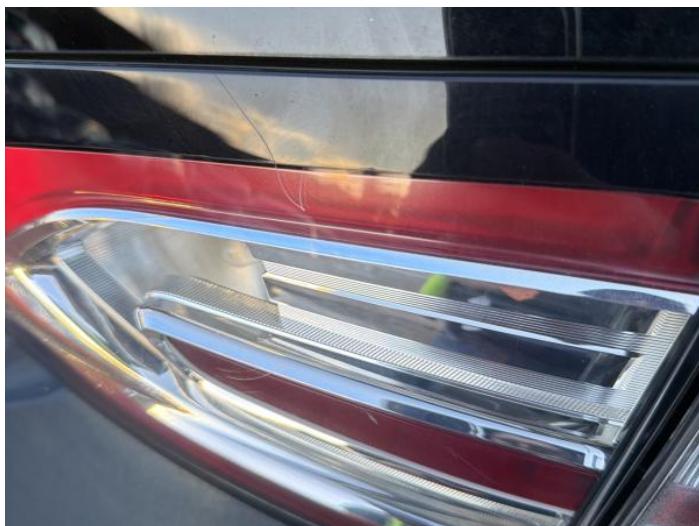
23: Lamp osr  
Broken  
Replace
