VEHICLE INSPECTION REPORT

LJ12KDN

Vauxhall Astra 1.6i 16V SRi [115] 3dr

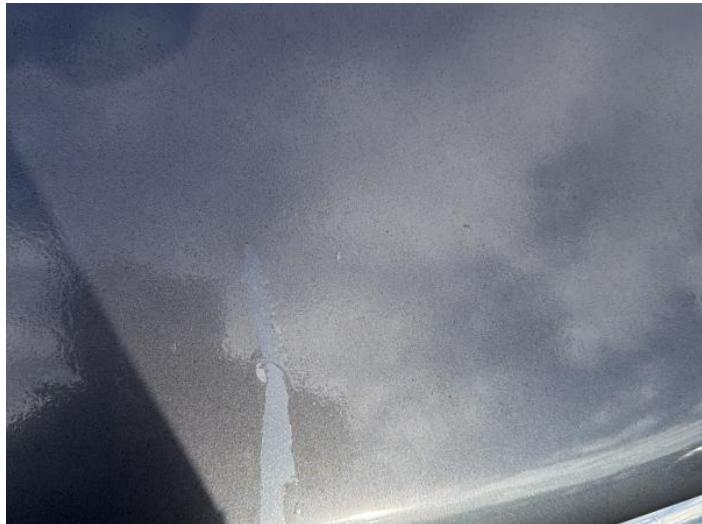
1: Bonnet
Poor Previous Repair
Paint Flake

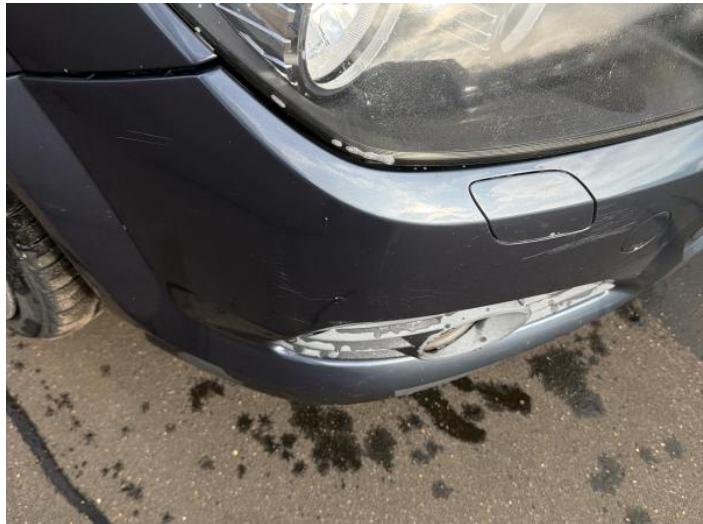
2: Bumper Front
Scratched
Over 100mm Thru Paint

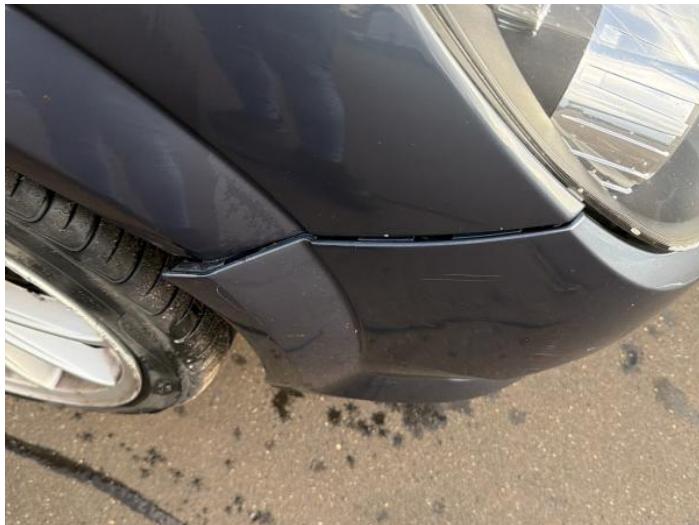
3: Bumper Front
Insecure
Action Required

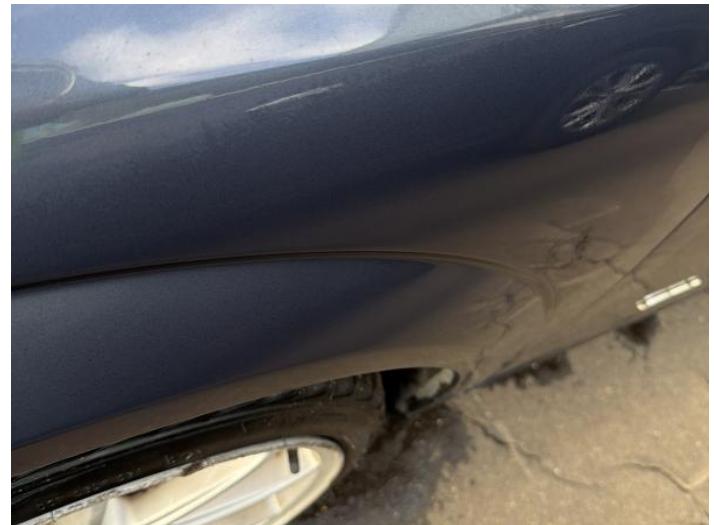
4: Wing nsf
Dented
Over 2 UpTo 10mm

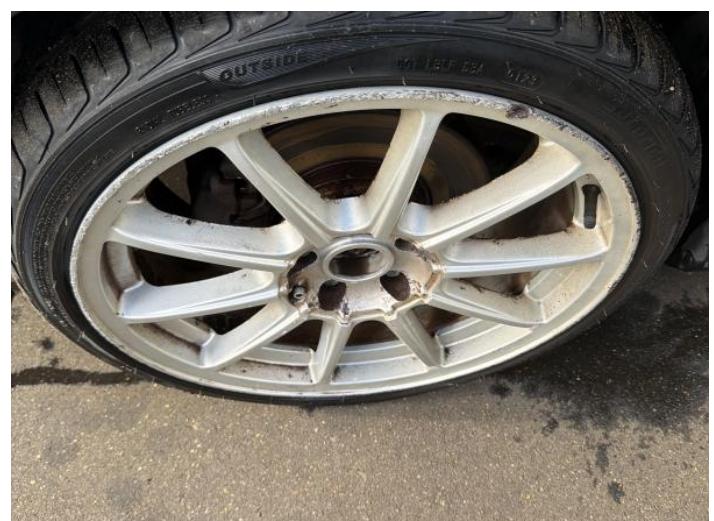
6: Wheel nsf
Scratched
Over 50mm

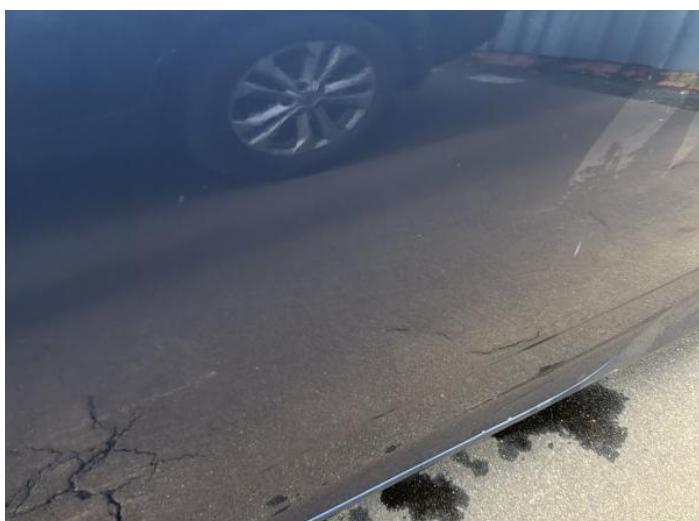
7: Door nsf
Chipped
Multiple Chips

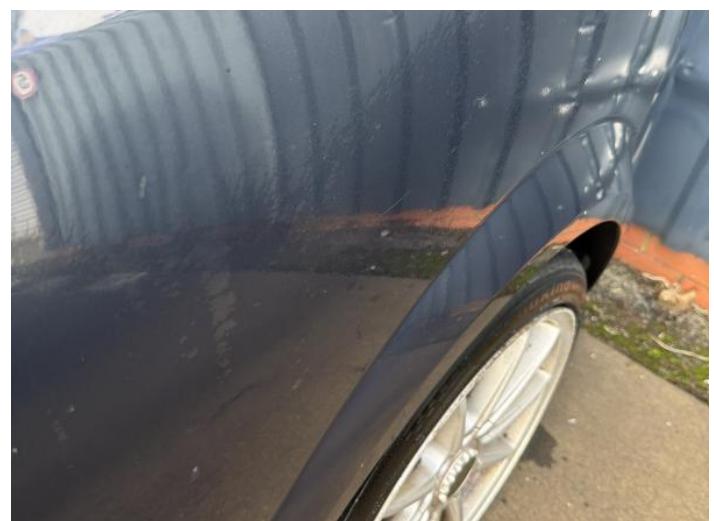
8: Qtr Panel nsr
Dented
With Paint Damage

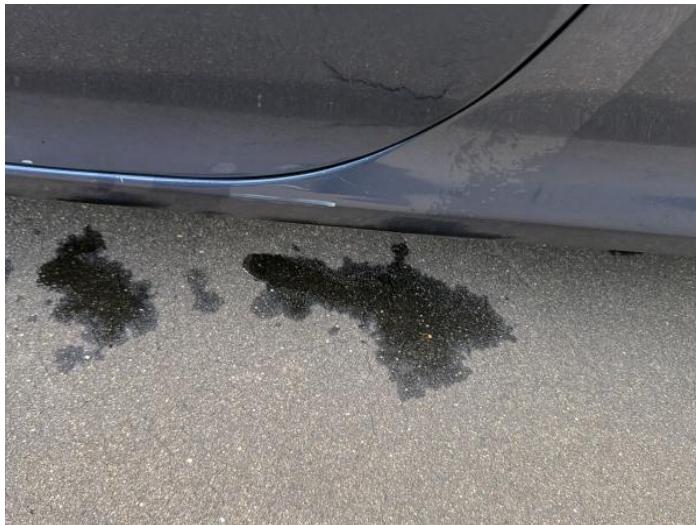
9: Sill ns
Scratched
Over 25mm Thru Paint

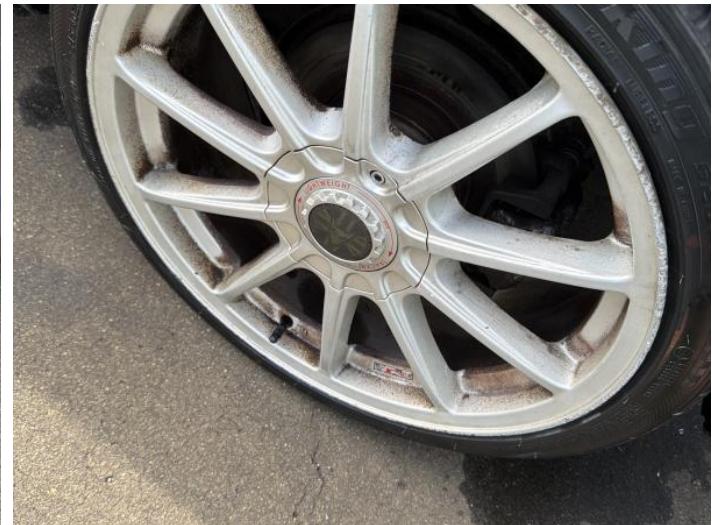
10: Wheel nsr
Scratched
Over 50mm

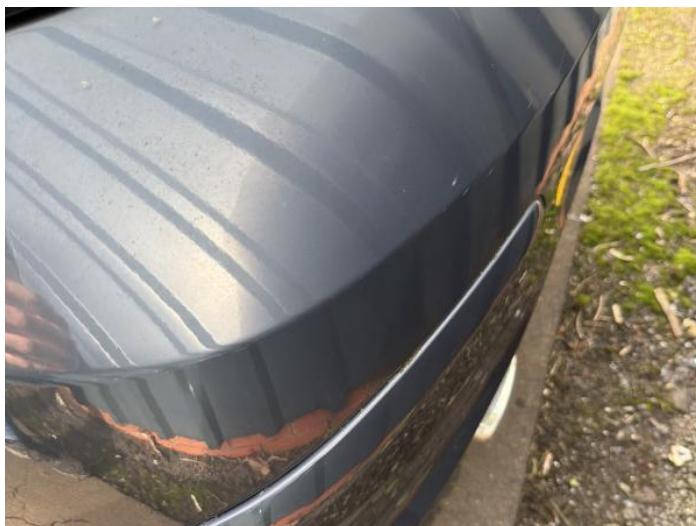
11: Bumper Rear
Poor Previous Repair
Poor Paint

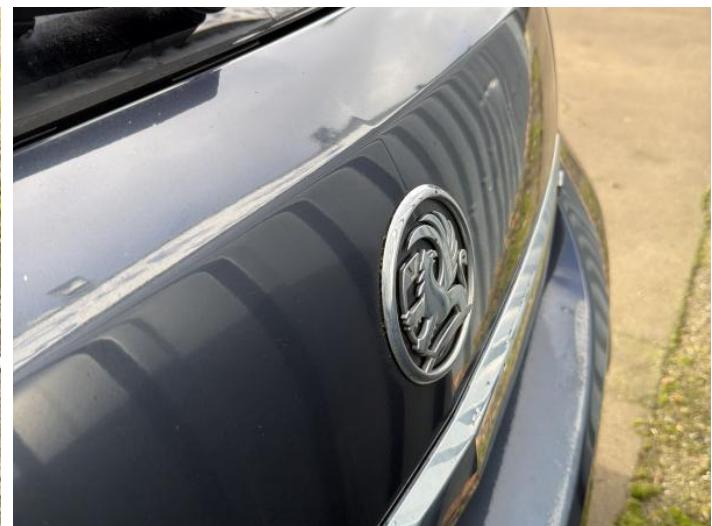
12: Boot Lid
Dented
Over 2 UpTo 10mm

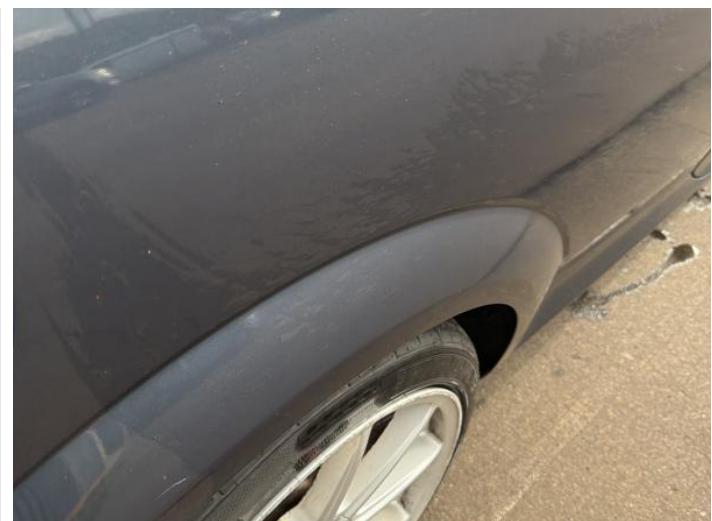
14: Qtr Panel osr
Chipped
Multiple Chips

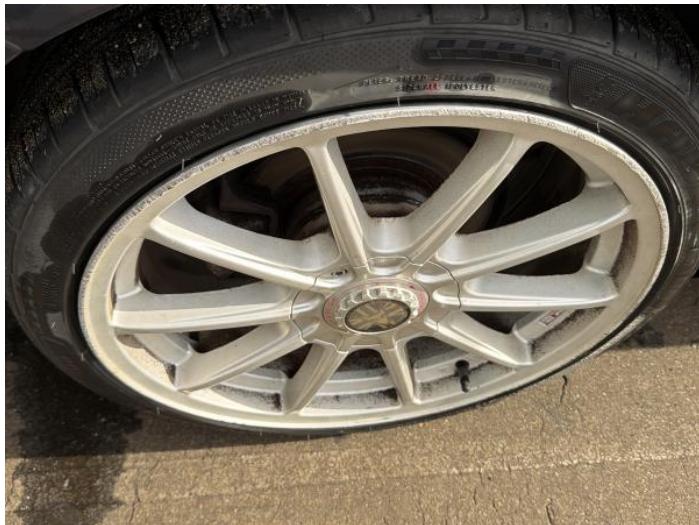
15: Wheel osf
Scratched
Over 50mm

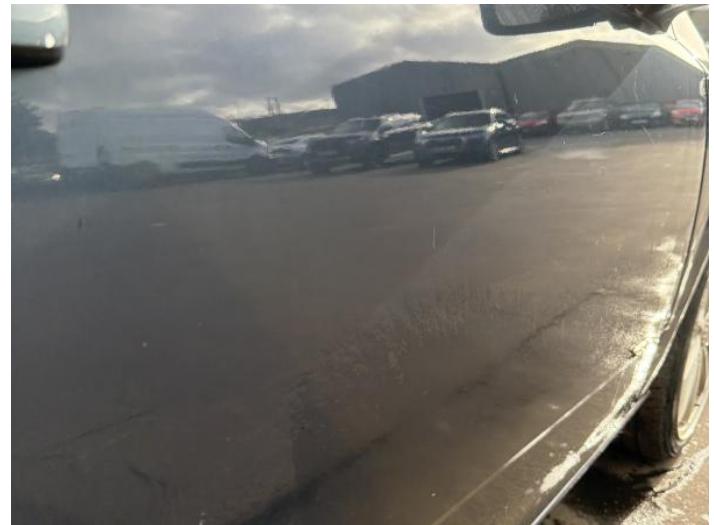
16: Door osf
Scratched
Over 25mm Thru Paint

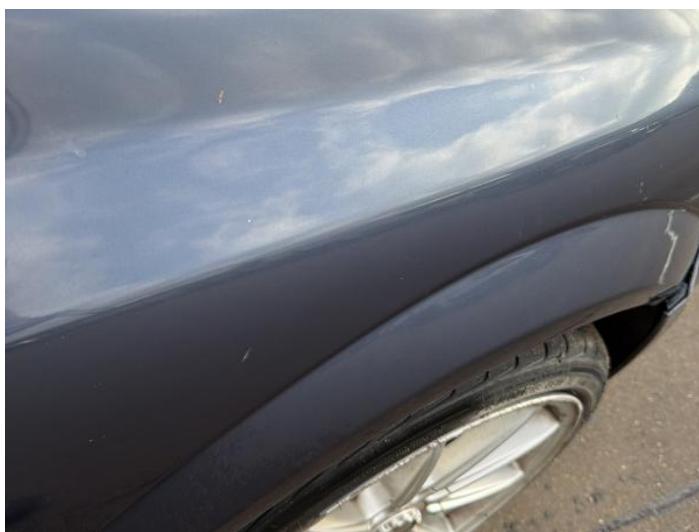
17: Wing osf
Chipped
Multiple Chips

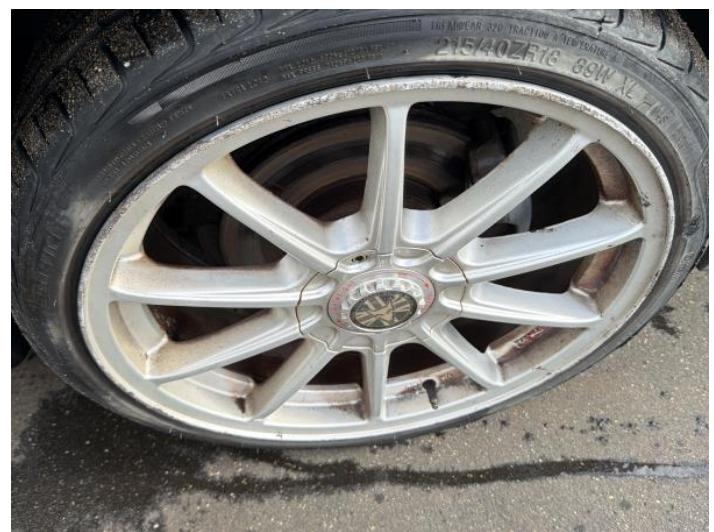
18: Wheel osf
Scratched
Over 50mm

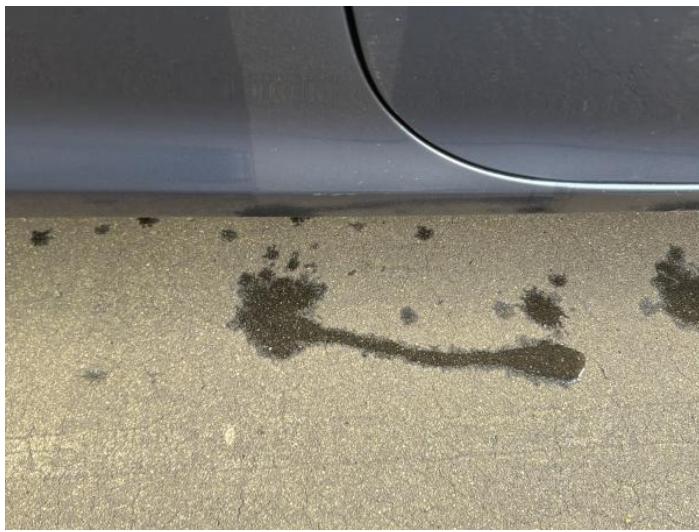
19: Sill os
Scratched
UpTo 25mm Thru Paint

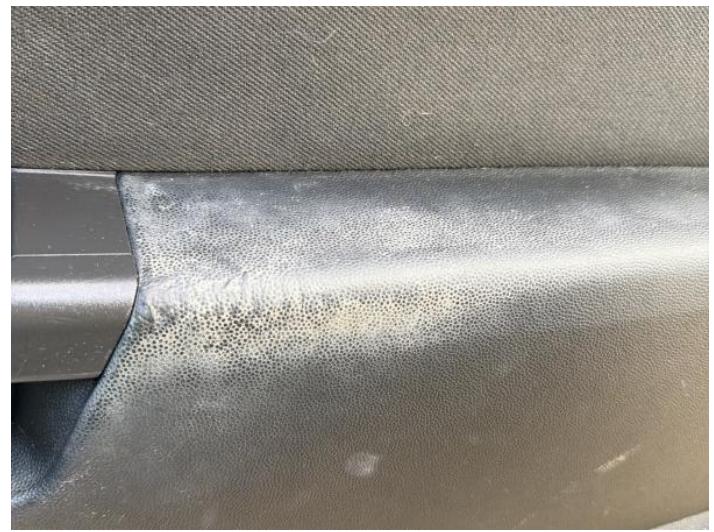
20: Door Pad osf
Scuffed
UpTo 25mm
