VEHICLE INSPECTION REPORT

BT13MFV

Volkswagen Golf 1.6 TDI BlueMotion Tech SE 2dr

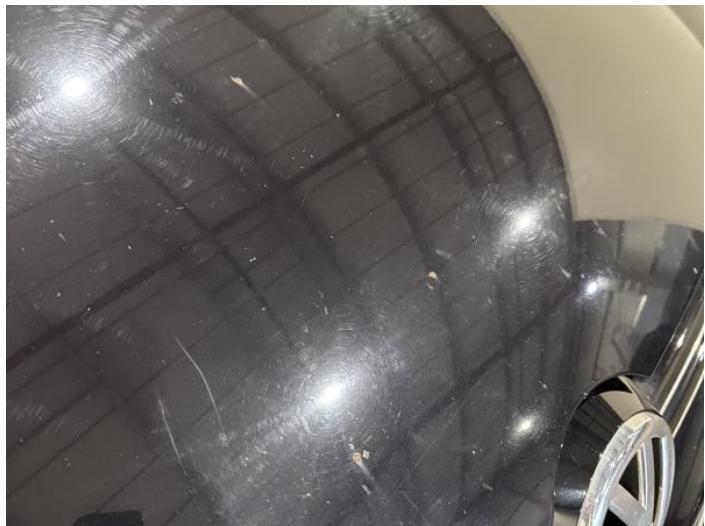
1: Bonnet
Chipped
Multiple Chips

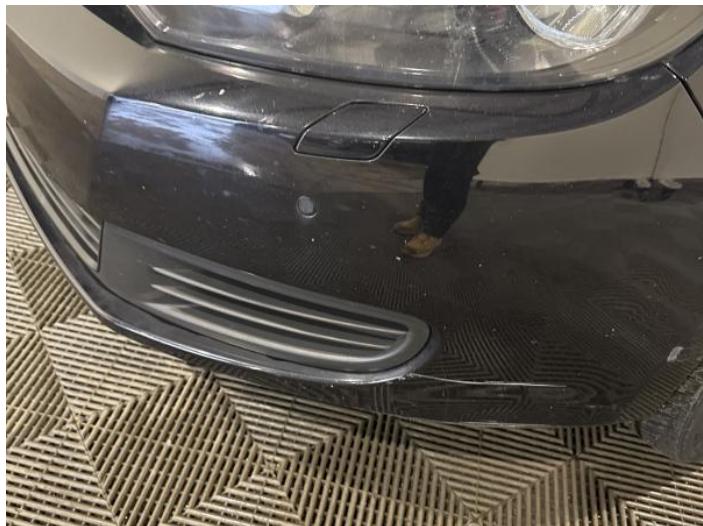
2: Bumper Front
Chipped
Multiple Chips

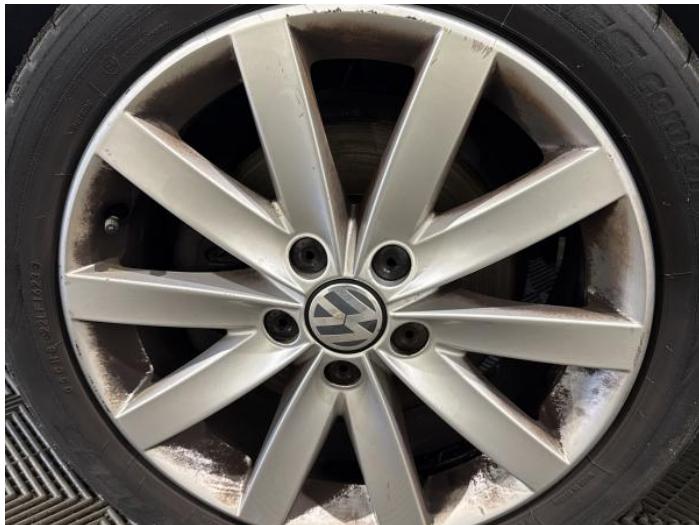
3: Wheel nsf
Scratched
Over 50mm

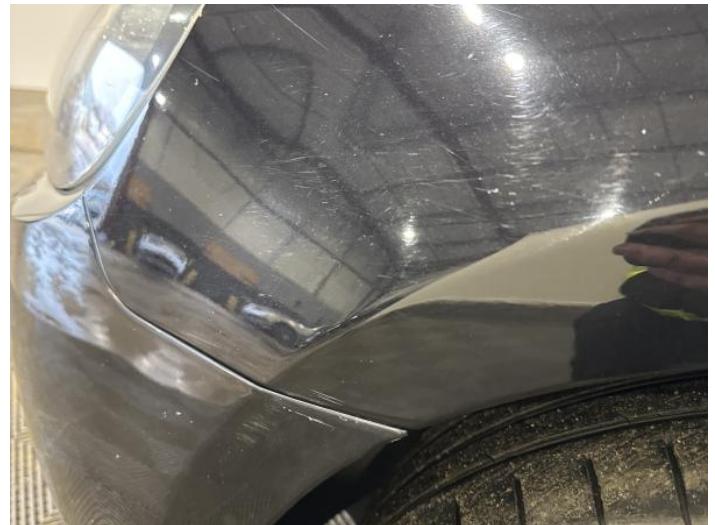
4: Wing nsf
Scratched
Over 25mm Thru Paint

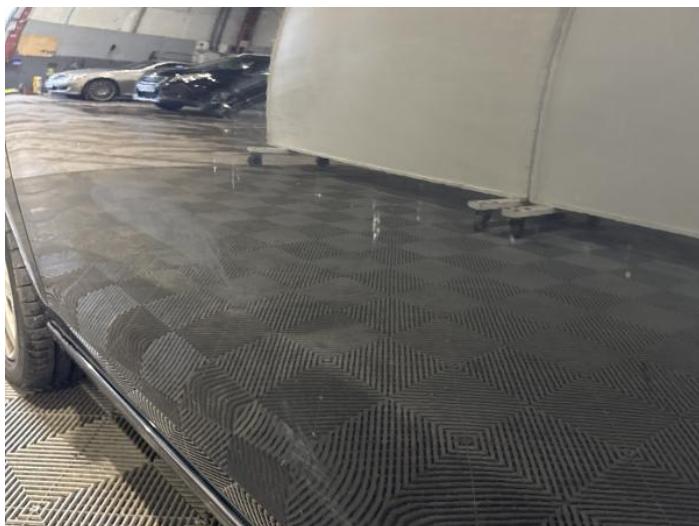
5: Door nsf
Scratched
Over 25mm Thru Paint

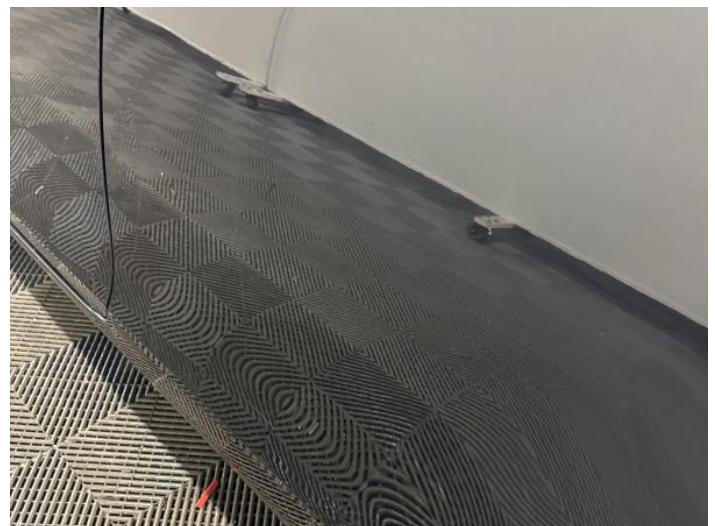
6: Qtr Panel nsf
Scratched
Over 25mm Thru Paint

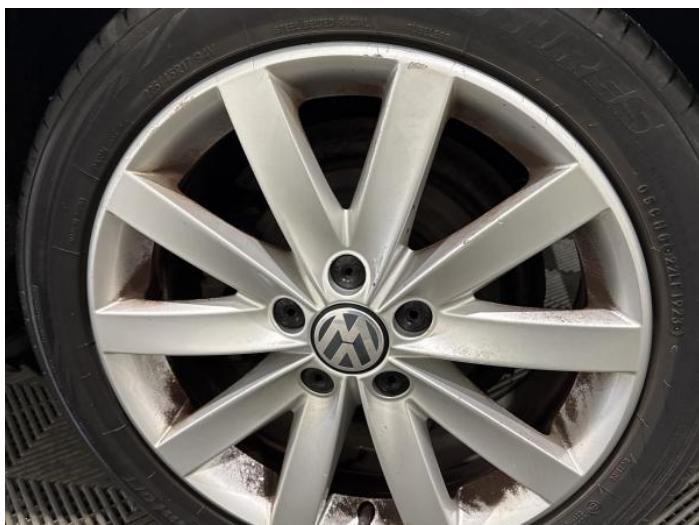
7: Wheel nsf
Scratched
Over 50mm

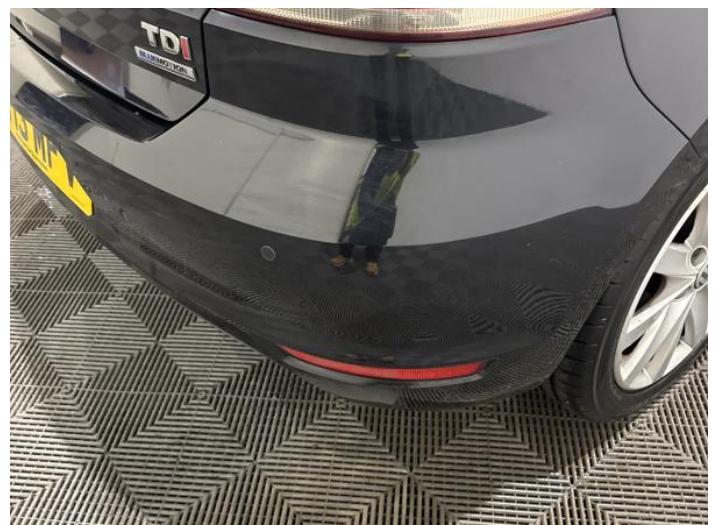
8: Bumper Rear
Scratched
25 to 100mm Thru Paint

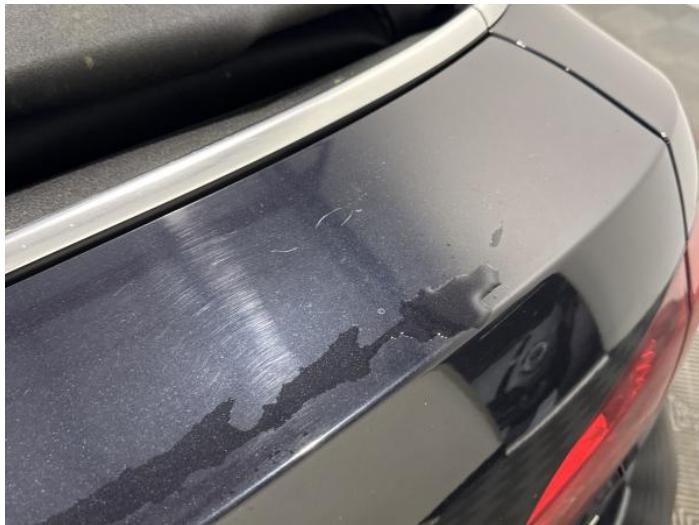
9: Boot Lid
Scratched
UpTo 25mm Thru Paint

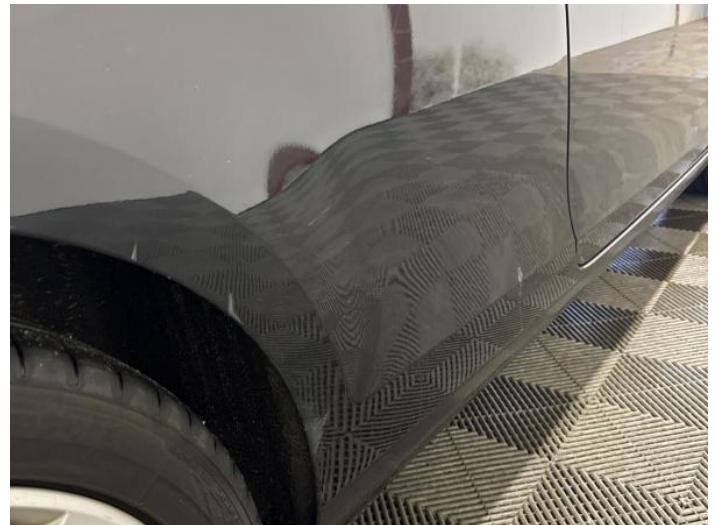
10: Qtr Panel osr
Scratched
Over 25mm Thru Paint

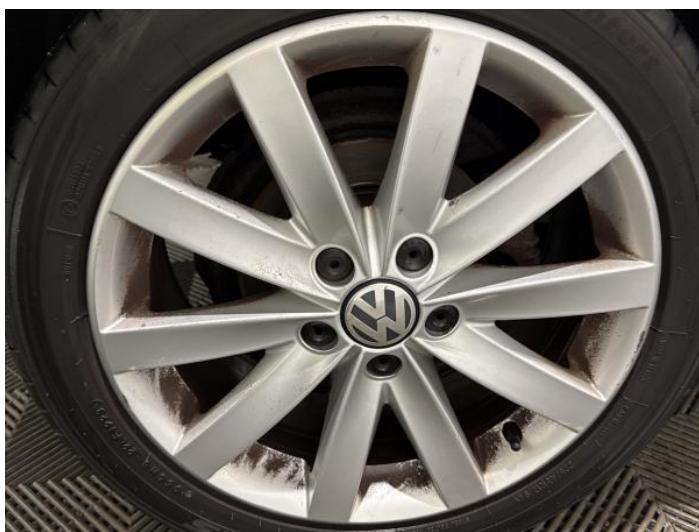
11: Wheel osr
Scratched
Over 50mm

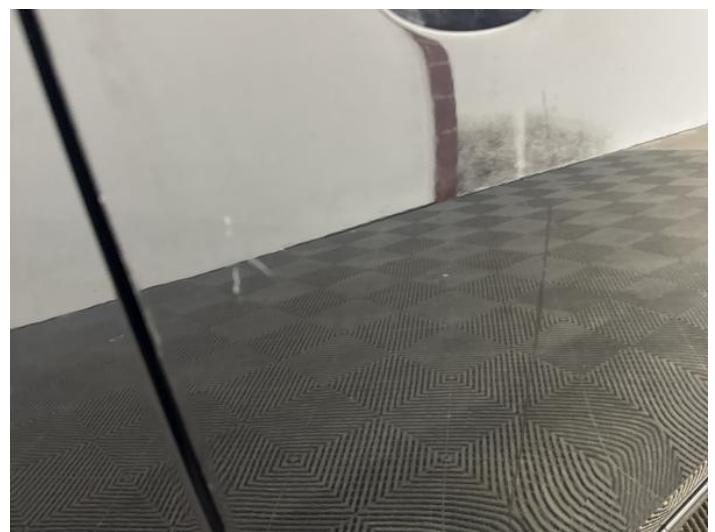
12: Door osr
Scratched
UpTo 25mm Thru Paint

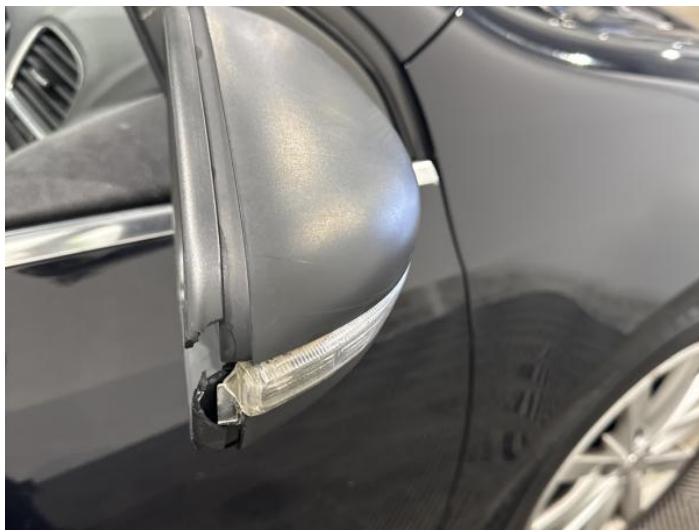
13: Door Mirror Assy osr
Broken
Replace

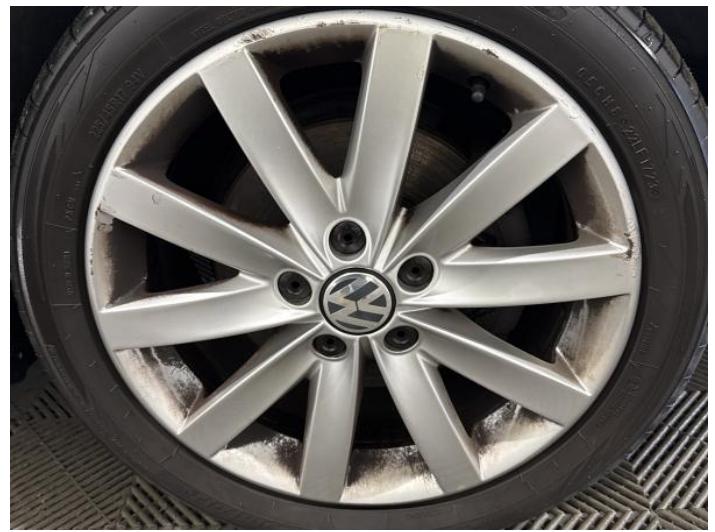
14: Wheel osr
Scratched
Over 50mm

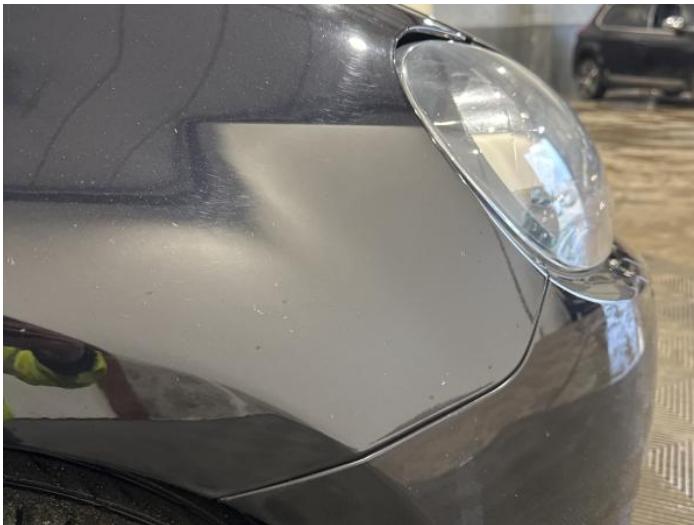
15: Wing osf
Chipped
1 To 5

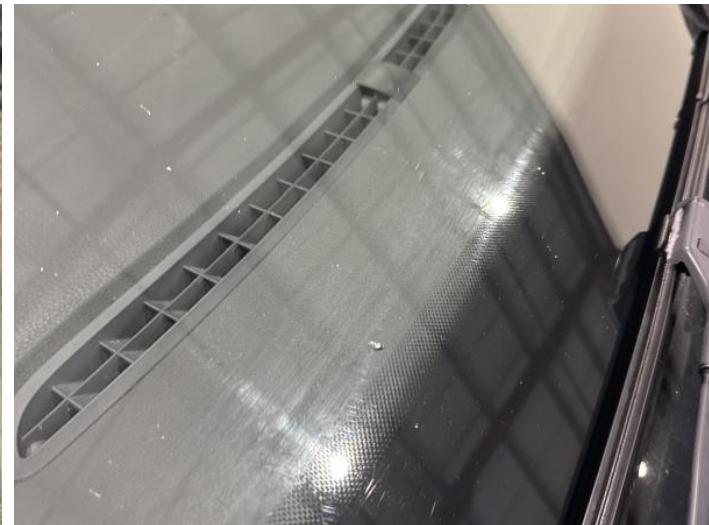
16: Screen Front
Chipped
UpTo 10mm

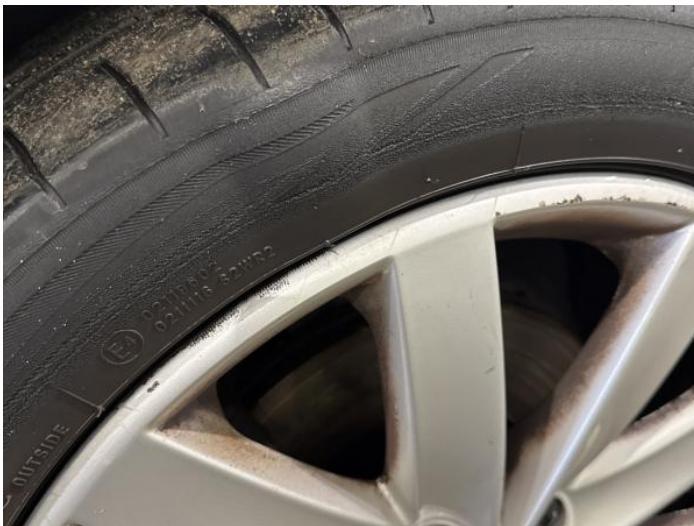
NSF	TOYO	Damaged
NSR	TOYO	5.0mm
OSF	TOYO	5.0mm
OSR	TOYO	5.0mm
Spare

17: Tyre nsf
Damaged
Replace
