VEHICLE INSPECTION REPORT

AO59FTV

Nissan Note 1.6 Acenta 5dr Auto

Inspection	Vehicle		nama GRADE 4
Serious Damage?	VAT	Margin	
No	V5	Present

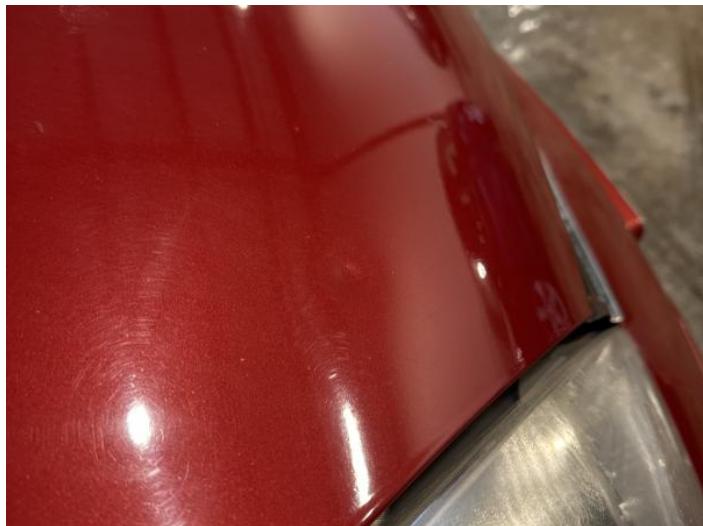
1: Bonnet
Dented
With Paint Damage

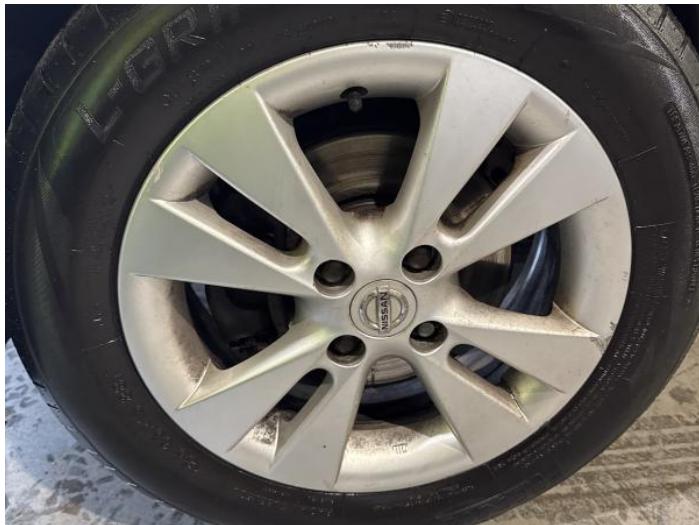
3: Wheel nsf
Scratched
Up To 50mm

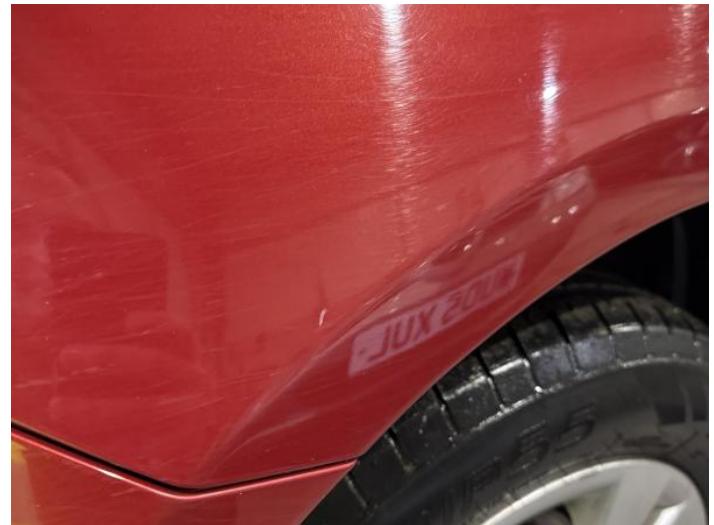
4: Wing nsf
Scratched
UpTo 25mm Thru Paint

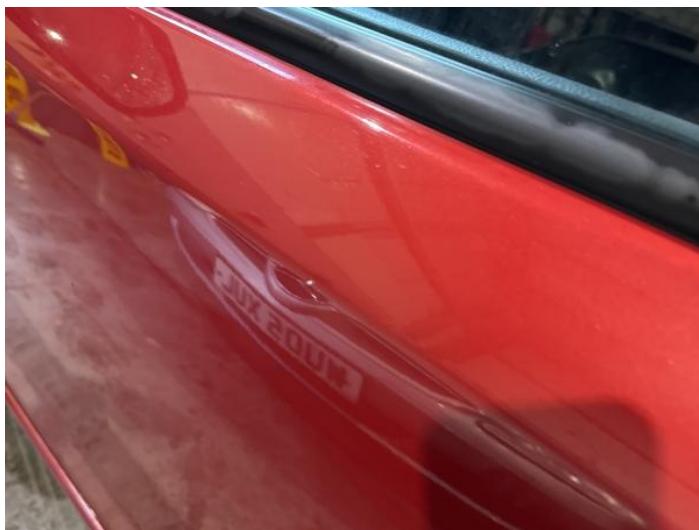
5: Door nsf
Chipped
1 To 5

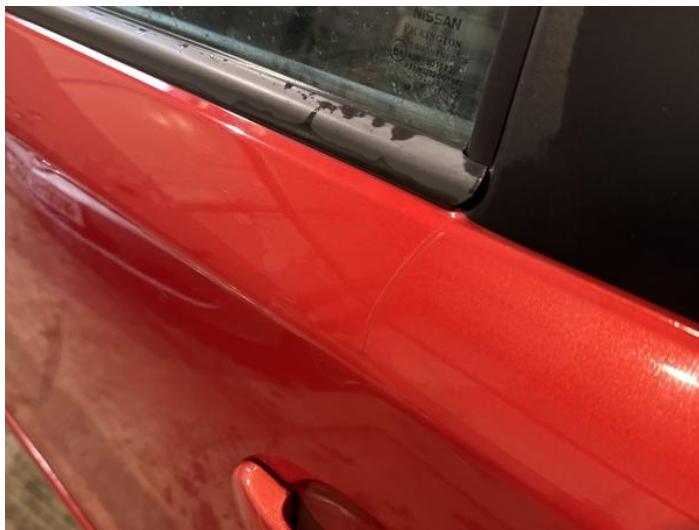
7: Door nsr
Scratched
Over 25mm Thru Paint

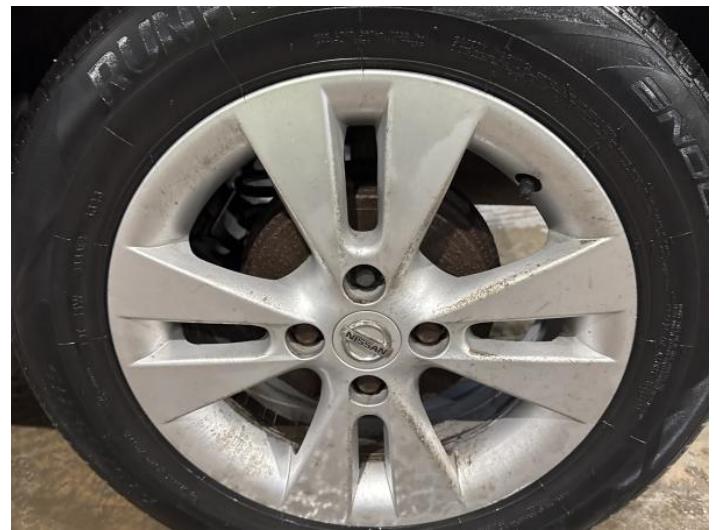
8: Wheel nsr
Scratched
Up To 50mm

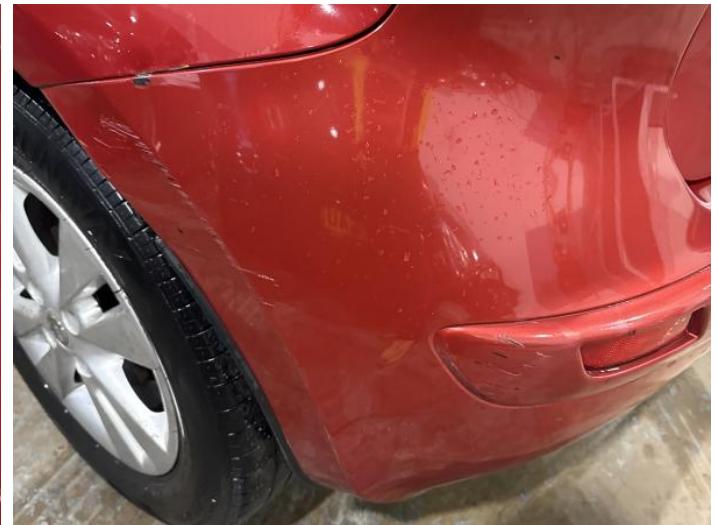
10: Bumper Rear
Scratched
Over 100mm Thru Paint

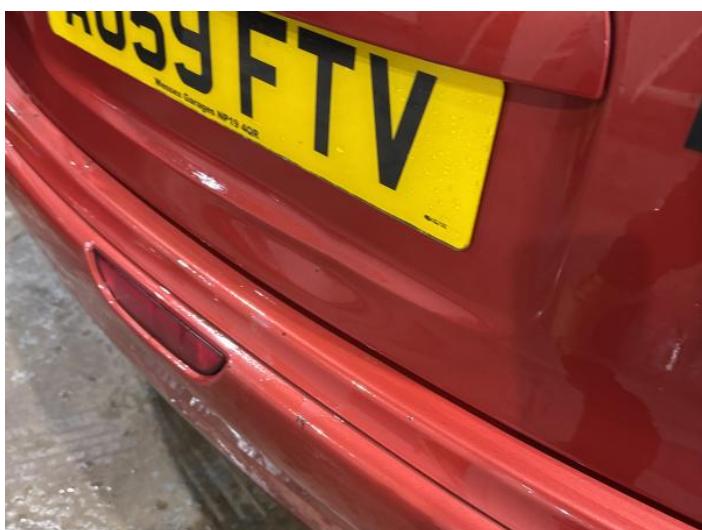
11: Tailgate
Dented
Over 30mm

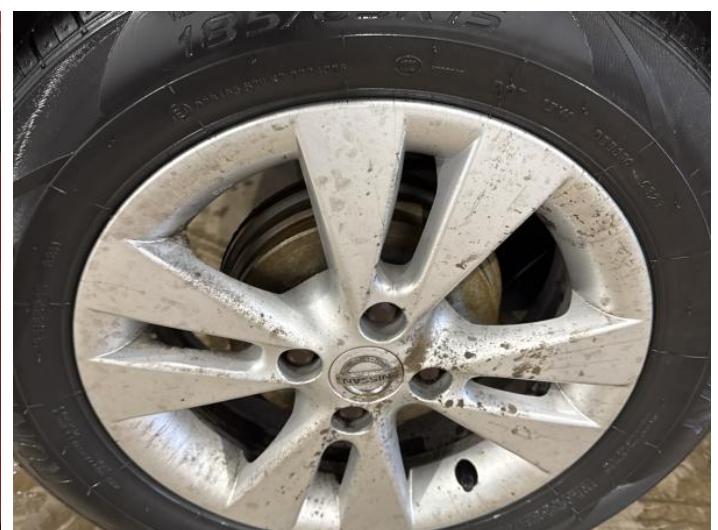
12: Wheel osr
Scratched
Up To 50mm

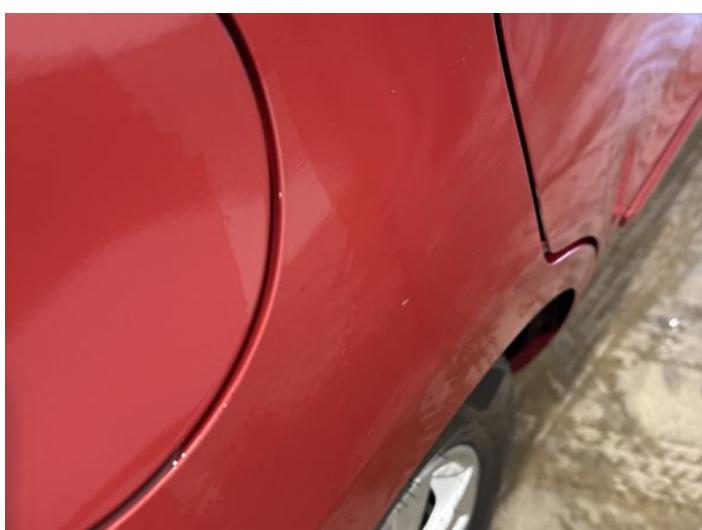
13: Qtr Panel osr
Scratched
UpTo 25mm Thru Paint

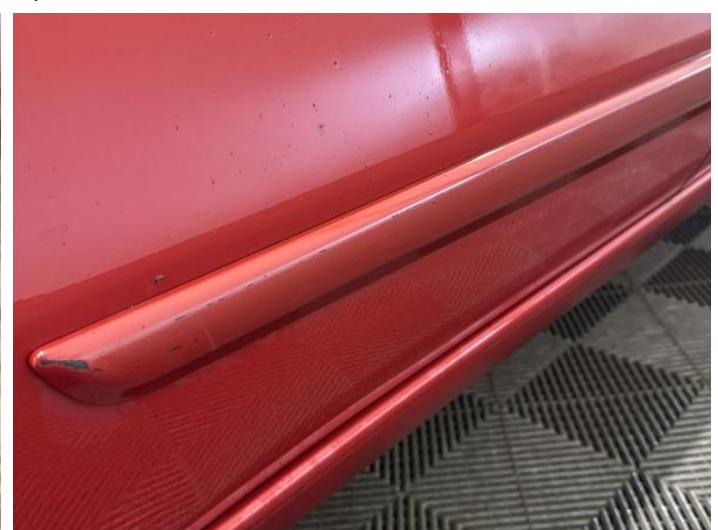
14: Door Moulding osr
Scratched (Painted)
Over 25mm Thru Paint

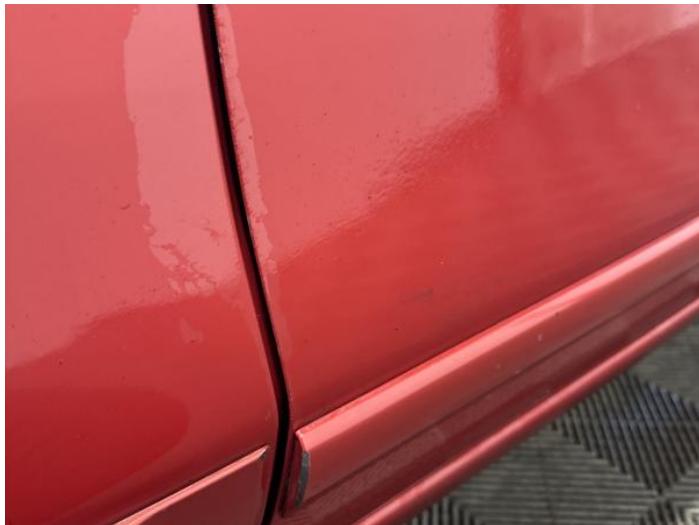
15: Door osf
Chipped
Edge Chip

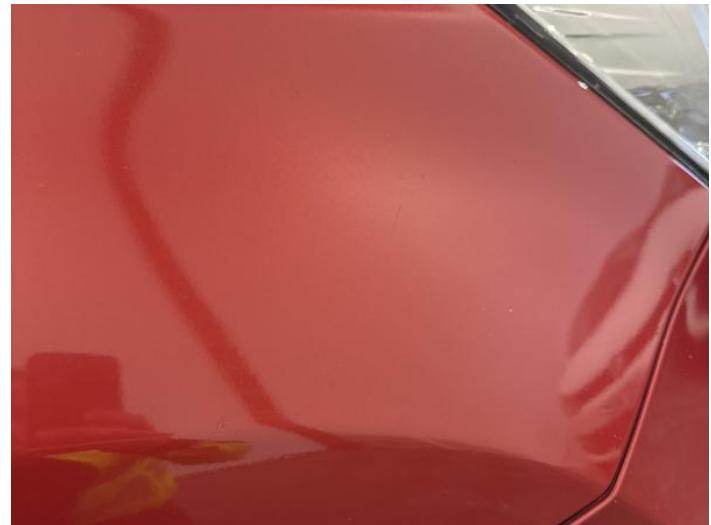
16: Wing osf
Poor Previous Repair
Poor Paint

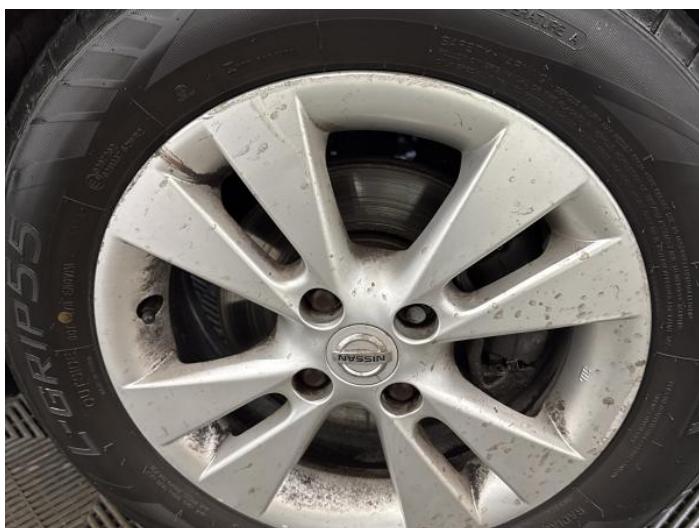
17: Wheel osf
Scratched
Over 50mm
