VEHICLE INSPECTION REPORT

YH61JGU

Nissan Micra 1.2 Acenta 5dr

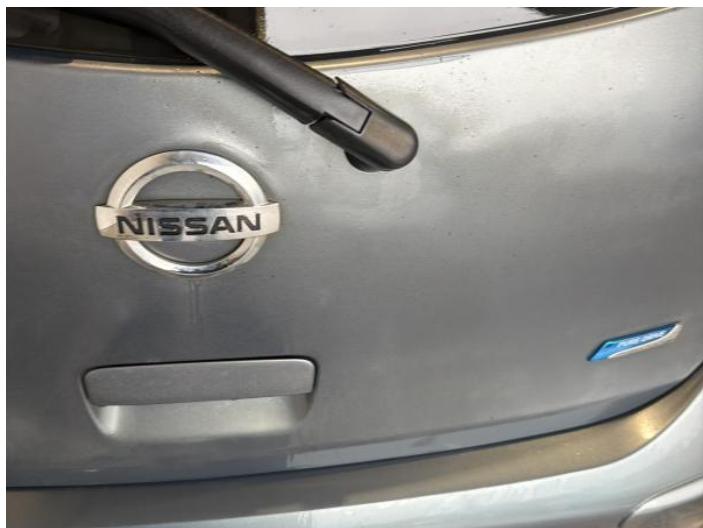
1: Boot Lid
Poor Previous Repair
Poor Paint

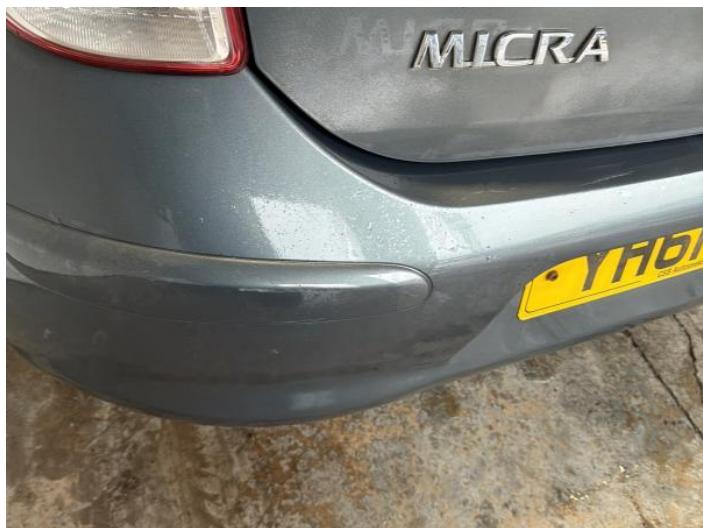
2: Bumper Rear
Scratched
Over 100mm Thru Paint

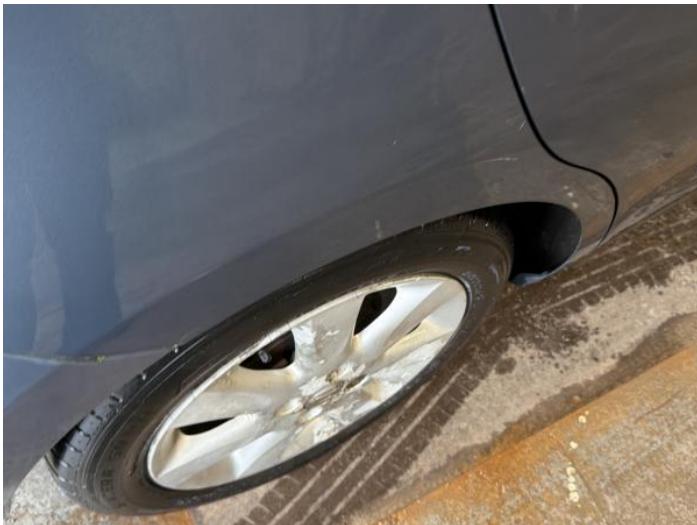
3: Qtr Panel osr
Chipped
1 To 5

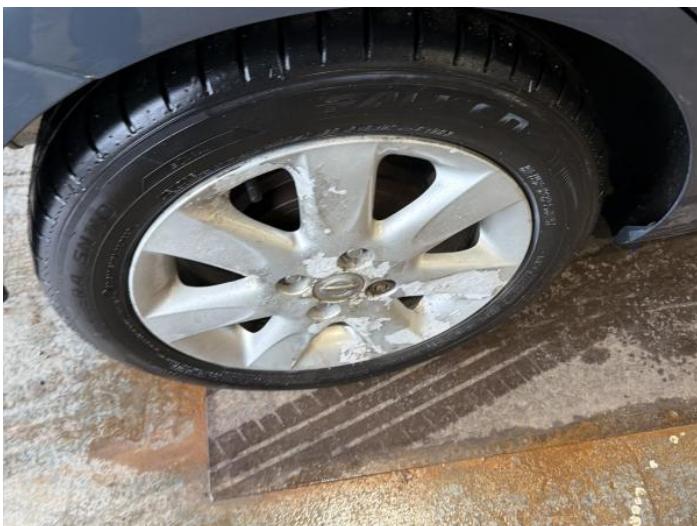
5: Wheel osr
Corroded
Light

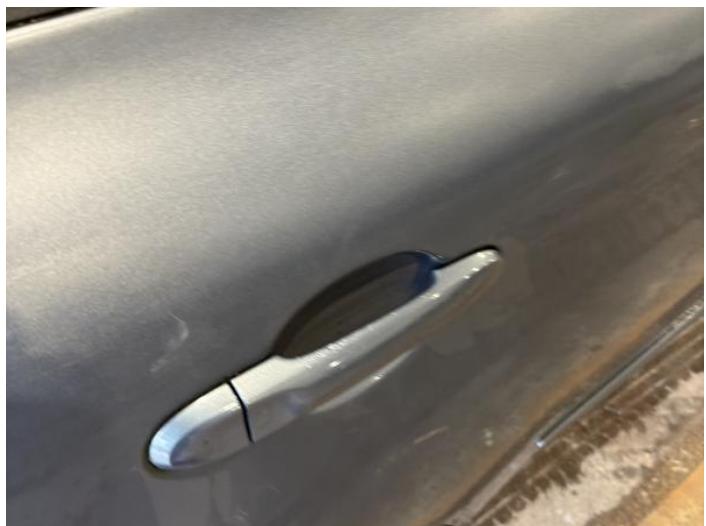
6: Door osr
Poor Previous Repair
Poor Paint

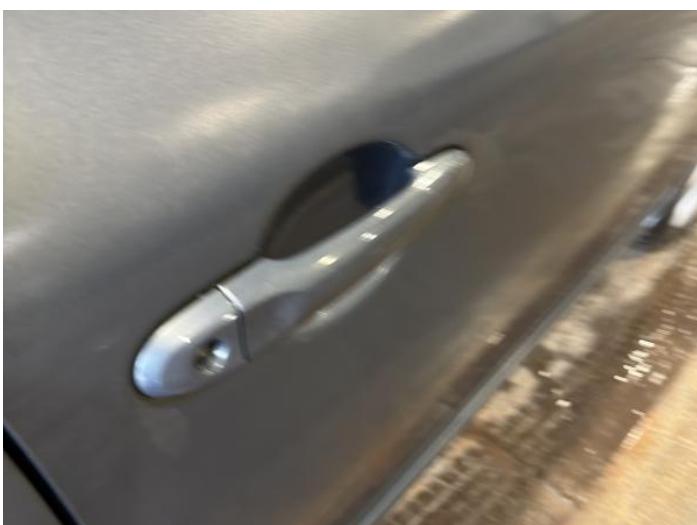
7: Door osf
Poor Previous Repair
Poor Paint

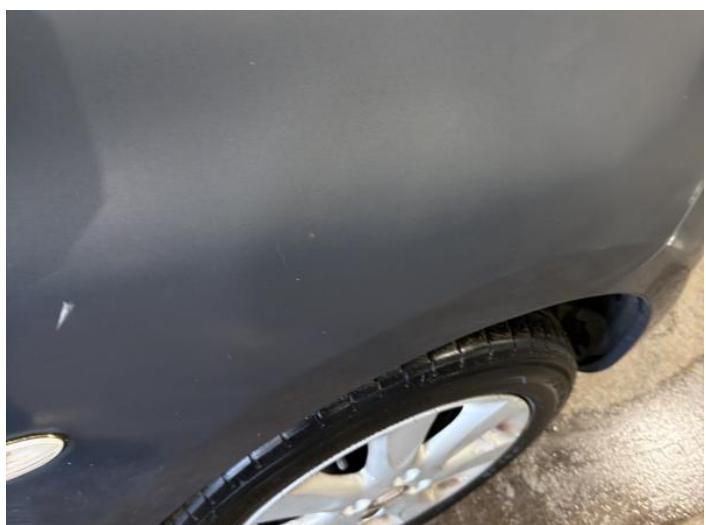
8: Wing osf
Poor Previous Repair
Poor Paint

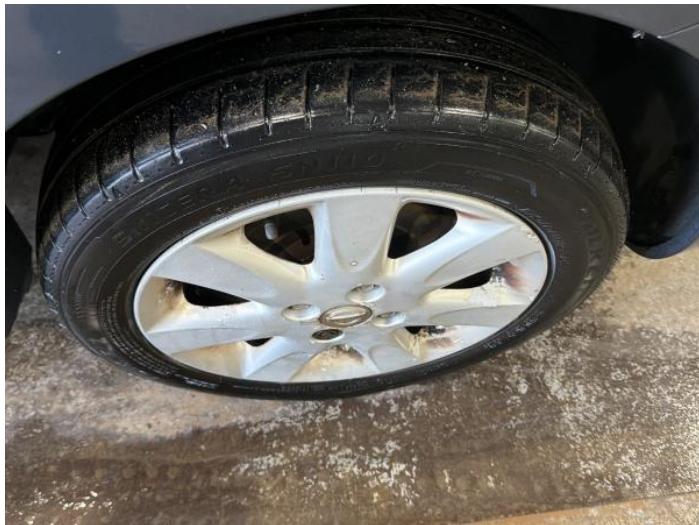
9: Wheel osf
Scratched
Up To 50mm

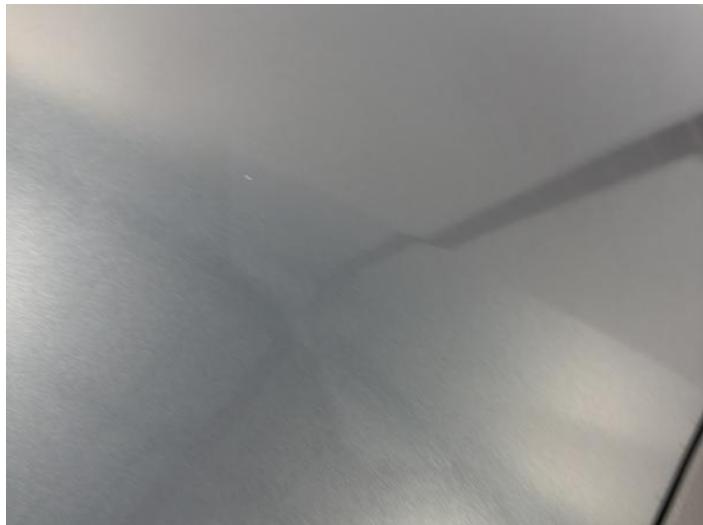
10: Bonnet
Chipped
1 To 5

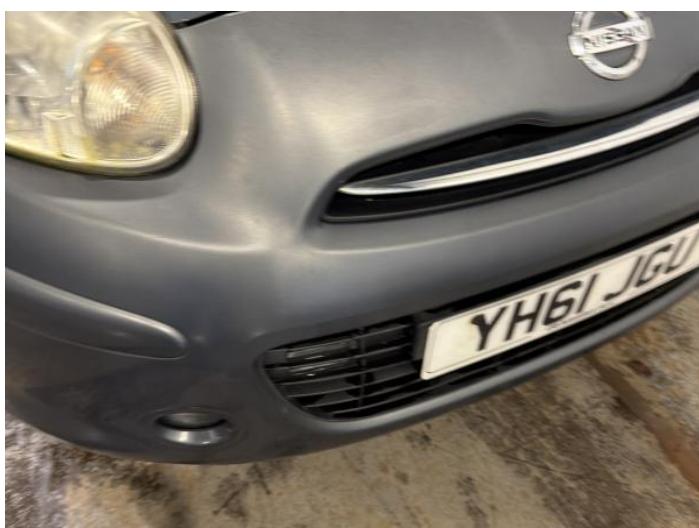
11: Bumper Front
Poor Previous Repair
Poor Paint

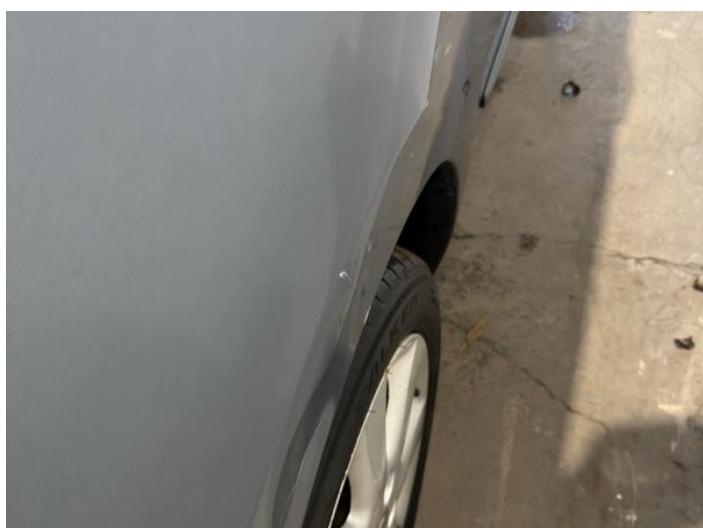
12: Wing nsf
Poor Previous Repair
Poor Paint

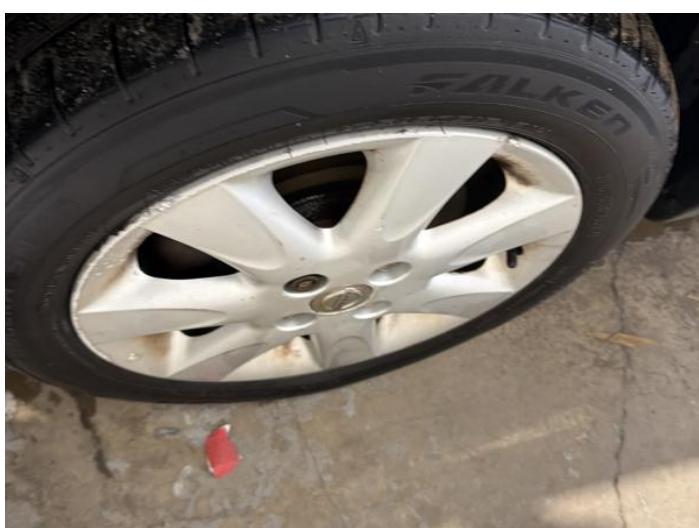
13: Wheel nsf
Scratched
Over 50mm

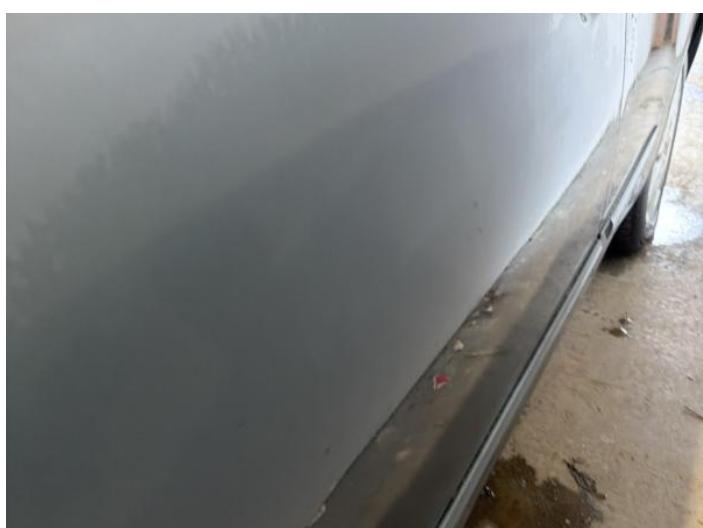
14: Door nsf
Poor Previous Repair
Poor Paint

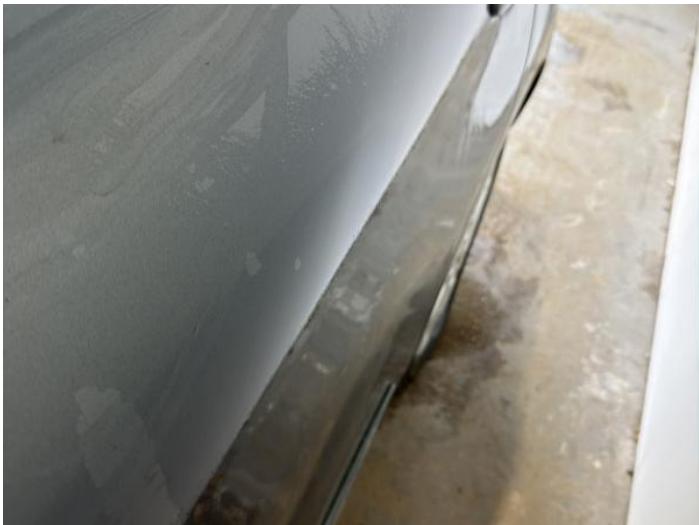
15: Door nsr
Dented
2 Or Less UpTo 10mm

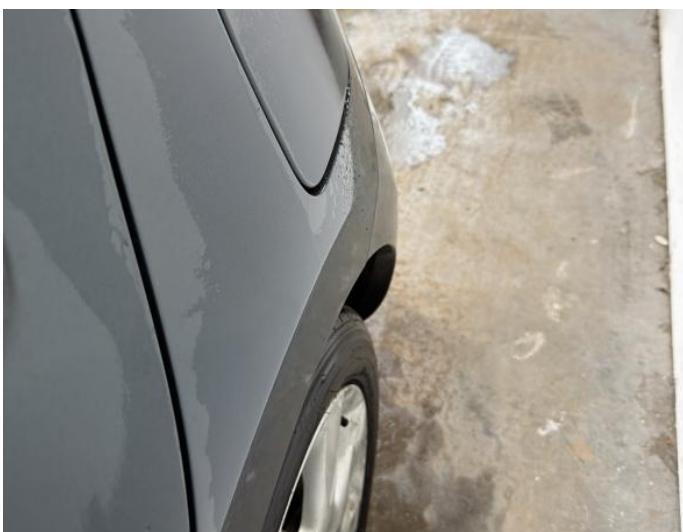
17: Qtr Panel nsr
Dented
Over 2 UpTo 10mm

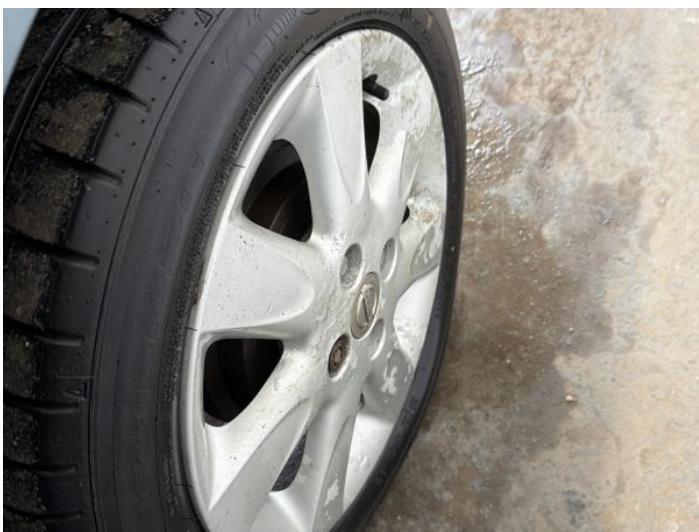
19: Wheel nsr
Corroded
Light
