VEHICLE INSPECTION REPORT

Y12CJK

BMW 1 Series 118d M Sport 5dr Step Auto

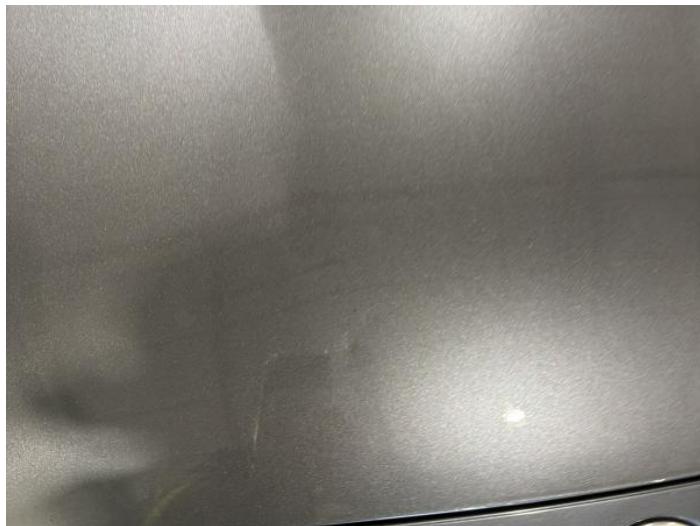
1: Bonnet
Dented
Between 10mm + 30mm

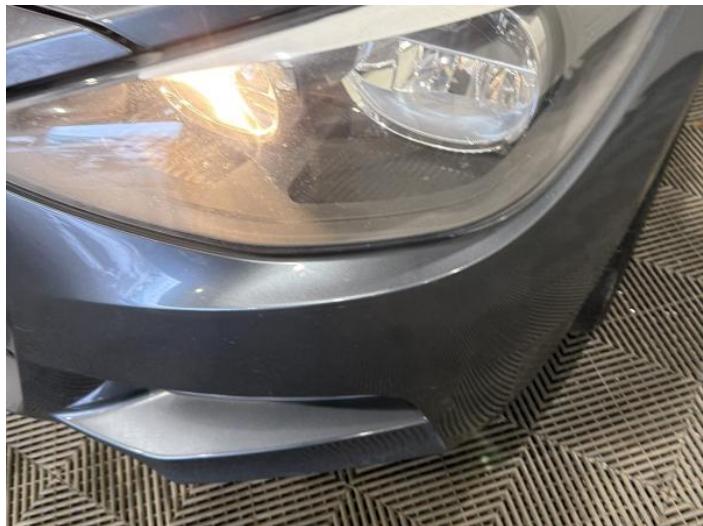
2: Bumper Front
Poor Previous Repair
Poor Paint

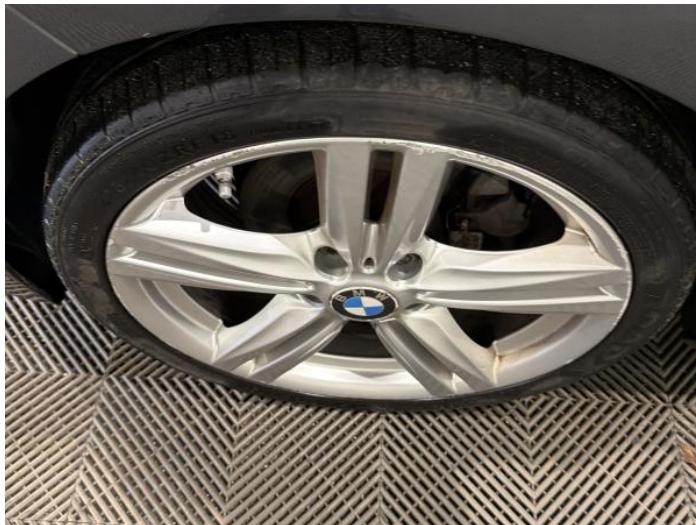
3: Wheel nsf
Scratched
Over 50mm

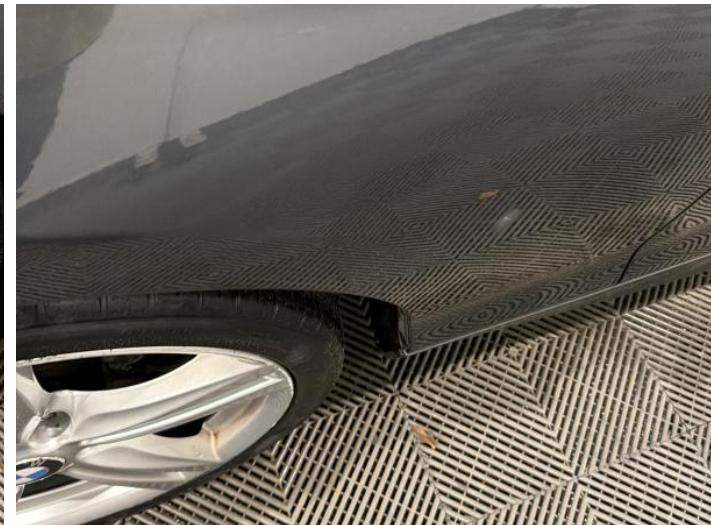
4: Wing nsf
Chipped
1 To 5

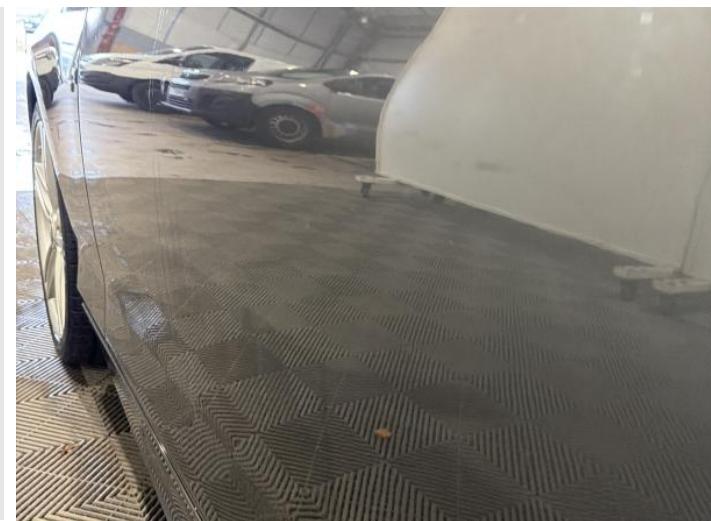
6: Door nsf
Poor Previous Repair
Poor Paint

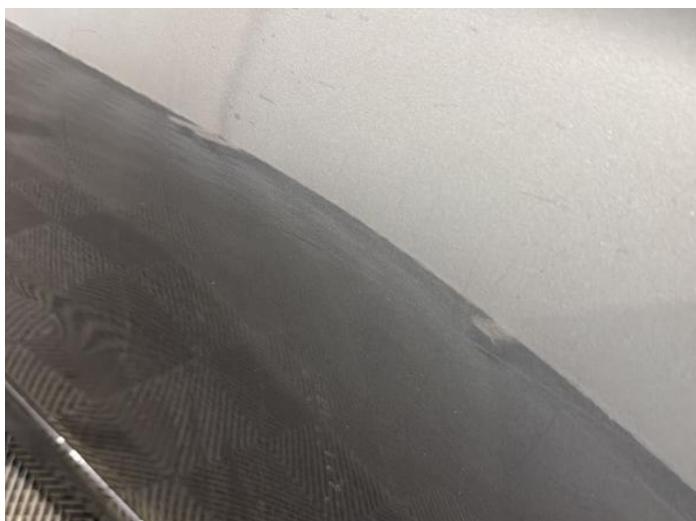
7: Door nsr
Poor Previous Repair
Poor Paint

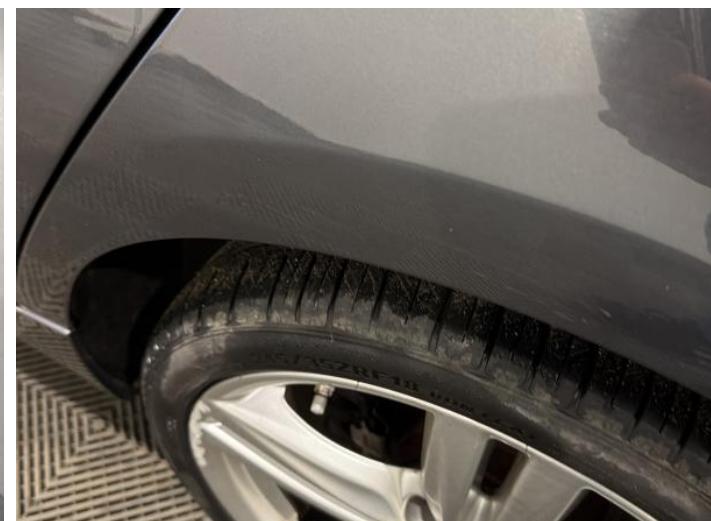
8: Qtr Panel nsr
Dented
Over 2 UpTo 10mm

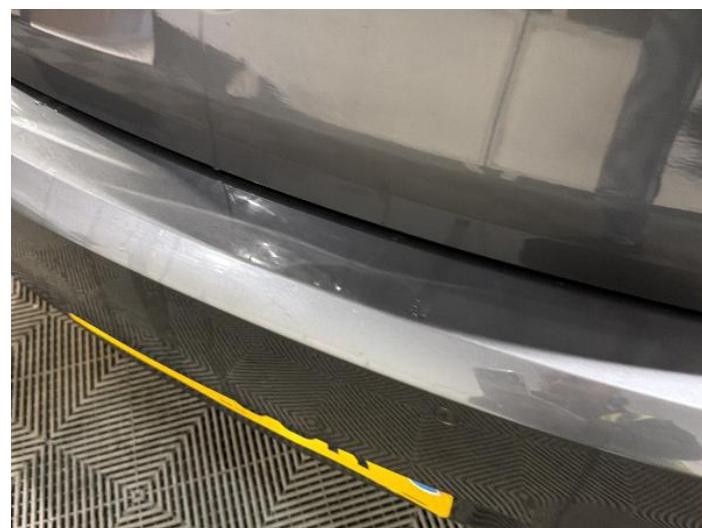
11: Bumper Rear
Chipped
Multiple Chips

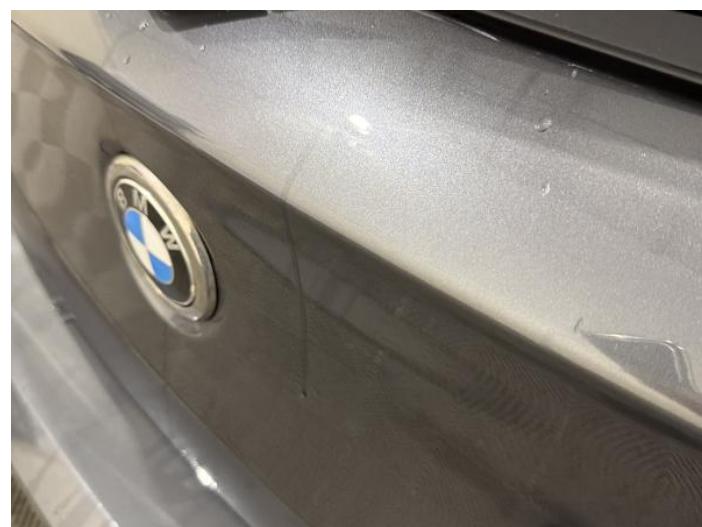
13: Boot Lid
Chipped
1 To 5

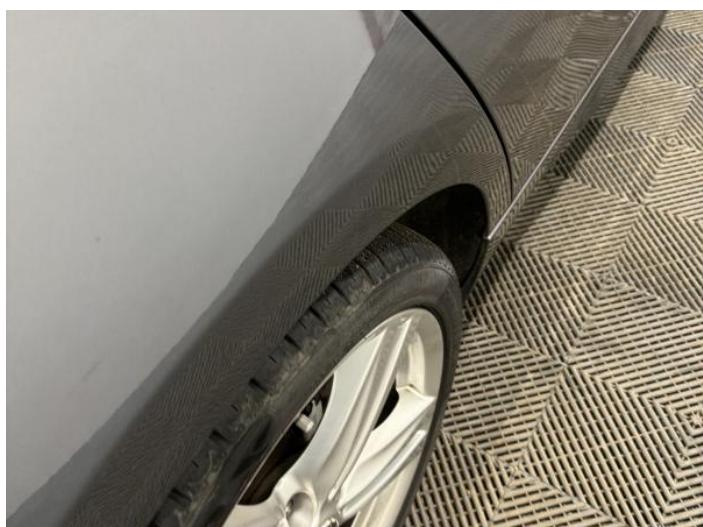
14: Qtr Panel osr
Chipped
1 To 5

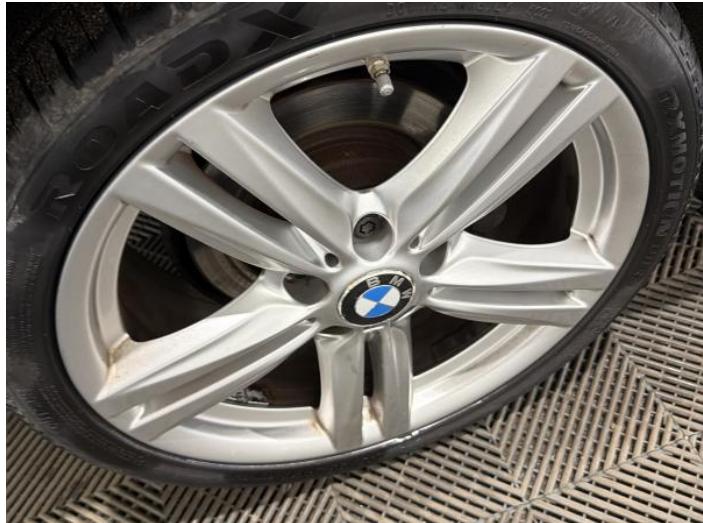
16: Wheel osr
Scratched
Up To 50mm

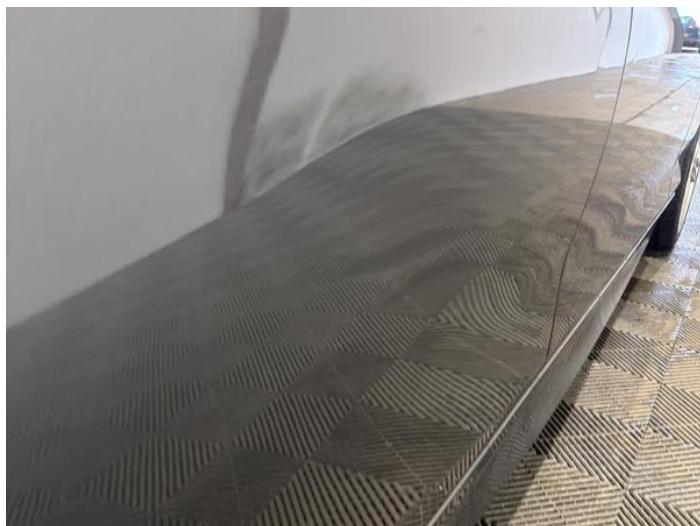
17: Door osr
Poor Previous Repair
Poor Paint

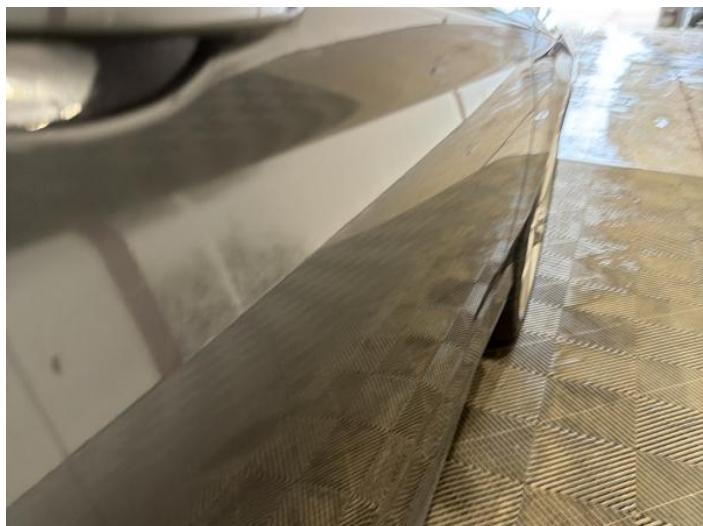
18: Door osf
Poor Previous Repair
Poor Paint

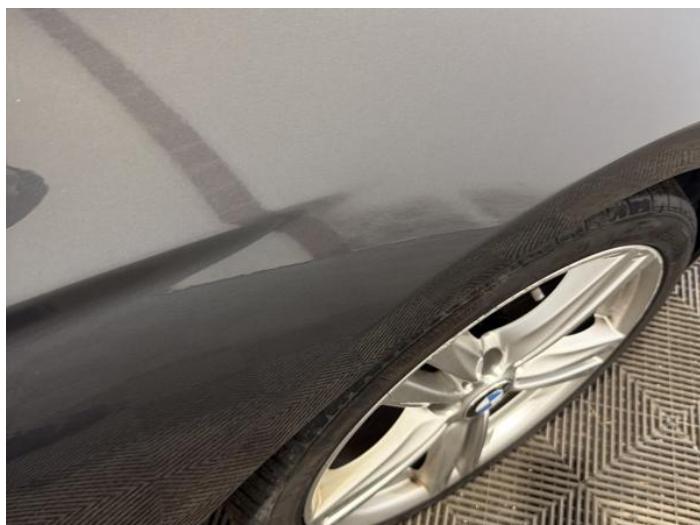
19: Wing osf
Dented
Over 2 UpTo 10mm

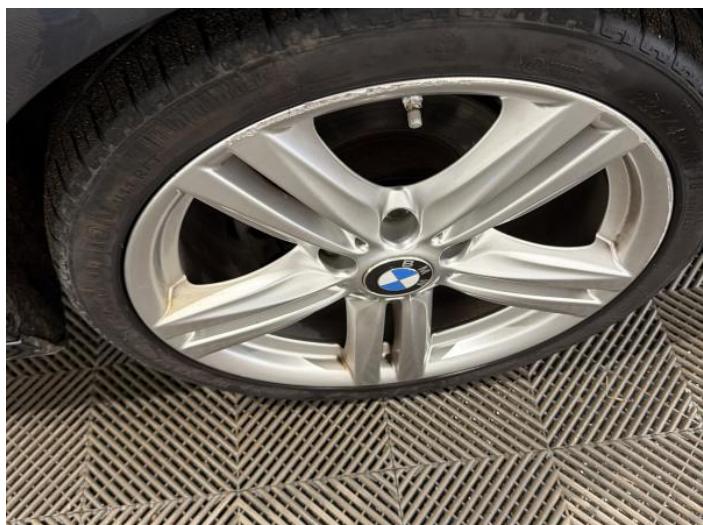
20: Wheel osf
Scratched
Over 50mm
