VEHICLE INSPECTION REPORT

LP66FOU

Nissan Micra 1.2 N-Tec 5dr

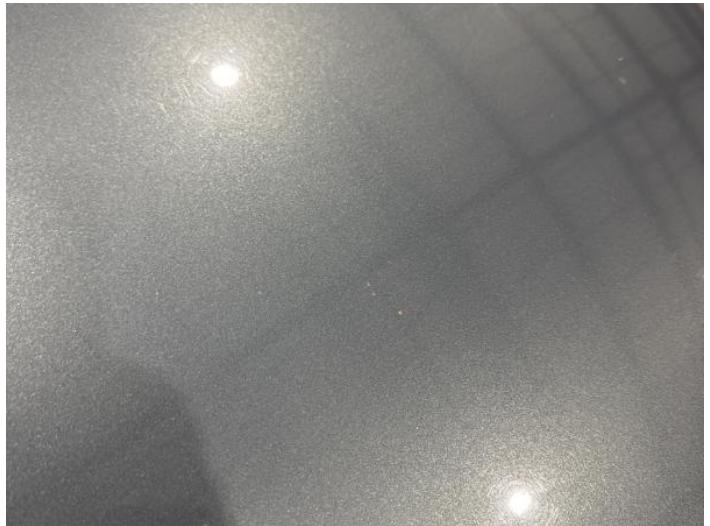
1: Bonnet
Chipped
1 To 5

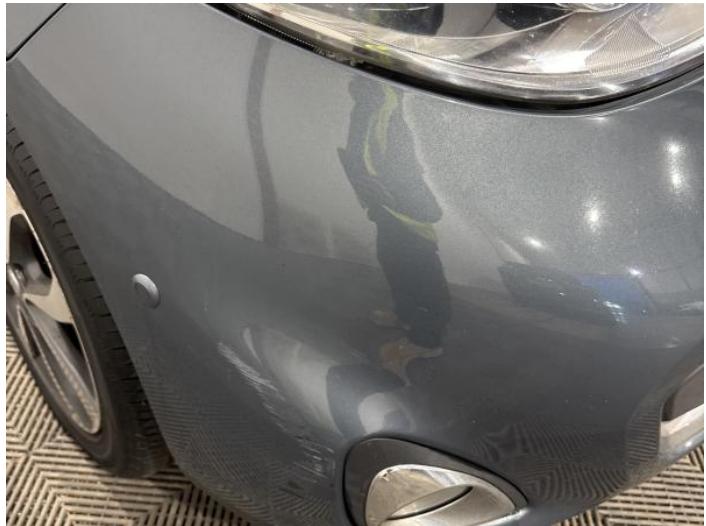
2: Bumper Front
Poor Previous Repair
Poor Colour

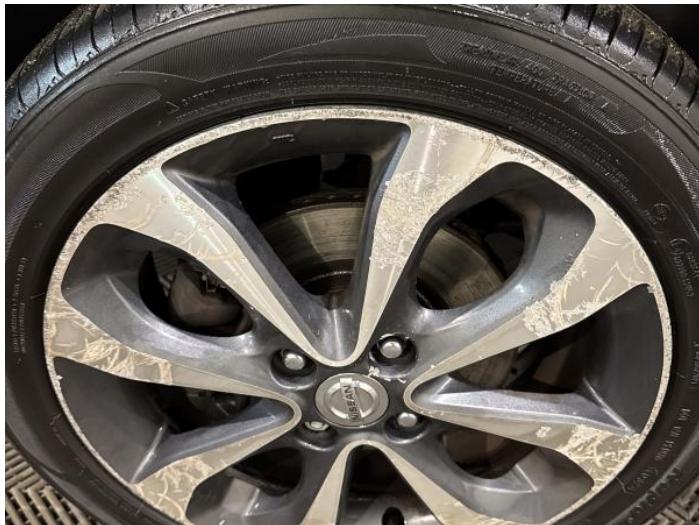
3: Wheel nsf
Scratched
Over 50mm

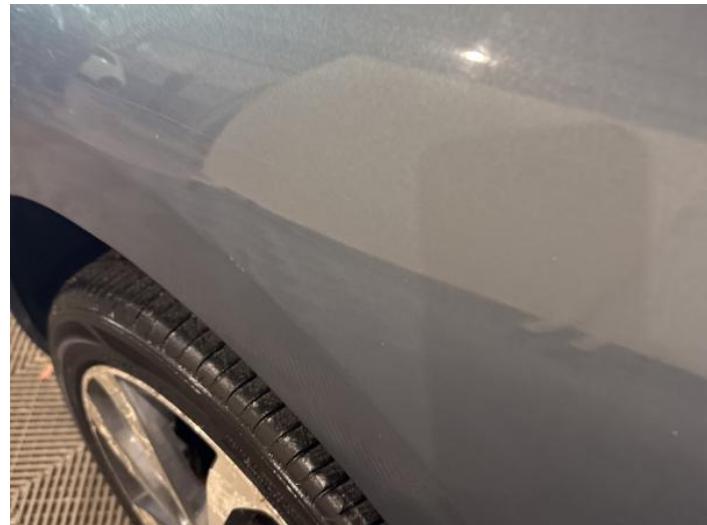
4: Wing nsf
Dented
Between 10mm + 30mm

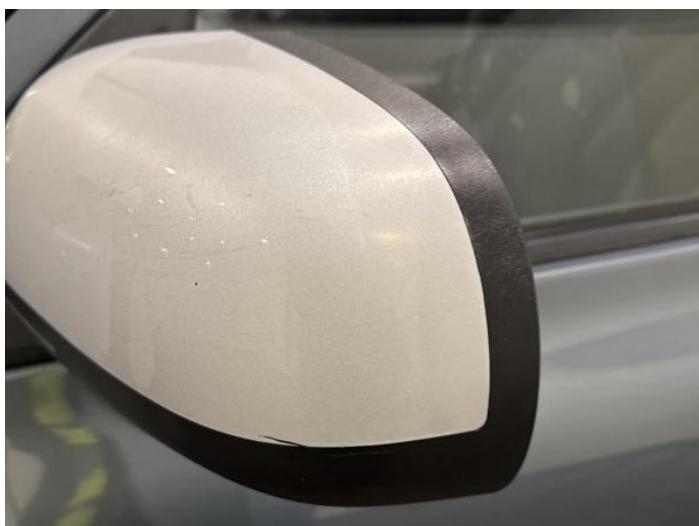
5: Door Mirror Assy nsf
Scratched (Painted)
UpTo 25mm Thru Paint

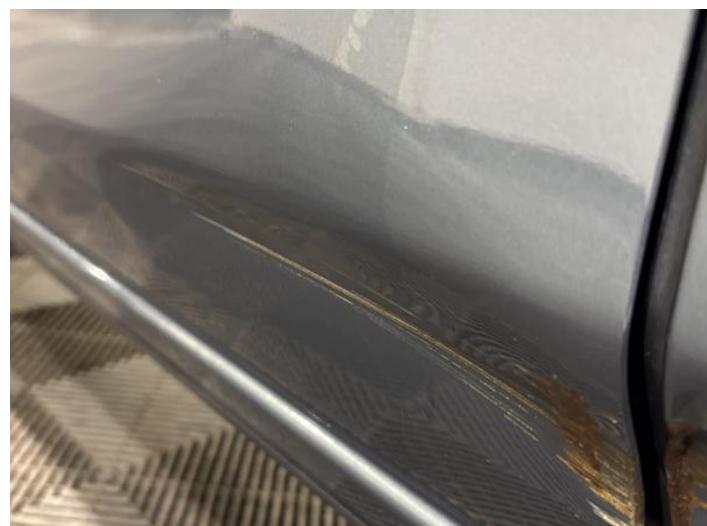
6: Door nsf
Dented
With Paint Damage

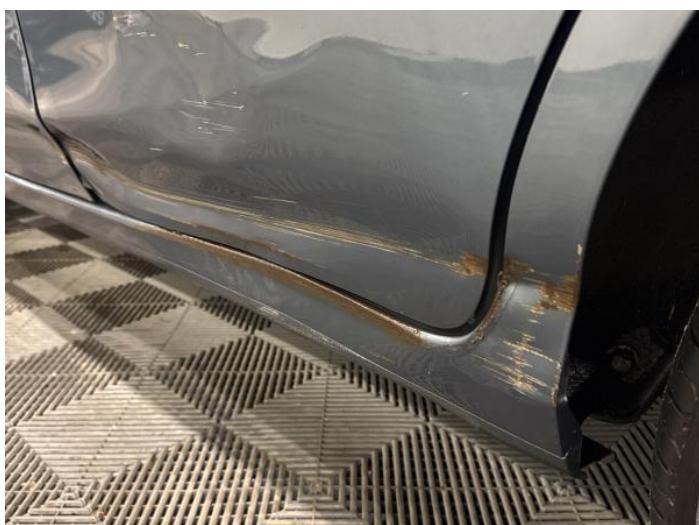
7: Sill ns
Dented
With Paint Damage

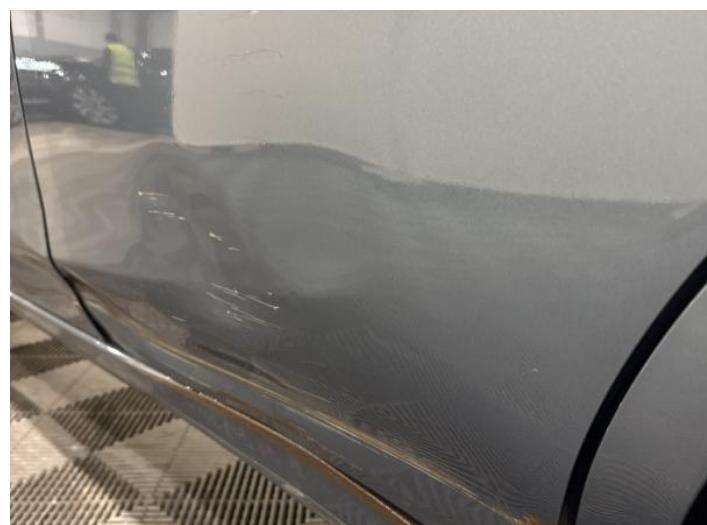
8: Door nsr
Dented
With Paint Damage

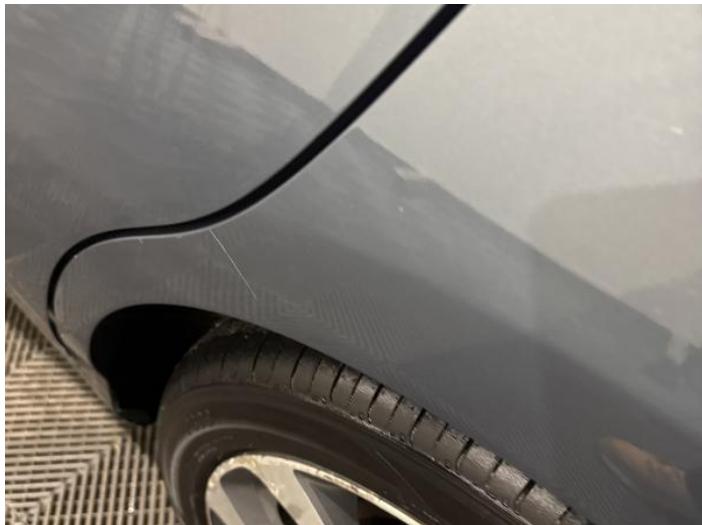
9: Qtr Panel nsr
Scratched
Over 25mm Thru Paint

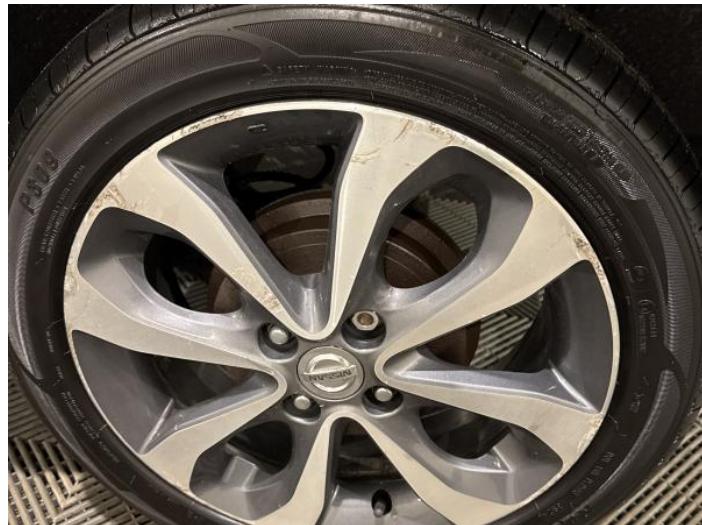
10: Wheel nsr
Scratched
Over 50mm

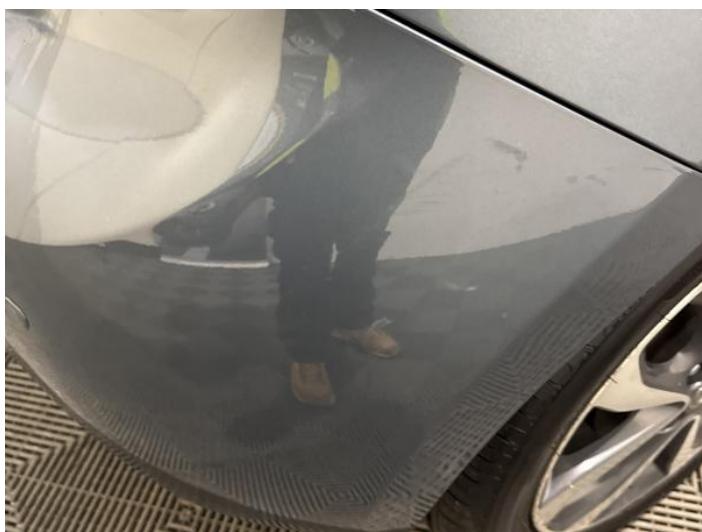
11: Bumper Rear
Scratched
25 to 100mm Thru Paint

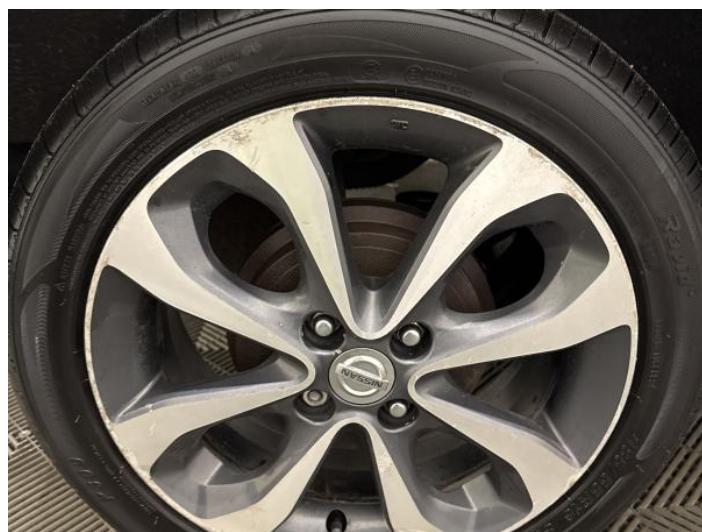
12: Wheel osr
Scratched
Over 50mm

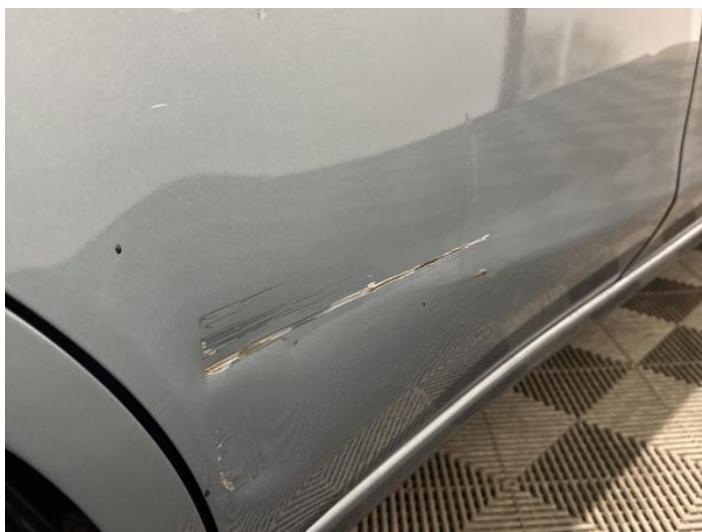
13: Door osr
Dented
With Paint Damage

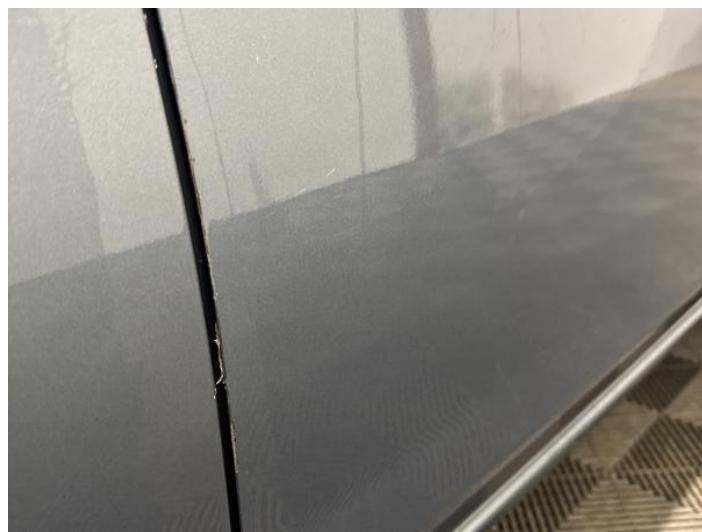
14: Door osf
Scratched
UpTo 25mm Thru Paint

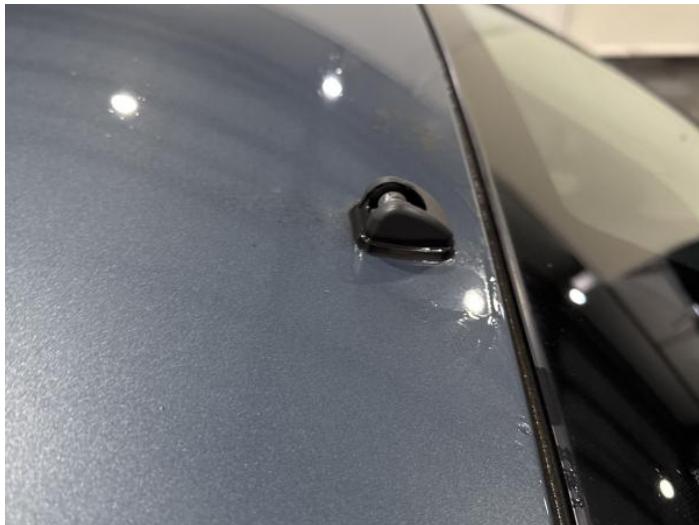
15: Aerial
Missing
Replace

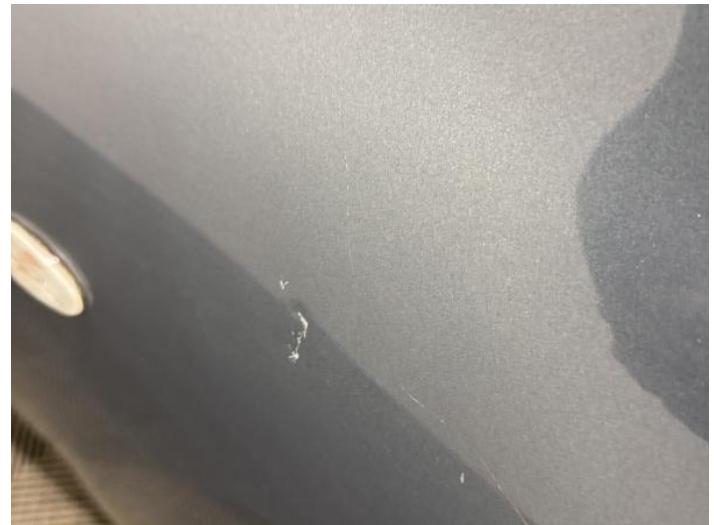
16: Wing osf
Dented
Between 10mm + 30mm

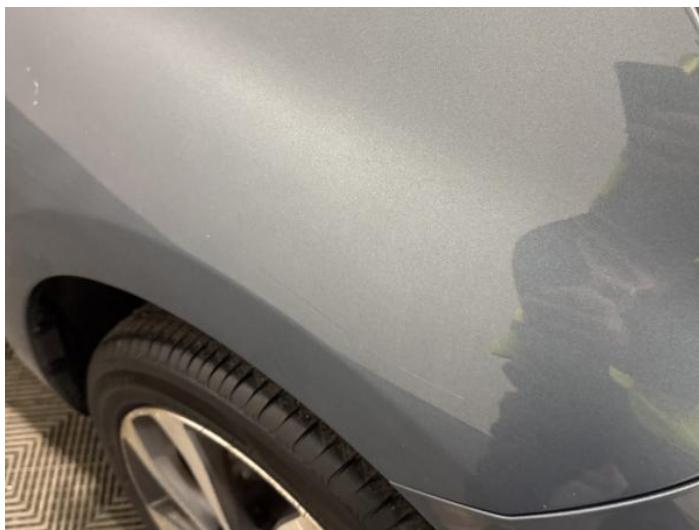
17: Wing osf
Scratched
Over 25mm Thru Paint

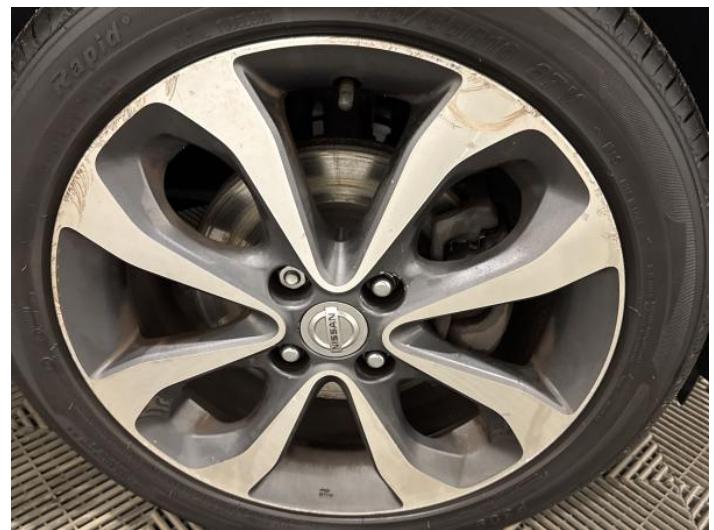
18: Wheel osf
Scratched
Over 50mm

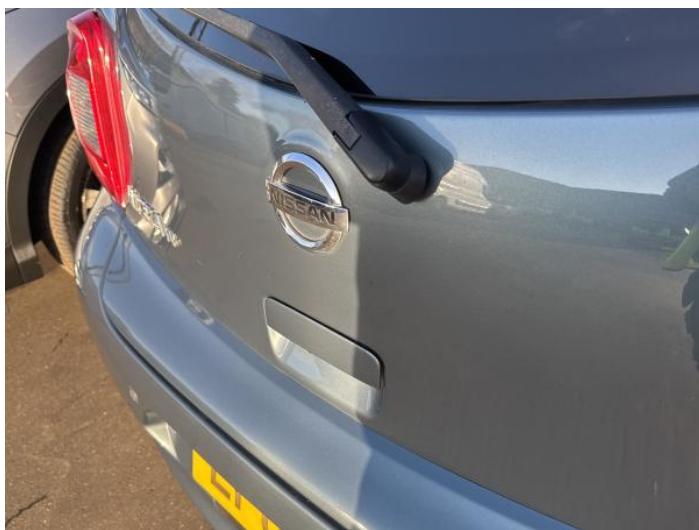
19: Tailgate
Dented
Over 30mm
