VEHICLE INSPECTION REPORT

HW68FDO

Nissan Qashqai 1.5 dCi Tekna+ 5dr

nama
GRADE
3

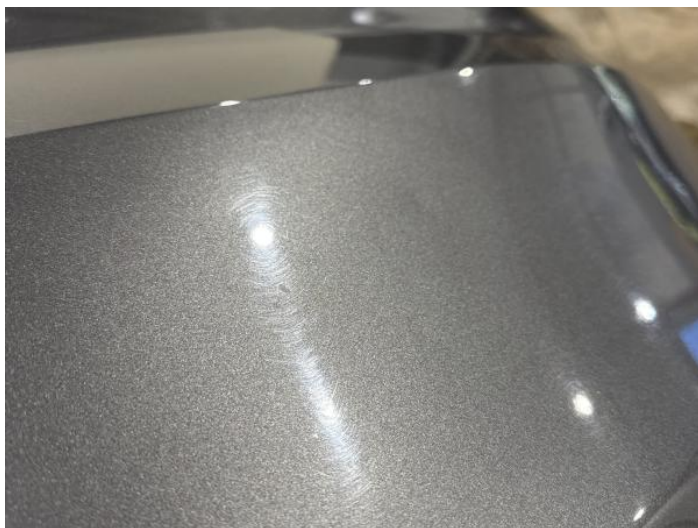
1: Bonnet
Dented
Between 10mm + 30mm

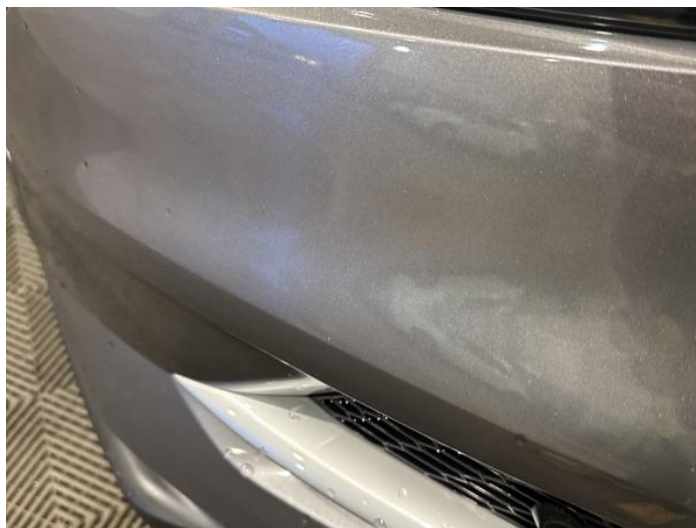
2: Bumper Front
Scratched
25 to 100mm Thru Paint

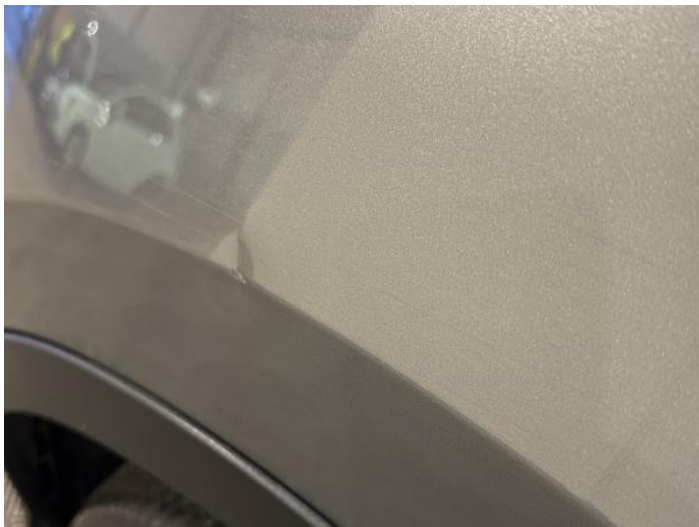
3: Wing nsf
Dented
Between 10mm + 30mm

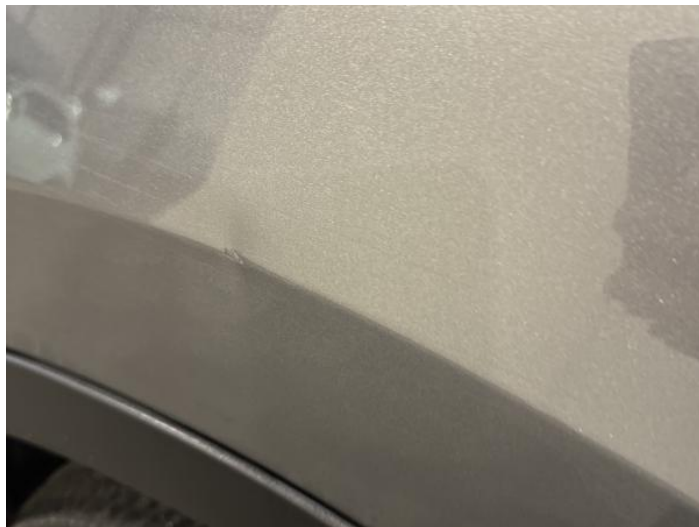
4: Wing nsf
Scratched
UpTo 25mm Thru Paint

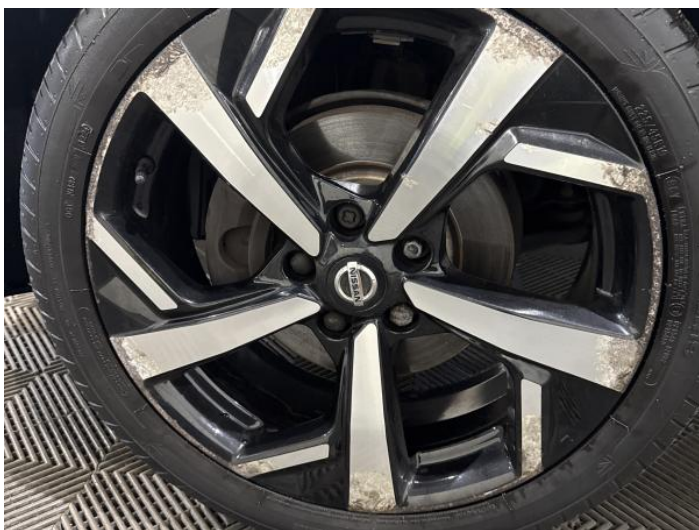
5: Wheel nsf
Scratched
Over 50mm

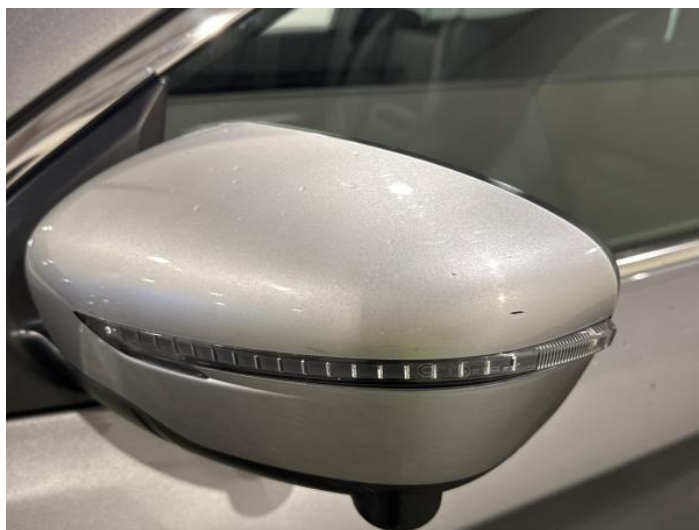
6: Door Mirror Assy nsf
Scratched (Painted)
UpTo 25mm Thru Paint

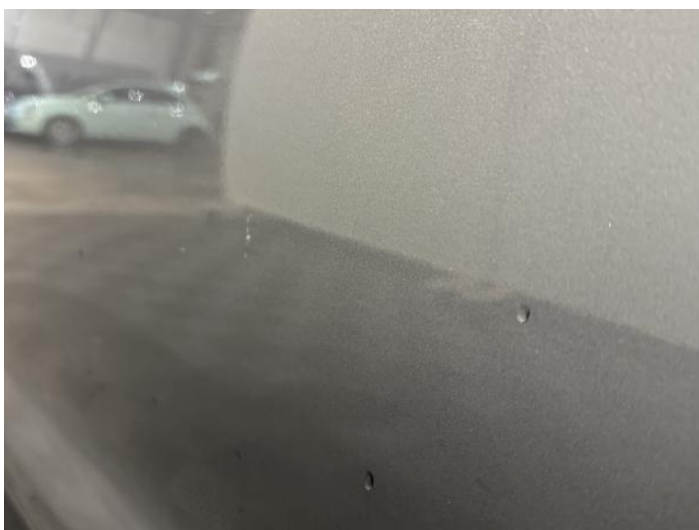
7: Door nsf
Scratched
UpTo 25mm Thru Paint

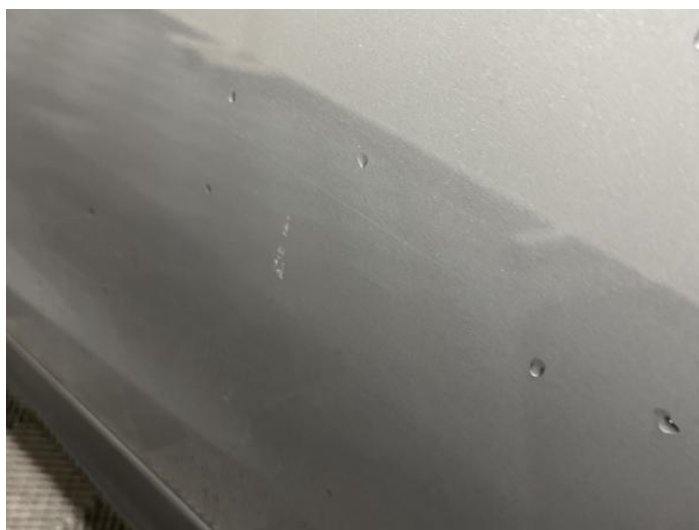
8: Door nsr
Scratched
UpTo 25mm Thru Paint

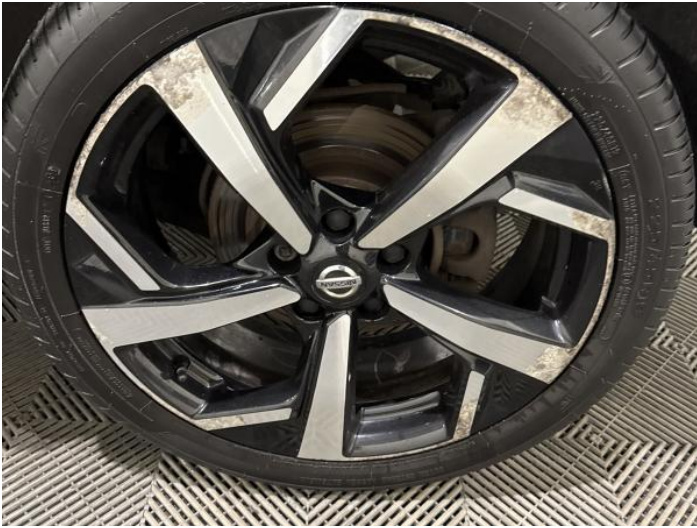
9: Wheel nsr
Scratched
Over 50mm

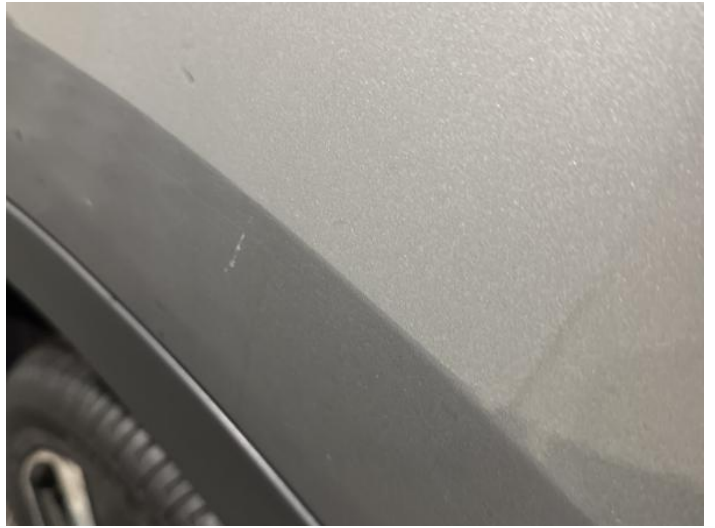
10: Qtr Panel nsr
Scratched
UpTo 25mm Thru Paint

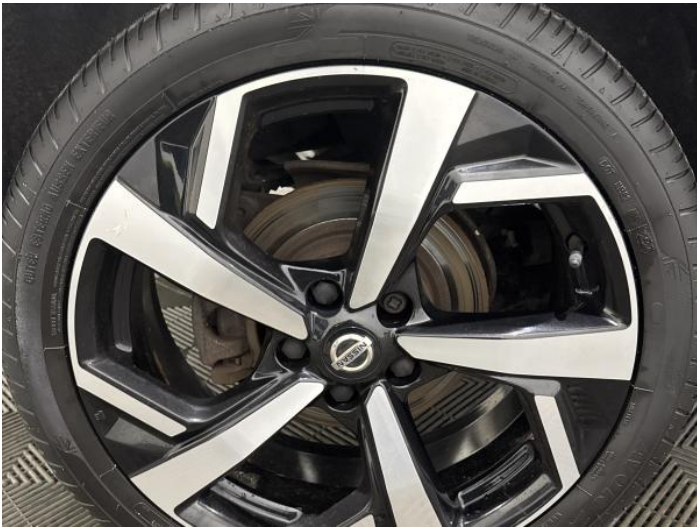
11: Wheel osr
Scratched
Up To 50mm

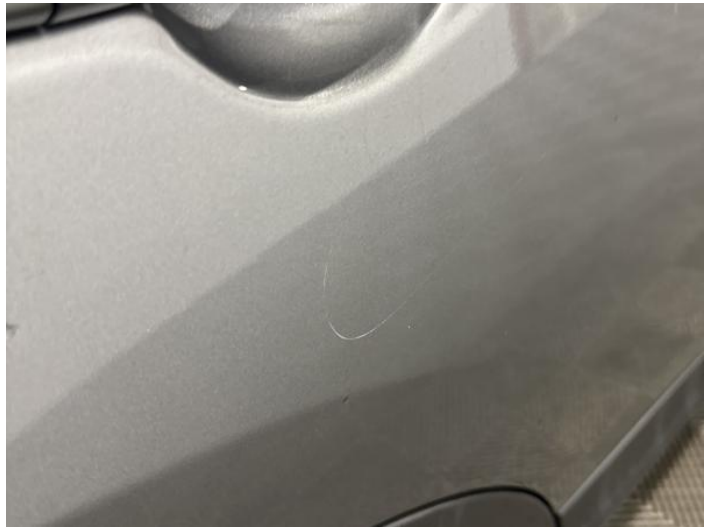
12: Door osr
Scratched
Over 25mm Thru Paint

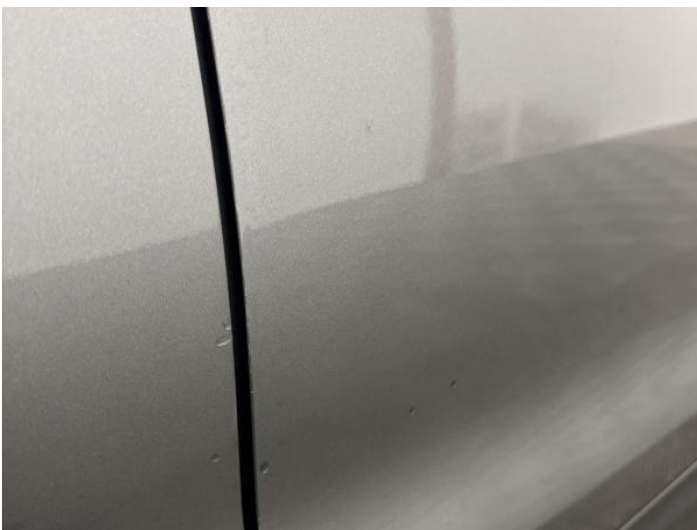
13: Door osf
Chipped
Edge Chip

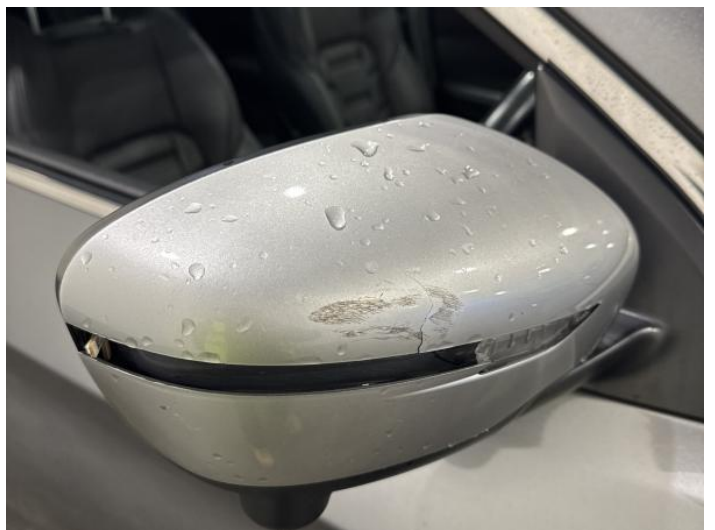
14: Door Mirror Assy osf
Broken
Replace

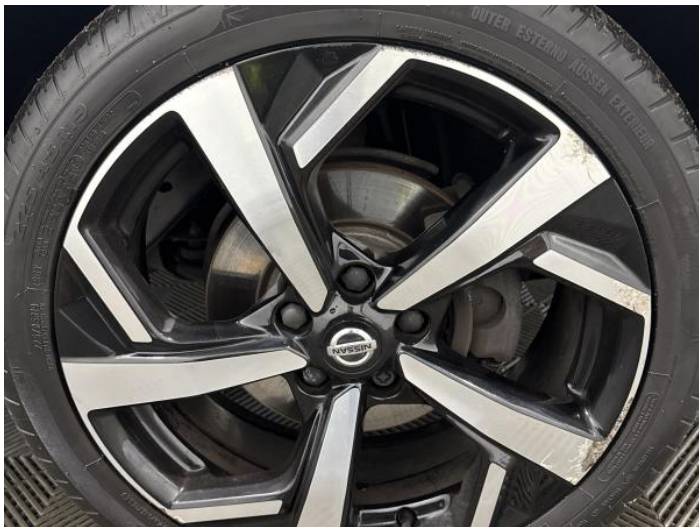
15: Wheel osf
Scratched
Over 50mm

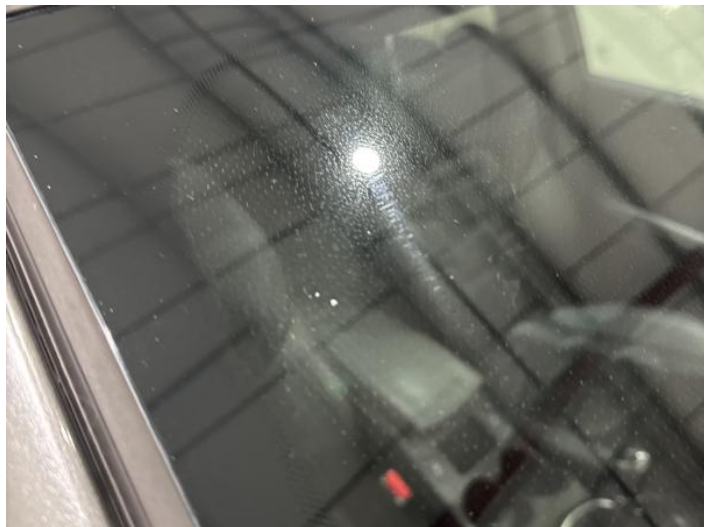
16: Screen Front
Chipped
UpTo 10mm
