VEHICLE INSPECTION REPORT

LF19AJR

Ford Focus 1.5 EcoBlue 120 Titanium 5dr

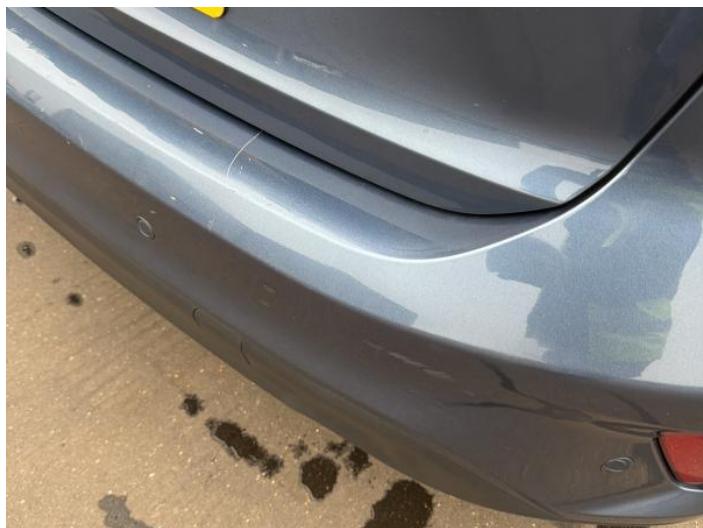
1: Bumper Rear
Scratched
Over 100mm Thru Paint

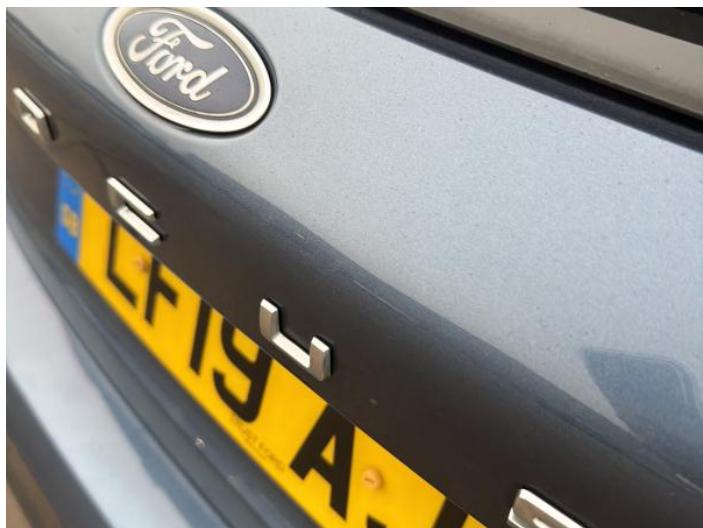
2: Boot Lid
Dented
Over 2 UpTo 10mm

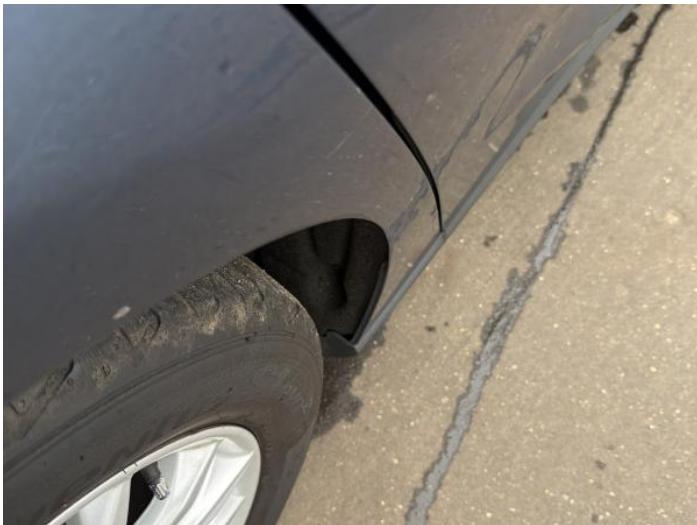
3: Qtr Panel osr
Scratched
UpTo 25mm Thru Paint

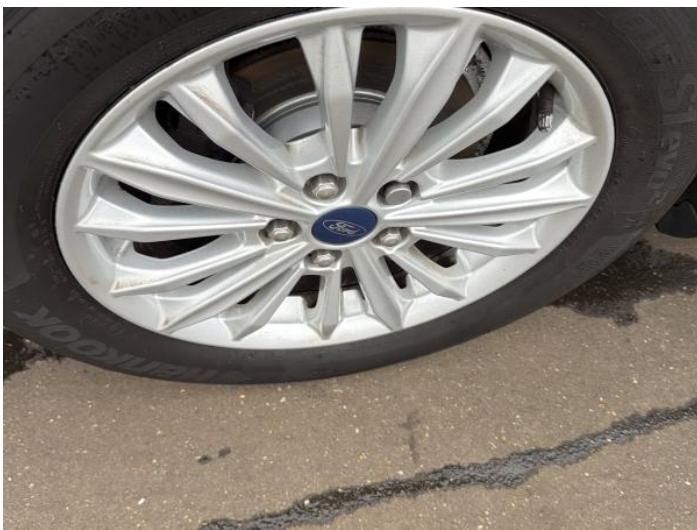
5: Wheel osr
Scratched
Up To 50mm

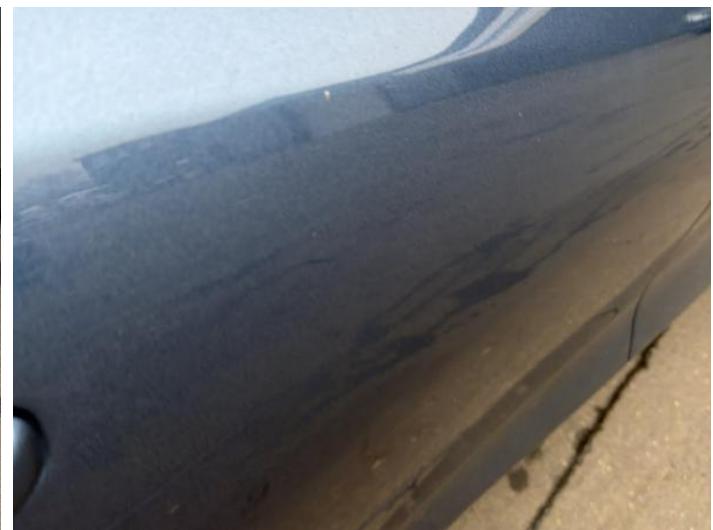
6: Door osr
Chipped
1 To 5

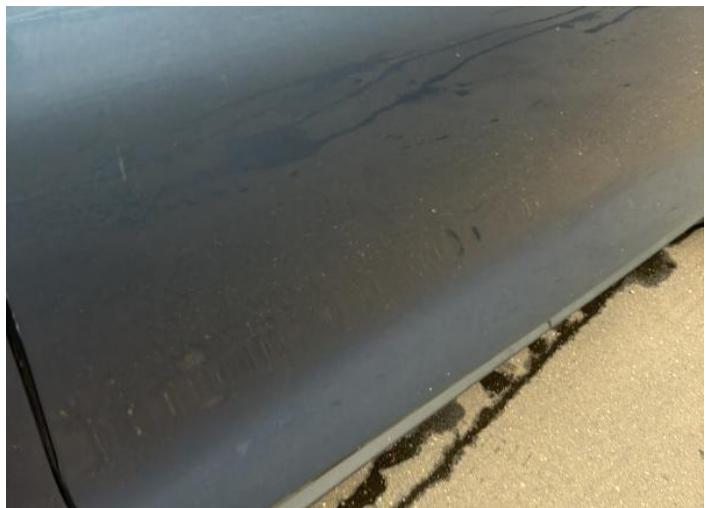
8: Door osf
Chipped
1 To 5

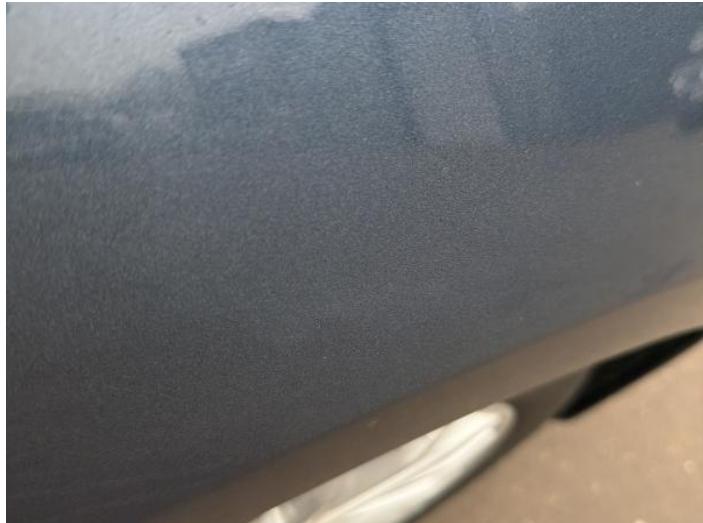
10: Wing osf
Poor Previous Repair
Poor Paint

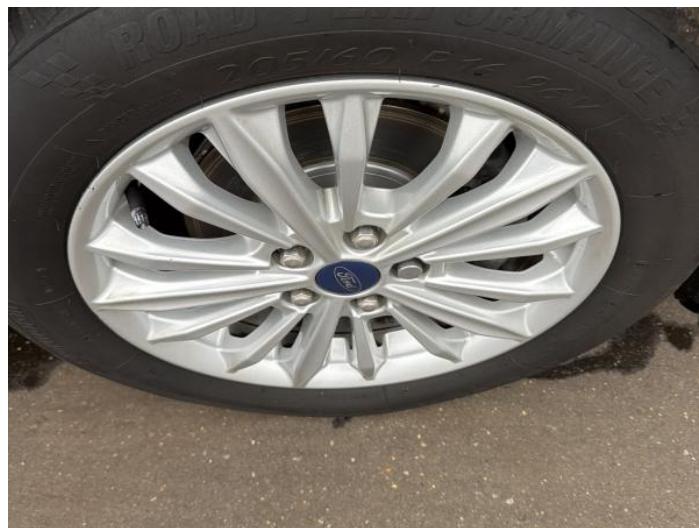
11: Wheel osf
Scratched
Up To 50mm

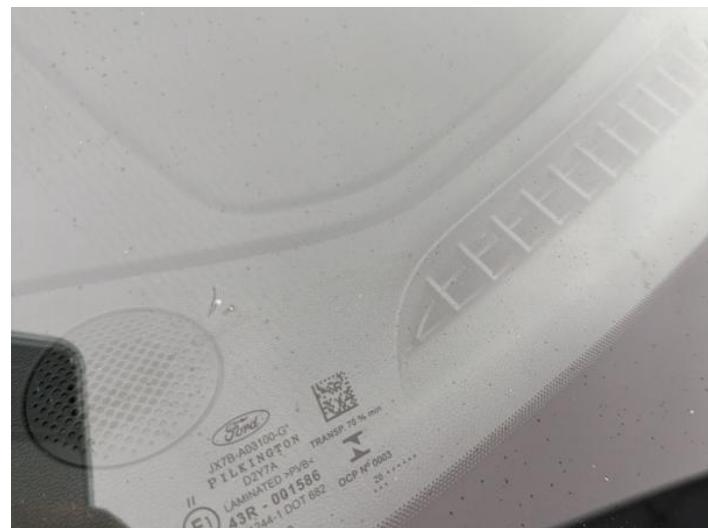
12: Screen Front
Chipped
UpTo 10mm

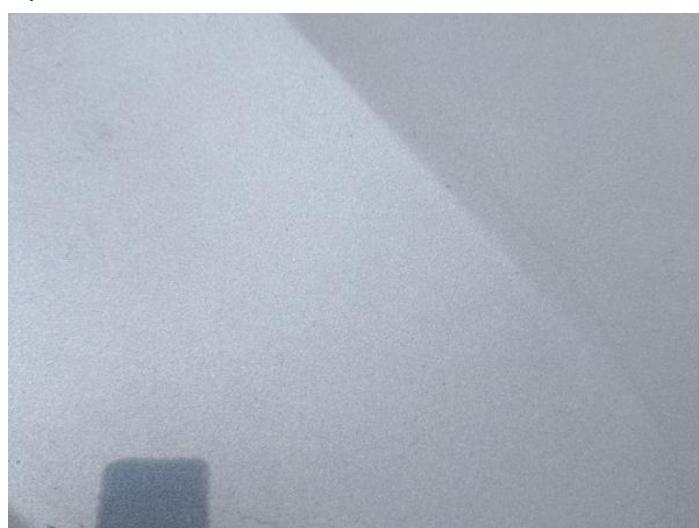
13: Bonnet
Chipped
1 To 5

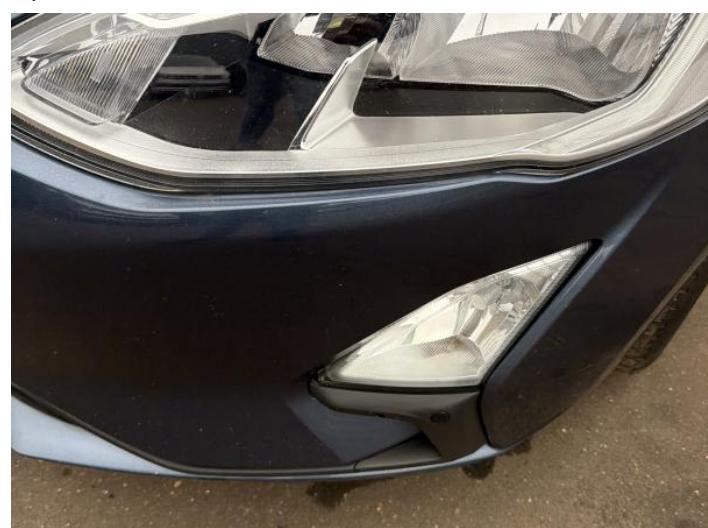
14: Bumper Front
Scratched
25 to 100mm Thru Paint

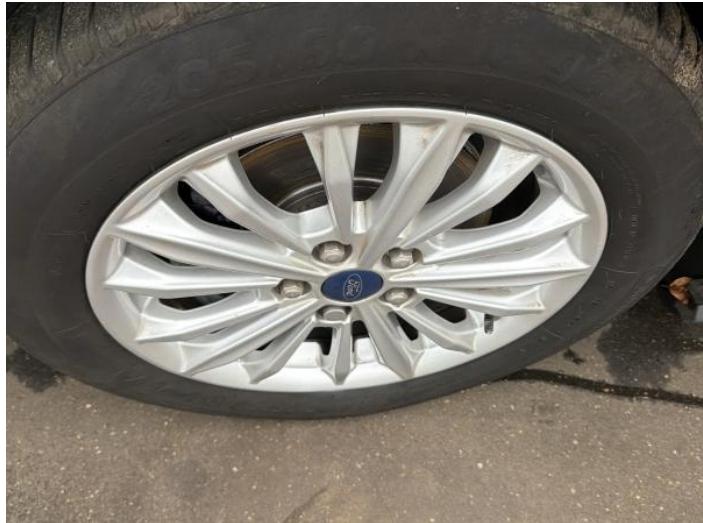
16: Wheel nsf
Scratched
Up To 50mm

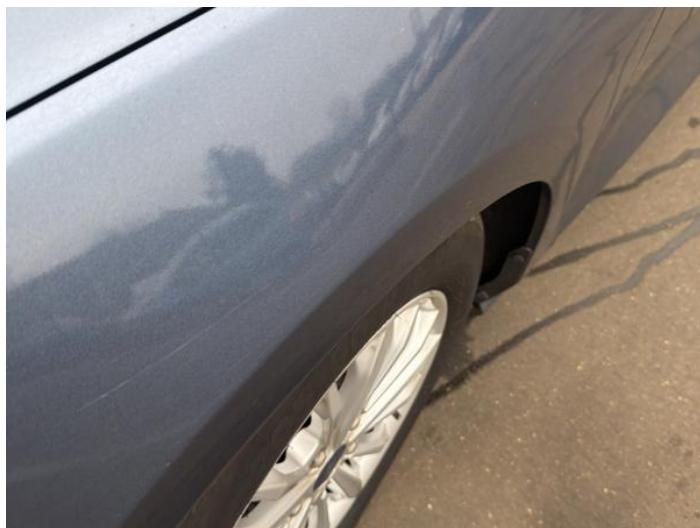
17: Wing nsf
Chipped
1 To 5

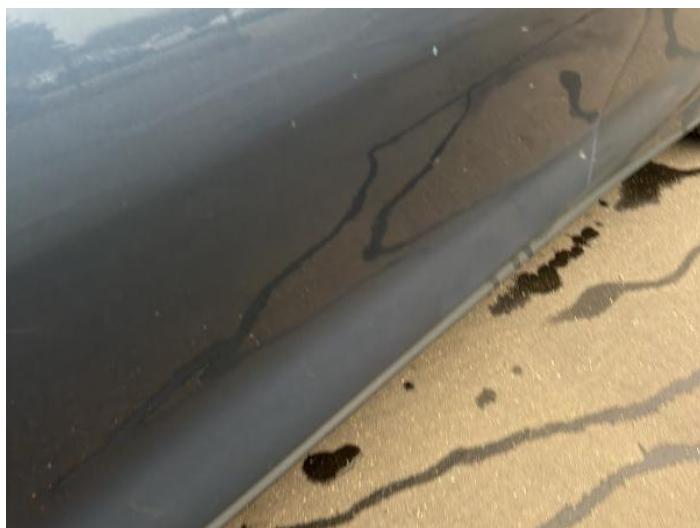
19: Door nsf
Chipped
Multiple Chips

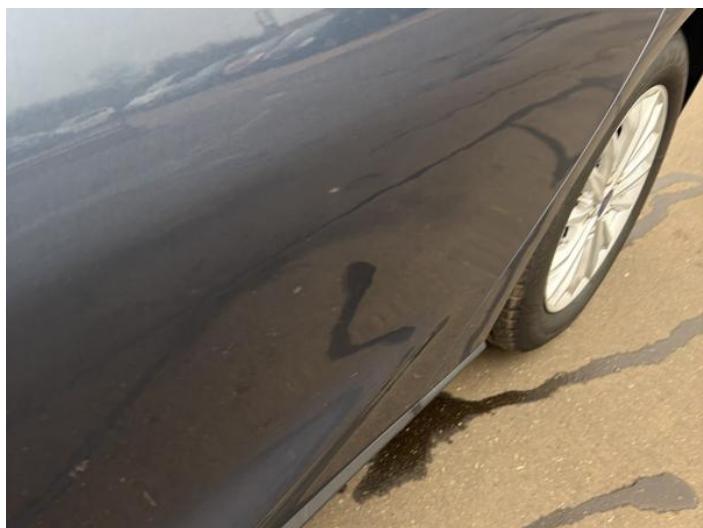
20: Door nsr
Chipped
1 To 5

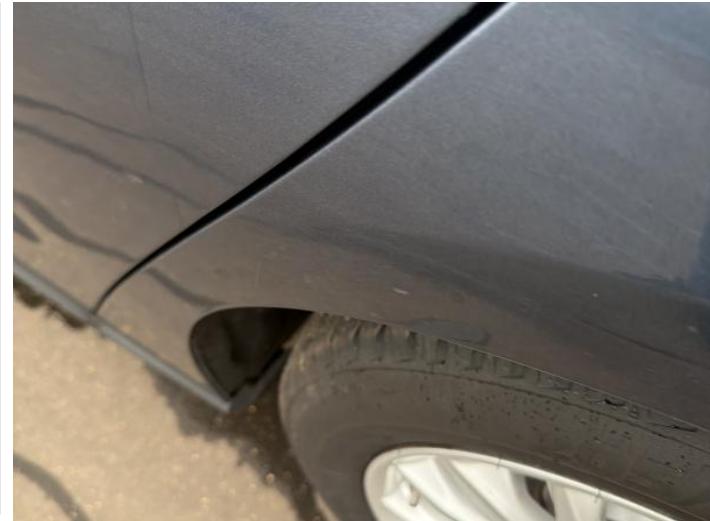
22: Qtr Panel nsr
Dented
Between 10mm + 30mm

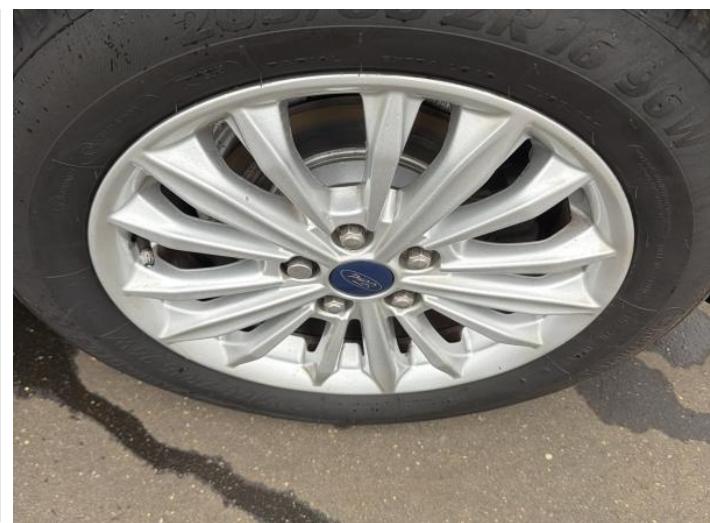
24: Wheel nsr
Scratched
Up To 50mm
