VEHICLE INSPECTION REPORT

LG20HUV

Ford Focus 1.5 EcoBoost 150 Active X 5dr

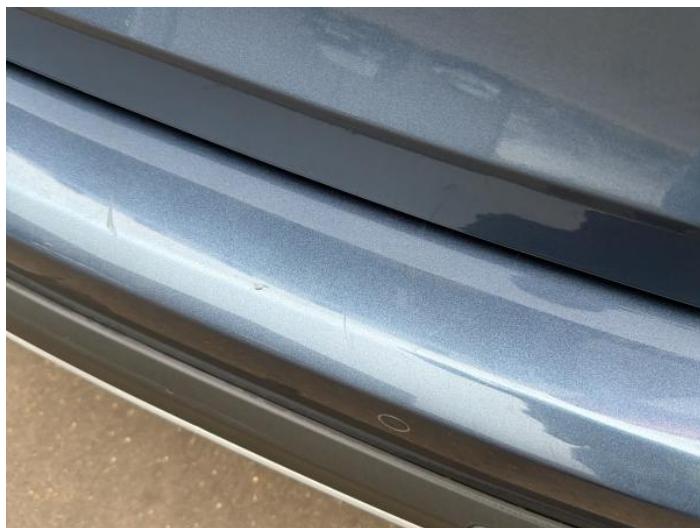
1: Bumper Rear
Scratched
25 to 100mm Thru Paint

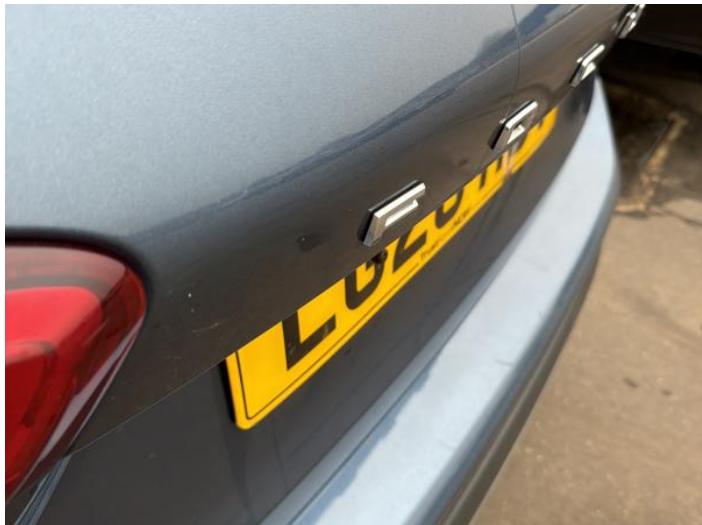
3: Boot Lid
Chipped
1 To 5

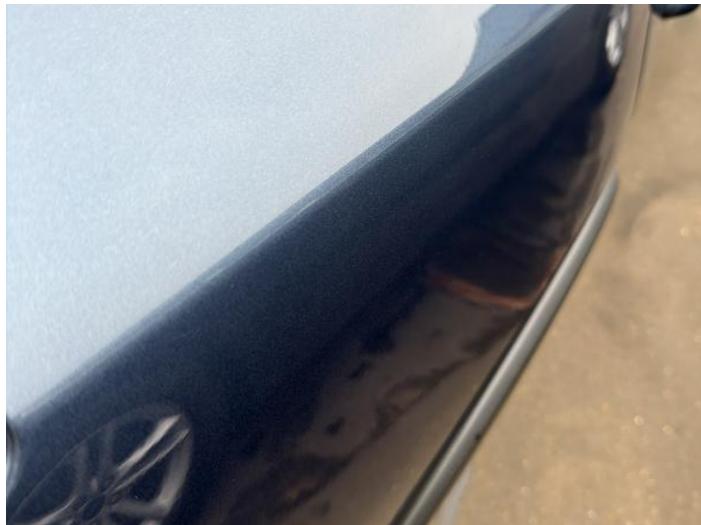
4: Qtr Panel osr
Dented
2 Or Less UpTo 10mm

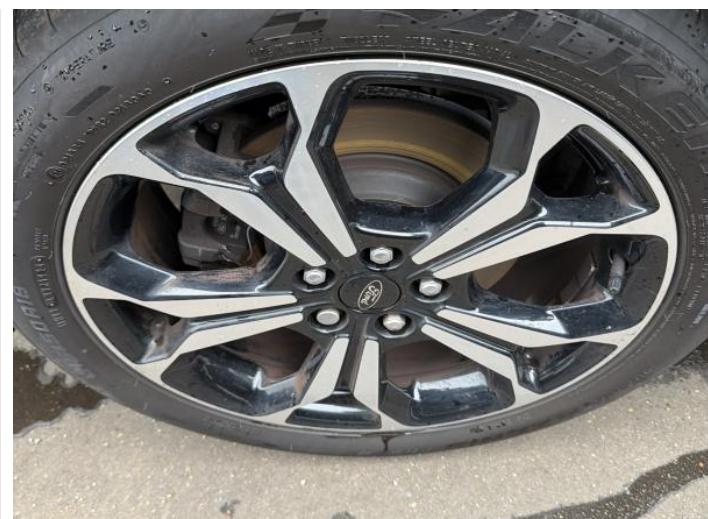
6: Wheel osr
Scratched
Up To 50mm

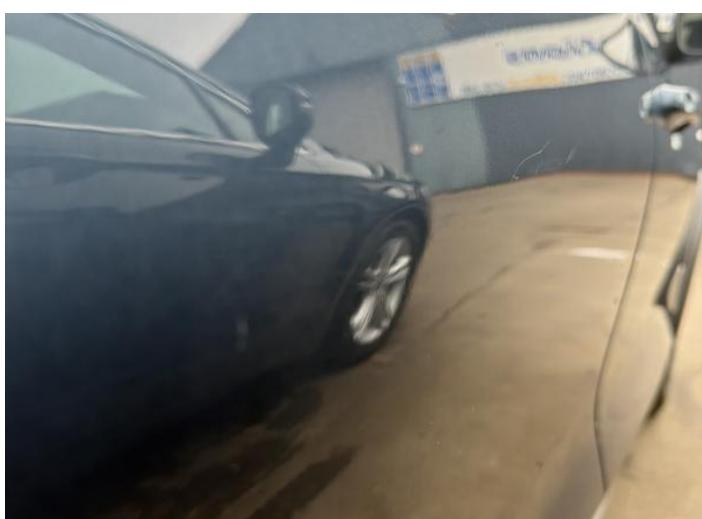
7: Door osr
Dented
With Paint Damage

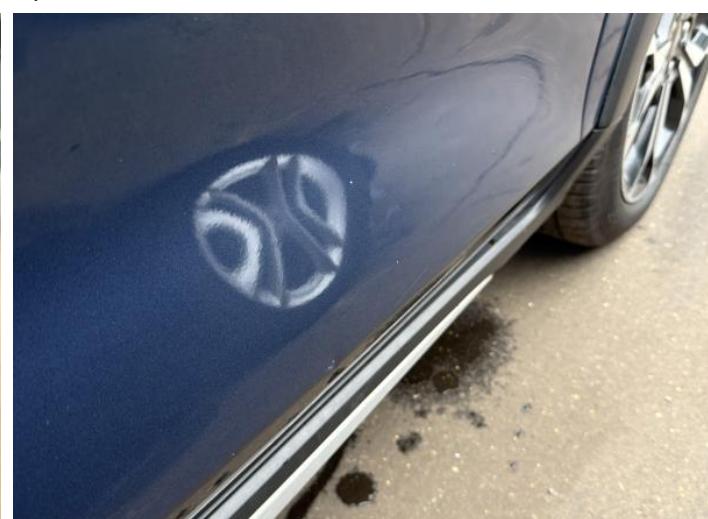
8: Door osf
Dented
With Paint Damage

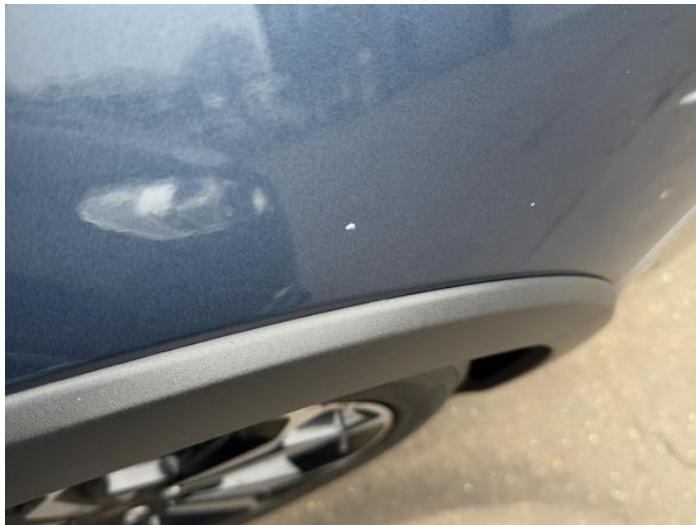
9: Wing osf
Chipped
1 To 5

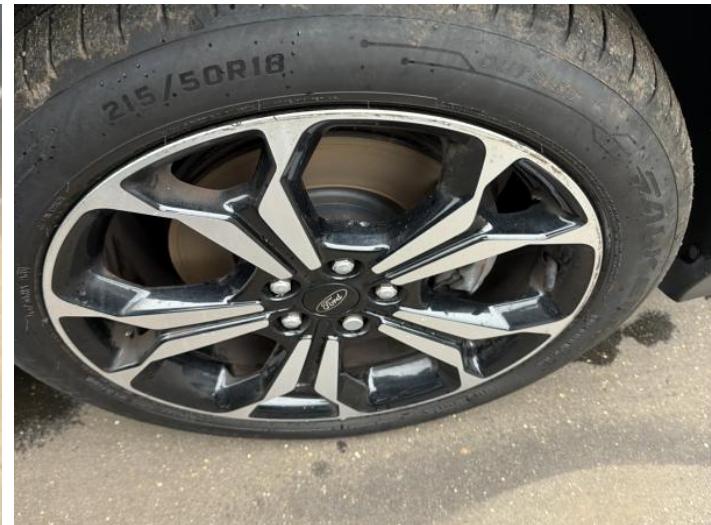
10: Wheel osf
Scratched
Up To 50mm

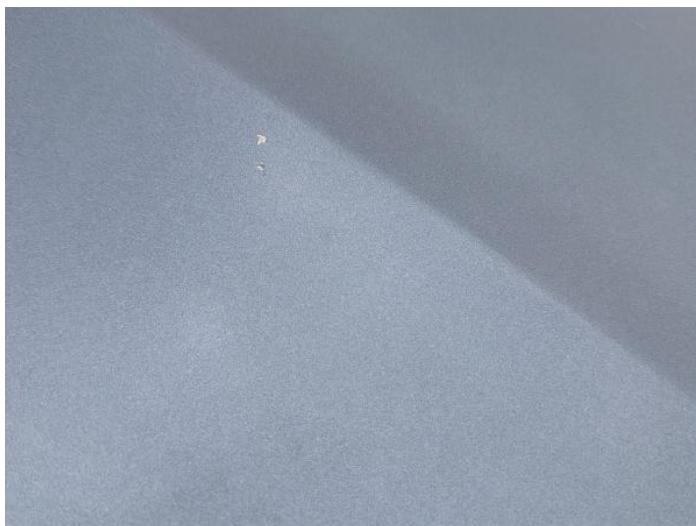
11: Bonnet
Chipped
1 To 5

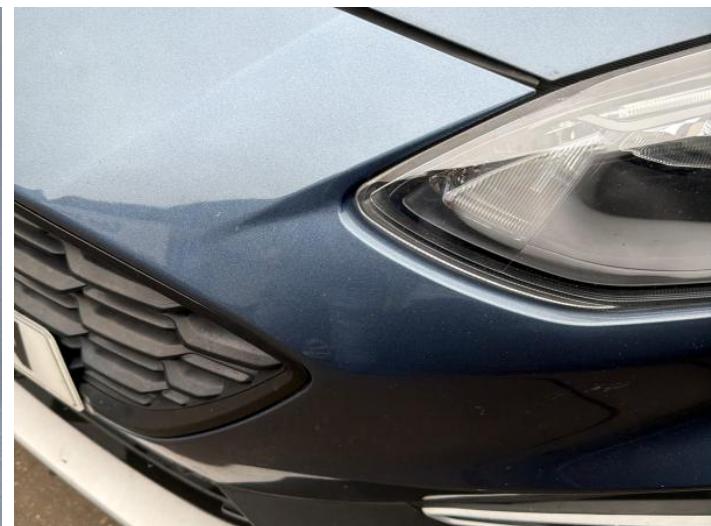
12: Bumper Front
Chipped
Multiple Chips

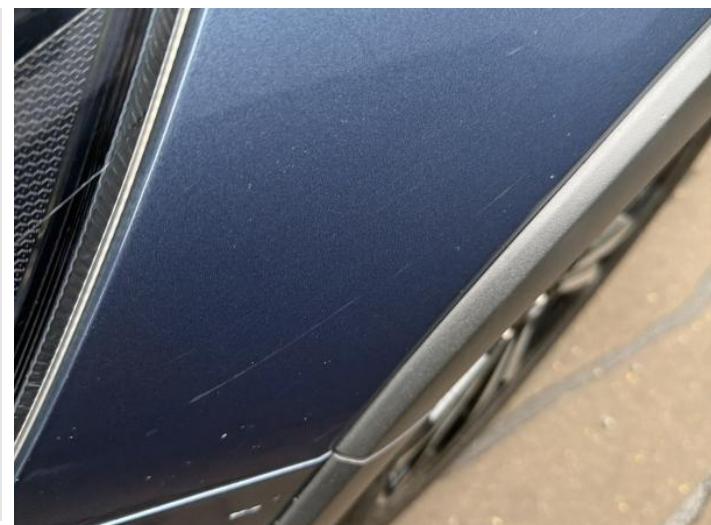
14: Wing nsf
Chipped
1 To 5

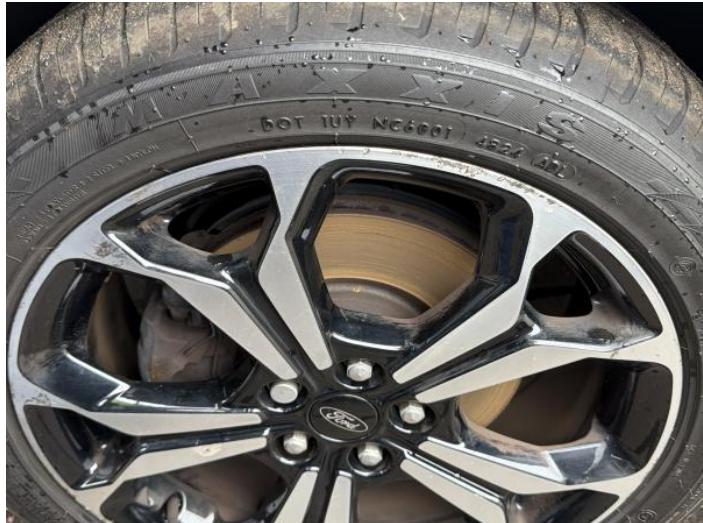
16: Wheel nsf
Scratched
Over 50mm

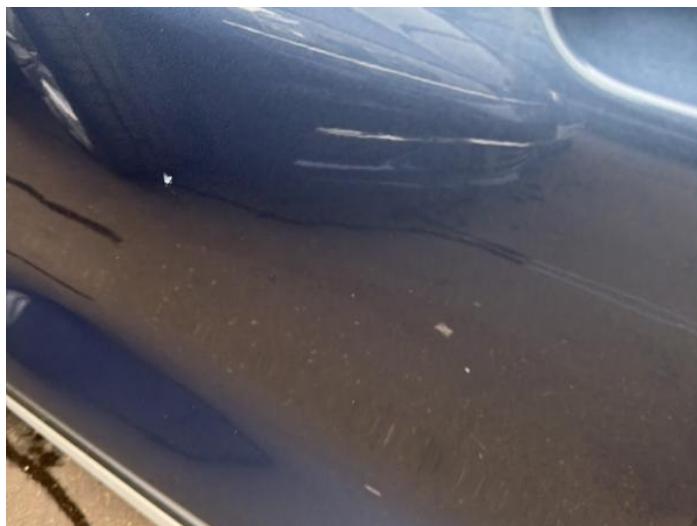
17: Door nsf
Chipped
Multiple Chips

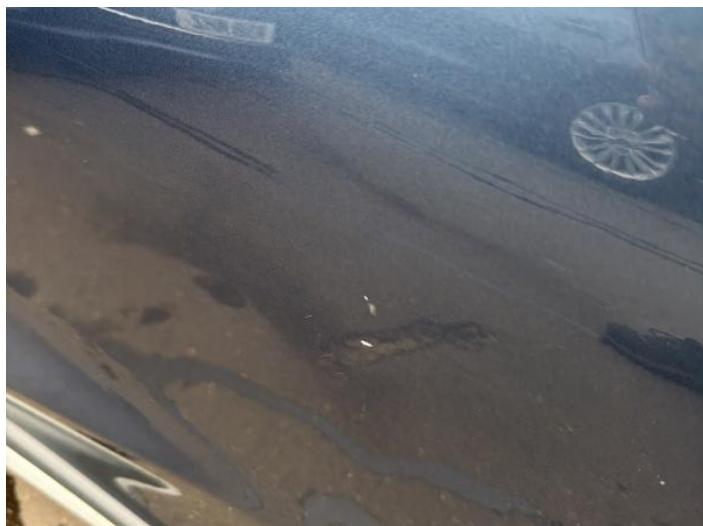
18: Door nsr
Chipped
1 To 5

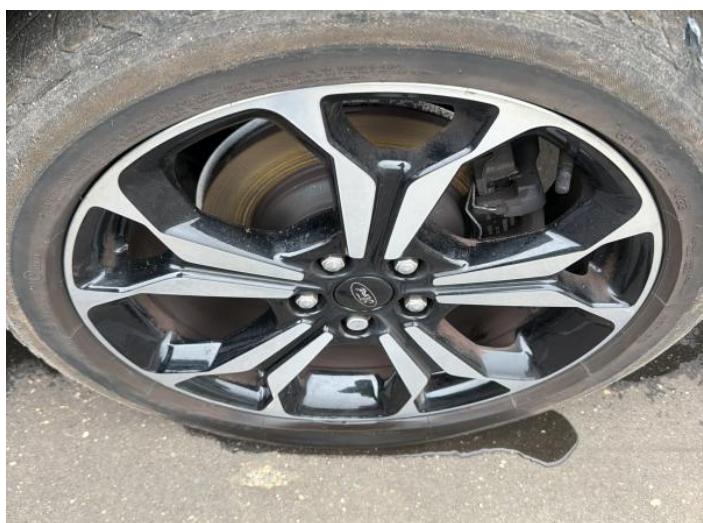
20: Wheel nsr
Scratched
Up To 50mm
