## VEHICLE INSPECTION REPORT

LF66VFJ

### Ford Mondeo 2.0 TDCi EConetic Zetec 5dr

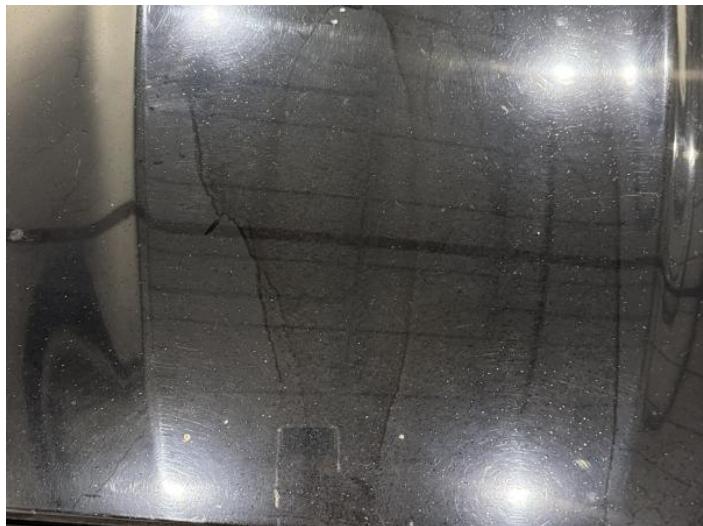
1: Bonnet  
Chipped  
Multiple Chips

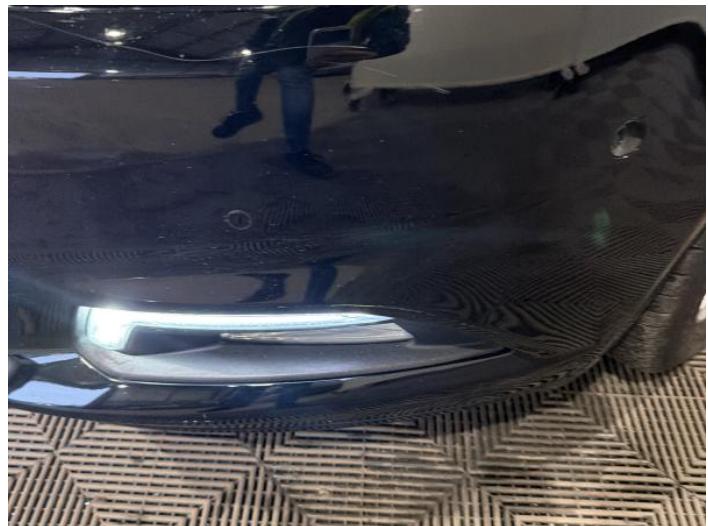
2: Bumper Front  
Scratched  
Over 100mm Thru Paint

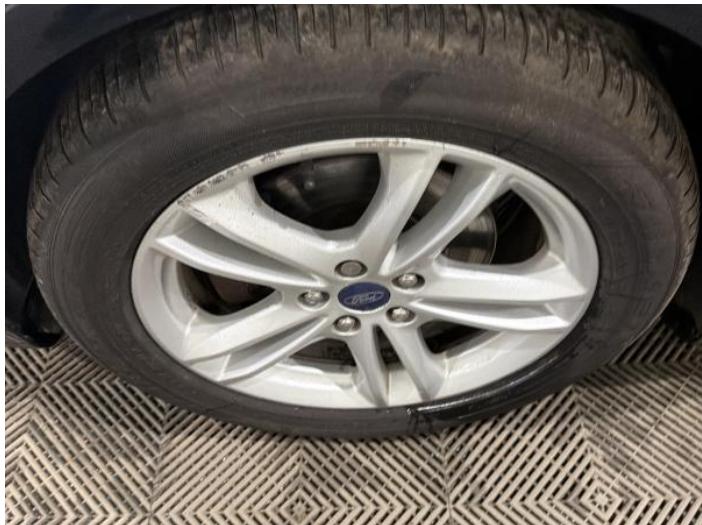
3: Wheel nsf  
Scratched  
Over 50mm

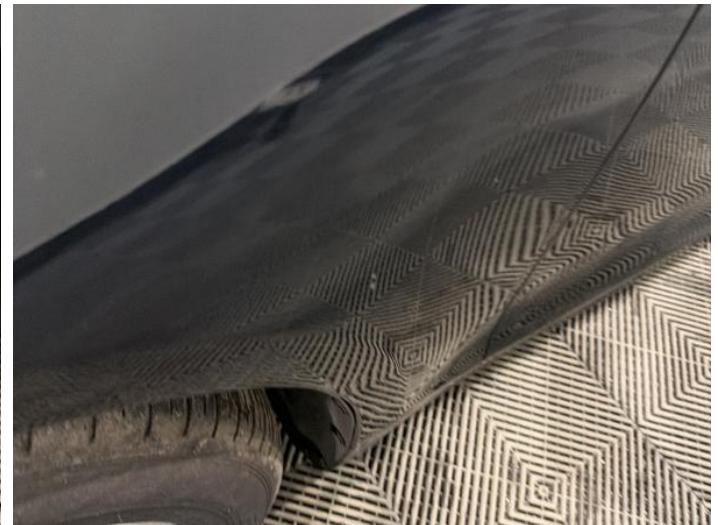
4: Wing nsf  
Chipped  
Multiple Chips

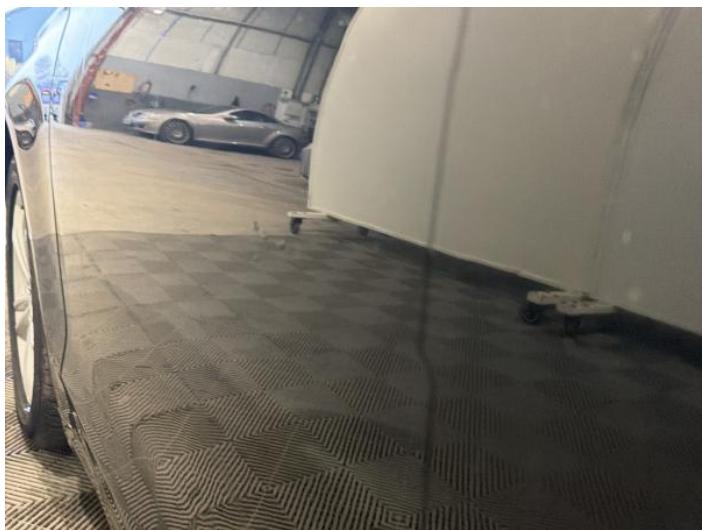
5: Door nsf  
Poor Previous Repair  
Poor Paint

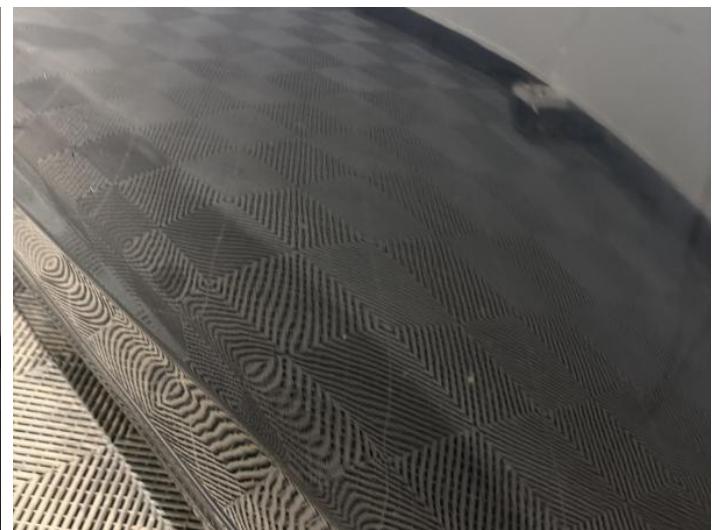
6: Door nsr  
Chipped  
Multiple Chips

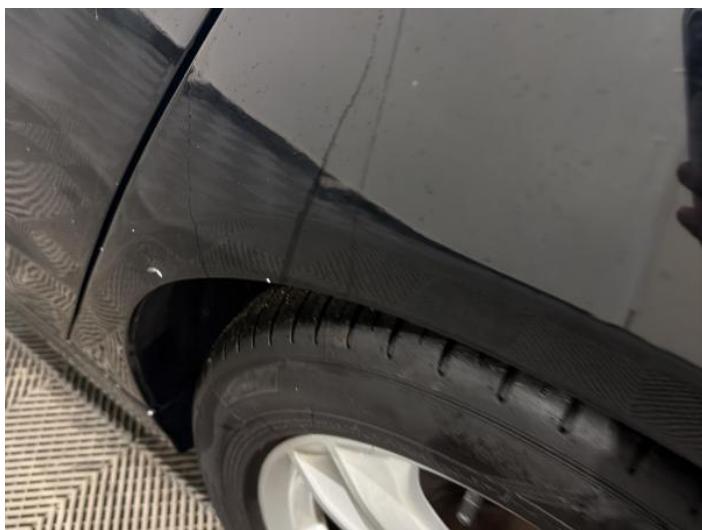
7: Qtr Panel nsr  
Dented  
With Paint Damage

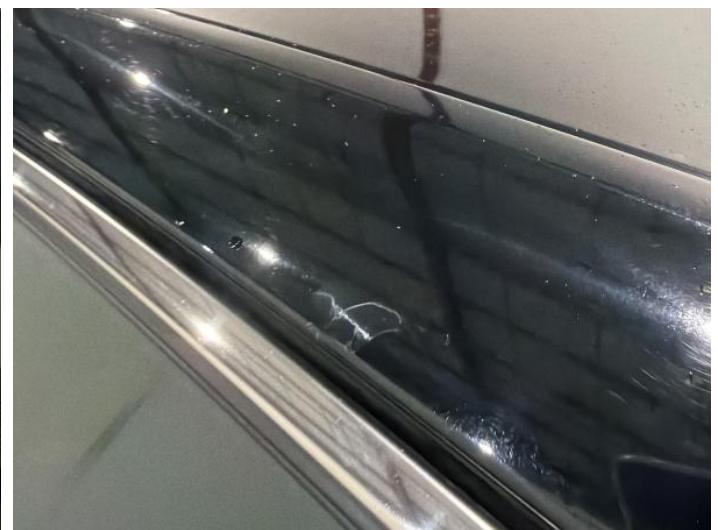
8: C Post ns  
Scratched  
UpTo 25mm Thru Paint

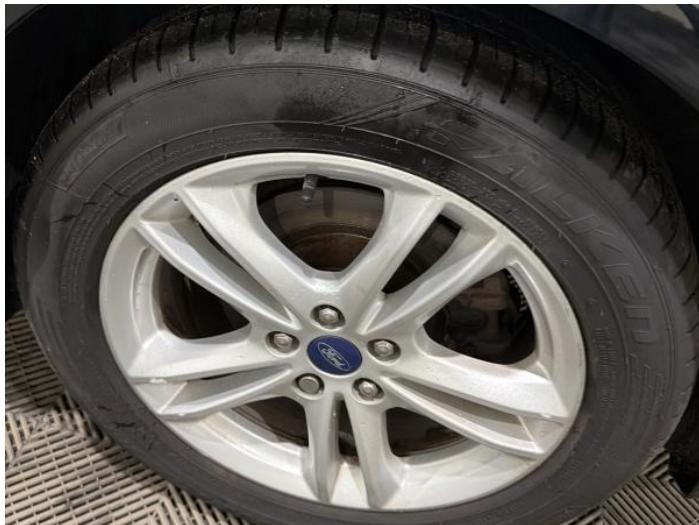
9: Wheel nsr  
Scratched  
Over 50mm

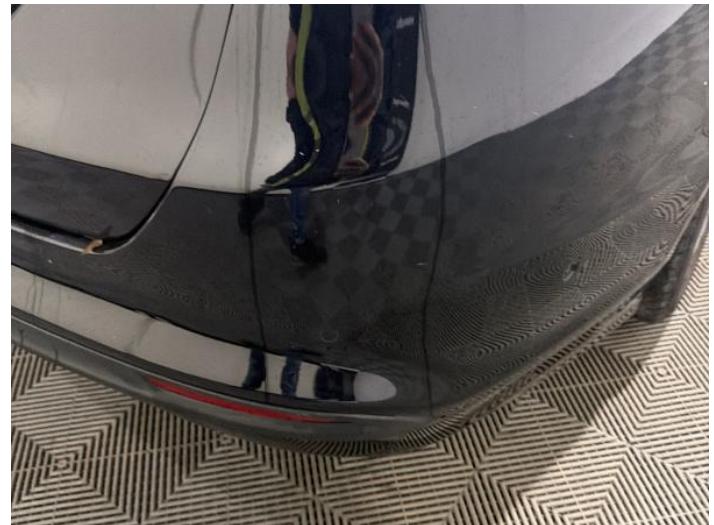
10: Bumper Rear  
Chipped  
Multiple Chips

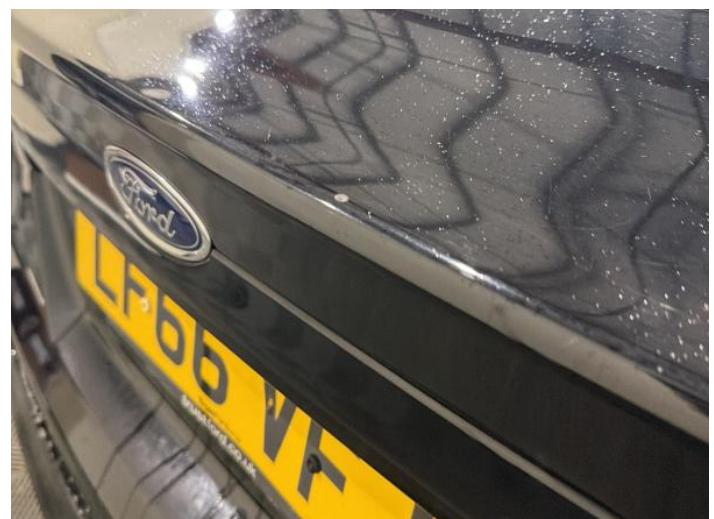
12: Boot Lid  
Chipped  
1 To 5

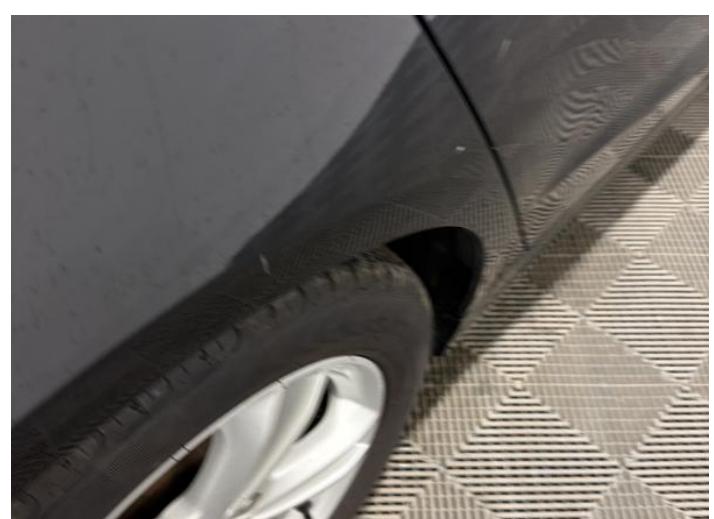
14: Qtr Panel osr  
Dented  
With Paint Damage

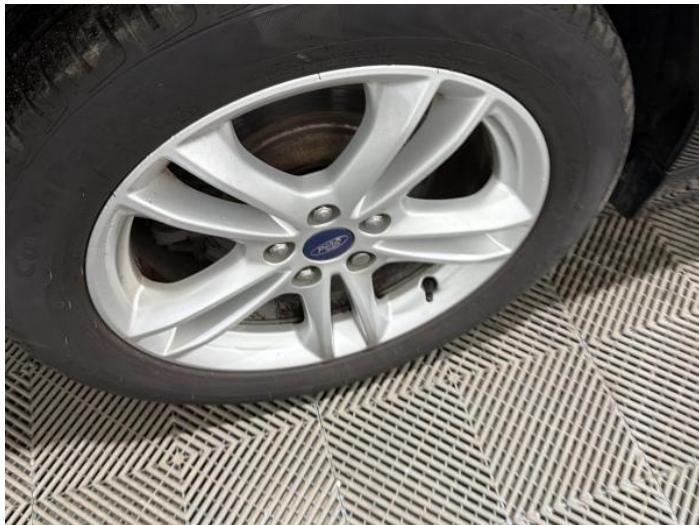
15: Wheel osr  
Scratched  
Up To 50mm

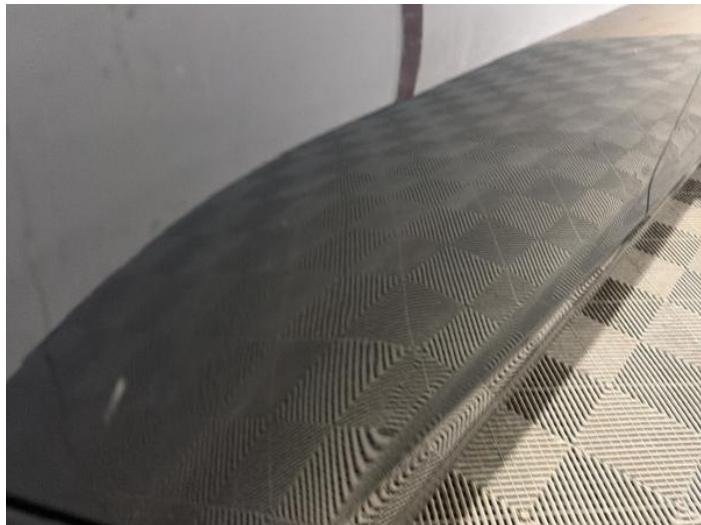
16: Door osr  
Chipped  
Multiple Chips

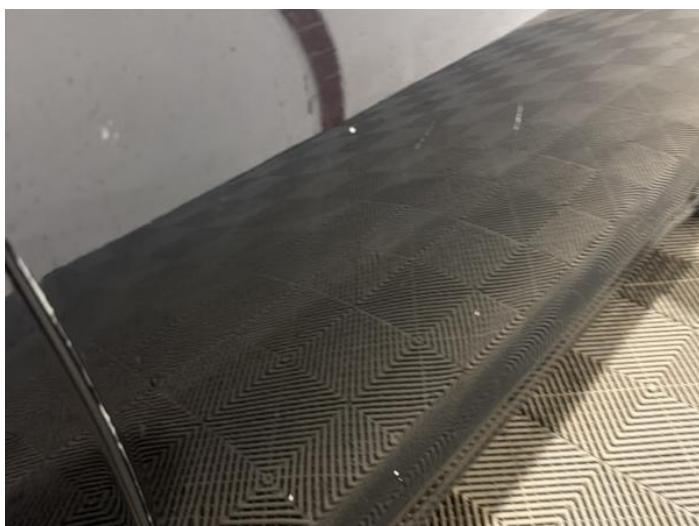
17: Door osf  
Chipped  
Multiple Chips

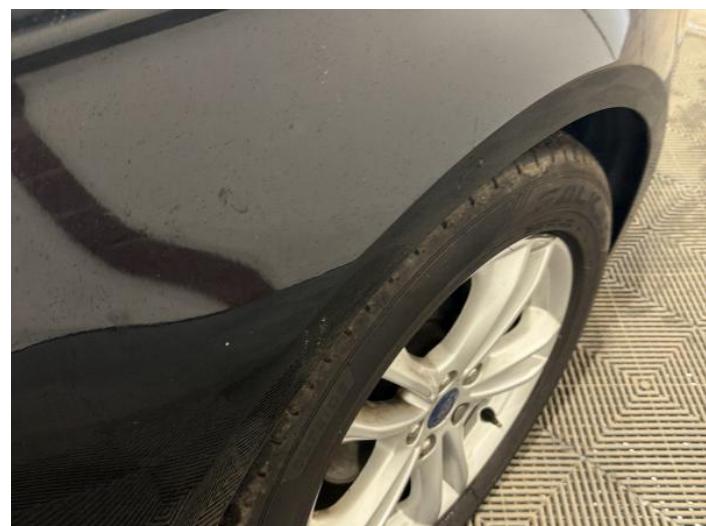
18: Wing osf  
Dented  
Over 2 UpTo 10mm

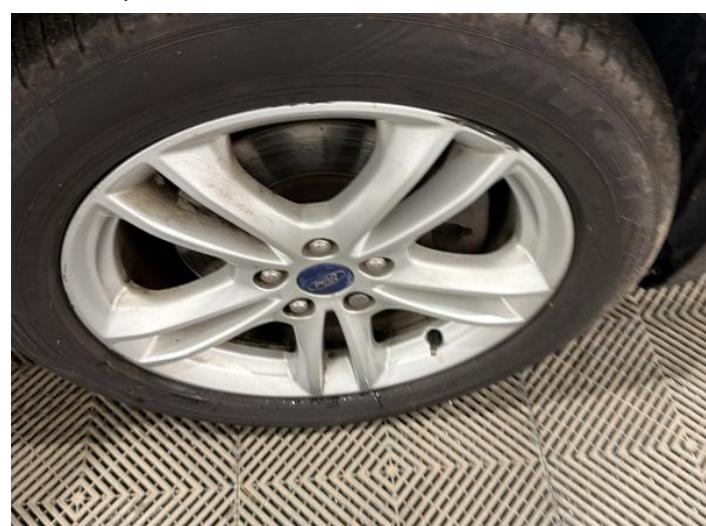
20: Wheel osf  
Scratched  
Over 50mm

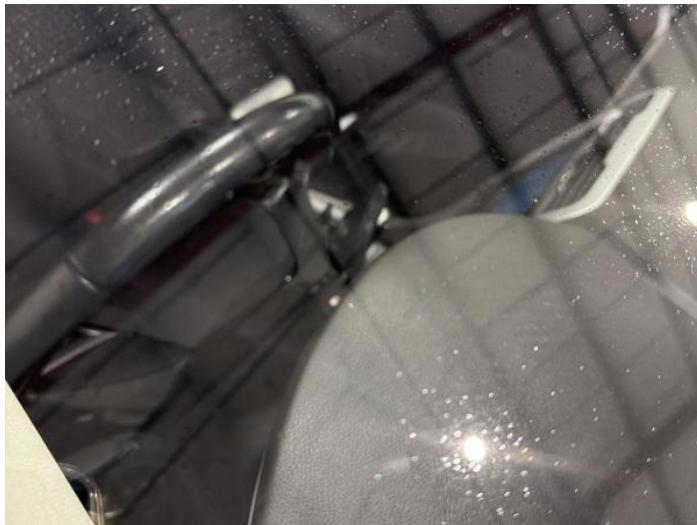
21: Screen Front  
Chipped  
UpTo 10mm
