VEHICLE INSPECTION REPORT

KF68WZV

Toyota Prius 1.8 VVTi Business Edition 5dr CVT

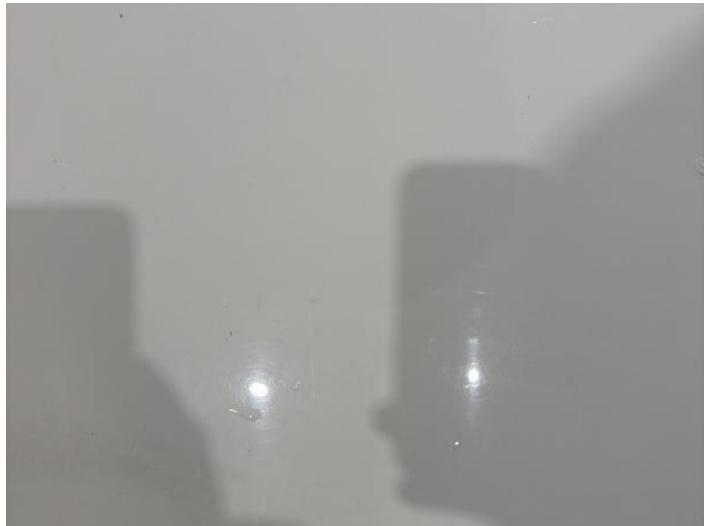
1: Bonnet
Chipped
1 To 5

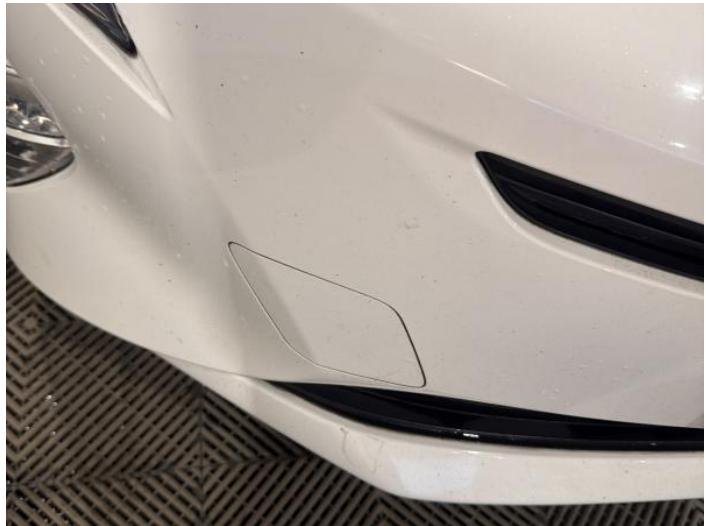
2: Bumper Front
Scratched
25 to 100mm Thru Paint

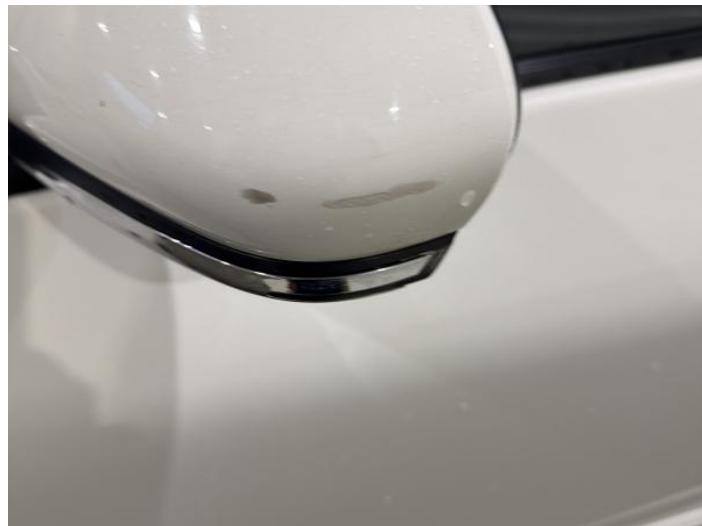
5: Door Mirror Assy nsf
Scratched (Painted)
UpTo 25mm Thru Paint

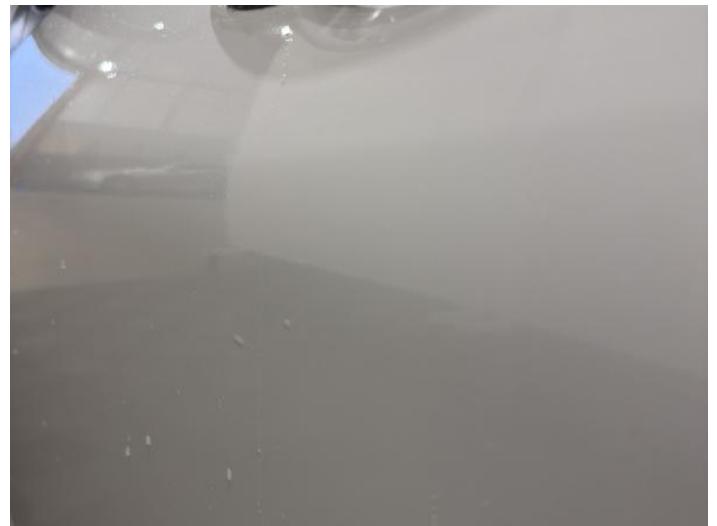
6: Door nsf
Dented
2 Or Less UpTo 10mm

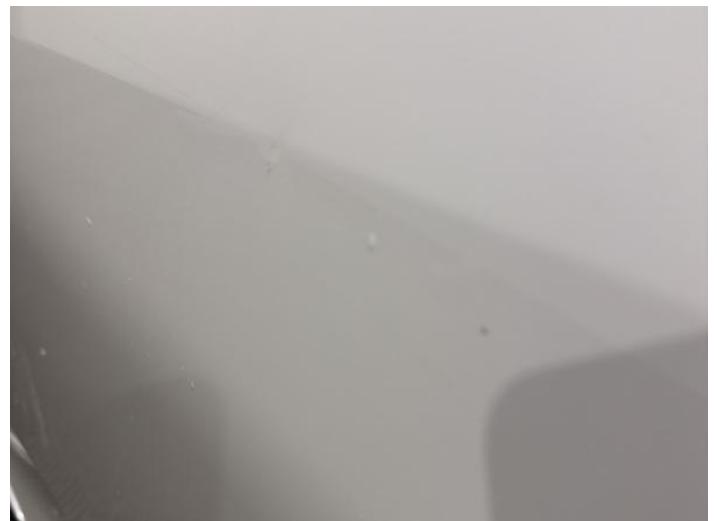
8: Door nsr
Dented
Between 10mm + 30mm

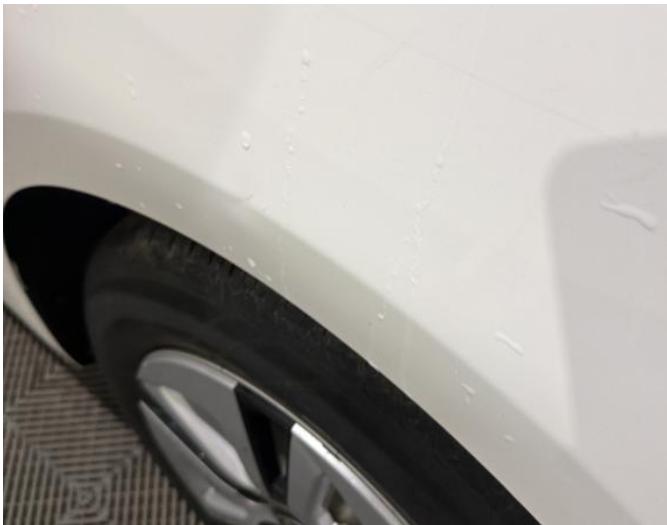
9: Qtr Panel nsr
Dented
Over 30mm

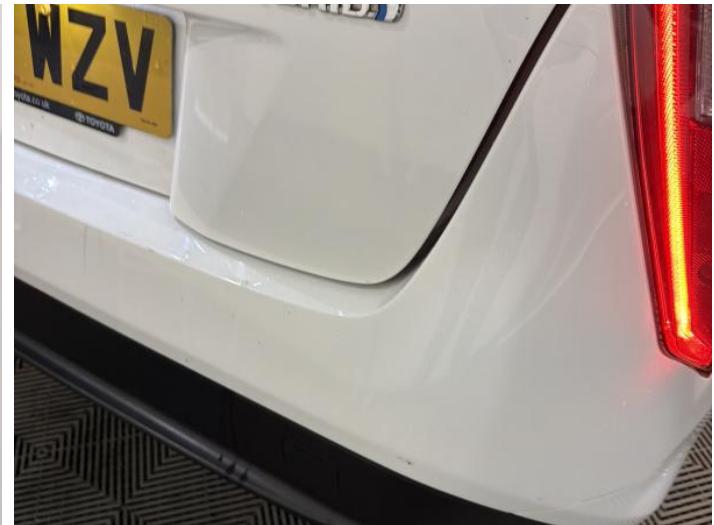
10: Bumper Rear
Scratched
Over 100mm Thru Paint

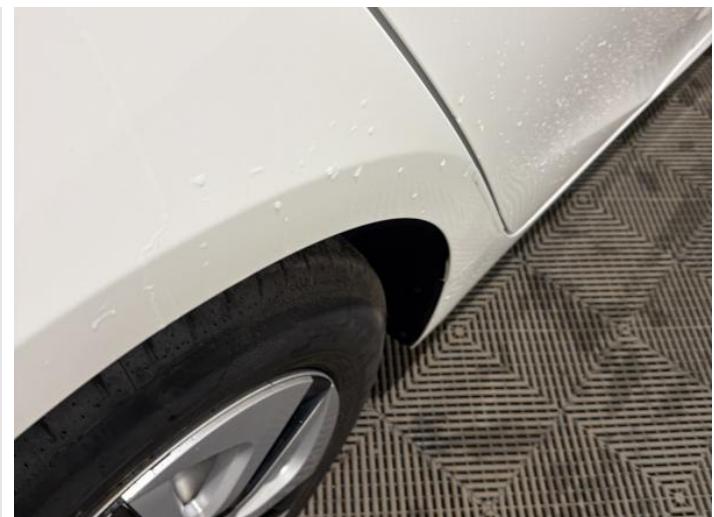
12: Qtr Panel osr
Dented
2 Or Less UpTo 10mm

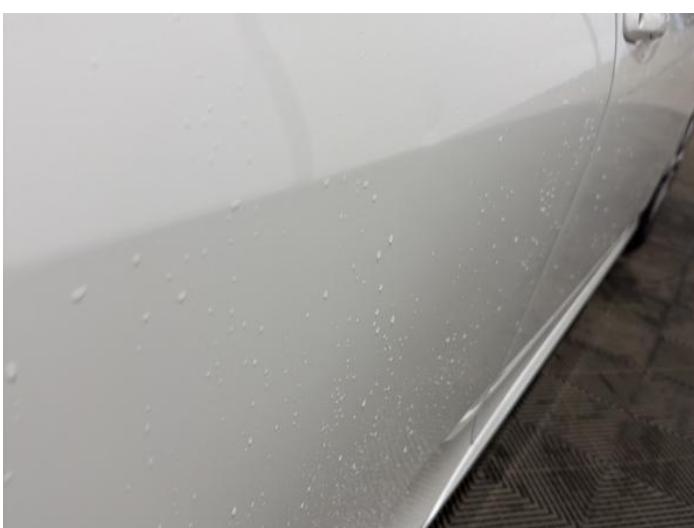
13: Door osr
Dented
Between 10mm + 30mm

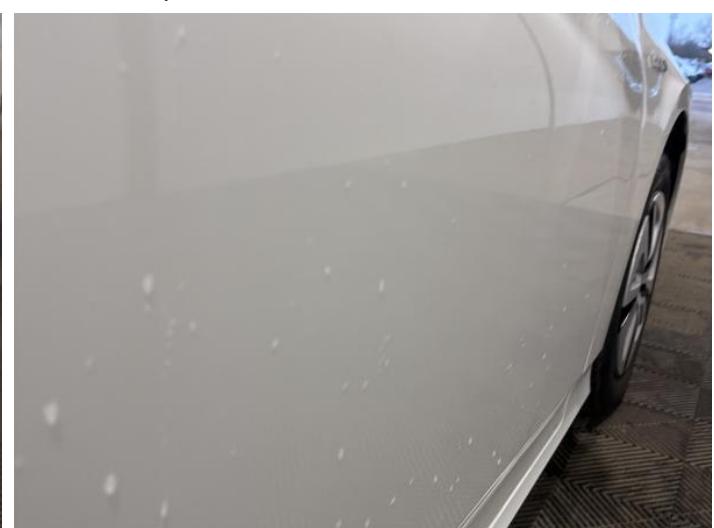
14: Door osf
Dented
Over 2 UpTo 10mm

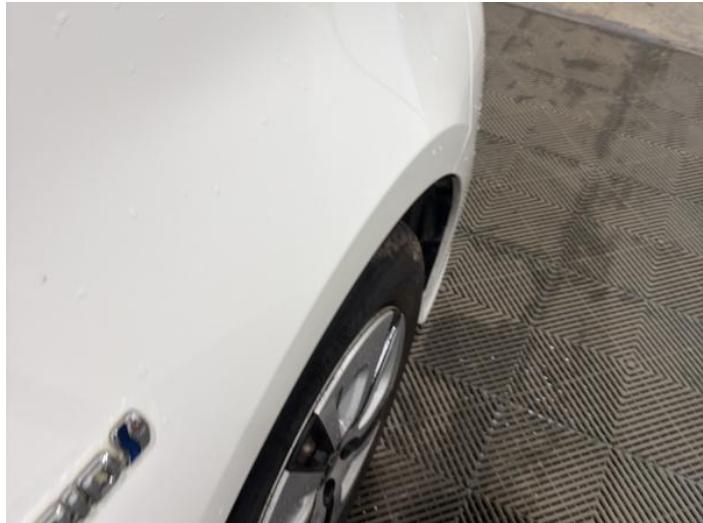
15: Door osf
Scratched
Over 25mm Not Thru Paint
