VEHICLE INSPECTION REPORT

LD19FLC

Ford Mondeo 1.5 EcoBoost 165 Titanium Edition 5dr

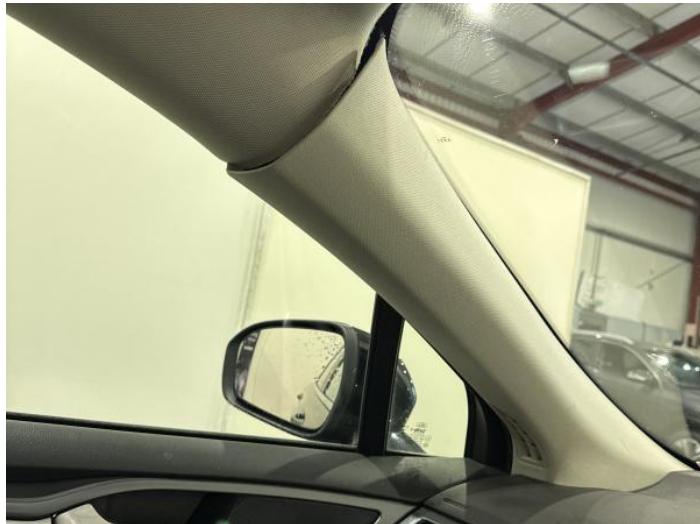
1: Fascia Trim
Damaged
Replace

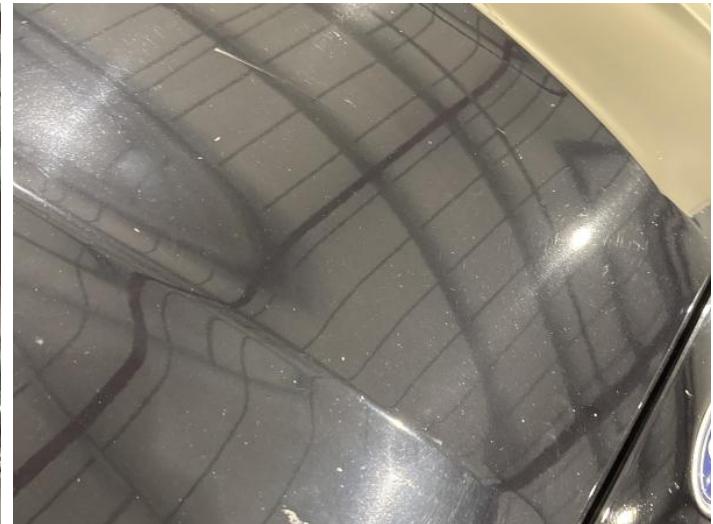
2: Bonnet
Chipped
Multiple Chips

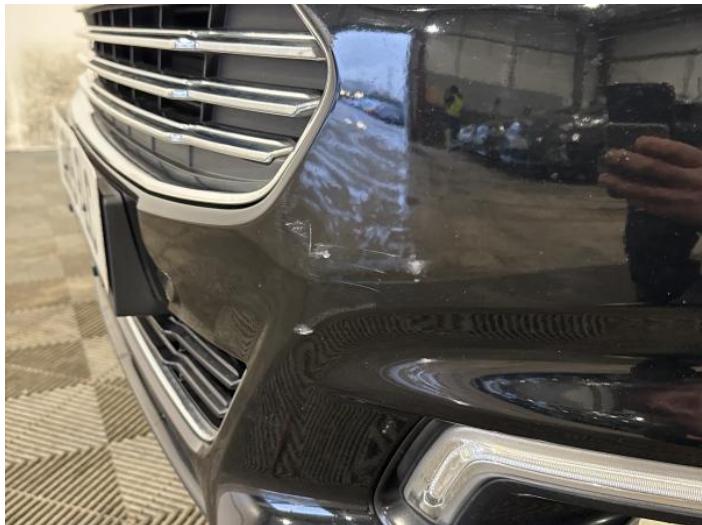
3: Bumper Front
Dented
With Paint Damage

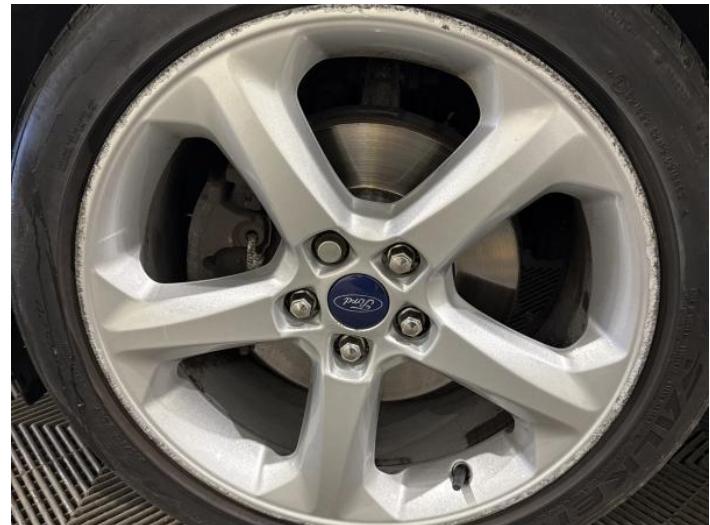
4: Wheel nsf
Scratched
Over 50mm

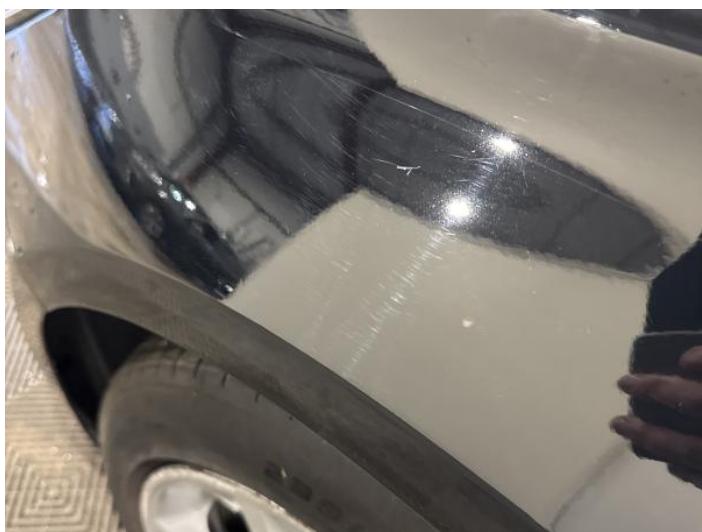
5: Wing nsf
Scratched
UpTo 25mm Thru Paint

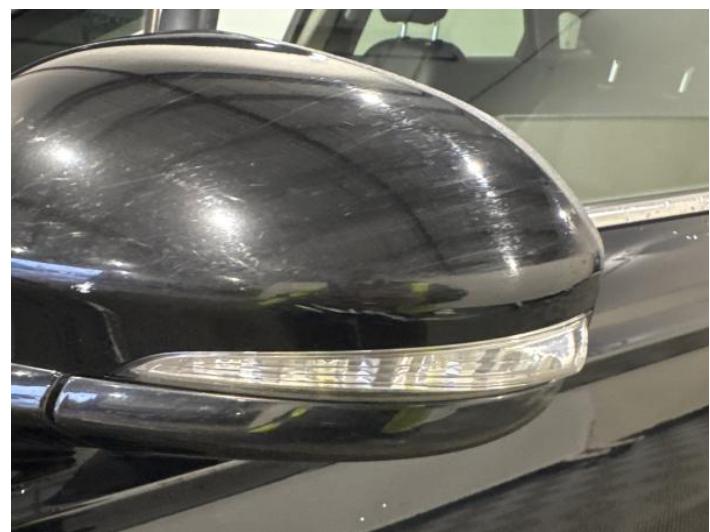
6: Door Mirror Assy nsf
Scratched (Painted)
Over 25mm Thru Paint

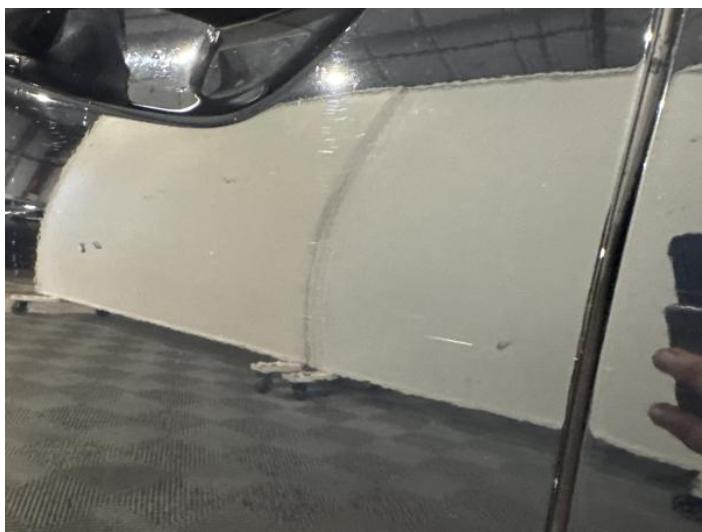
7: Door nsf
Scratched
UpTo 25mm Thru Paint

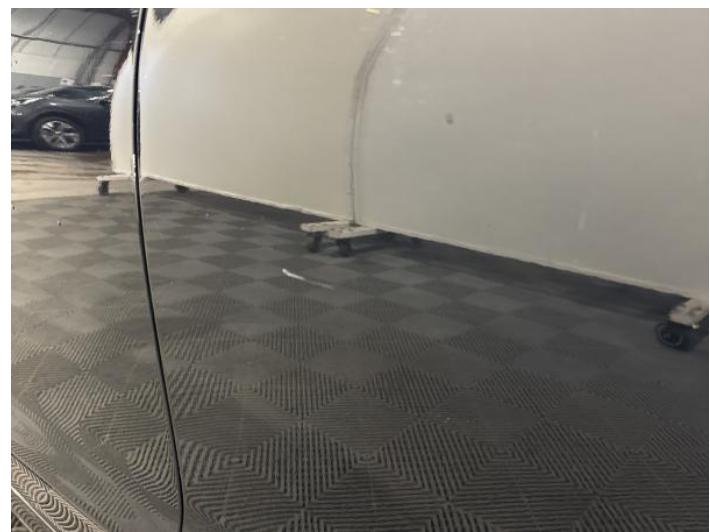
8: Door nsf
Scratched
Over 25mm Thru Paint

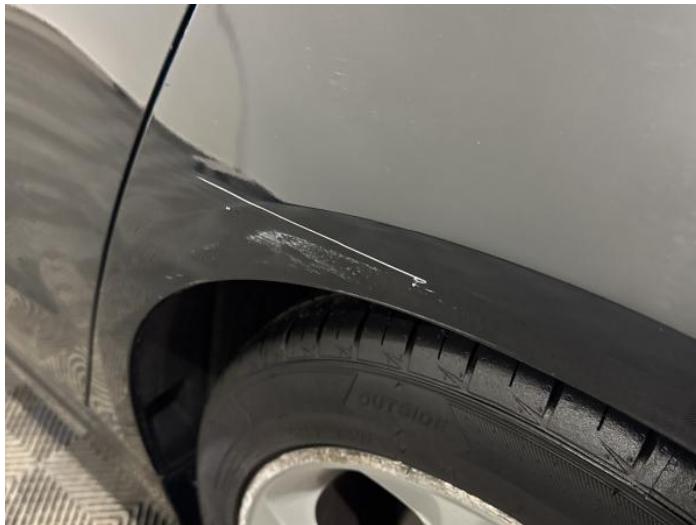
9: Qtr Panel nsr
Scratched
Over 25mm Thru Paint

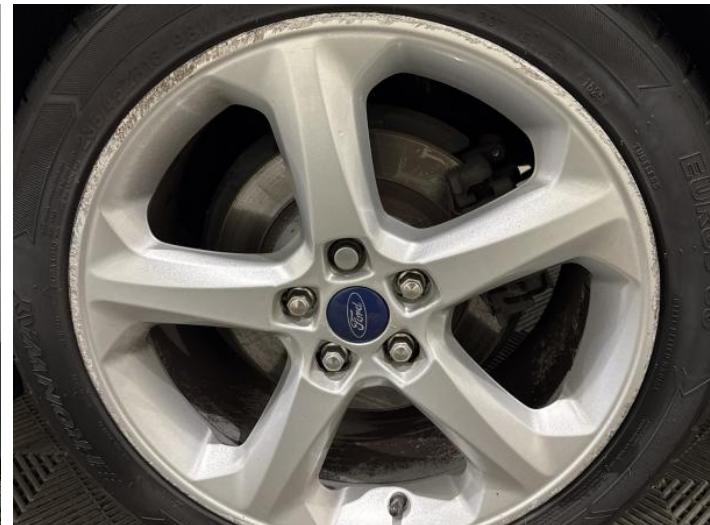
10: Wheel nsr
Scratched
Over 50mm

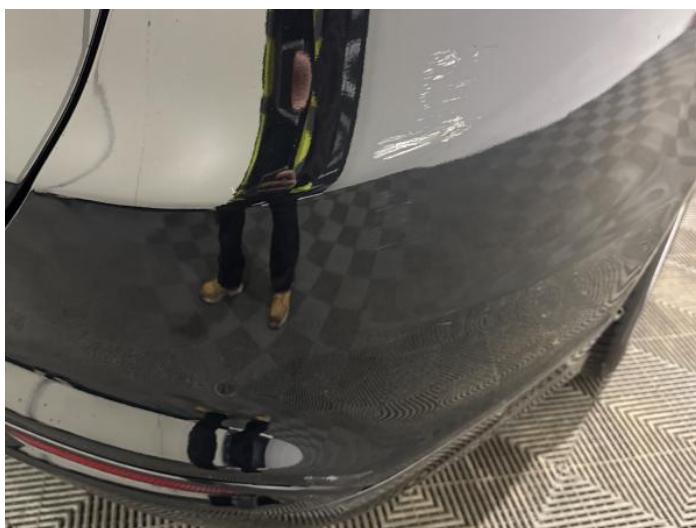
11: Bumper Rear
Scratched
Over 100mm Thru Paint

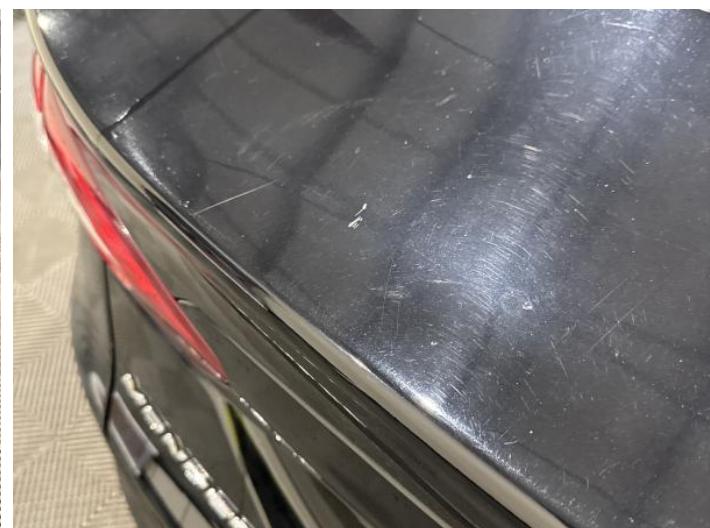
12: Tailgate
Scratched
Over 25mm Thru Paint

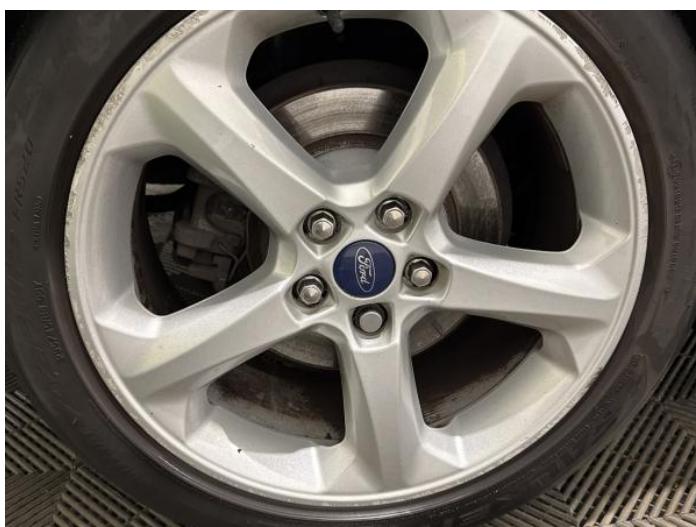
13: Wheel osr
Scratched
Over 50mm

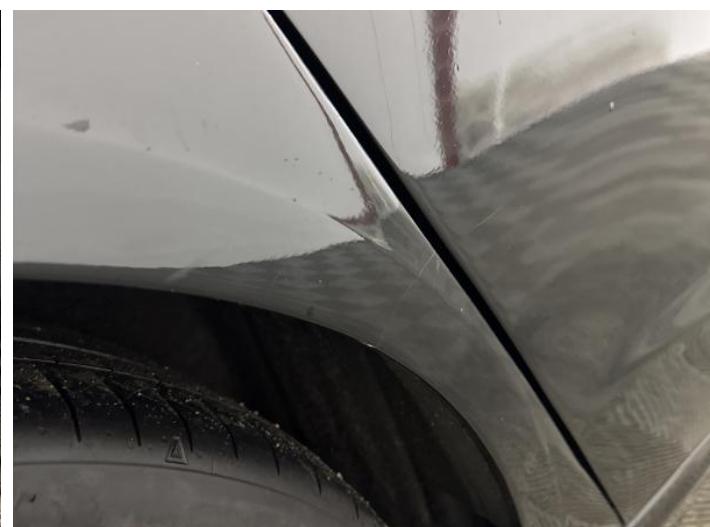
14: Qtr Panel osr
Poor Previous Repair
Poor Paint

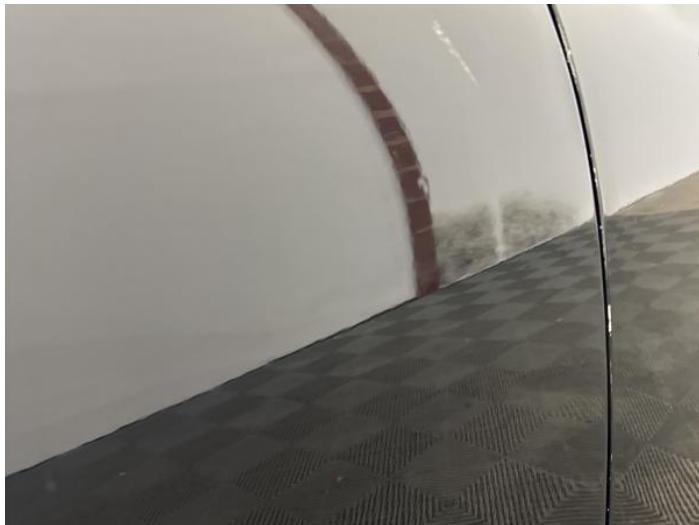
15: Door osr
Poor Previous Repair
Poor Paint

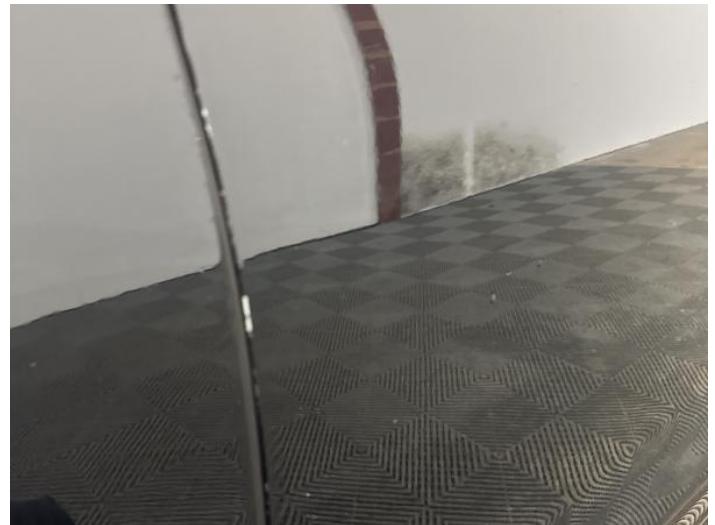
16: Door osf
Chipped
Edge Chip

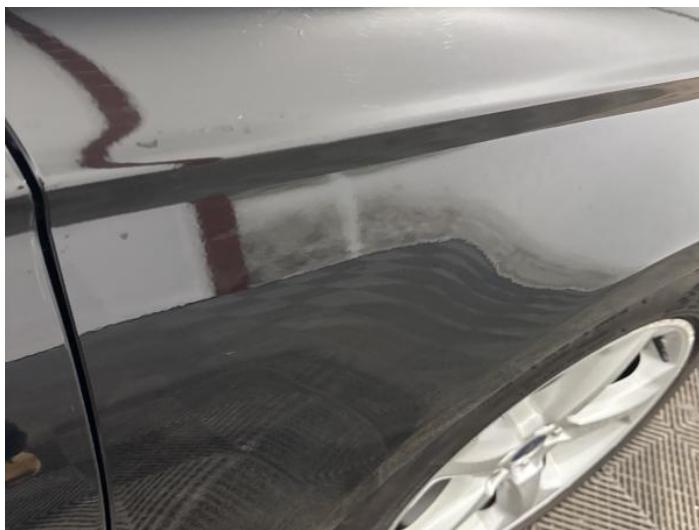
17: Wing osf
Dented
Between 10mm + 30mm

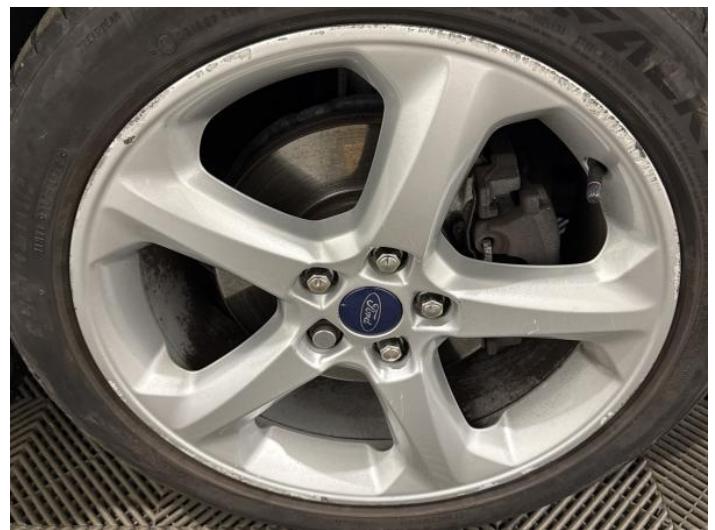
18: Wheel osf
Scratched
Over 50mm

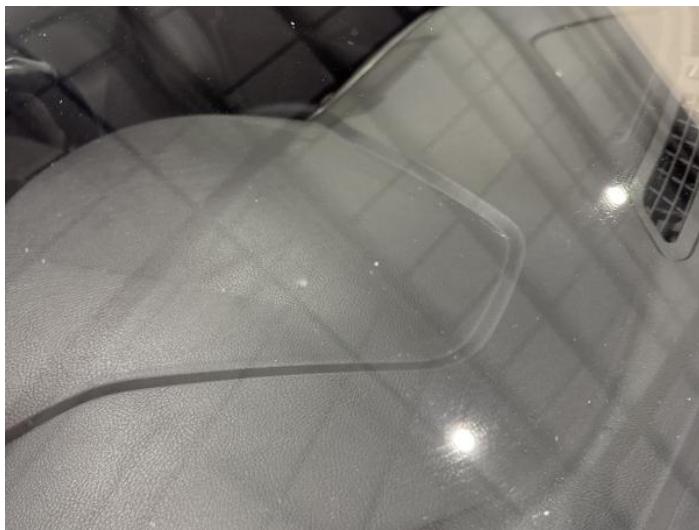
19: Screen Front
Chipped
UpTo 10mm
