# VEHICLE INSPECTION REPORT

GY71ZRR

## MG Mg 3 EXCITE VTI-TECH

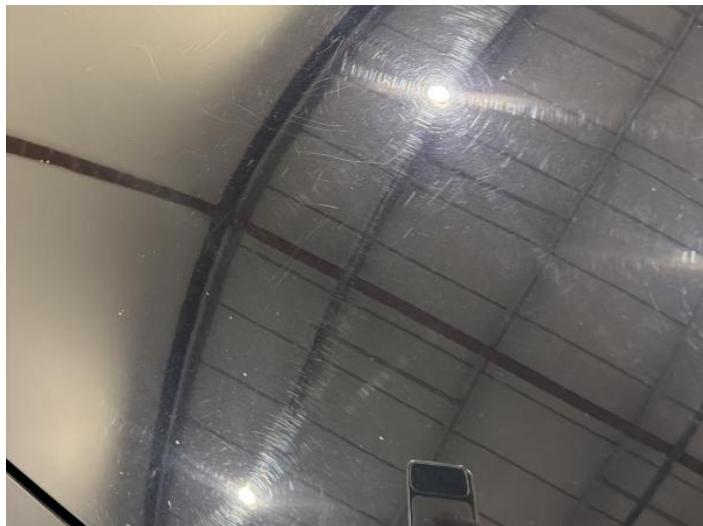
1: Bonnet  
Dented  
With Paint Damage

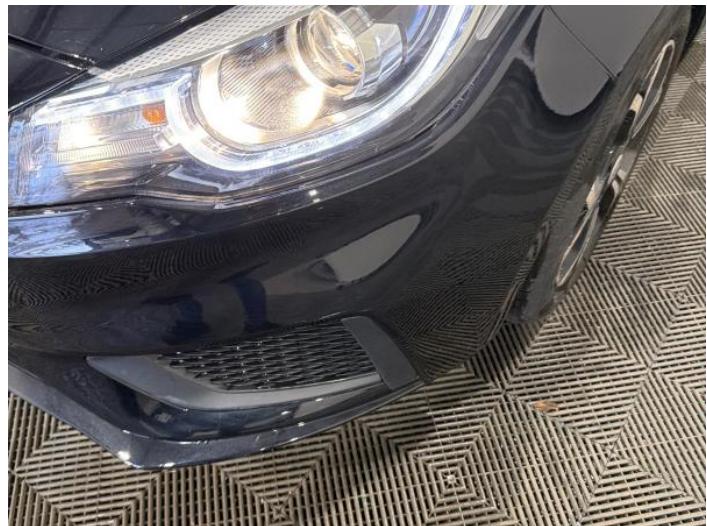
2: Bumper Front  
Scratched  
25 to 100mm Thru Paint

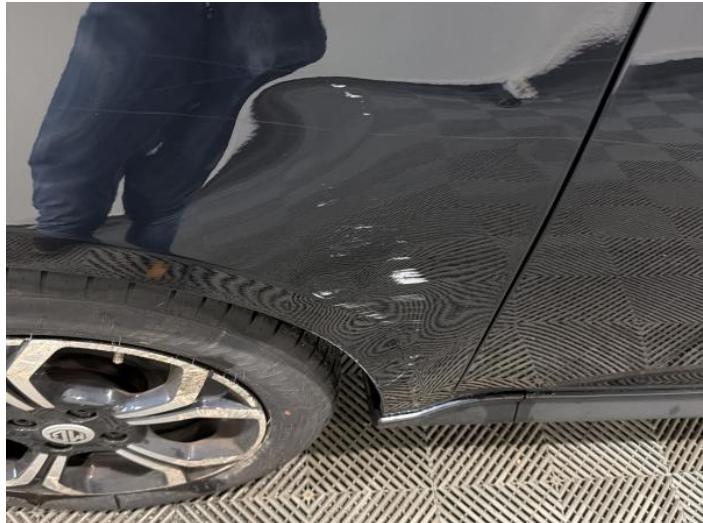
4: Wing nsf  
Dented  
With Paint Damage

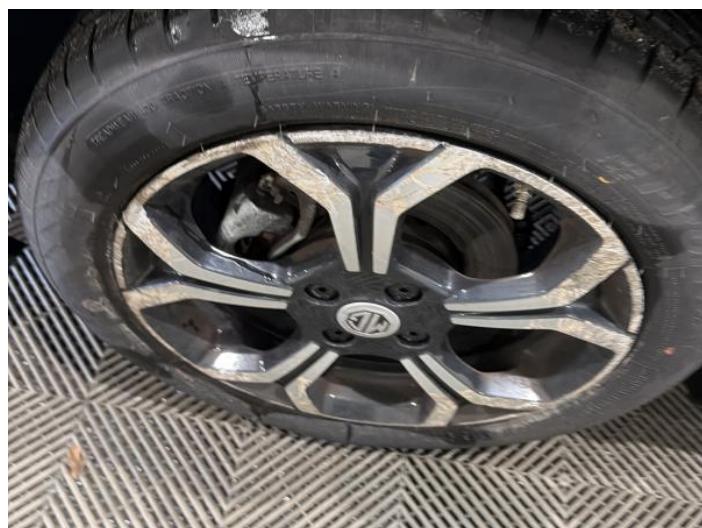
5: Wheel nsf  
Scratched  
Over 50mm

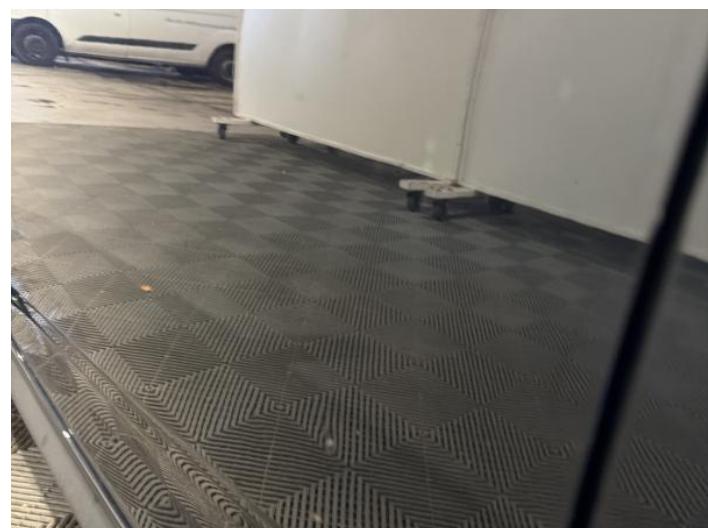
6: Door nsf  
Chipped  
1 To 5

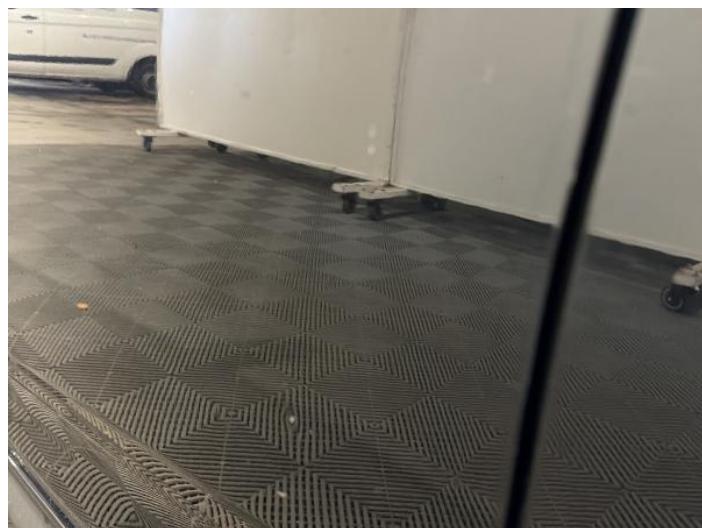
7: Door nsf  
Dented  
Over 2 UpTo 10mm

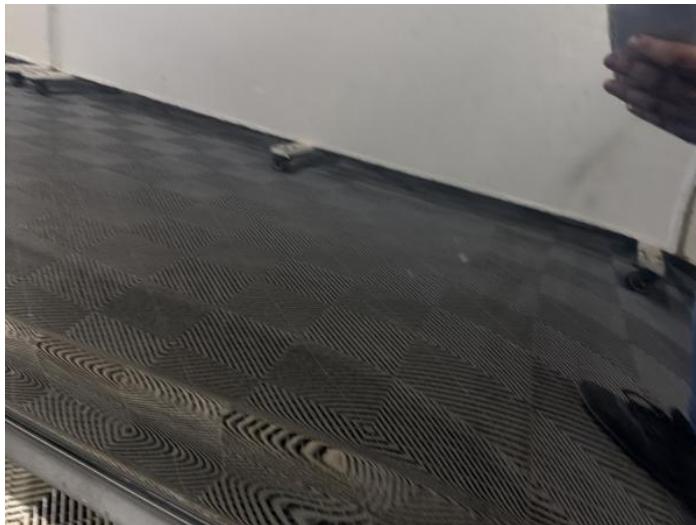
9: Door nsr  
Dented  
With Paint Damage

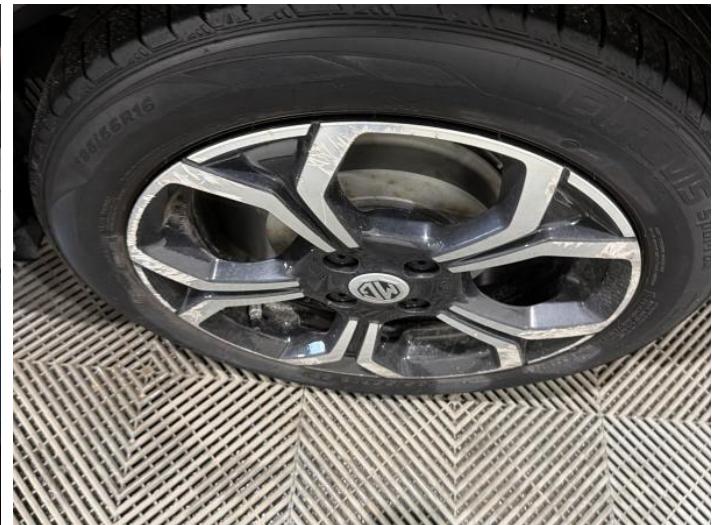
10: Wheel nsr  
Scratched  
Over 50mm

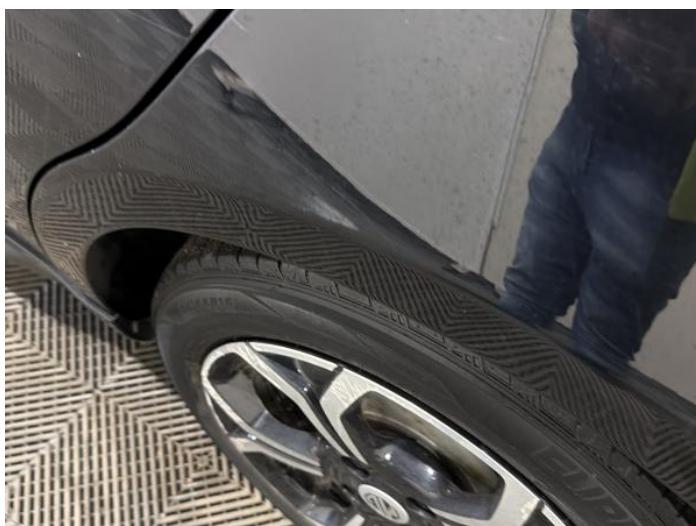
11: Qtr Panel nsr  
Poor Previous Repair  
Poor Paint

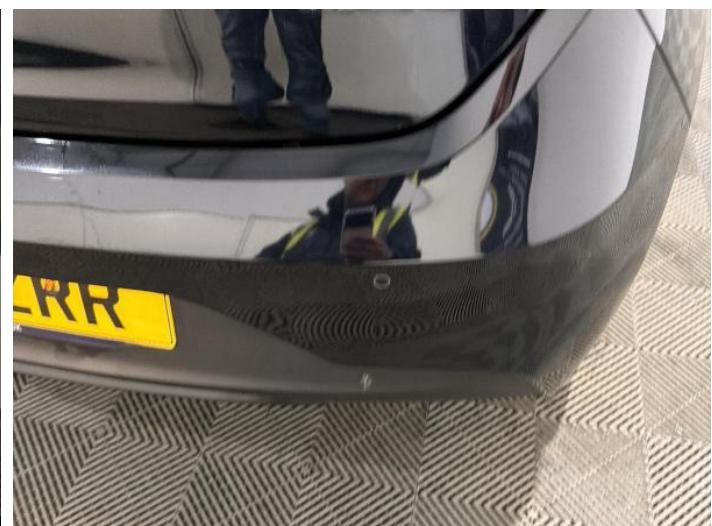
12: Bumper Rear  
Scratched  
25 to 100mm Thru Paint

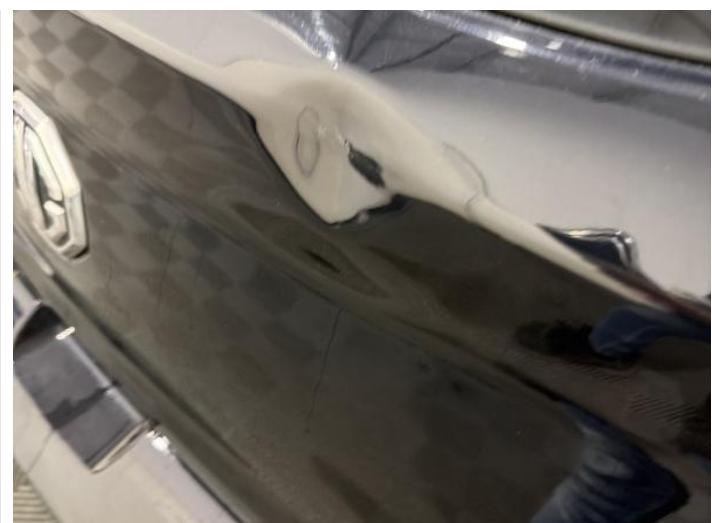
14: Boot Lid  
Dented  
Over 30mm

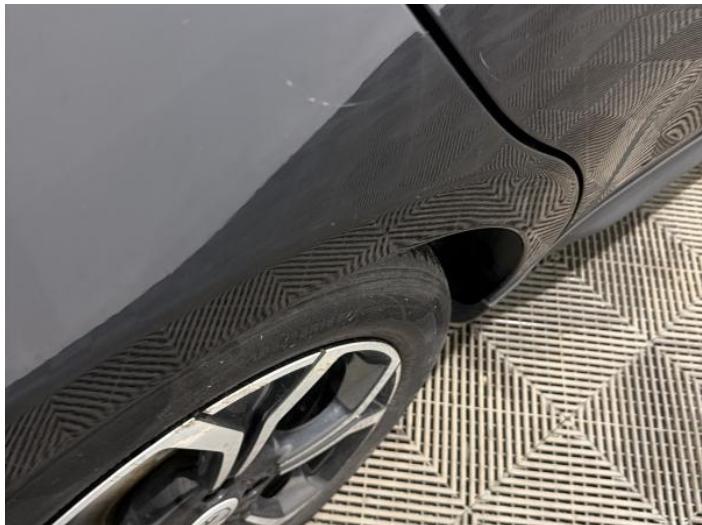
15: Qtr Panel osr  
Dented  
With Paint Damage

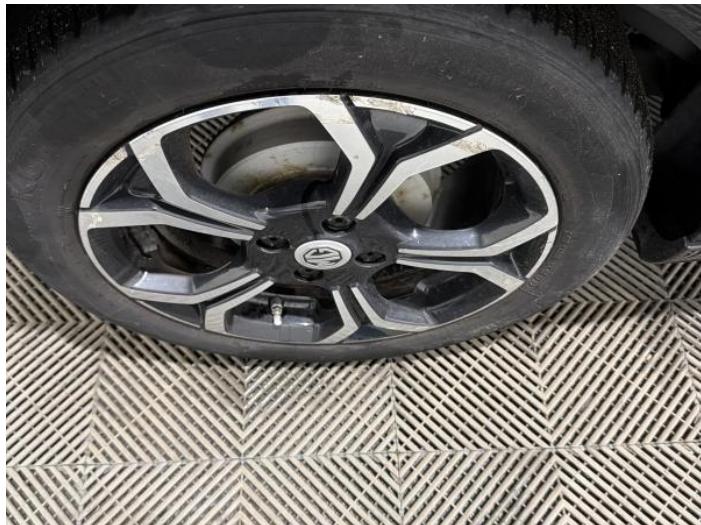
16: Wheel osr  
Scratched  
Over 50mm

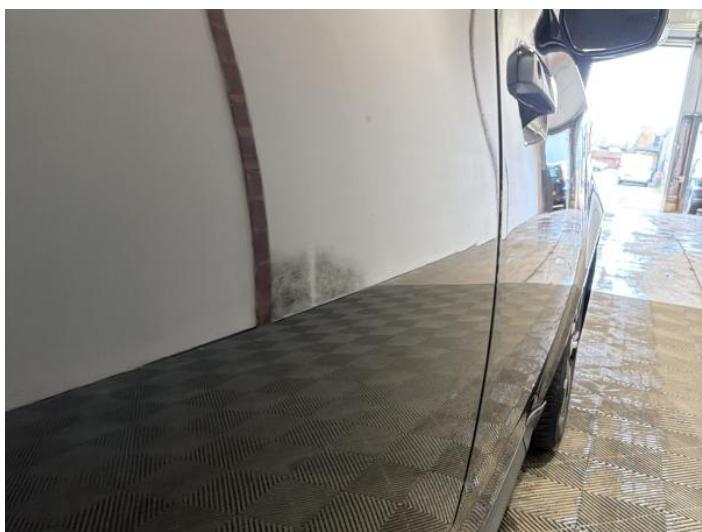
17: Door osr  
Dented  
With Paint Damage

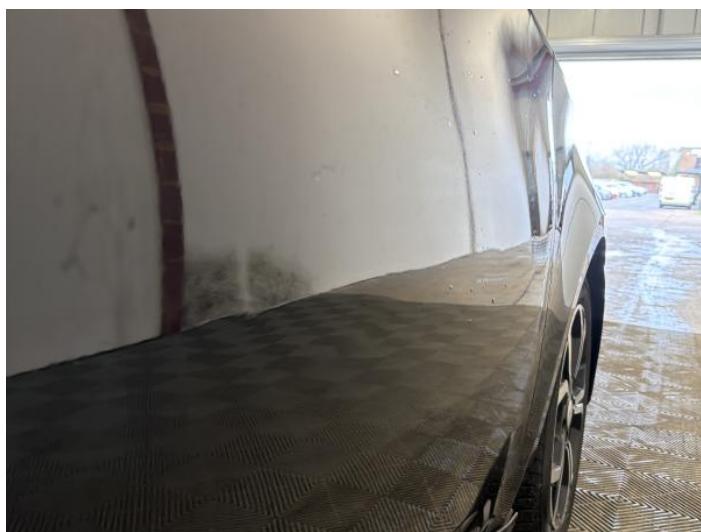
18: Door osf  
Dented  
Over 30mm

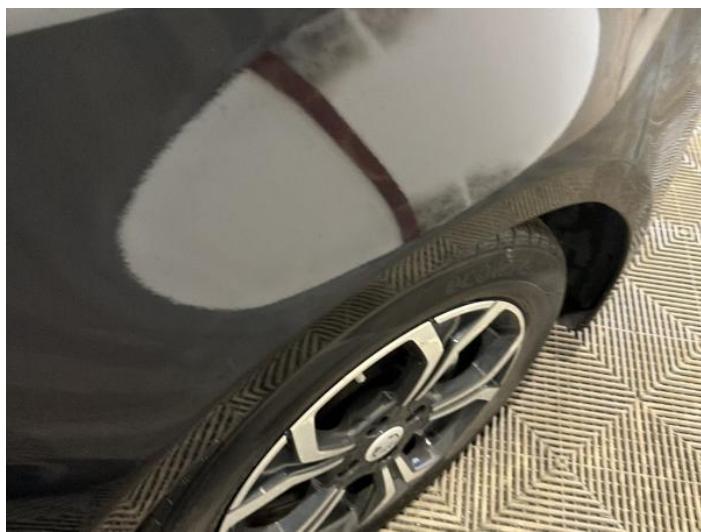
20: Wing osf  
Chipped  
1 To 5
